Incident Summary #II-965949-2020 (#16335) (FINAL)

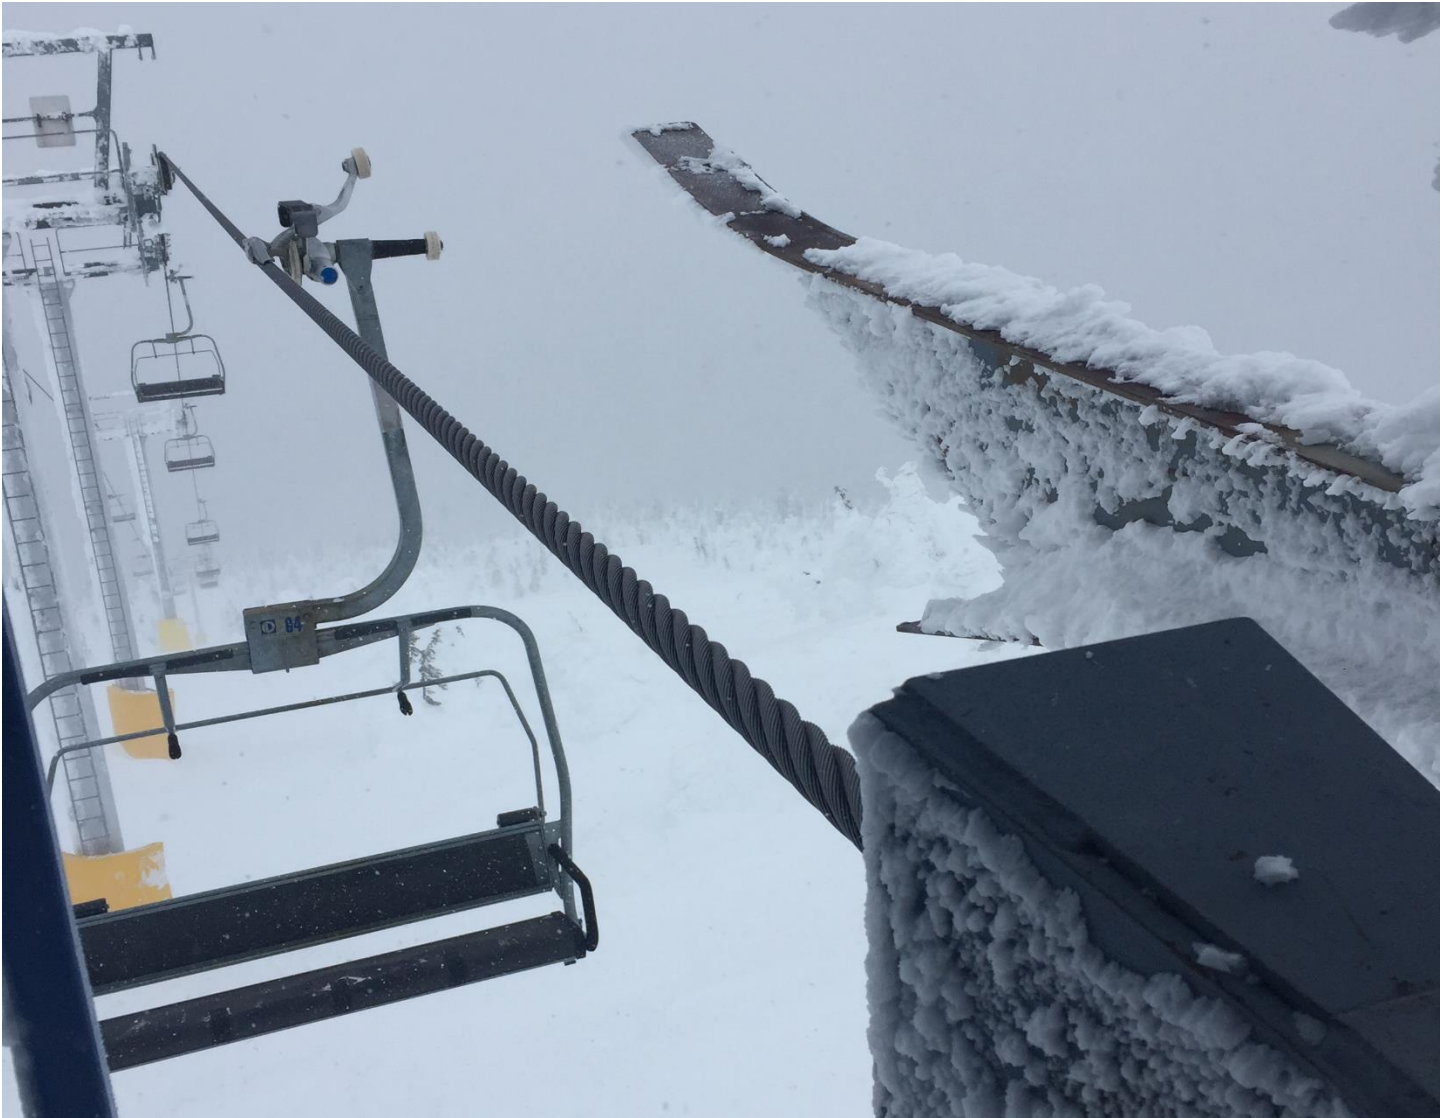
Carrier approaching Terminal entrance

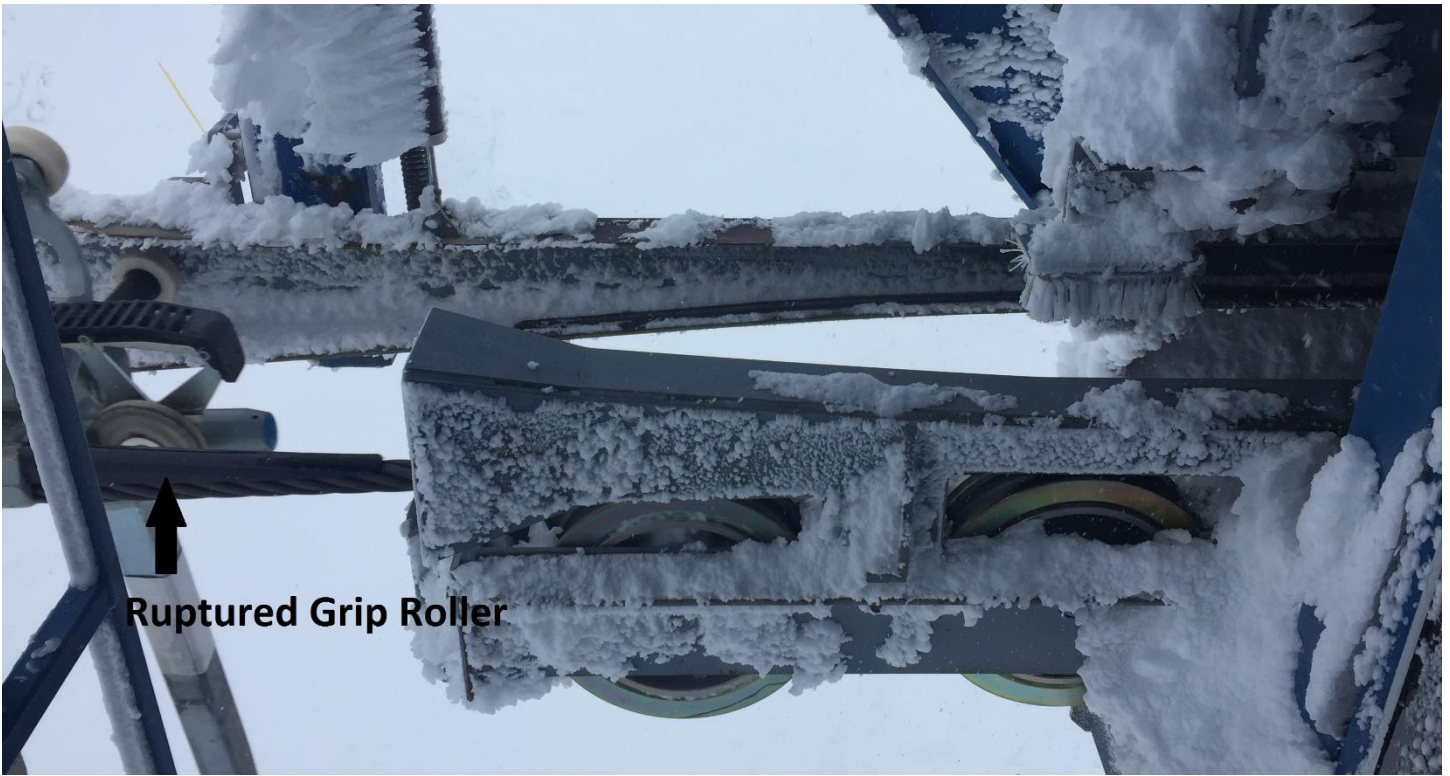
<p>Causes and contributing factors</p>	<p>It is possible that inclement weather, strong wind and freezing rain may have caused a grip rolling element to rupture upon entry into the top terminal. As the wind gauge was inoperable, the ropeway attendant was unable to adhere to operational procedures; this may have contributed to the incident. Replacement of the rolling element bearings may have created stressors to the roller.</p>

Ruptured grip roller

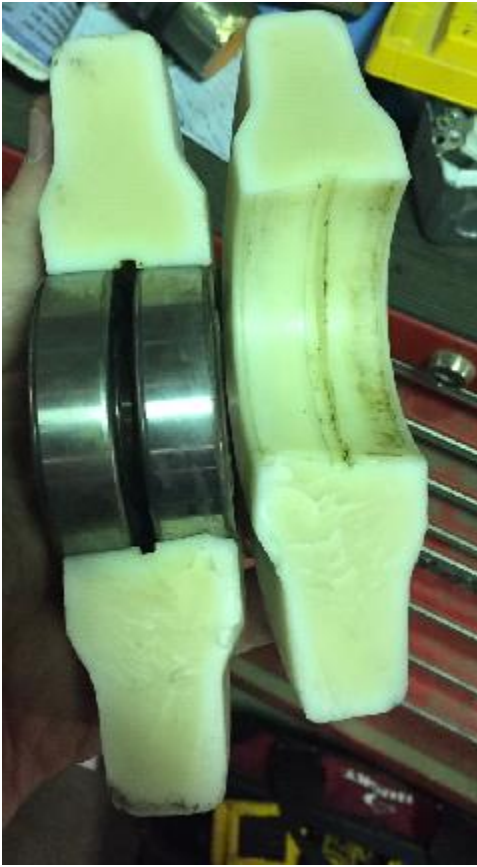
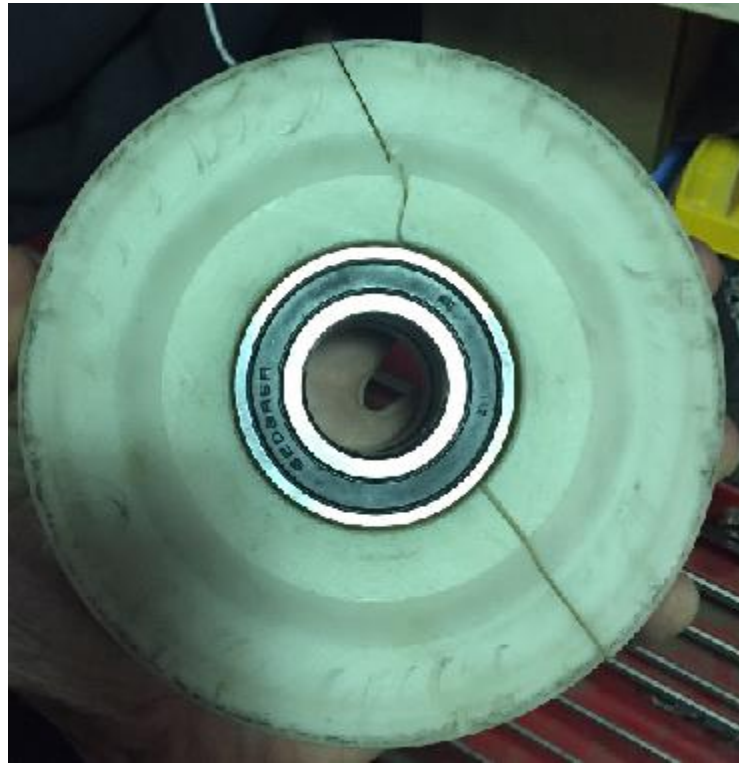
Ruptured grip rolling element

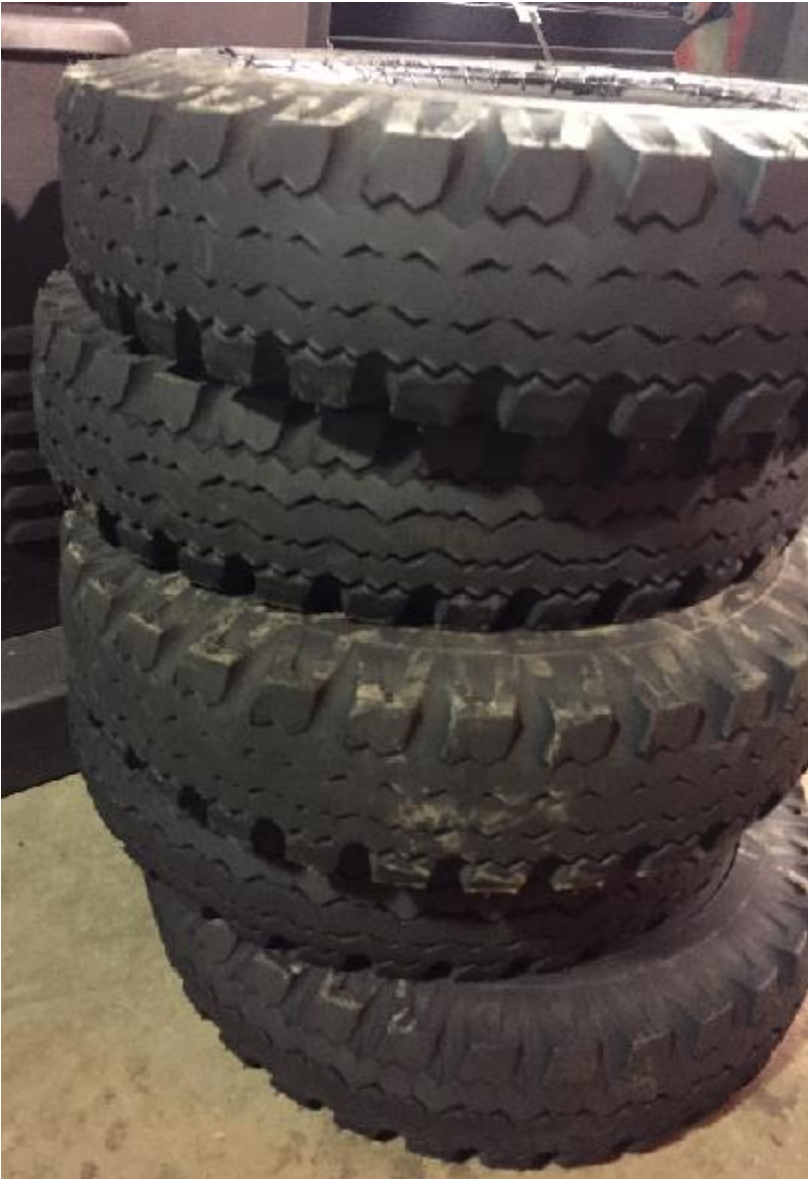
Replaced conveyance rubber tires
