SUPPORTING INFORMATION	Incident Date	August 16, 2023	
	Location	Cowichan Valley	
	Regulated industry sector	Electrical - Low voltage electrical system (30V to 750V)	
	Impact	Qty injuries	1
		Injury description	Person shocked by a live wire.
		Injury rating	Minor
	Damage	Damage description	N/A
		Damage rating	None
Incident rating	Minor		
Incident overview	Homeowner was shocked by live exposed wires when crawling through a crawl space.		
INVESTIGATION CONCLUSIONS	Site, system and components	Baseboard heating circuit decommissioned, and the wires were not properly isolated.	
	Failure scenario(s)	<p>Spring of 2022 an electrical contractor (contractor A) was hired by an HVAC company to run a circuit for a new heat pump at a single-family dwelling.</p> <p>The service was undersized for the new load, so it was decided to remove a baseboard heating circuit to facilitate the addition of the heat pump and use the free space in the panel to connect the circuit breaker for the new heat pump.</p> <p>The base board heating circuit conductors were removed from the breaker, the base board heaters were disconnected and removed, and the conductors were pushed down into the crawl space. The individua

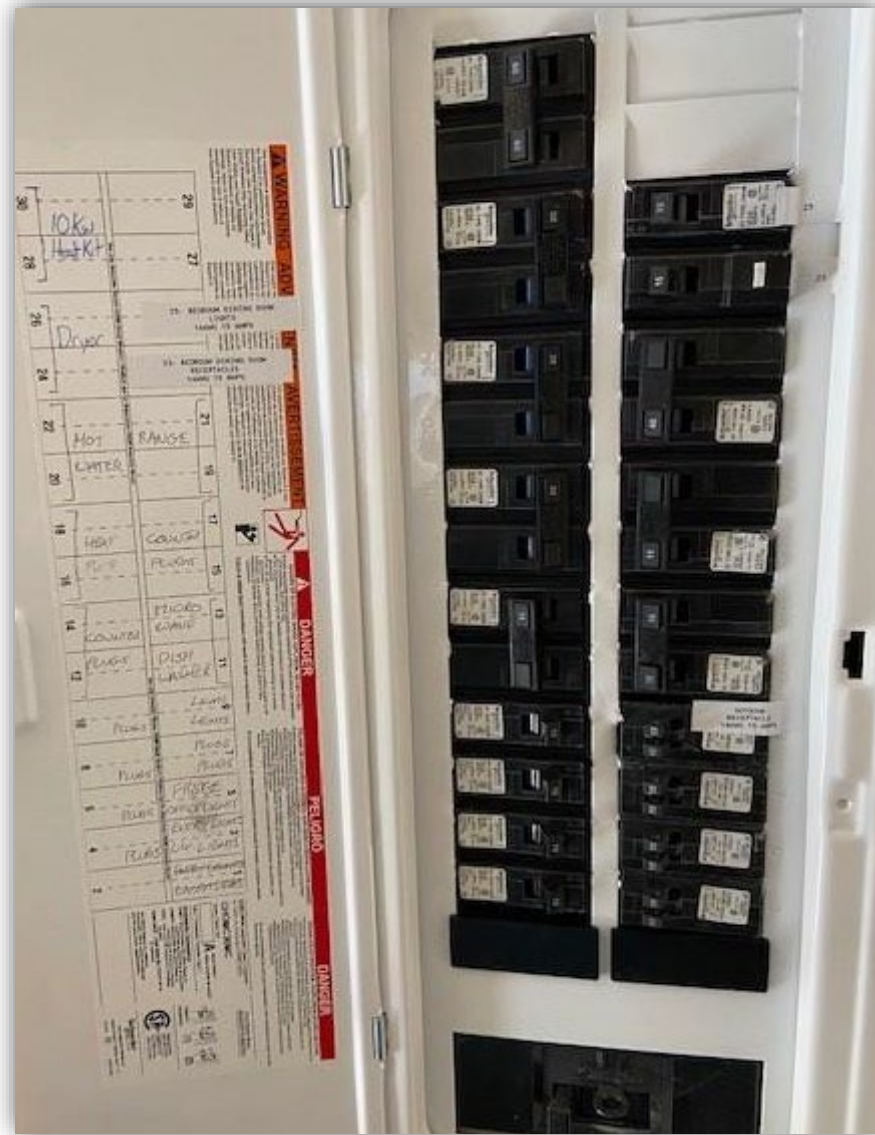
Image 1 - New panel in dwelling.

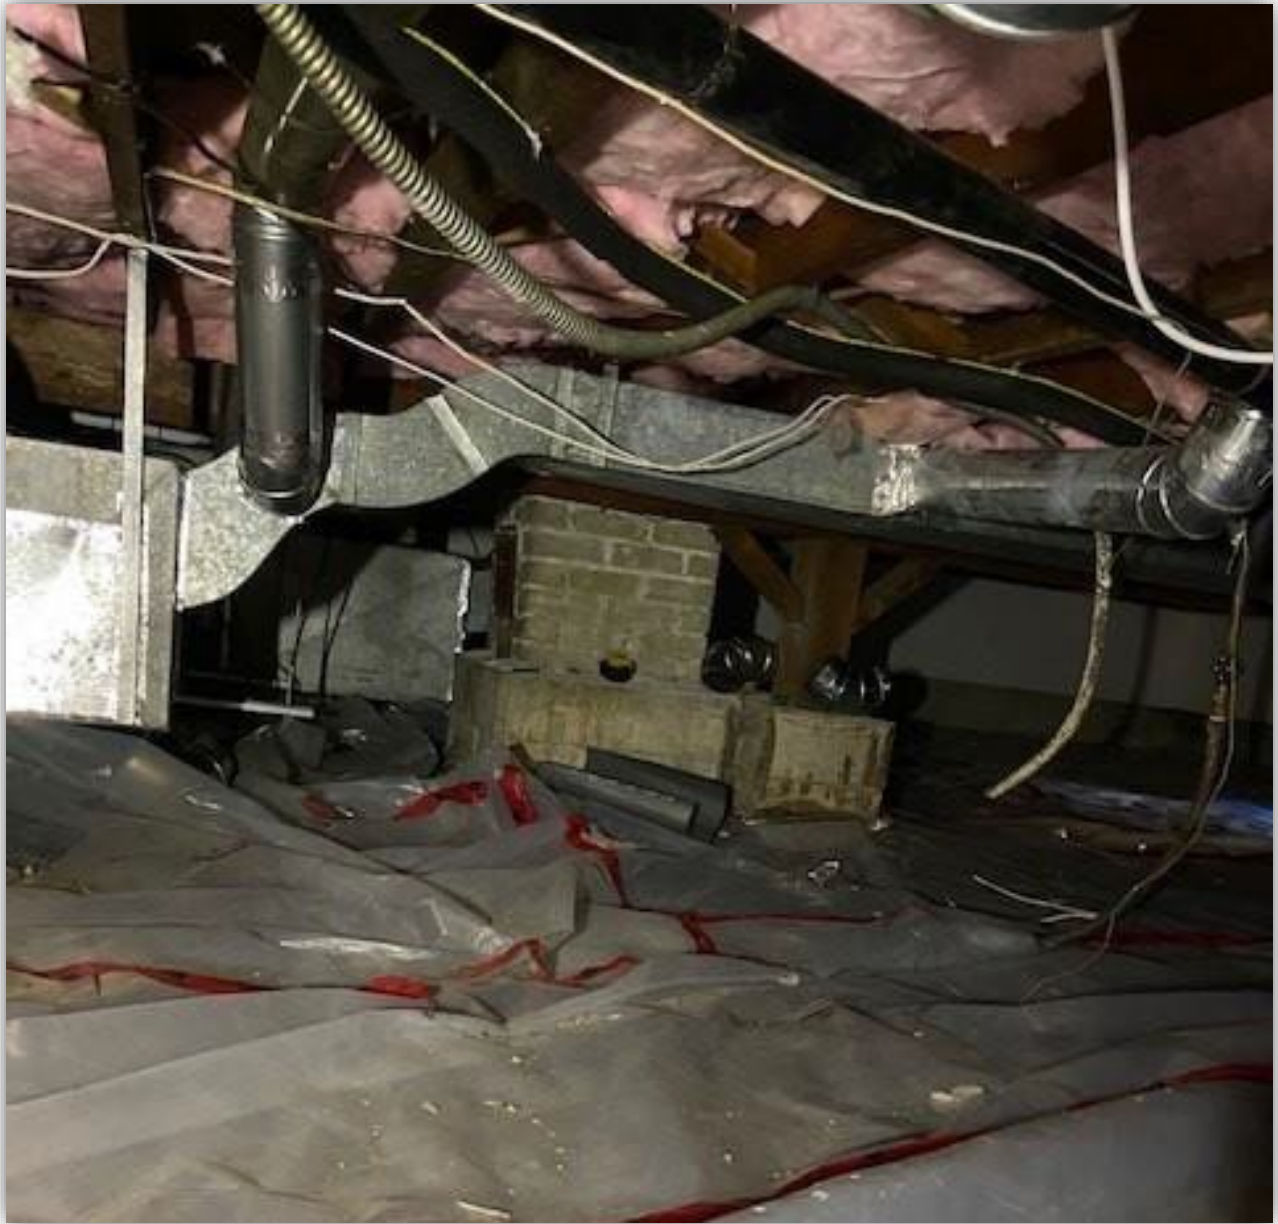
Image 2 - Crawl space where incident occurred.

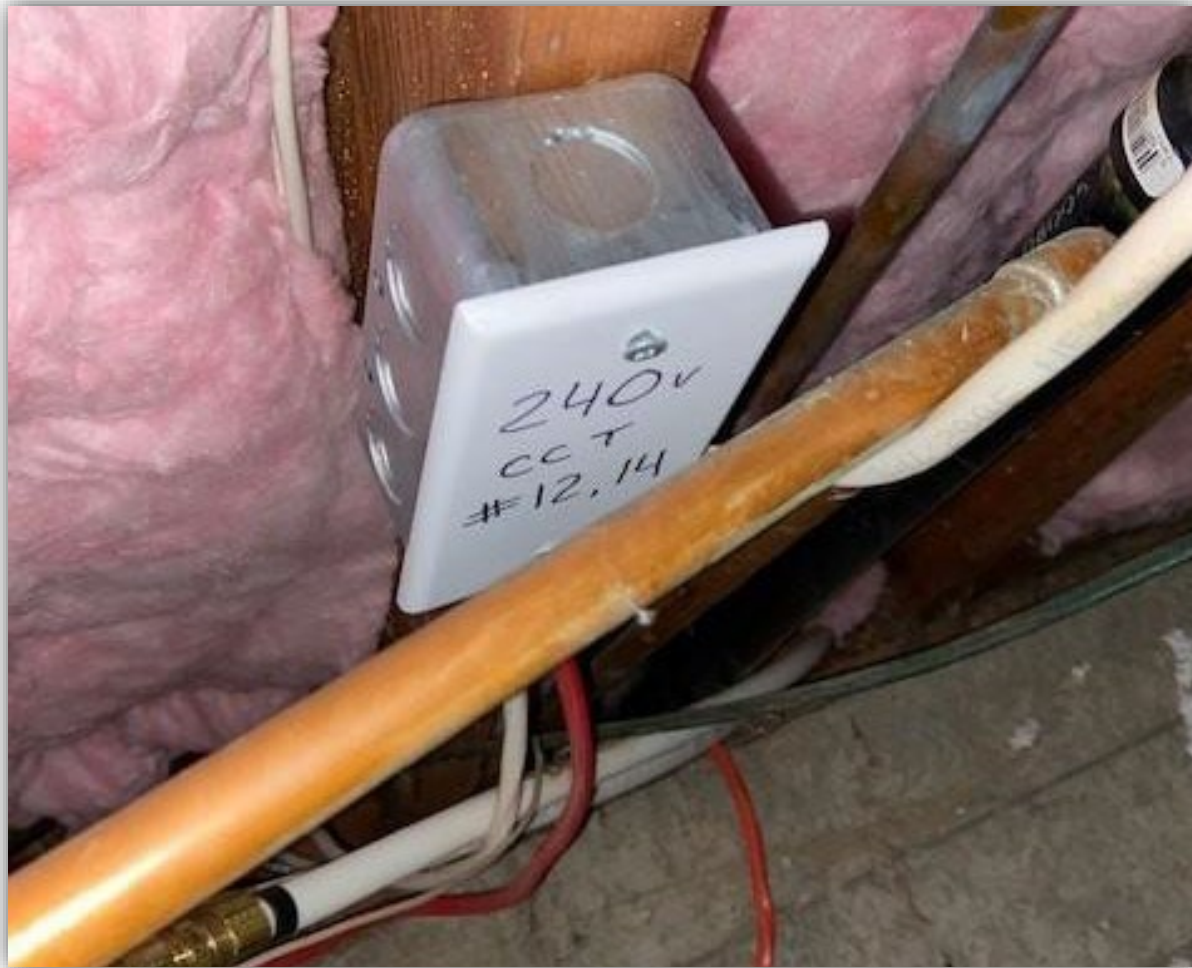
Contractor B failed to recognize that there were energized exposed wires in the crawl space after the panel swap, and the circuit breaker that was feeding the conductors were labeled as "kitchen counter plugs".

Image 3 - 2c #12 wire from panel to crawl that was feeding the exposed circuit.

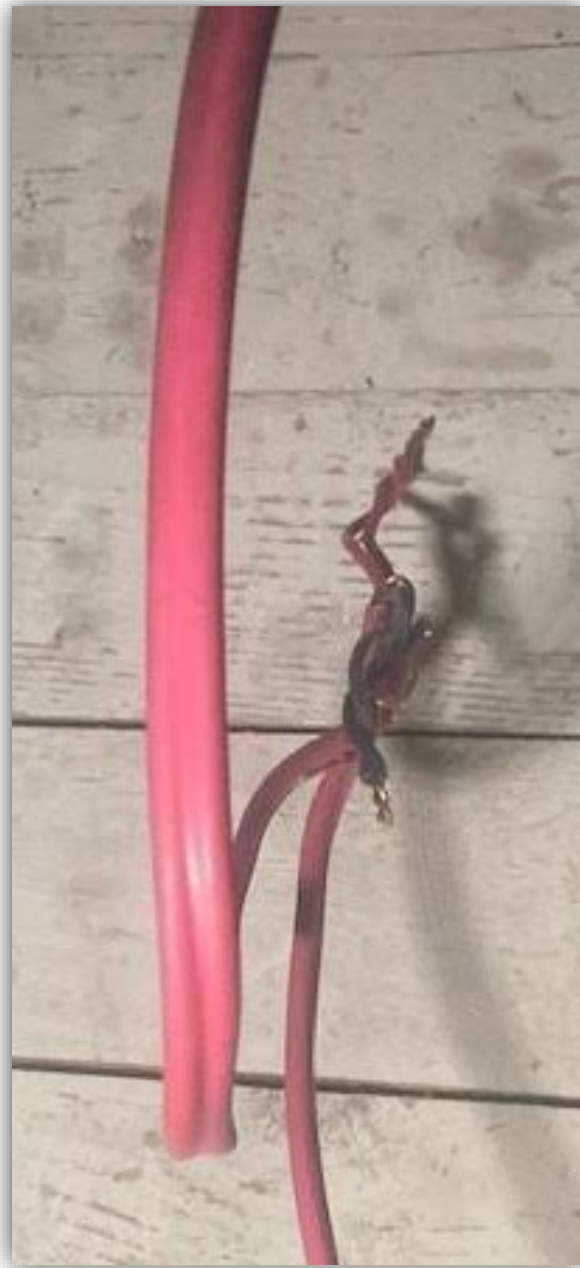
Image 4 - Bare conductors from decommissioned base board heating circuit.

Even though contractor A was coming back to do the service upgrade, the bare wires in the crawl should have been properly dealt with, a minimum safe practice would be to connect all conductors together and cover with insulating tape prior to pushing them down into the crawl space.

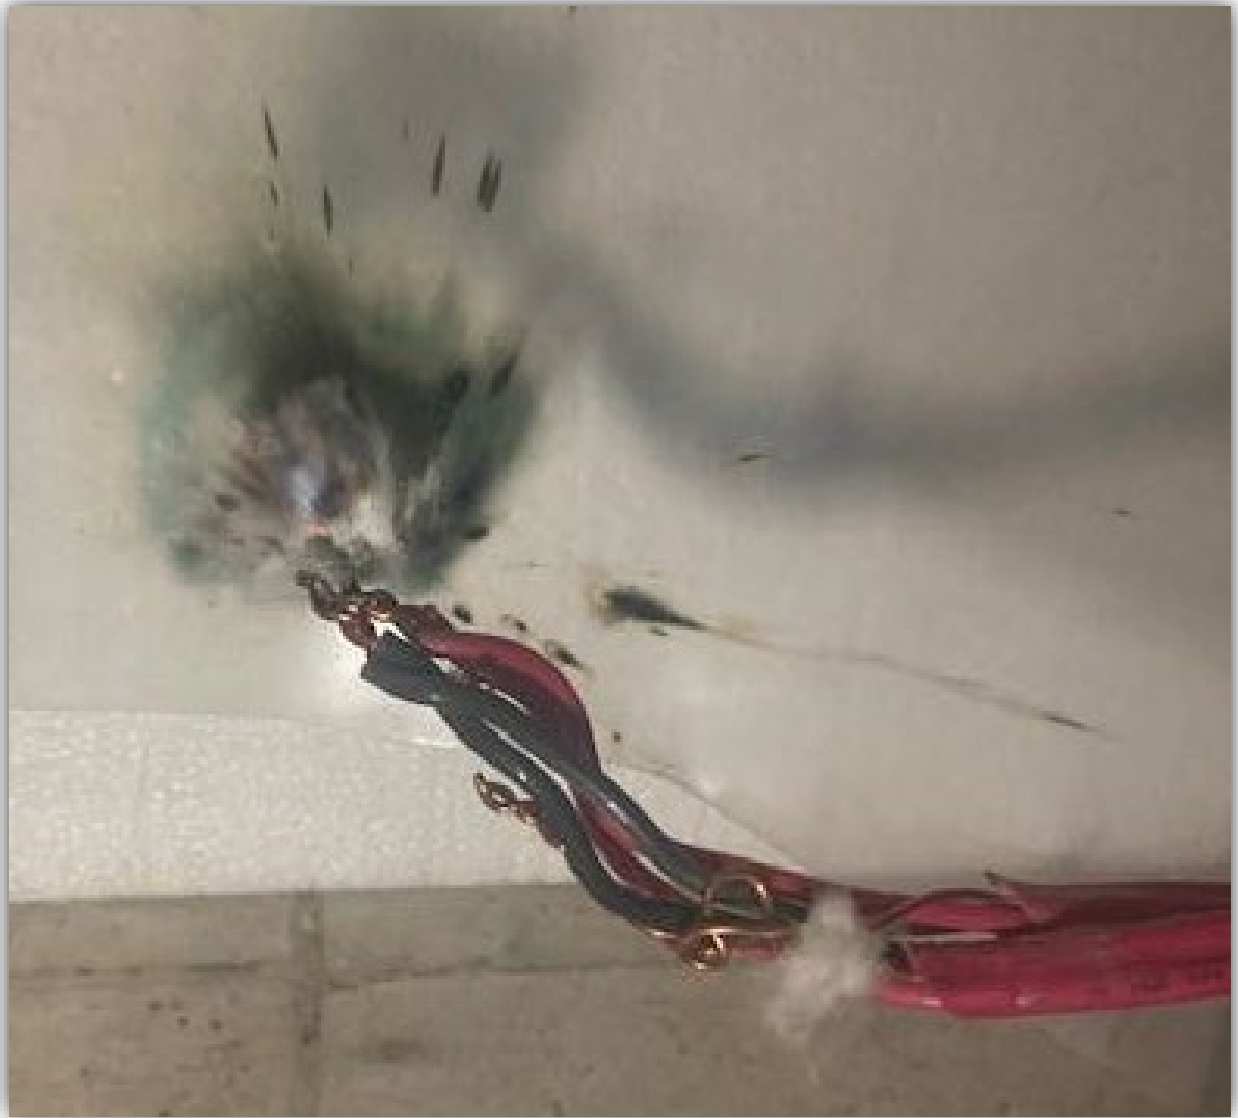
Image 5 - Live conductors that the owner contacted in the crawl space.
