Incident Summary (II-636367-2018)

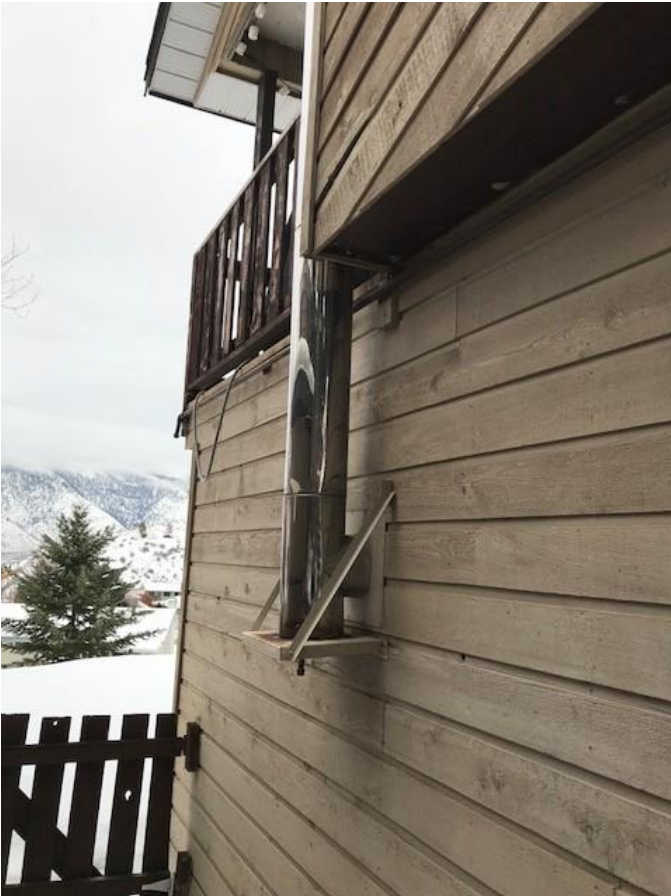
Causes and contributing factors	The chimney is located on the outside of the house and is approximately 20 feet in height extending above the roof line of the house and is not enclosed. This would allow the four inch flexible liner to remain cold within the 6 inch chimney. At the bottom of the chimney the base tee is open which would allow cold air to travel down the outside of the flexible liner keeping it colder. Without the hot air able to rise up the chimney by way of a draft it is likely the products of combustion were forced to vent inside the home.

Bottom section of vent and chimney base tee

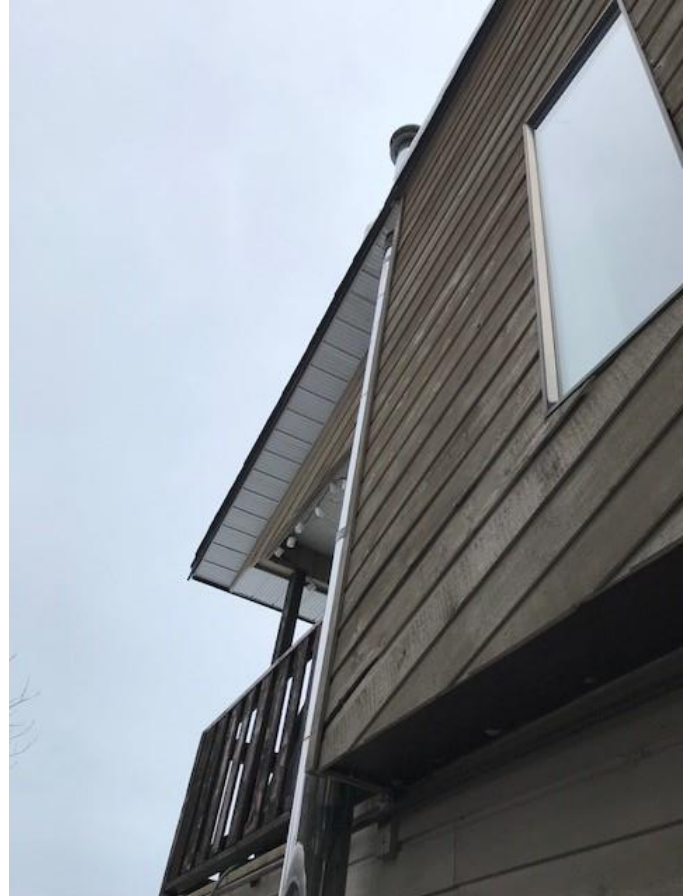
Top section of vent

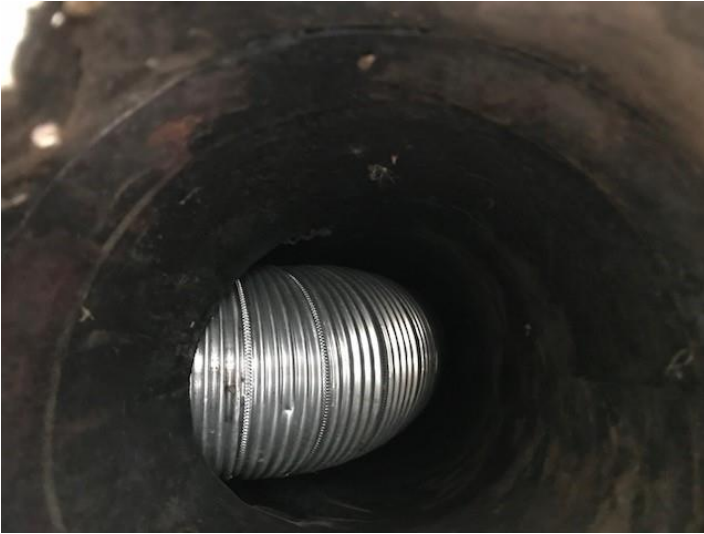
4" flexible liner inside 6" chimney
