Incident Summary #II-784543-2018 (#9424) (FINAL)

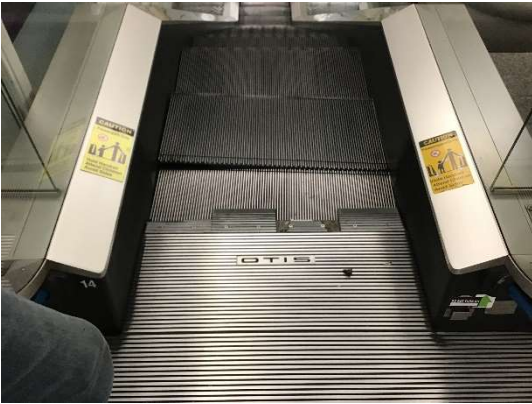
Causes and contributing factors	The damage shows that the external force likely exceeded the maximum allowable forces permissible to the combplate section.

Damage to steps and combplate section.

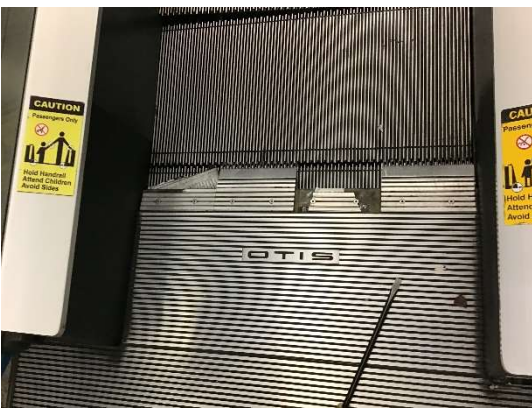
Damaged combplate sections.

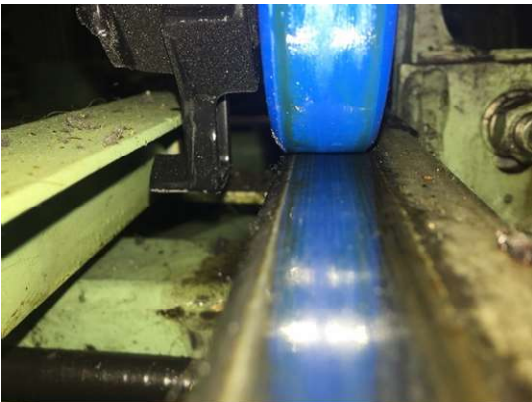
Failure scenario(s)	<p>Upthrust retainer track gap to step retainer may exceed manufacture specifications. Step chain retainer track gap to step chain rollers may exceed manufacture specifications.</p> <p>It is also speculated that an external force may have been applied to the combplate section which allowed the combplate to make contact with the step tread. Combplate sections are required to perform when a maximum allowable force of 160 kg (350 lb) is applied to any area on the plate 300mm (12 in.) dimension parallel to the direction of travel. If this force is exceeded, then the combplate would flex and make contact with the step tread.</p>	
	Facts and evidence	<p>Up thrust track clearance was adjusted to meet manufacture specification. Step chain track clearance was within manufacture specification.</p> <p>The combplate sections may not meet code requirements for forces applied parallel to the direction of travel. Maintenance provider is now using a new manufacture for combplate sections.</p> <p>For the step tread to contact the combplate assembly, the upthrust track and the step chain track clearance would both have had to exceed the manufacture specifications. If the upthrust track and the step chain track failed, the step tread would have contacted the entire combplate assembly.</p> <p>It had been previously witnessed that freight operators were using the escalator to transport freight from one level to the next using the escalator</p>

Upthrust track retainer before adjustment.

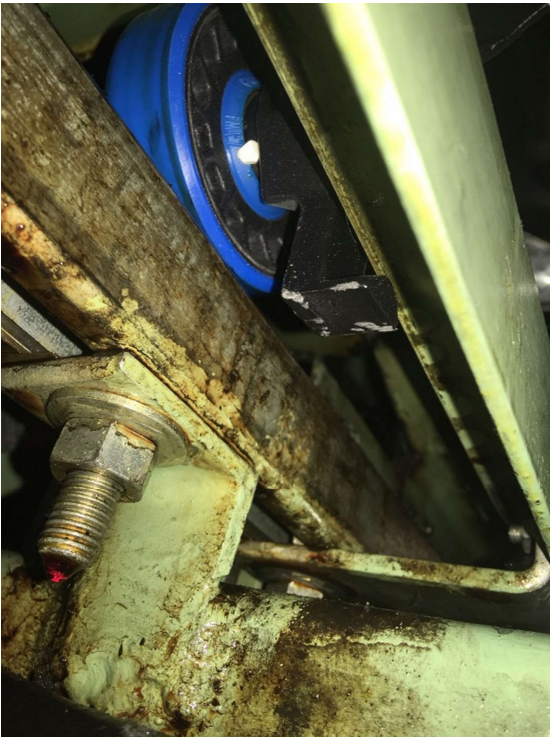
Upthrust track after adjustment.

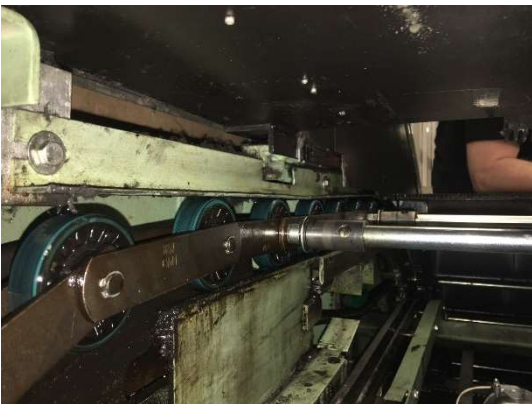
Step chain retainer track.

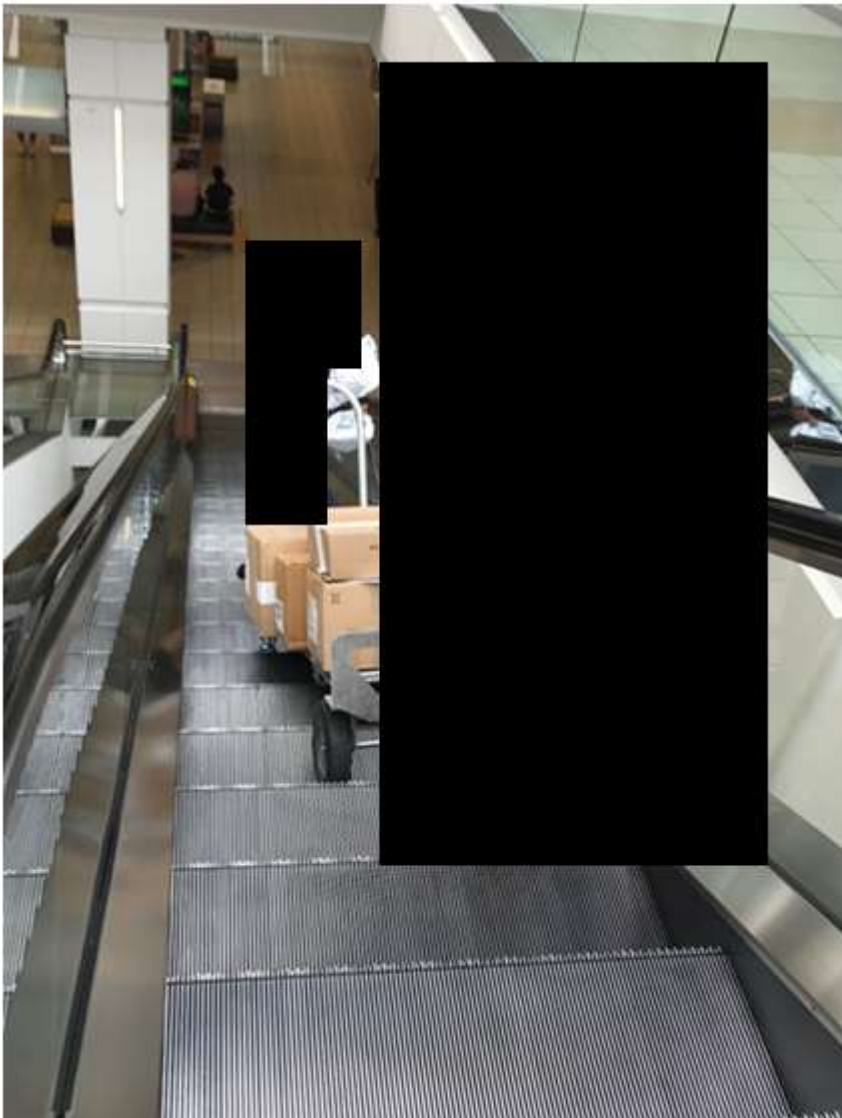
Freight being transported on escalator.
