Incident Summary #II-1604791-2023 (#39000) (FINAL)

SUPPORTING INFORMATION	Incident Date	September 14, 2023	
	Location	Mission	
	Regulated industry sector	Electrical - Low voltage electrical system (30V to 750V)	
	Impact	Qty injuries	0
		Injury description	N/A
		Injury rating	None
	Damage	Damage description	Outer jacket burned, crimp from utility melted and minor fire damage to the wooden building structure and wooden service post. Damaged overhead consumer service cable insulation and utility connection point.
		Damage rating	Minor
	Incident rating	Minor	
	Incident overview	The connection point from the utility supply conductor to the main consumer service conductor failed and ignited accumulated wood dust between the roof and soffit area at a pallet manufacturing facility.	
INVESTIGATION CONCLUSIONS	Site, system and components	<p>Site:</p> <ul style="list-style-type: none"> A pallet manufacturing facility with lighting and wood manufacturing equipment such as saws, compressors, dust collectors. <p>Components:</p> <ul style="list-style-type: none"> 400 Amp, 120/208 Volt, 3 Phase, overhead service. Appears to be 4/0 AWG single conductor, armoured cables installed from the service c

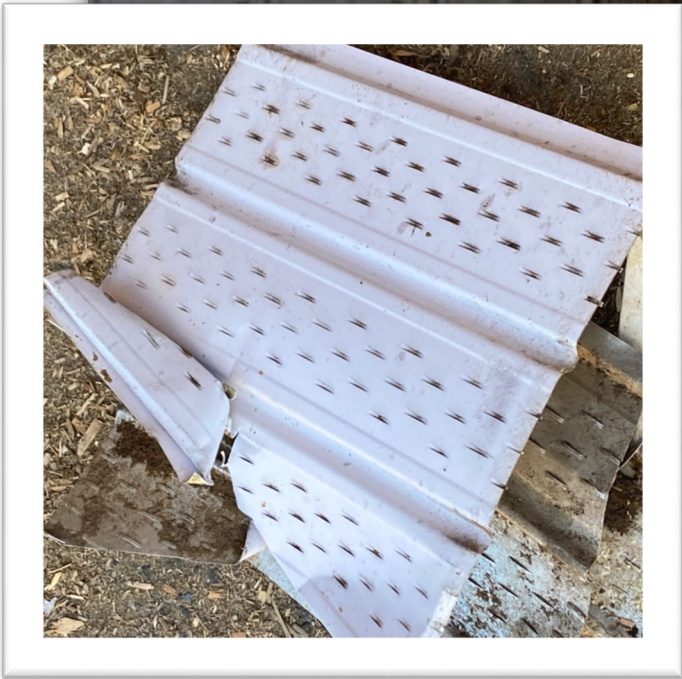
Image 1 – Soffit removed by the fire department.

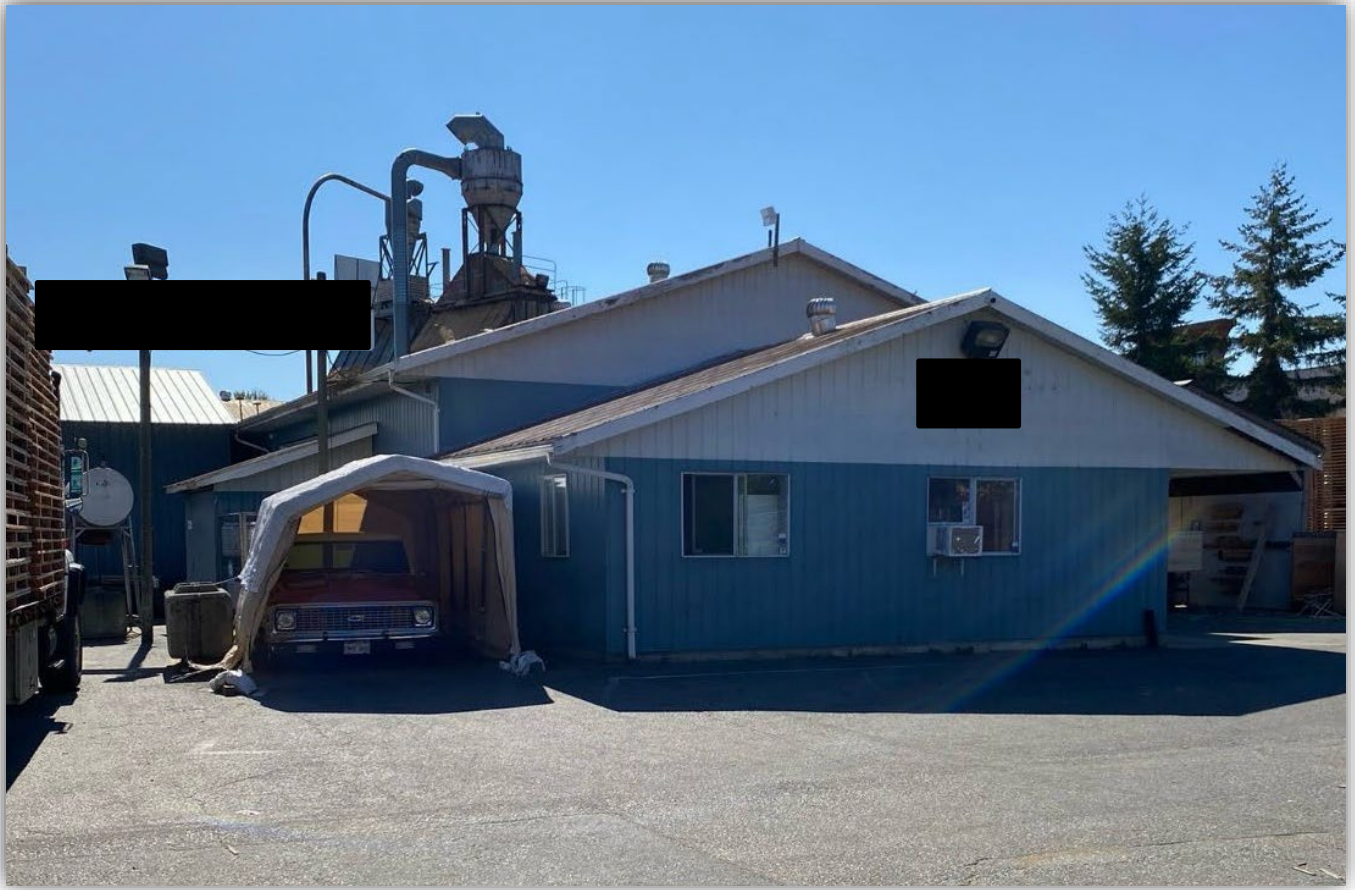
Image 2 – Pallet manufacturing facility.

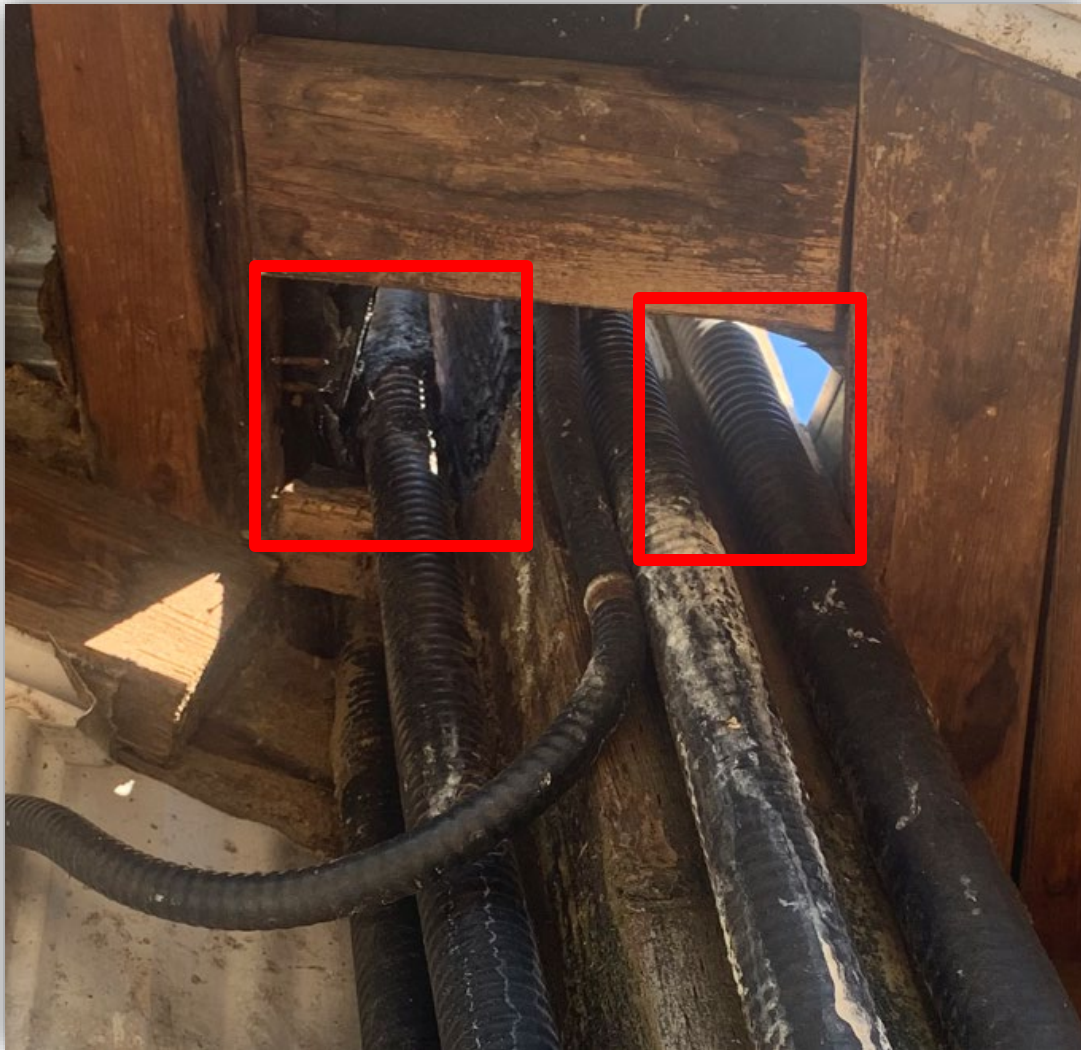
Causes and contributing factors	<p>It's likely that loose service conductor connections combined with loading on the service conductors overheated and melted the service conductor connections, copper and aluminum service conductors, and conductor insulation. Hot material dripping into the roof/soffit area ignited dry wood dust.</p> <p>A contributing factor may have been warm dry weather, prior to the incident, drying the accumulated wood dust that had collected inside the soffit area below the melted connections.</p>

Image 3 – Gaps for dust to enter between the roof and the soffit.

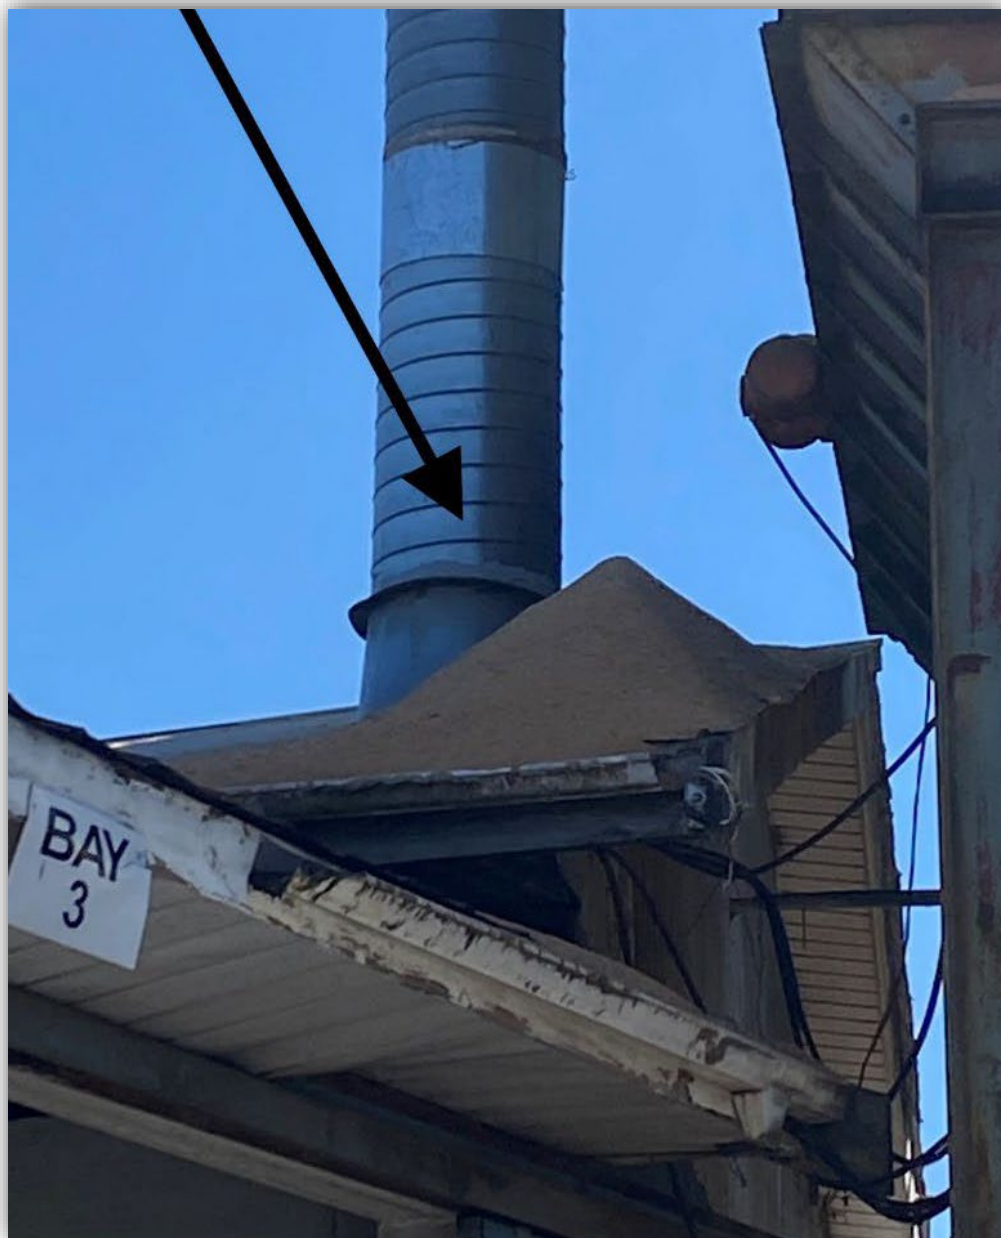
Image 5 – Dust accumulated on the roof.

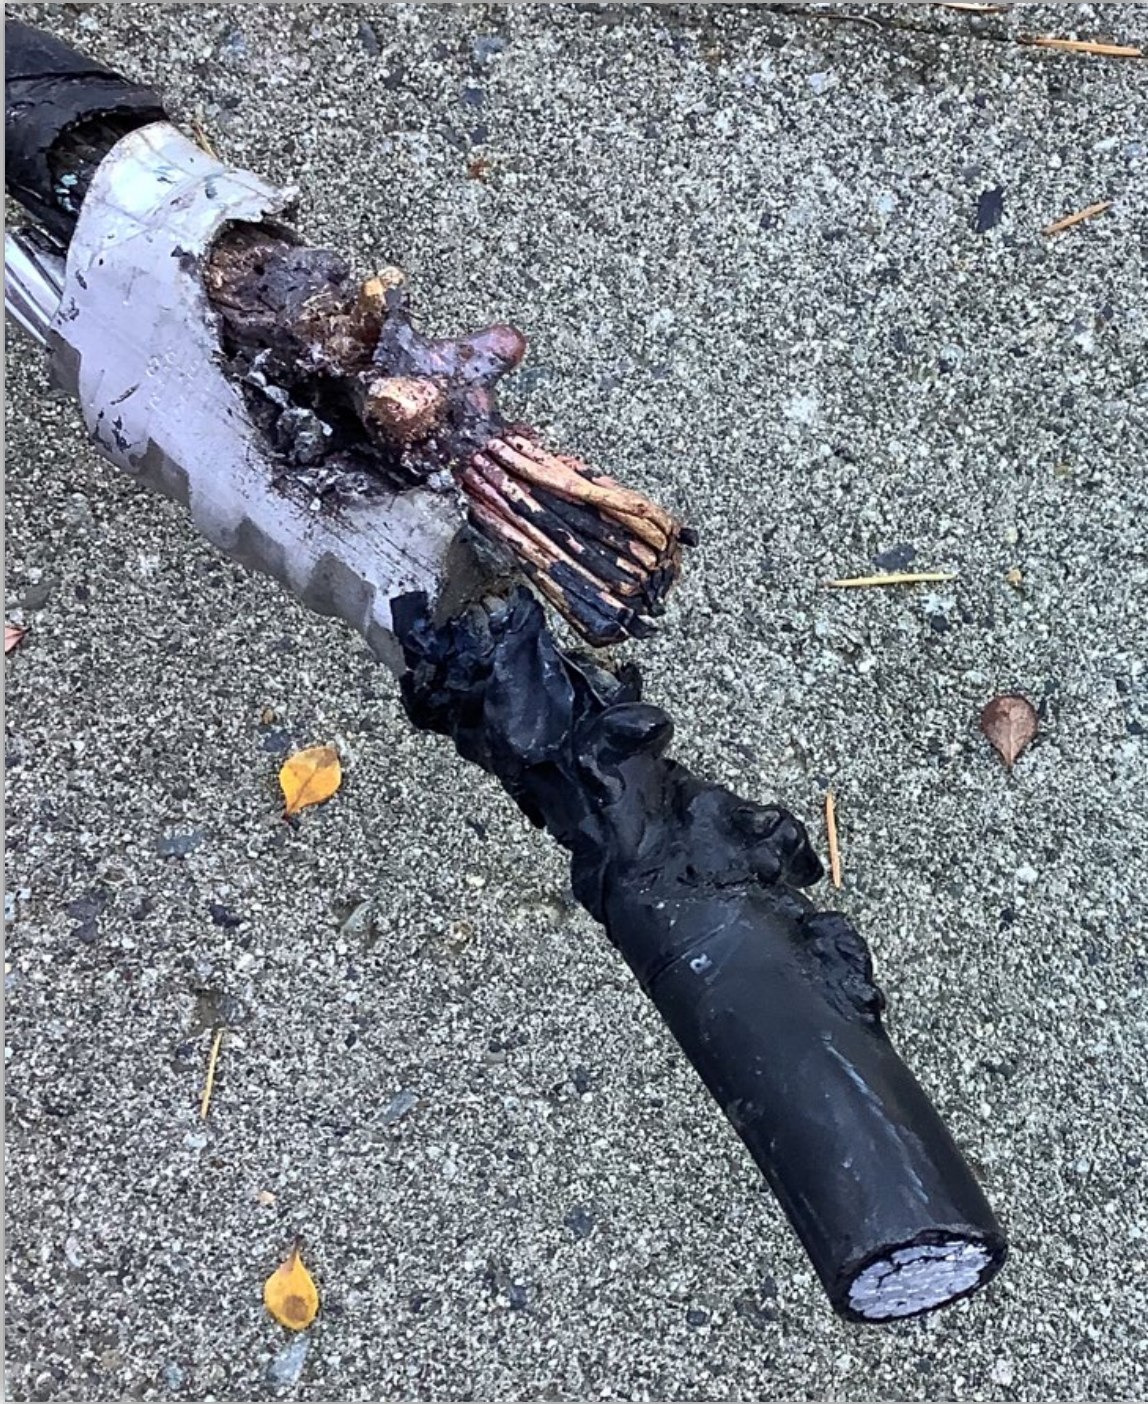
Failure scenario(s)	<p>Over time, the overhead utility supply conductors and service conductors became loose and heat was likely building up eventually to the point where the crimp failed.</p> <p>When the crimp melted, and the service conductor overheated molten aluminum and copper likely fell into the opening around the service post. Wood dust may have been collecting there and was ignited.</p>

Image 6 – Molten drips and melted insulation.

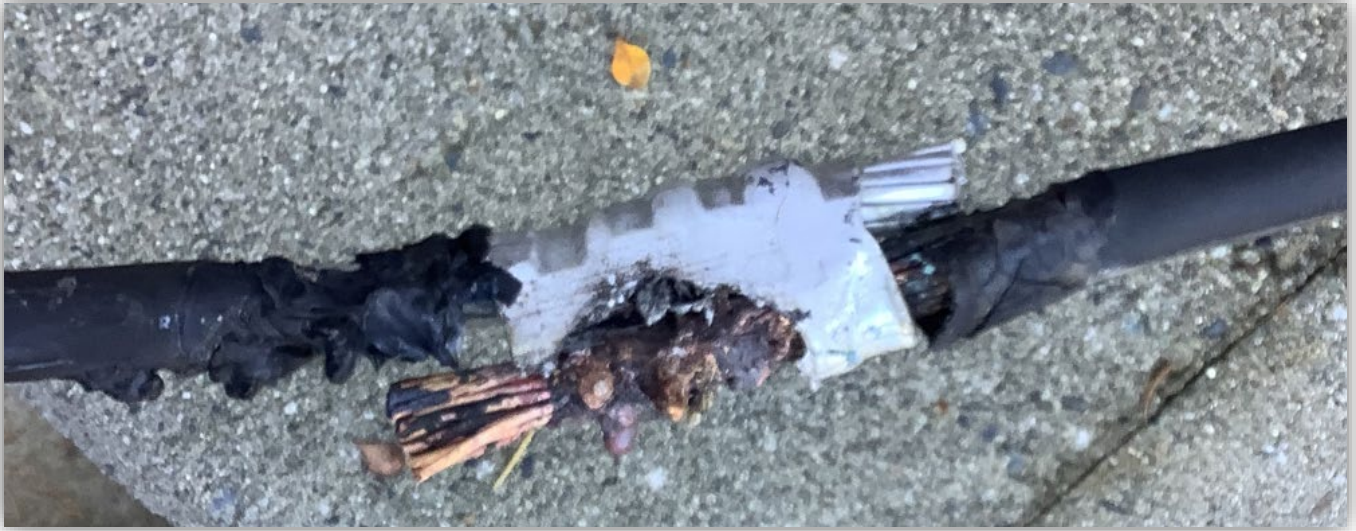
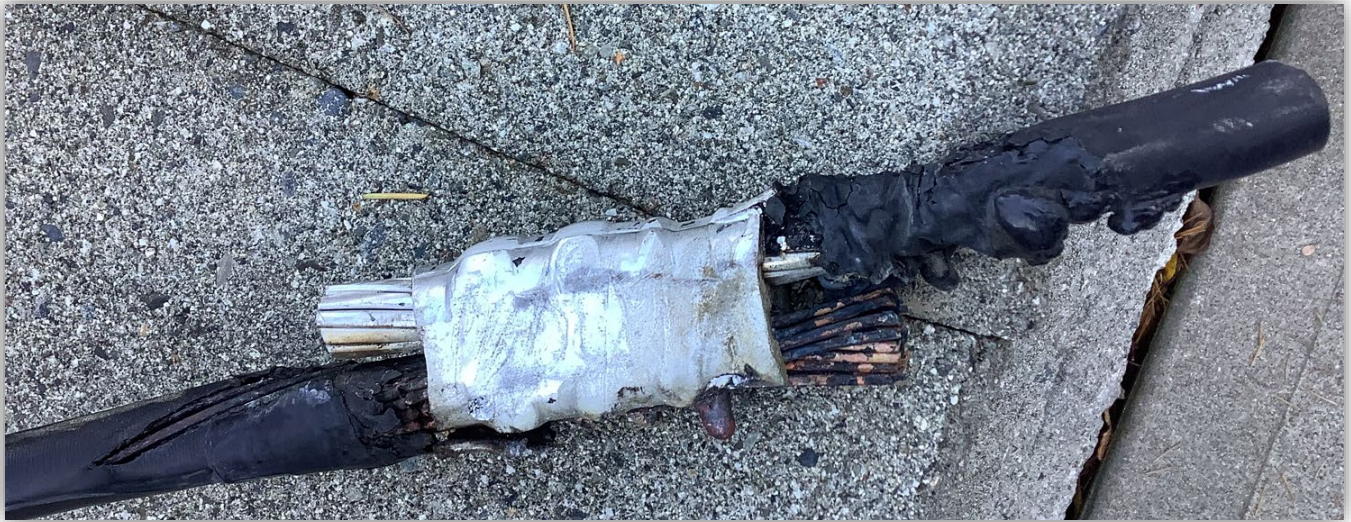
Image 7 - Failed crimp.
