Incident Summary #II-1454740-2022 (#30195) (FINAL)

SUPPORTING INFORMATION	Incident Date	October 20, 2022	
	Location	Golden, BC	
	Regulated industry sector	Electrical - Low voltage electrical system (30V to 750V)	
	Impact	Qty injuries	0
		Injury description	N/A
		Injury rating	None
	Damage	Damage description	Electrical short damage to transformer is non-reparable causing a permanent loss of equipment and temporary loss of operations.
		Damage rating	Moderate
	Incident rating	Moderate	
	Incident overview	<p>During an underground installation at the site, the excavator equipment while digging hooked the transformer grounding conductor and ground plate. The force applied to the grounding conductor caused the transformer coils and terminations to physically shift.</p> <p>Damage beyond repair occurred to the internal components of the transformer resulting in an electrical short.</p>	
INVESTIGATION CONCLUSIONS	Site, system and components	<p>Different components of an electrical system need different voltages that may not be readily available by the supply authority. When these voltages are not available, a transformer will be installed to step-up or step-down the voltages as required.</

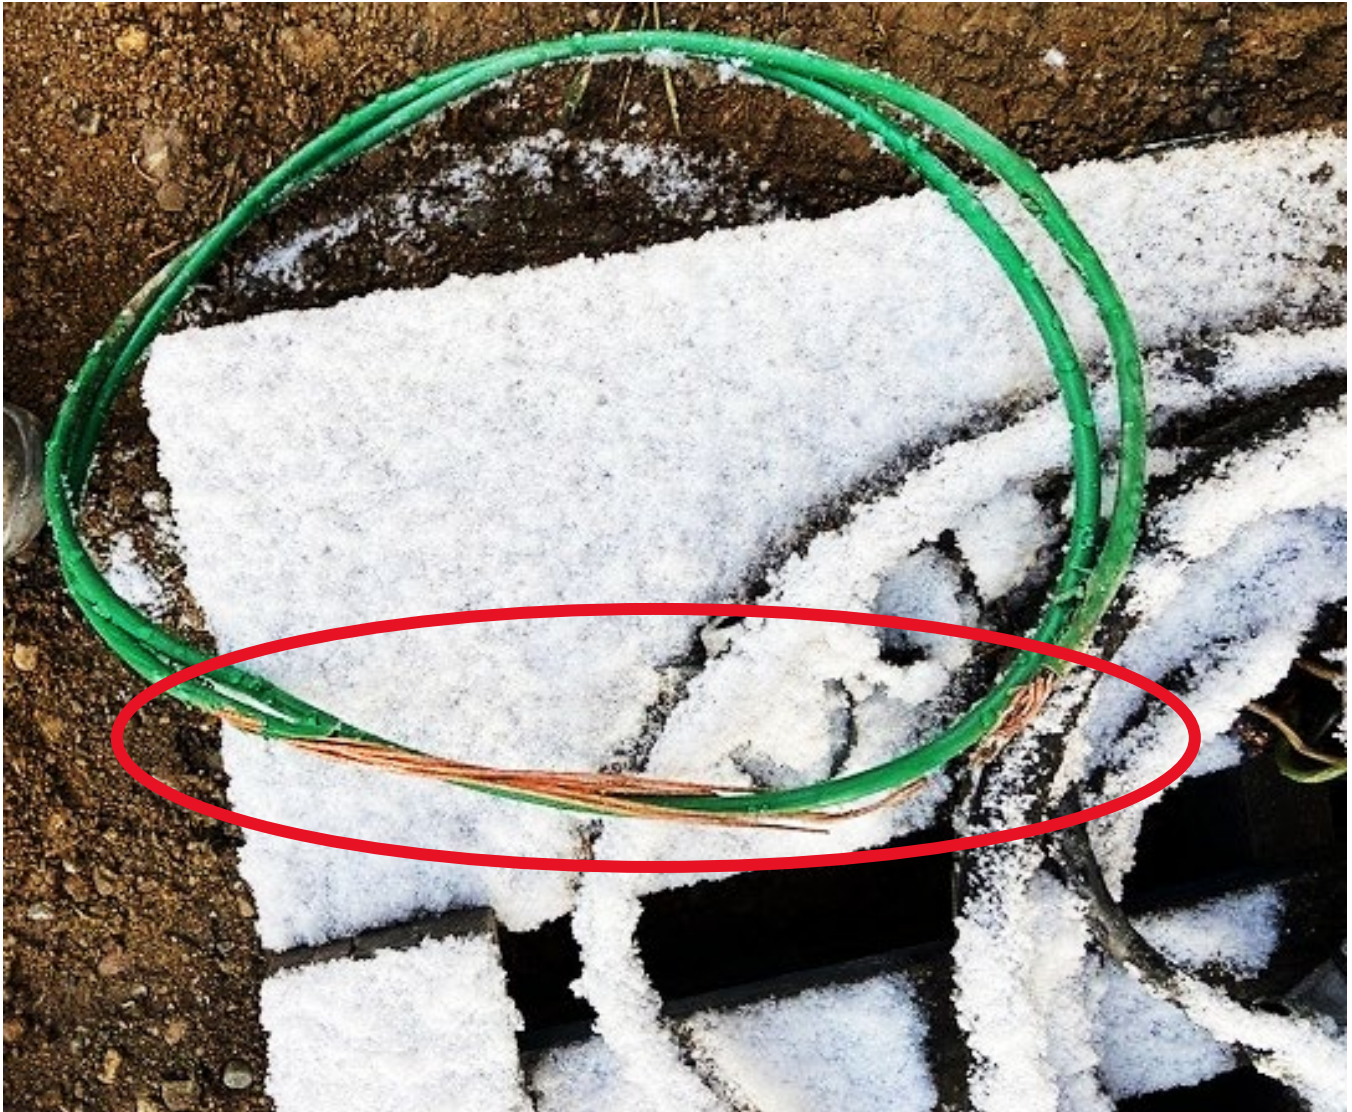
Photo 1 - Exposed copper is due to strain on conductor from excessive force from excavator.

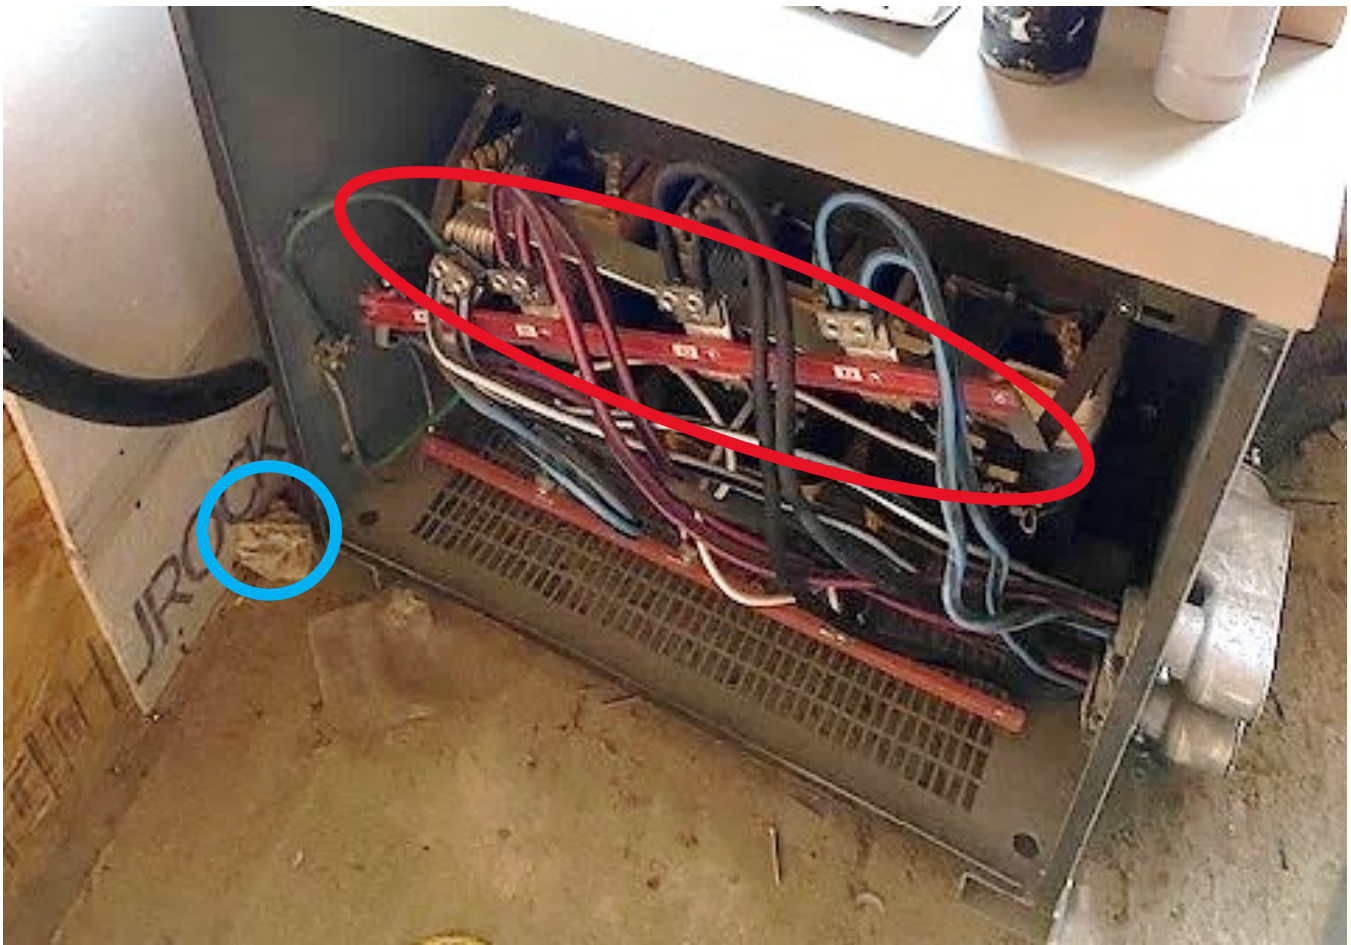
Photo 2 - BLUE - 4" clockwise rotation of transformer due to grounding conductor being pulled on. **RED** - Damaged secondary insulating bar should be level.

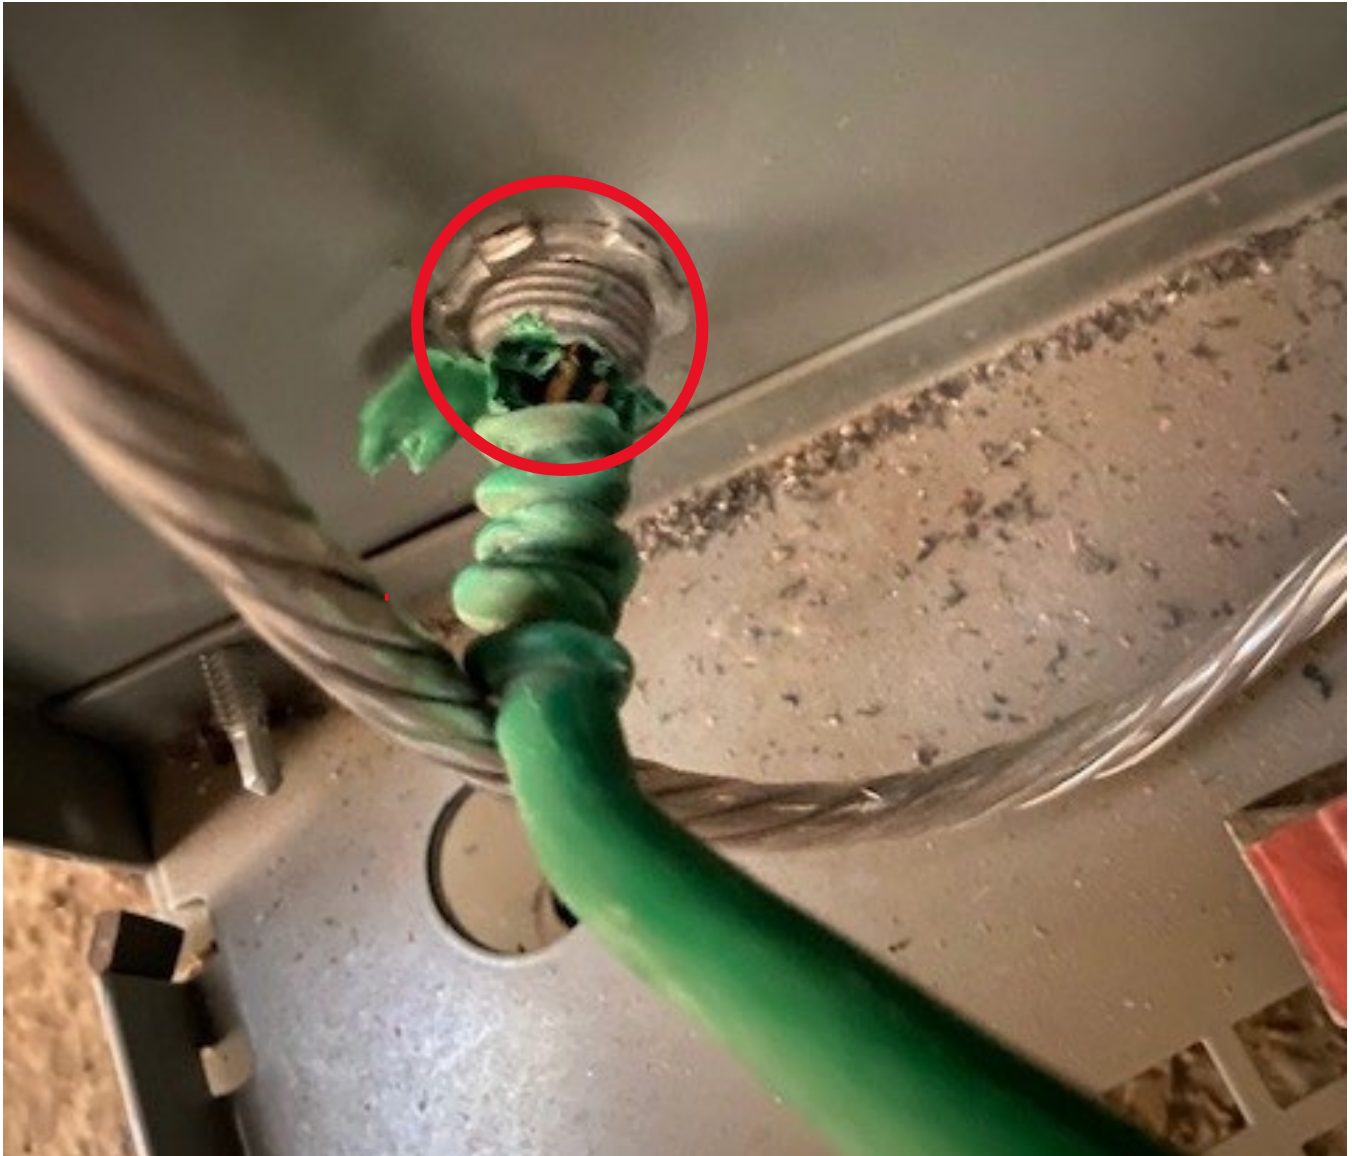
Photo 3 - Damage to grounding conductor insulation due to excess strain.

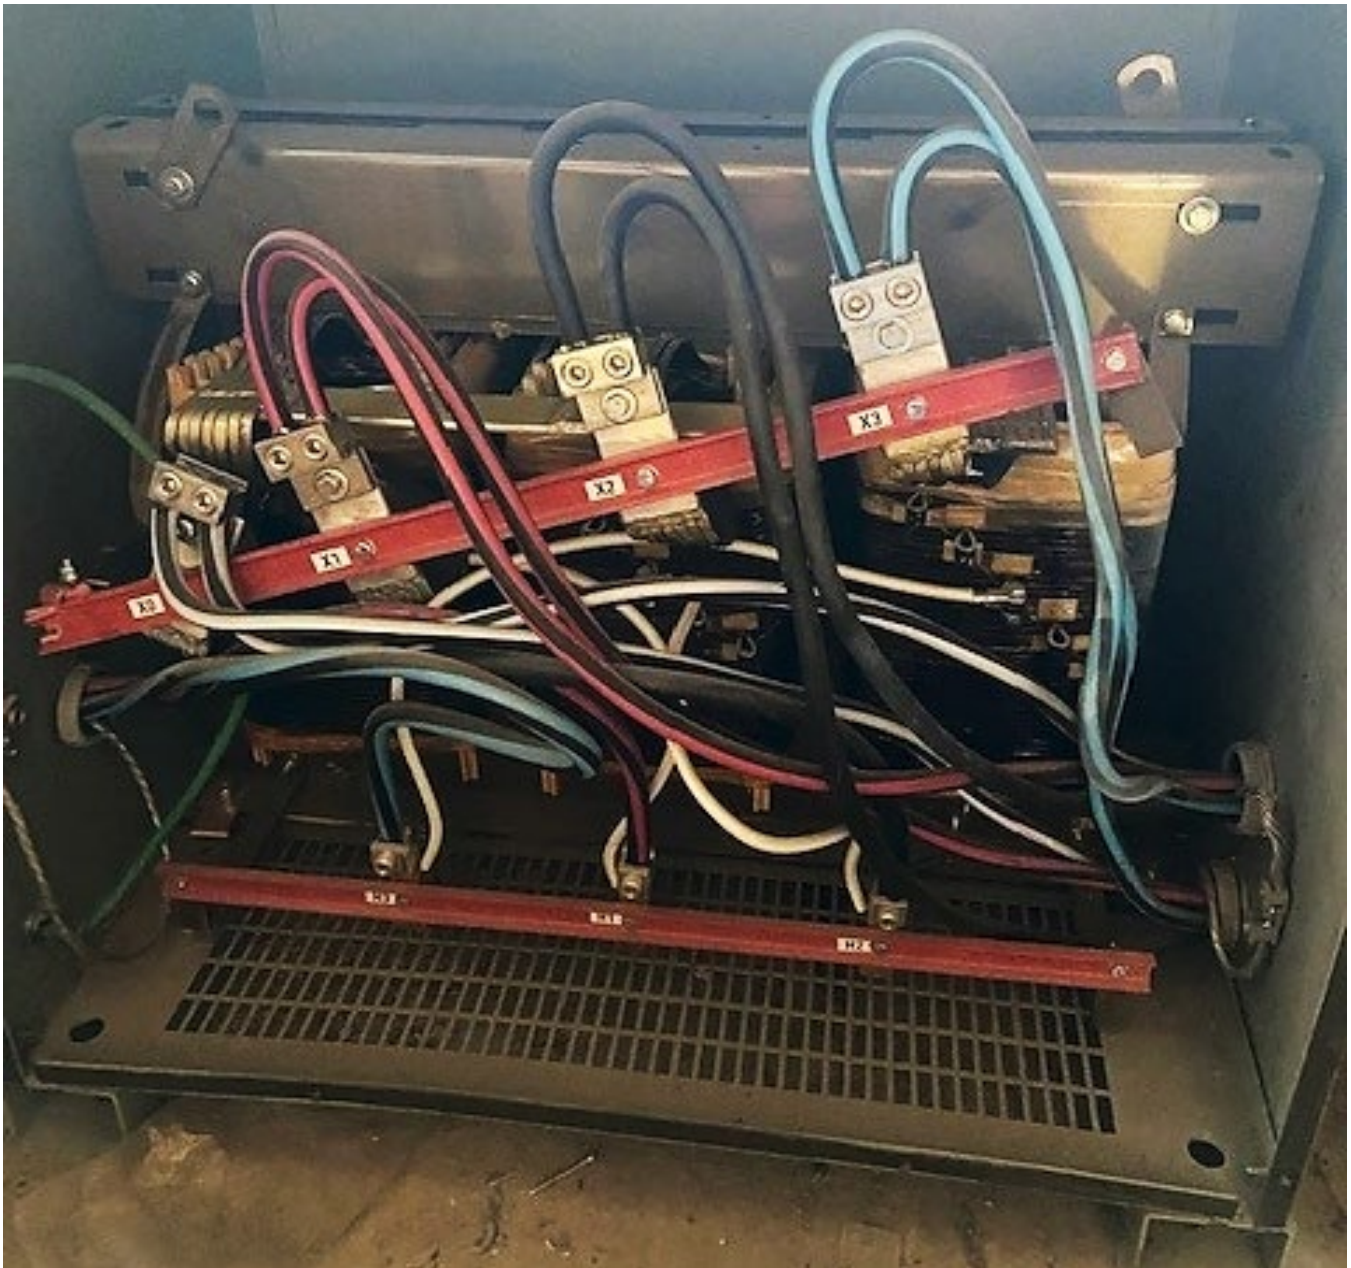
Photo 5 - Secondary insulating bar, should be level, but was pulled down by the X0 point on the left side. Smoke damage throughout.

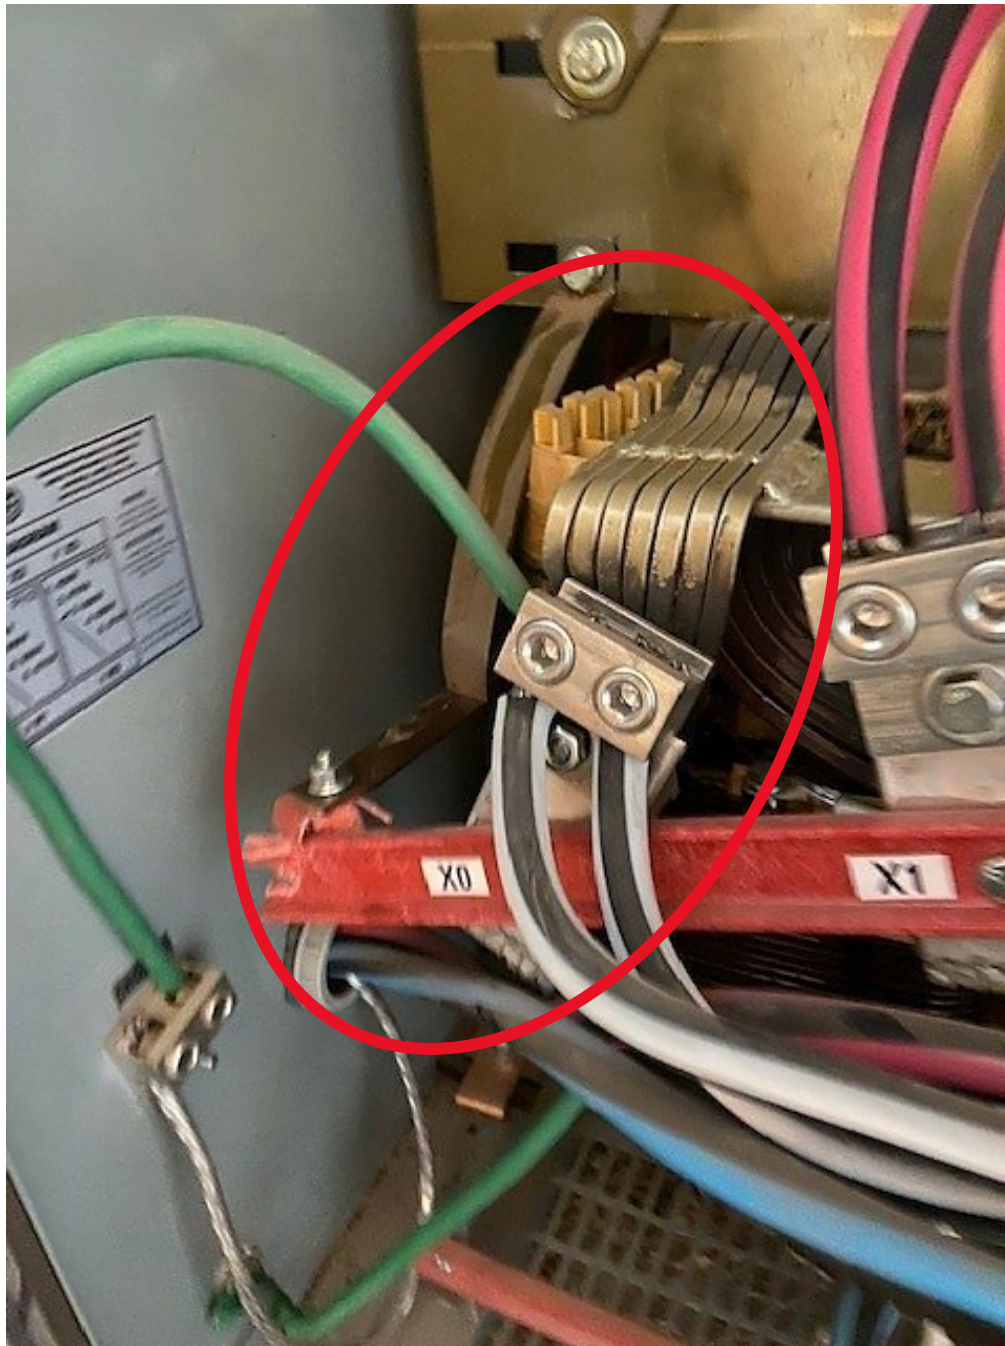
Photo 6 - Where grounding conductor enters transformer, bottom left and is terminated on X0 point pulling the entire bar down.

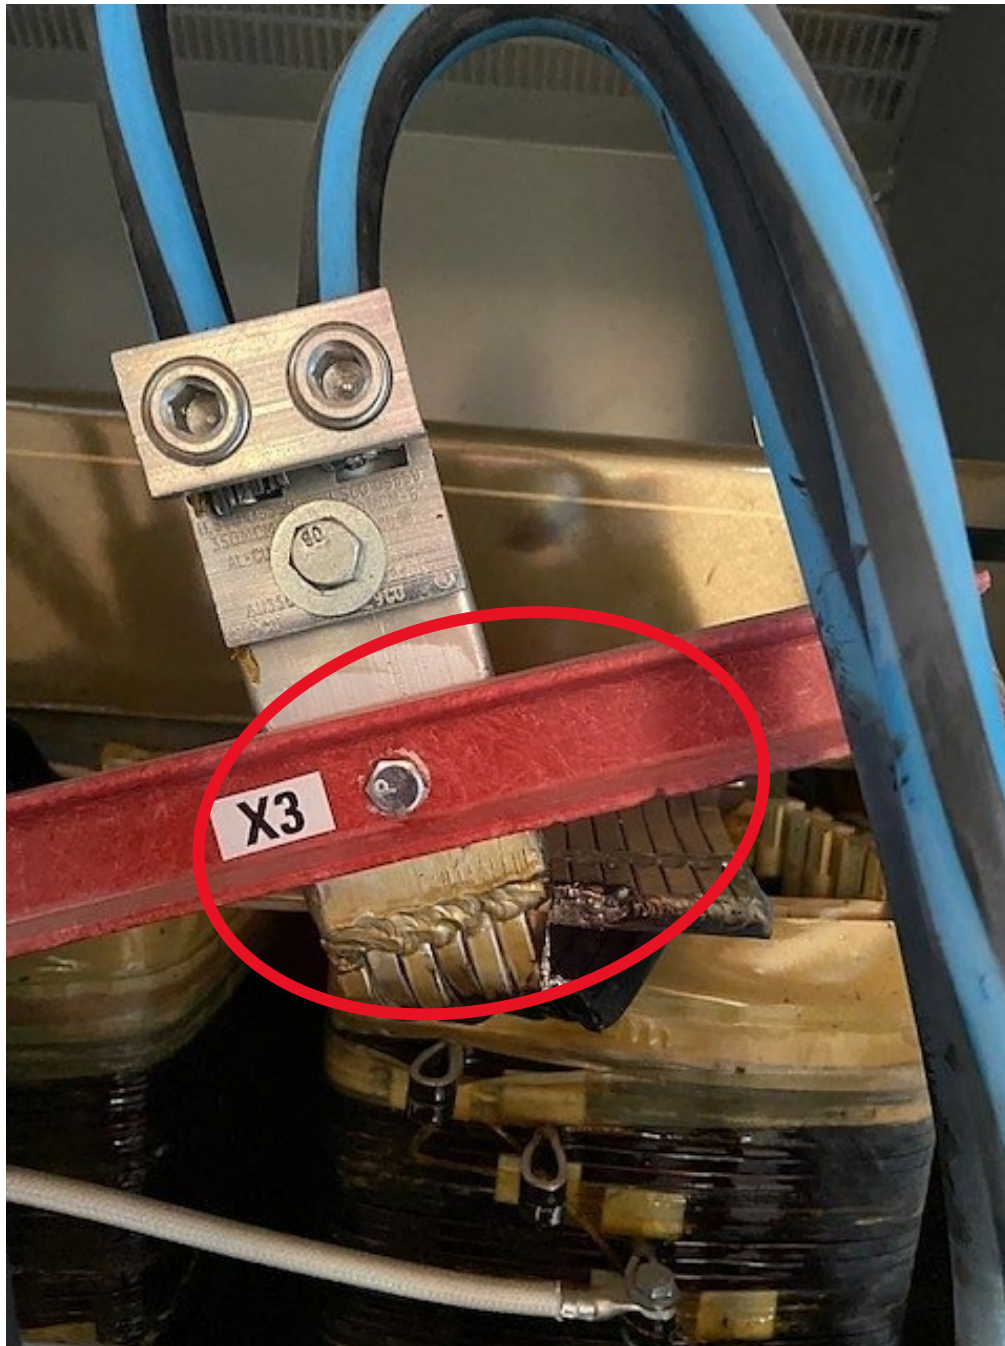
Photo 7 - X3 point where it shorted out.
