Incident Summary #II-1459160-2022 (#30241) (FINAL)

SUPPORTING INFORMATION	Incident Date	October 27, 2022	
	Location	Langford	
	Regulated industry sector	Gas - Natural gas system	
	Impact Injury	Qty injuries	0
		Injury description	None
		Injury rating	None
	Damage	Damage description	Fire damage to free standing patio enclosure.
		Damage rating	Minor
	Incident rating	Minor	
	Incident overview	A structure fire occurred that was contained to the ceiling space of a free-standing patio enclosure following installation and operation of two new radiant heaters.	
INVESTIGATION CONCLUSIONS	Site, system and components	<p>Radiant heaters utilize a catalytic membrane resulting in infrared energy with little to no open flame. The surface temperature of the burner face is 600-1000 F.</p> <p>The radiant heaters were Heatstar model HS 4040 SPNG 40,000 Btus.</p> <p>The following clearances to combustibles are required for proper installation.</p> <ul style="list-style-type: none"> • Side 30" • Rear 30" • Above 34" • Below 68" <p>Due to the open nature of the space, an on/ off power supply was provided instead of a thermostat.</p>

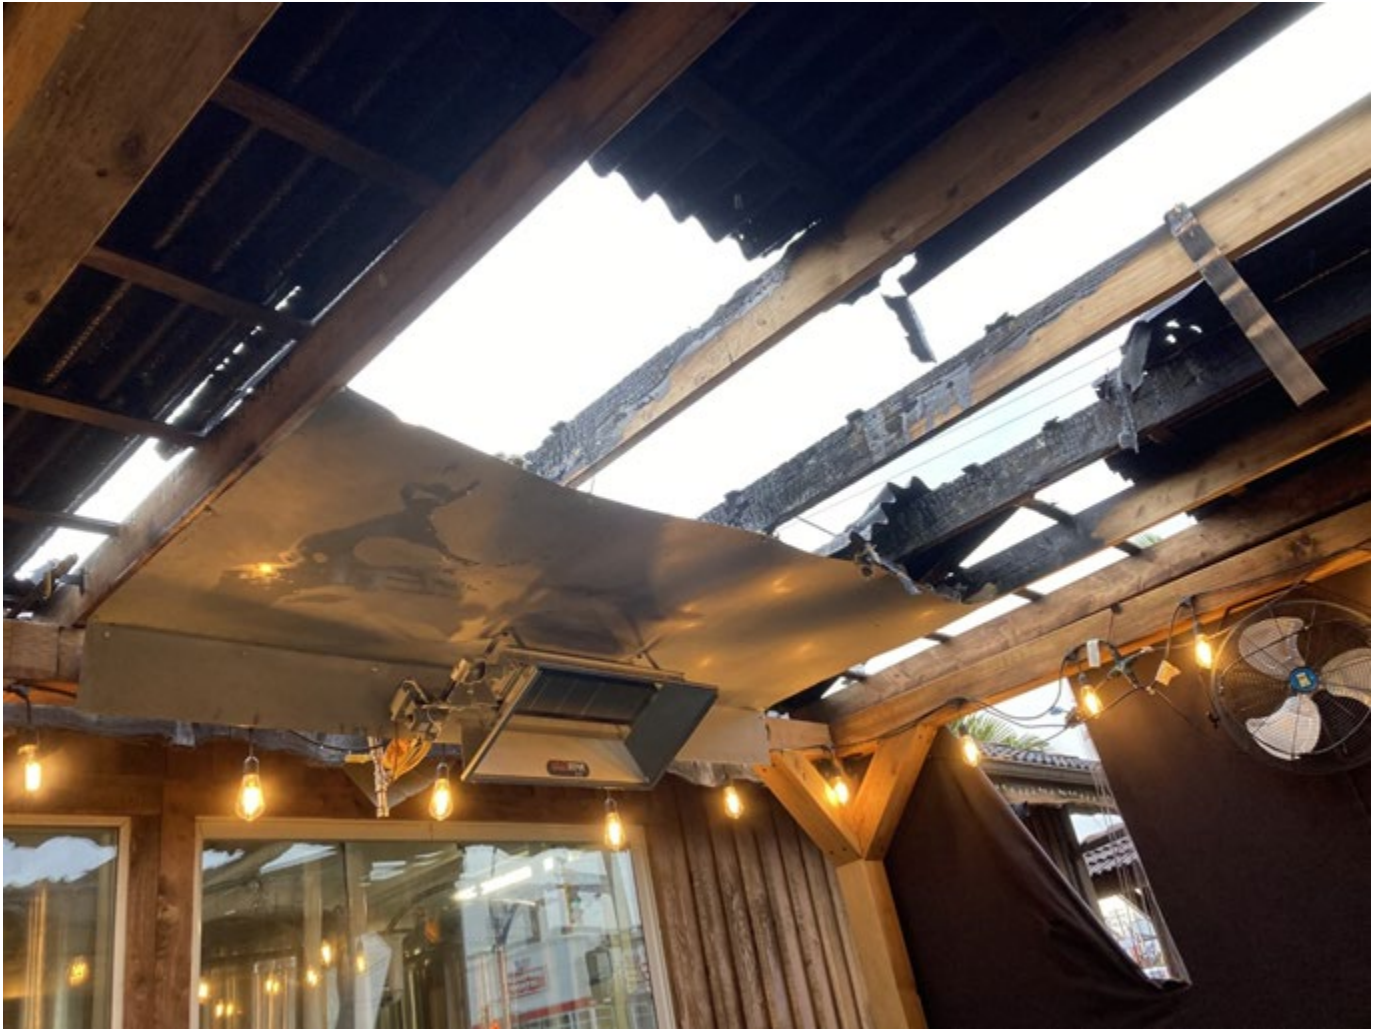
Photo 1: Location one

<p>Clearances were scaled off based on photos provided by the gas utility. Full charring of the ceiling space was evident above the first heater (Photo 1) with additional charring noted above the second heater (Photo 2).</p> <p>Photos show a protective sheet metal guard with mineral wool insulation was installed between the heater and the wood roof trusses.</p> <p>Manufacturers installation instructions and the appliance rating plate show the following clearance to combustibles</p> <ul style="list-style-type: none">• Side 30"• Rear 30"• Above 34"• Below 68"
Causes and contributing factors	<p>It is possible that the minimum clearance requirements between the heater and combustible material were not provided, as stated by the manufacture, based on the supplied photos.</p> <p>The installation of the mineral wool insulation and the sheet metal guard may not have provided the overhead/rear clearance reductions shown in table 4.1 of the B149.1.20</p>

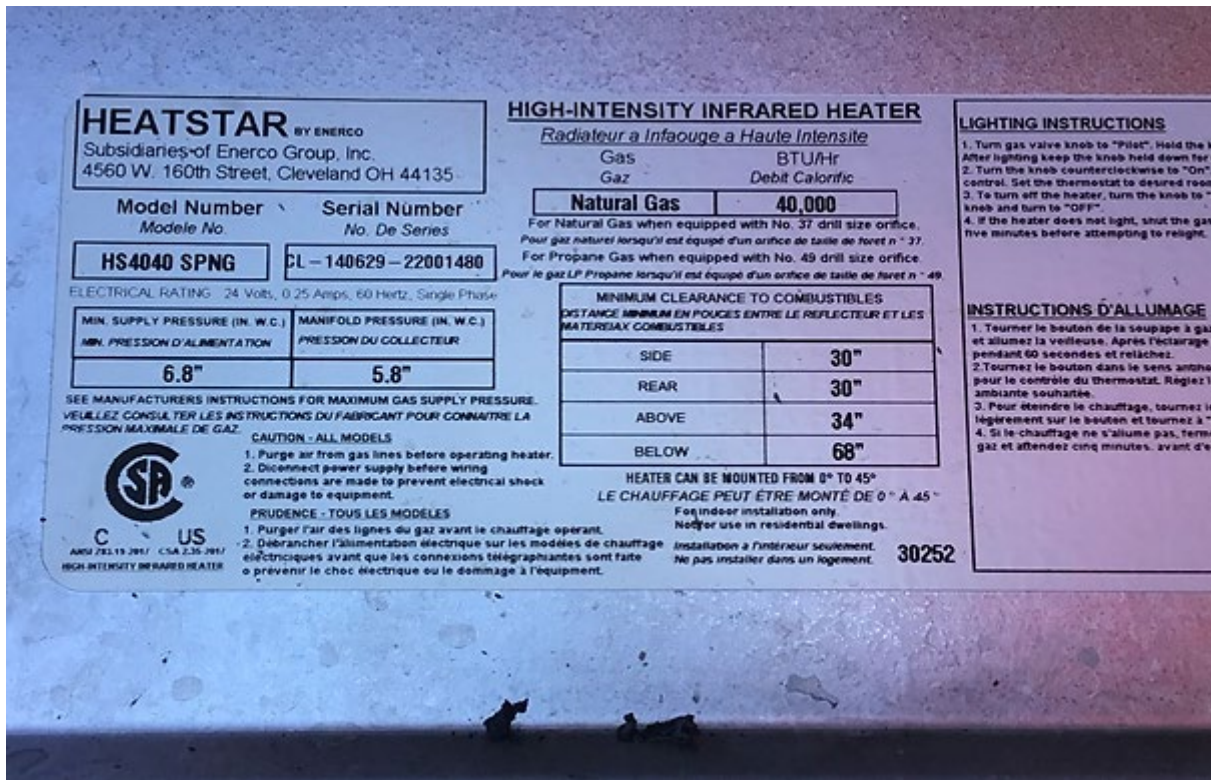
Photo 3: Rating plate showing clearances.

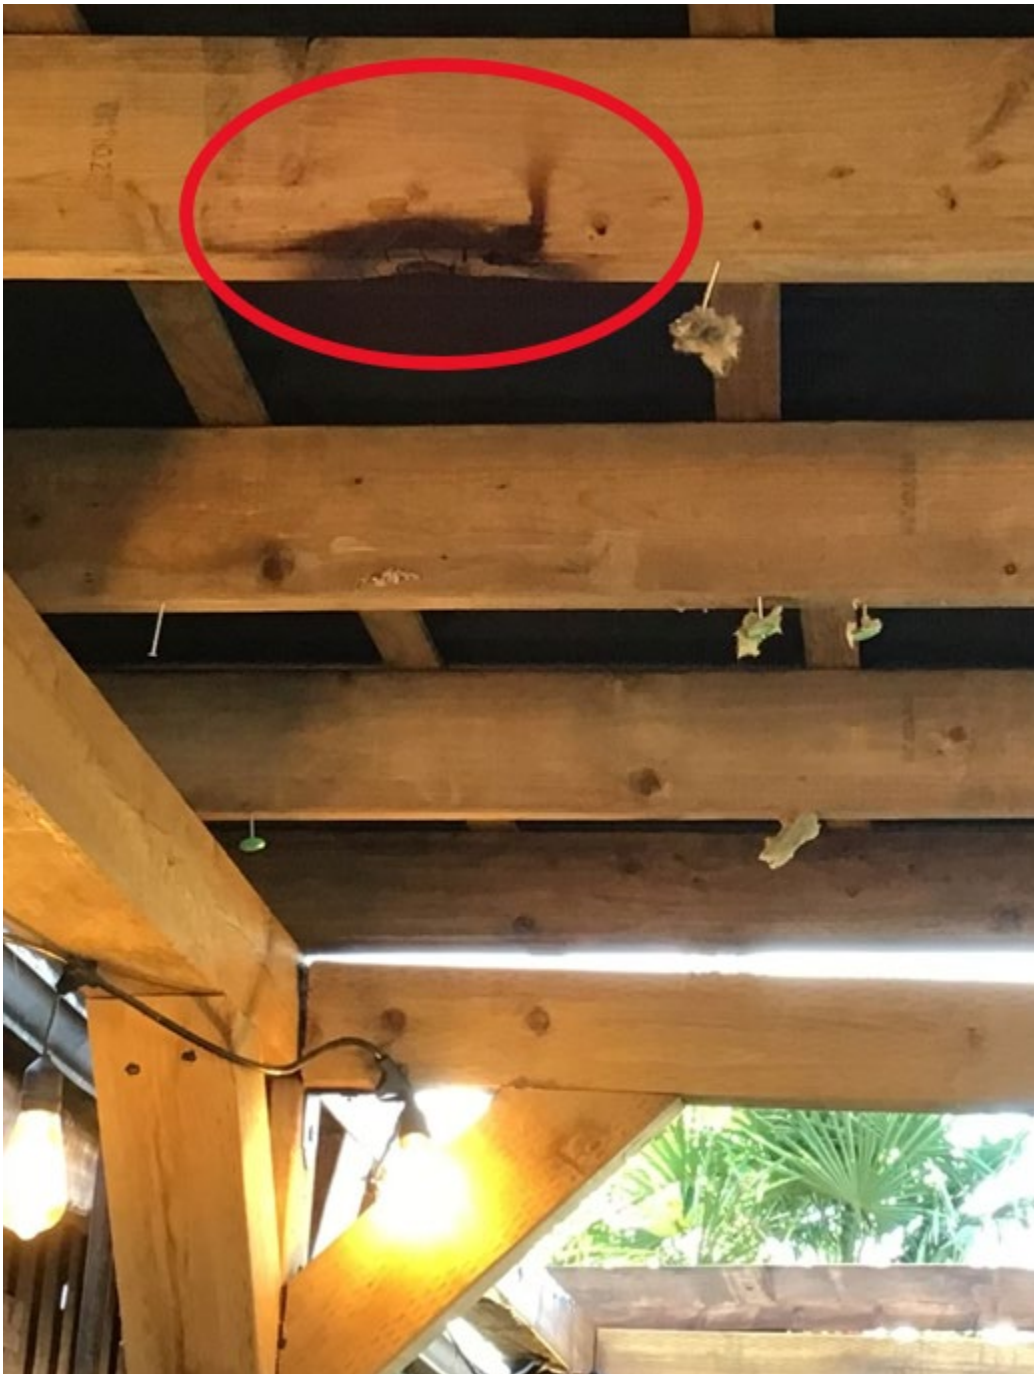
Photo 4: Charring above unit 2 when heater and metal sheeting removed.
