Incident Summary #II-1263823-2021 (#24292) (FINAL)

SUPPORTING INFORMATION	Incident Date	October 5, 2021	
	Location	Courtenay, British Columbia	
	Regulated industry sector	Electrical	
	Impact	Qty injuries	1
		Injury description	Shock received on left forearm, leaving minor redness in a localised area.
	Damage	Injury rating	Minor
		Damage description	"A" phase conductor had a thermal event take place inside the service raceway. The raceway for service conductor had a hole burnt through. Entrance cap to the main service raceway was broken and dislodged. Main service ground had a metal connector that burnt through.
		Damage rating	Moderate
Incident rating	Moderate		
Incident overview	Contractor was servicing electrical equipment in preparation for replacement the following week. Contractor received an electrical shock while working on the exterior of an energized panel by touching his left forearm to the exterior can of the electrical panel.		
INVESTIGATION CONCLUSIONS	Site, system and components	<p>The facility is a commercial office space with an overhead electrical service. The service consists of two parallel metal service conduits attached to the outside of the building that brin

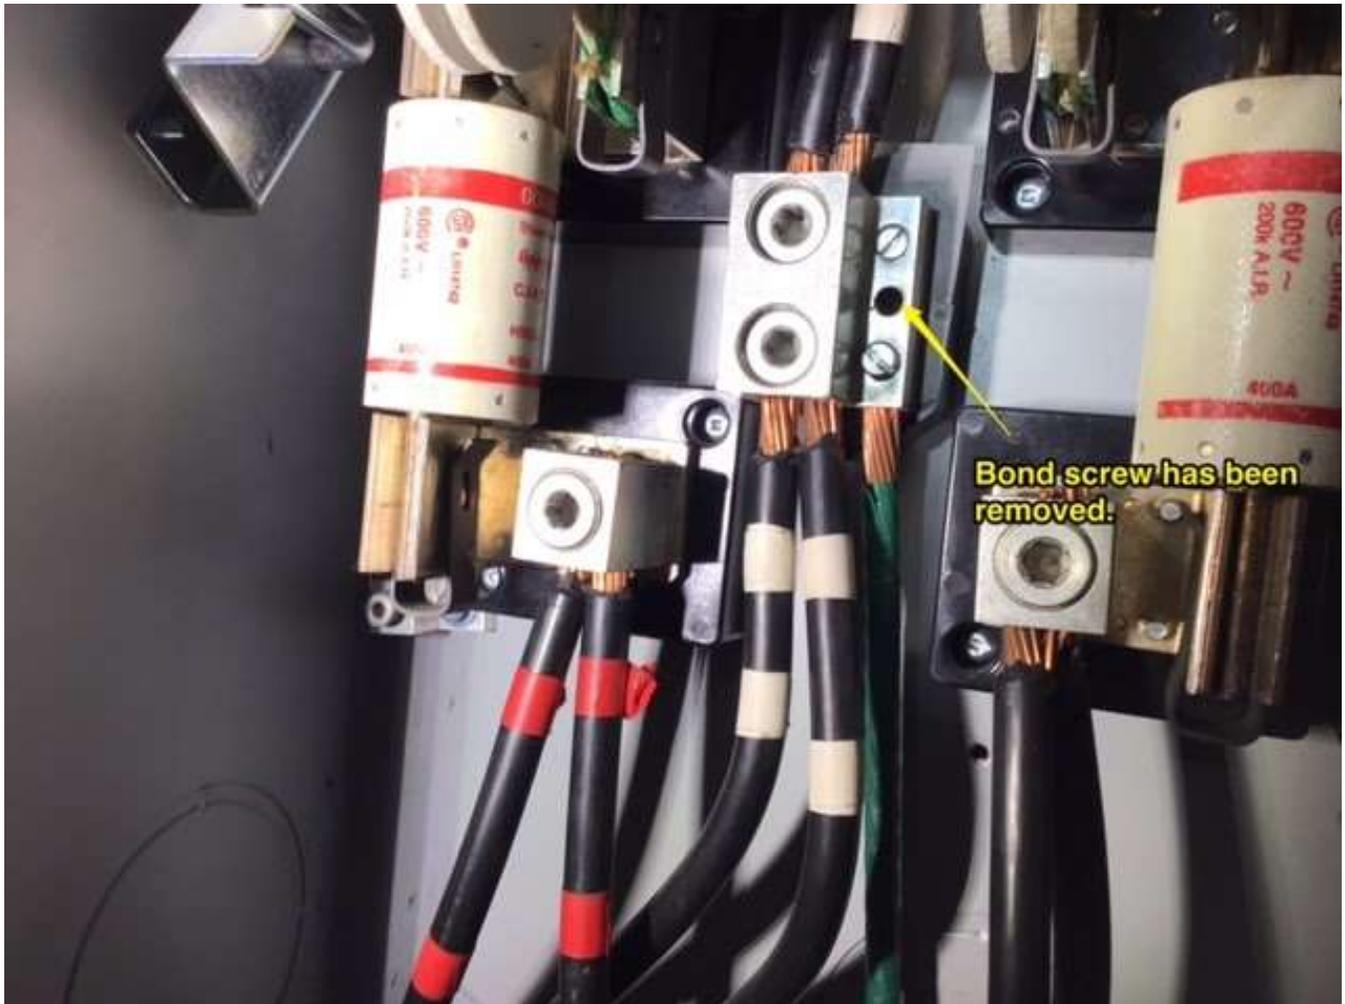
Figure 1 - Service disconnect switch with the required system bonding jumper screw missing

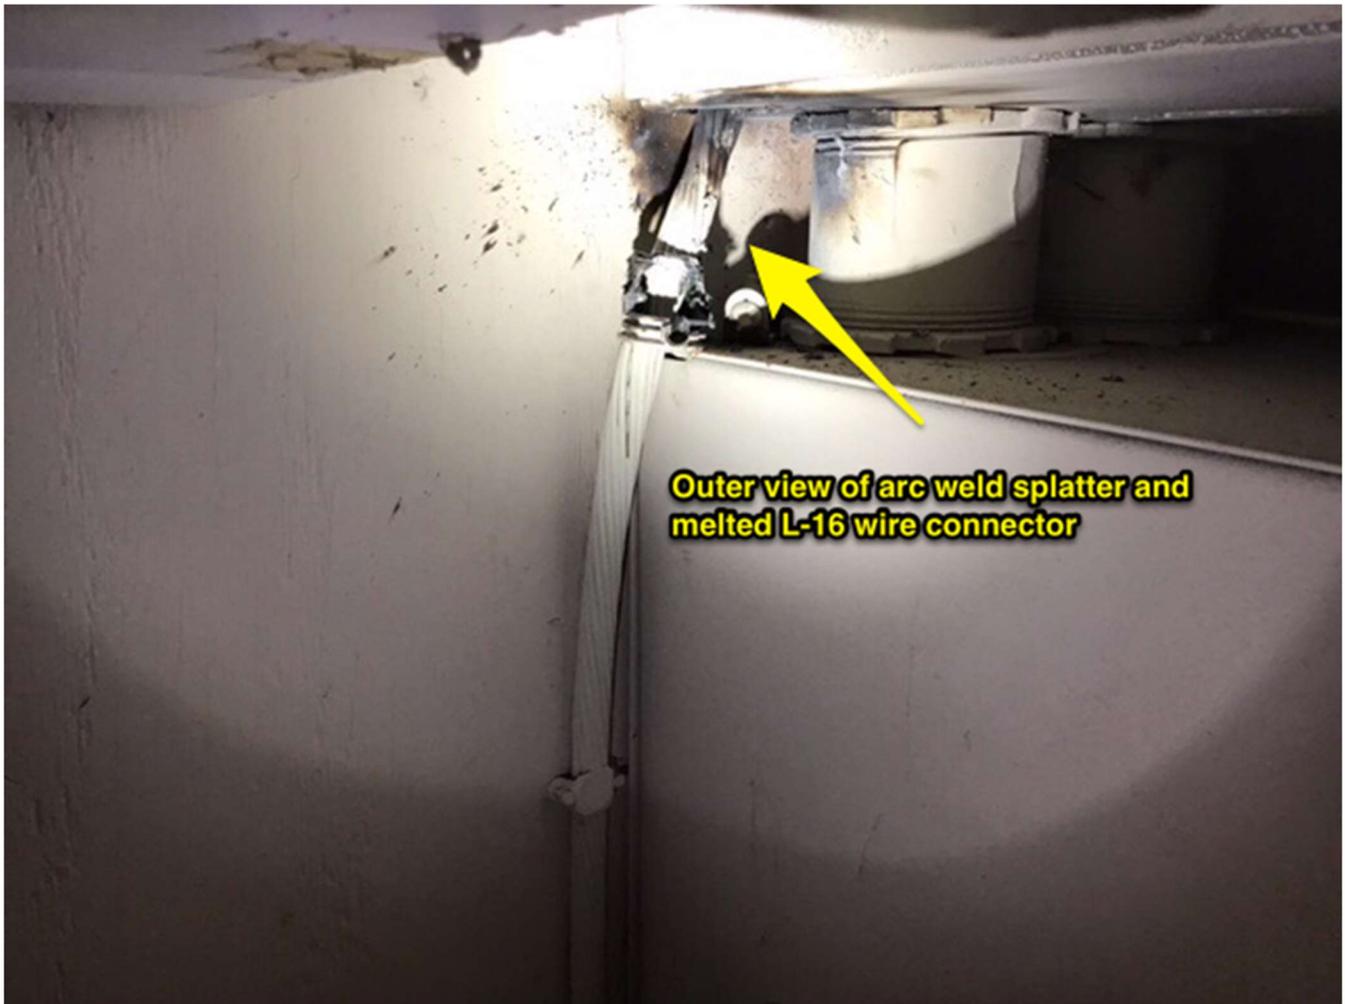
Figure 2 – Connector melted from passing current to the neutral conductor

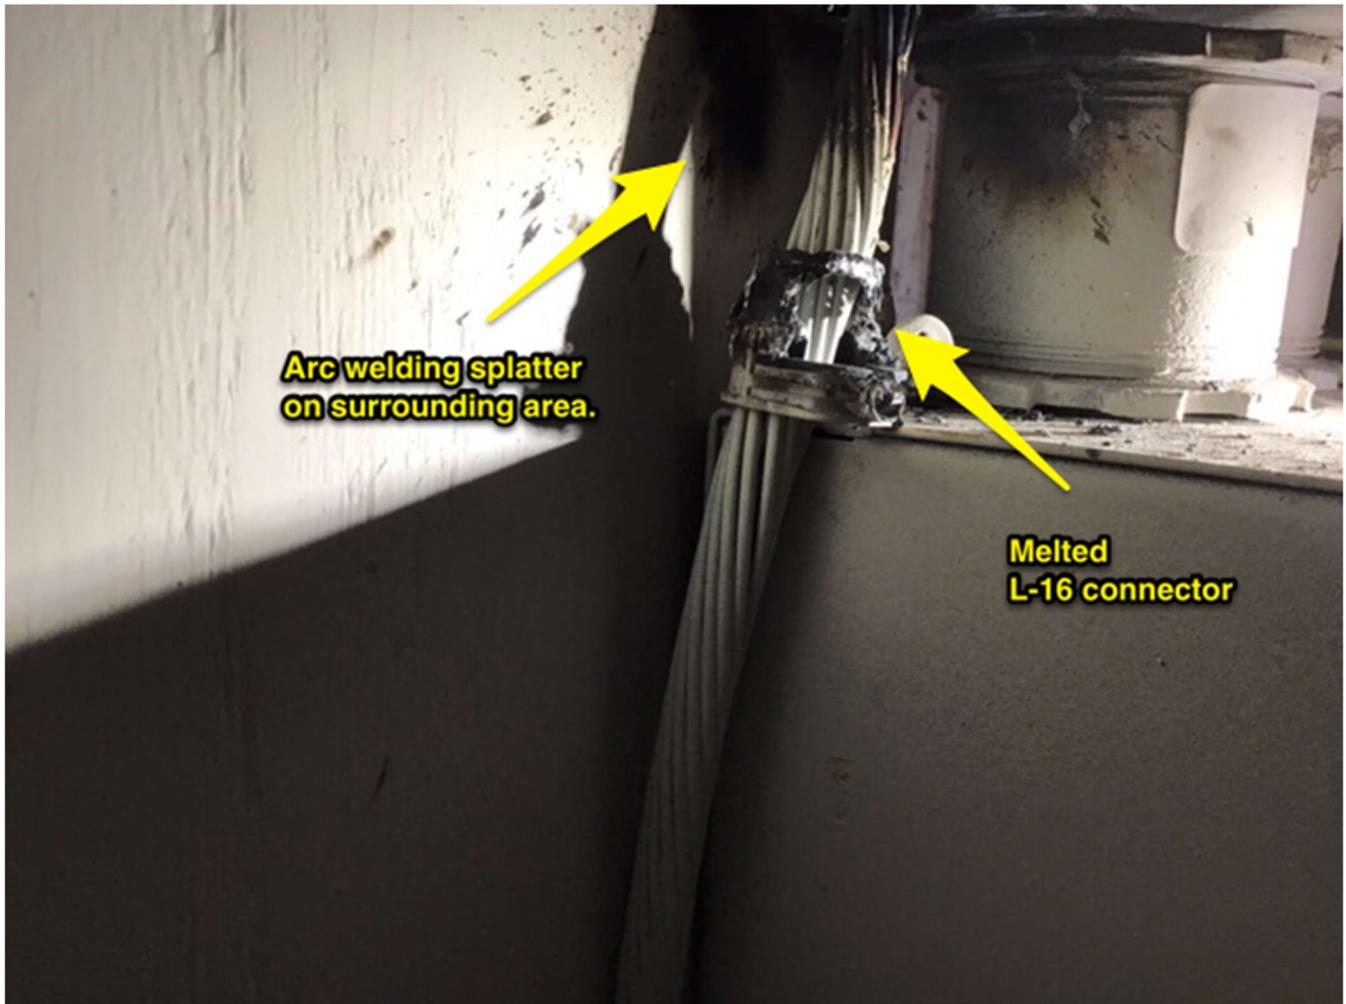
Figure 3 – Close up of metal connector melted

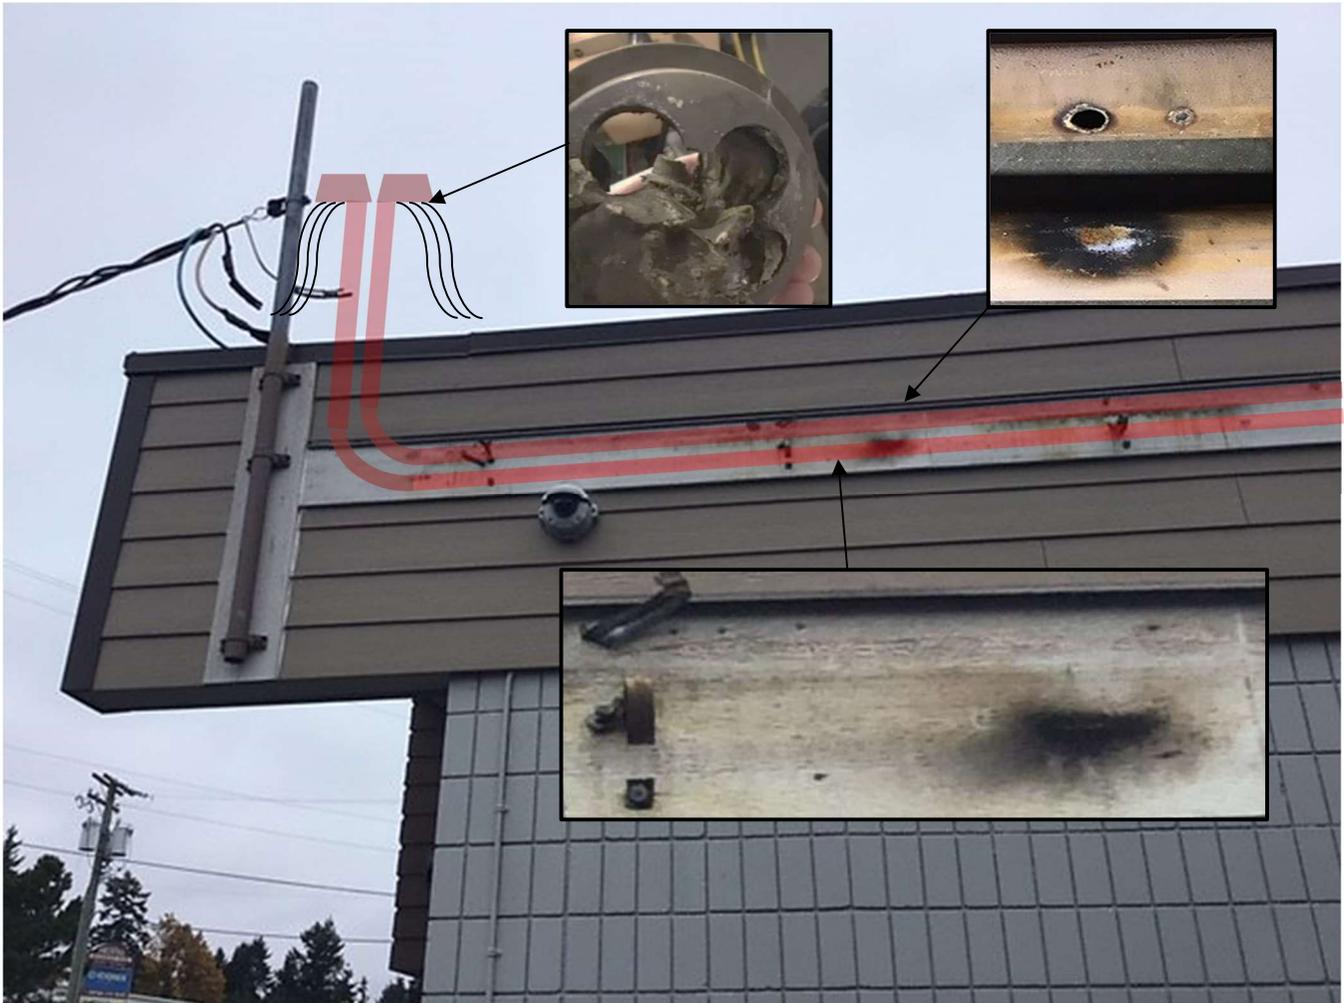
Figure 4 - Location of the parallel metal service conduits (in red). The arcing occurred on the horizontal section of the upper conduit with the smoke mark shown on the backboard (bottom). Damage to the entrance cap openings (top left). Back view of the arcing hole on the damaged conduit and smoke damage on the adjacent conduit (top right).

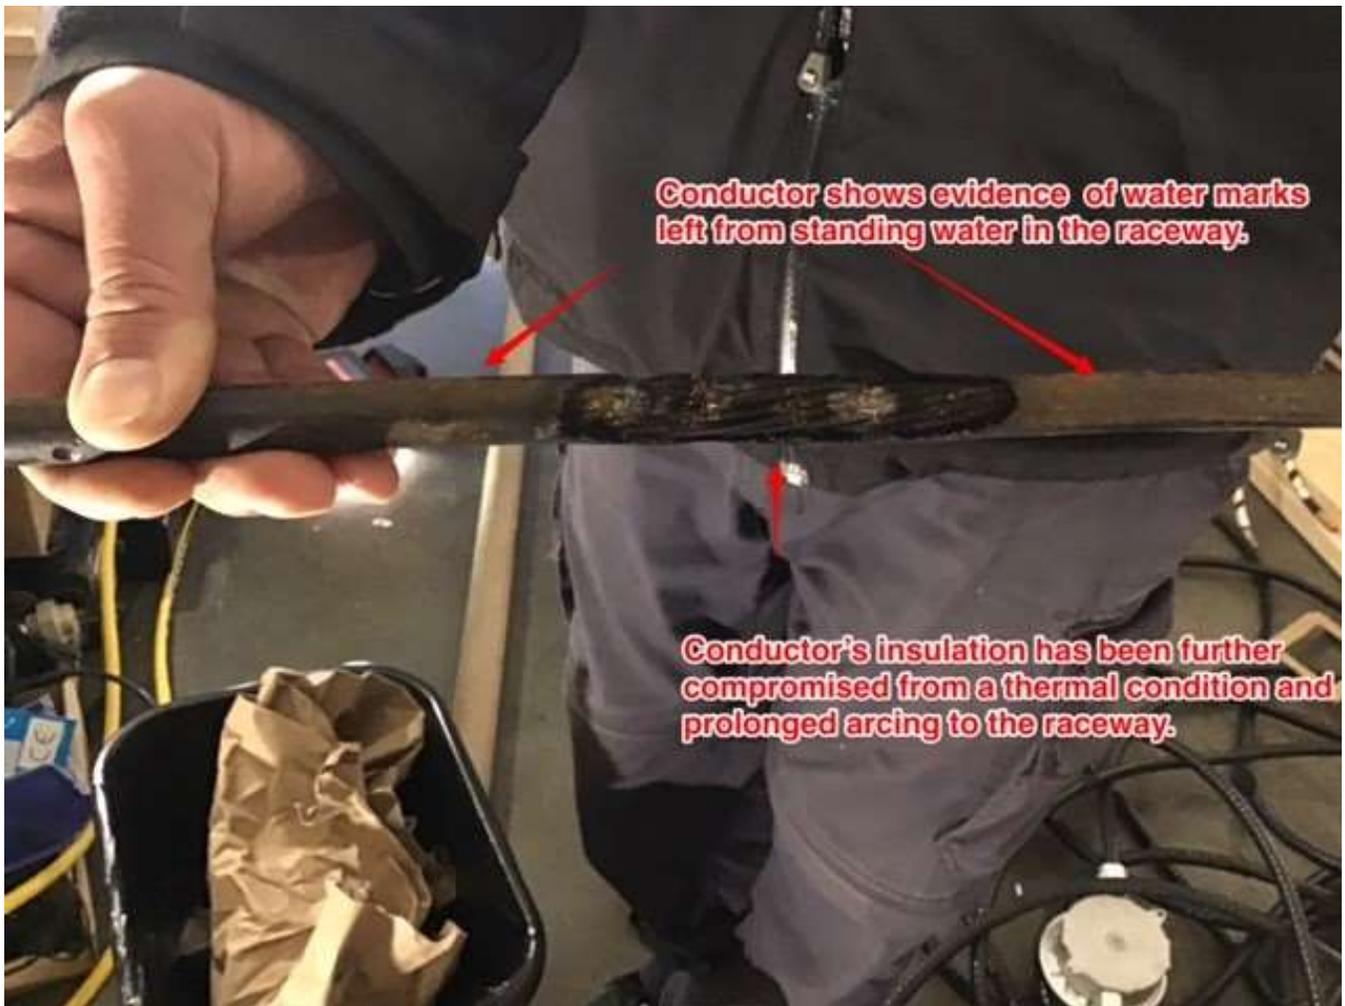
Figure 5 - Melting damage to the uninsulated portion of a line conductor

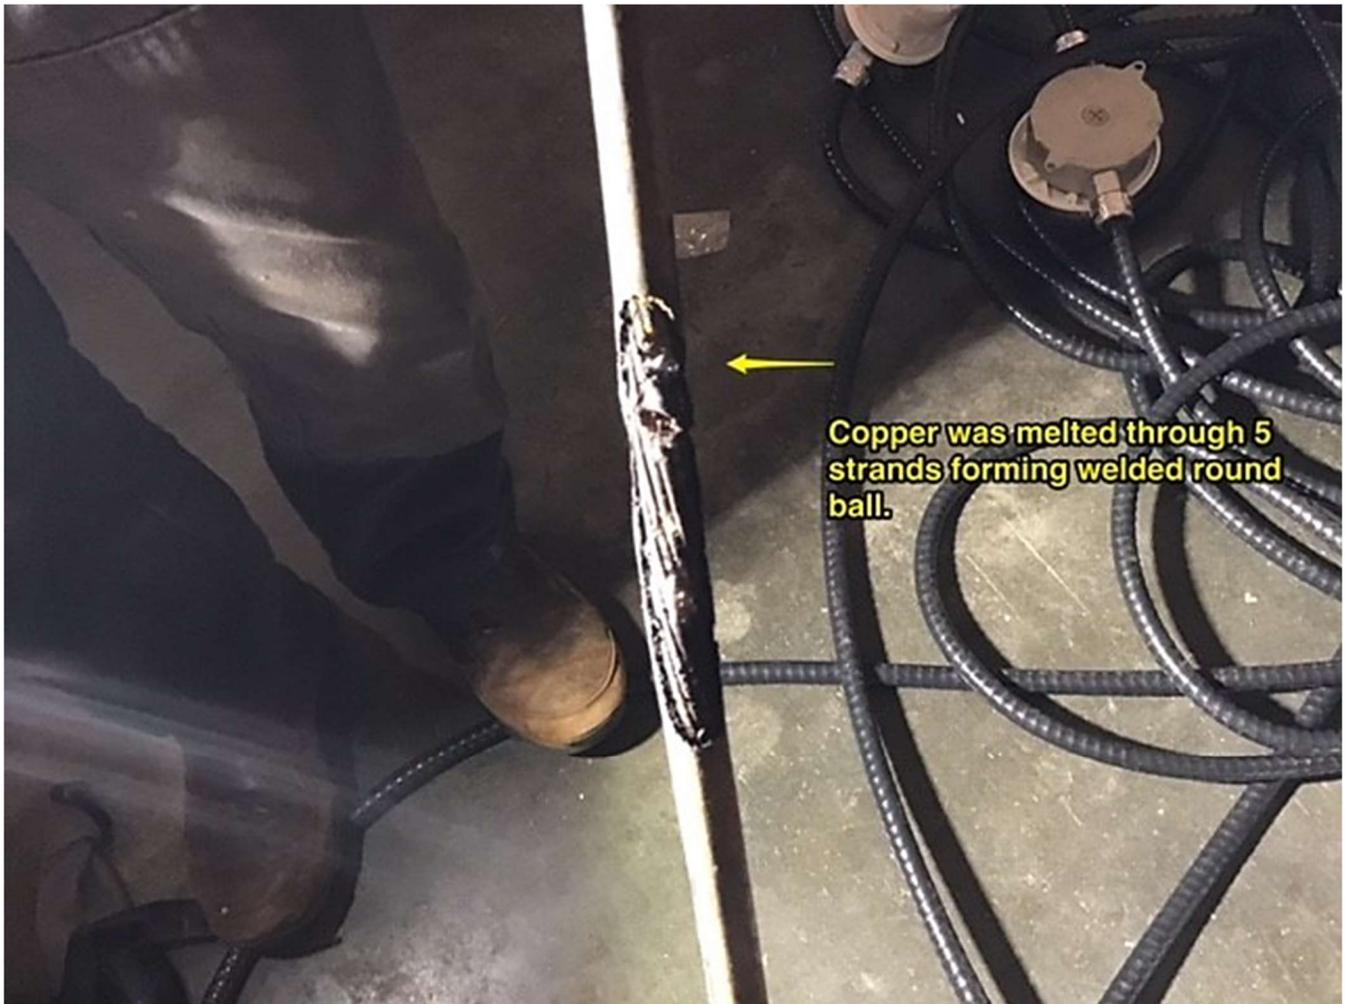
Figure 6 – Close up of melting damage to the uninsulated portion of a line conductor
