Incident Summary #II-1659153-2024 (#43298) (FINAL)

SUPPORTING INFORMATION	Incident Date	January 6, 2024	
	Location	Maple Ridge	
	Regulated industry sector	Gas - Natural gas system	
	Impact	Qty injuries	8
		Injury description	Individuals experienced carbon monoxide exposure symptoms including, headaches, dizziness, nausea, to varying degrees. Symptoms abated within two hours of vacating the building.
		Injury rating	Minor
	Damage	Damage description	Flue gas containing dangerous amounts of carbon monoxide (CO) leaked into occupied indoor spaces. Office staff and all the animals were evacuated from the building.
		Damage rating	Moderate
Incident rating	Moderate		
Incident overview	A wall-hung condensing boiler exhausted flue gases containing carbon monoxide into the rooftop mechanical room of a non-profit animal shelter. The flue gasses entered the office spaces on the main floor overnight. Staff members who entered Sunday morning began to feel sick and evacuated the premises, along with the animals who resided at the location at the time.

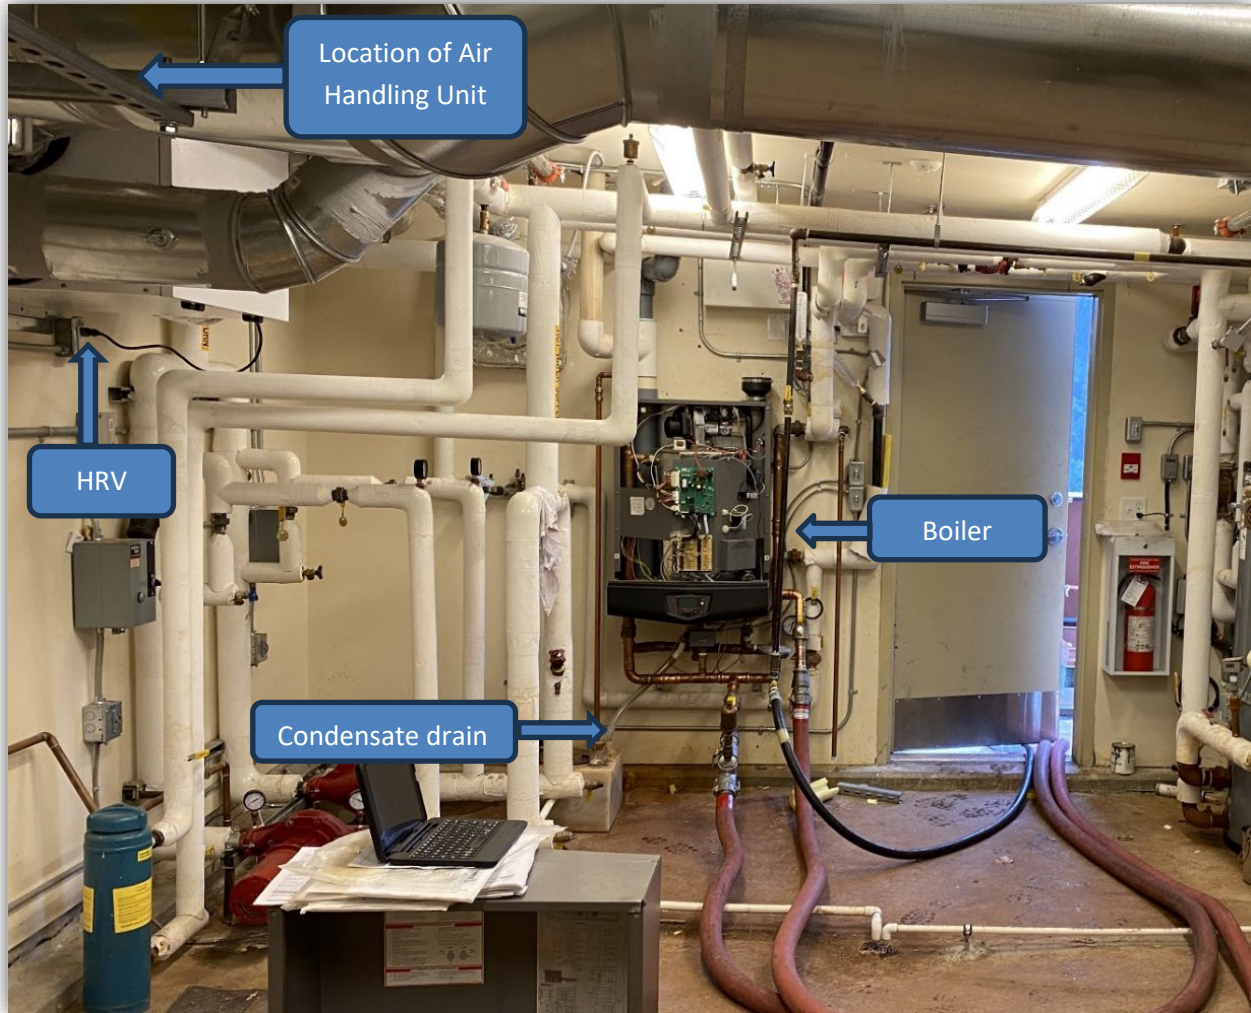
Image 1 – Mechanical room.

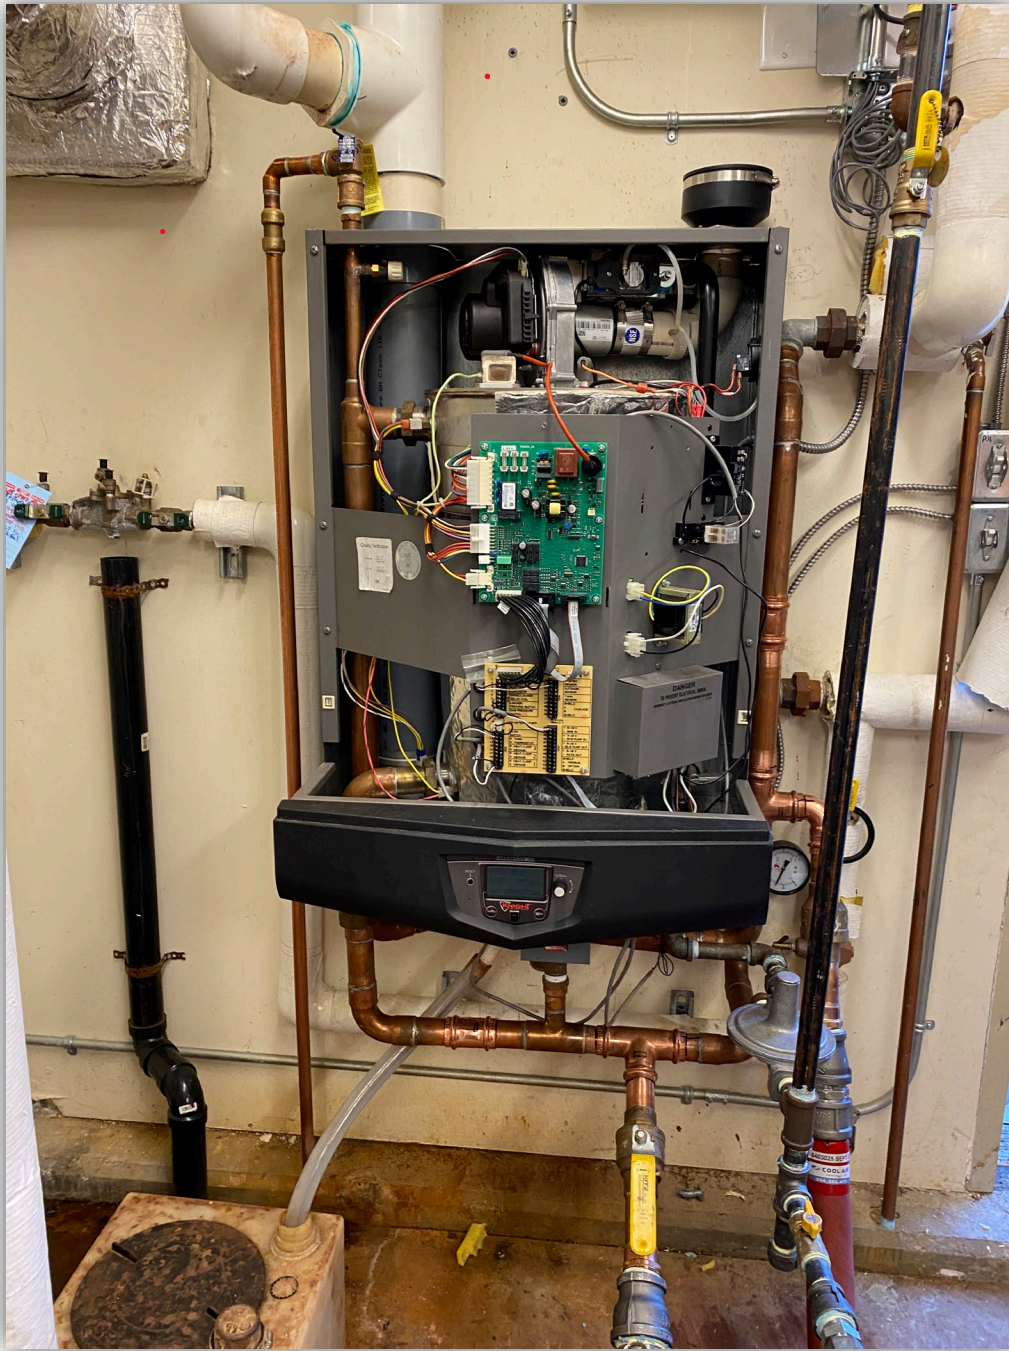
Image 2 – Boiler showing left side flue/exhaust piping and right-side showing supply air intake.

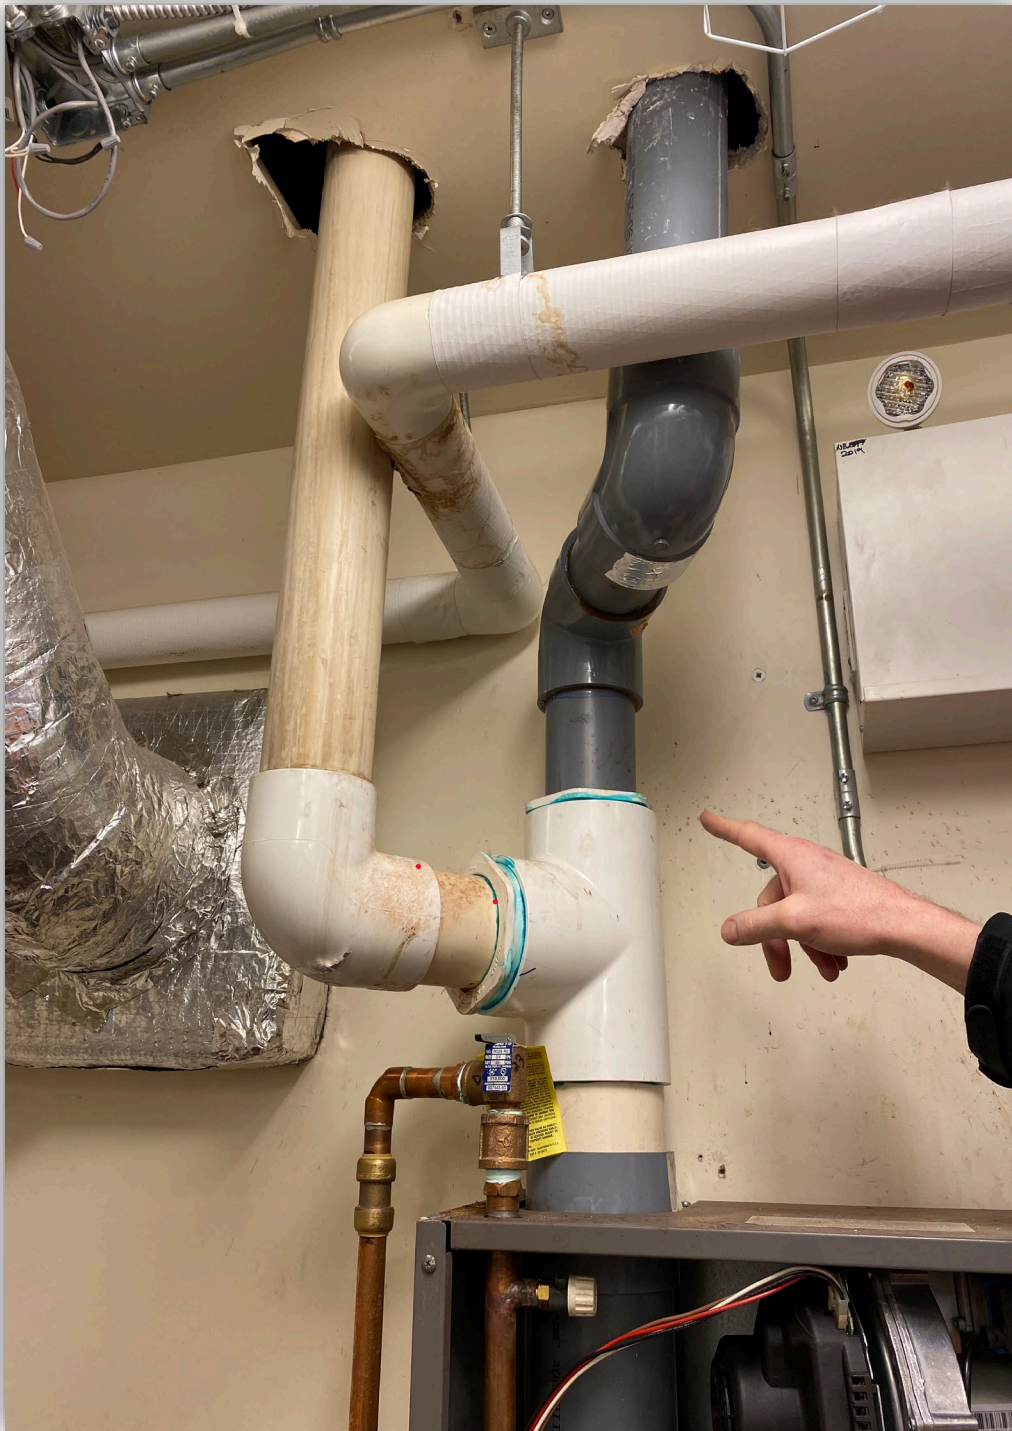
Image 3 - Exhaust piping modification that occurred sometime in the life of the appliance.

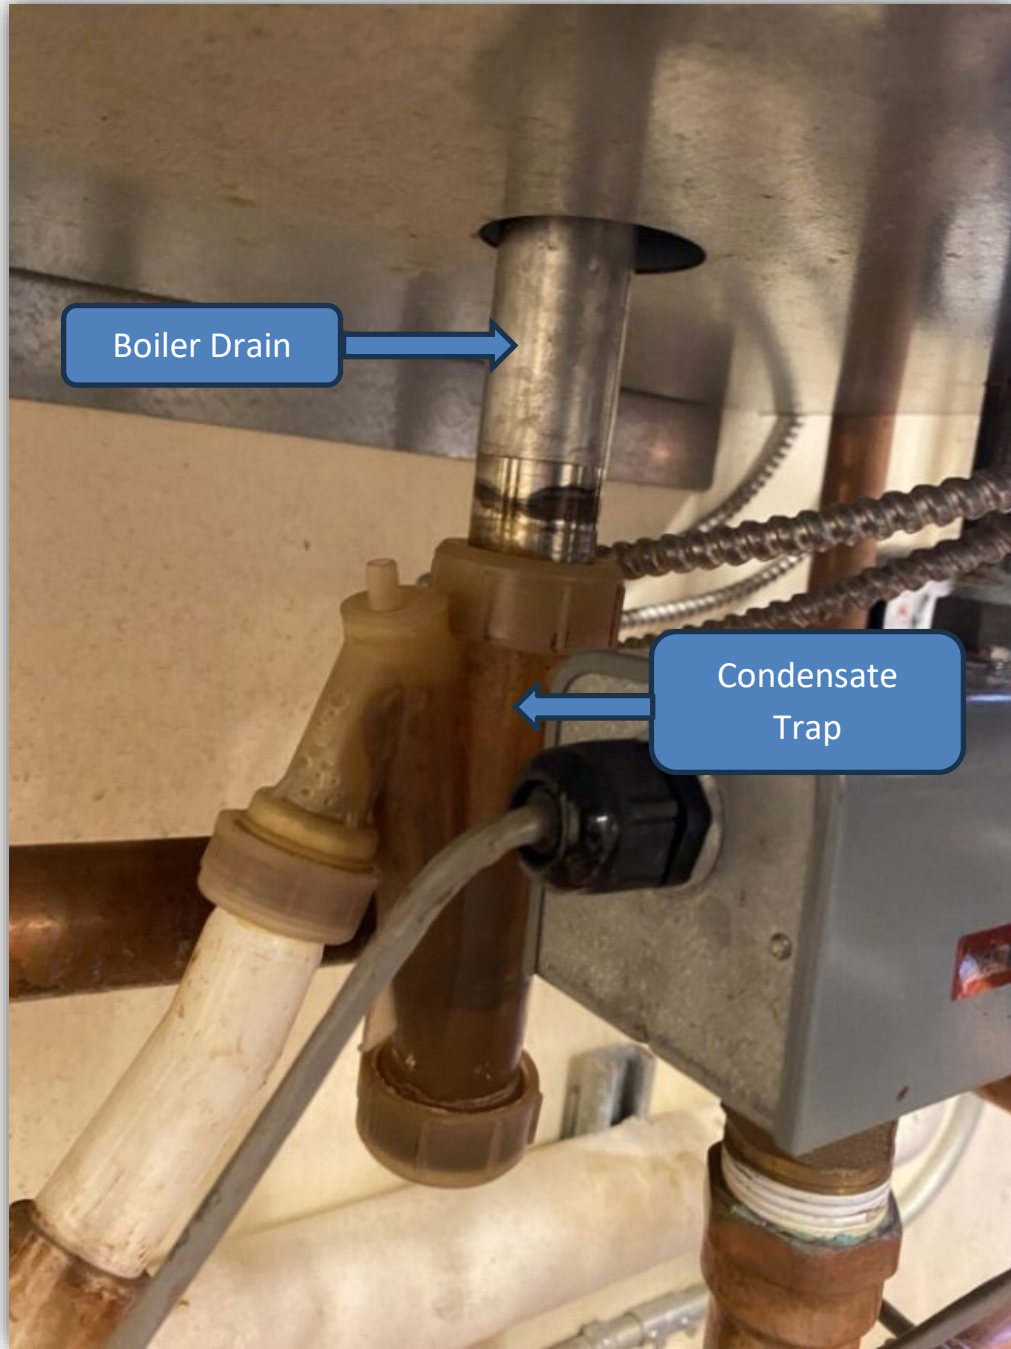
Image 4 – Underside of boiler.

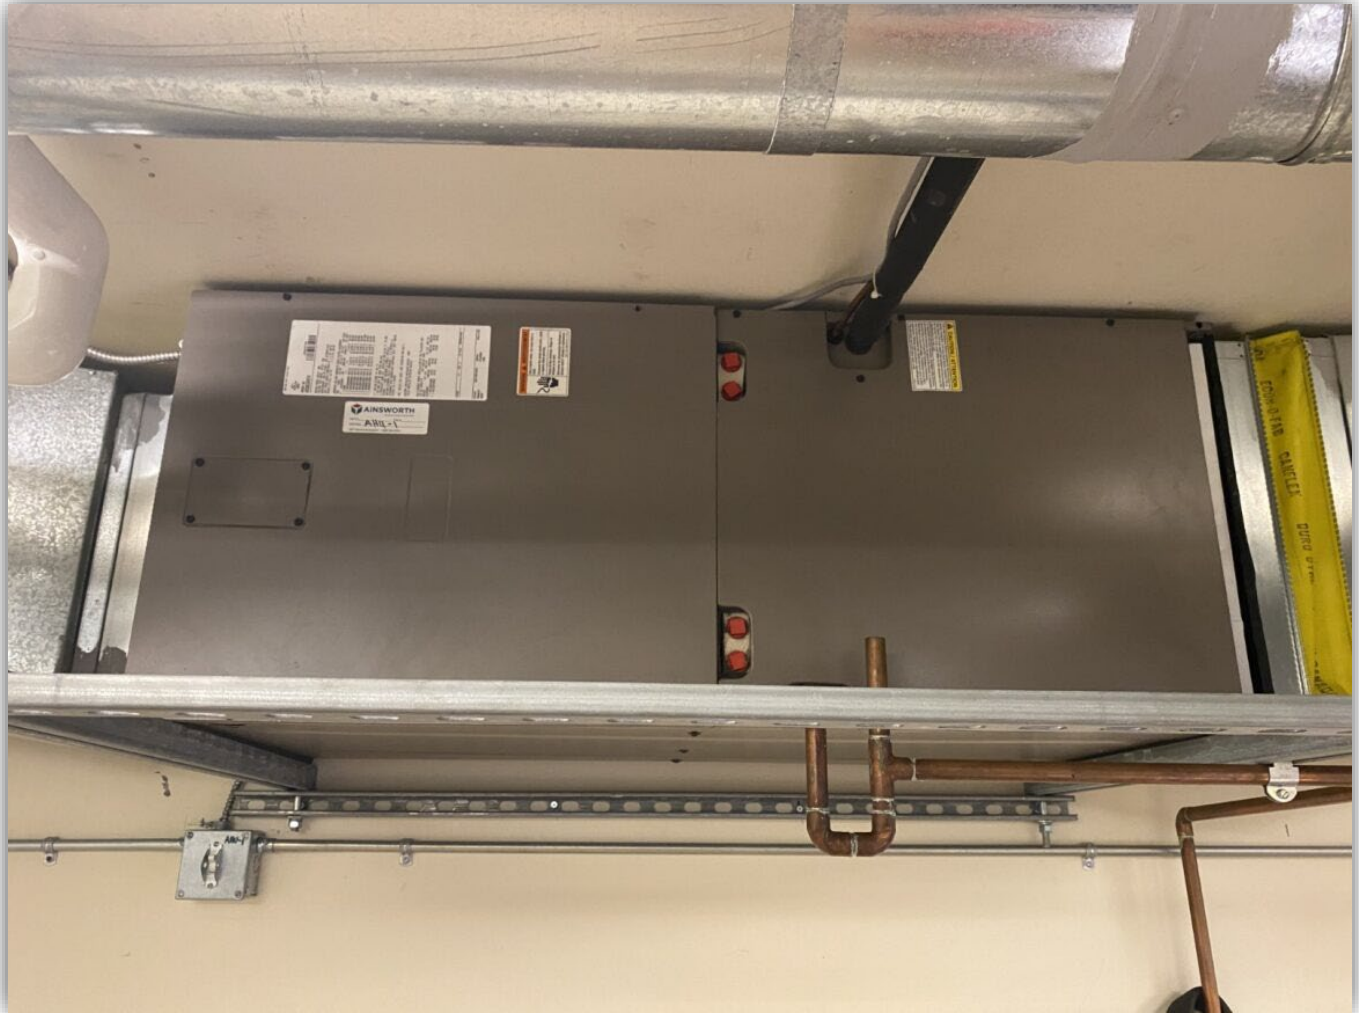
Image 5 – Air handling unit with inlet filter rack on right side.

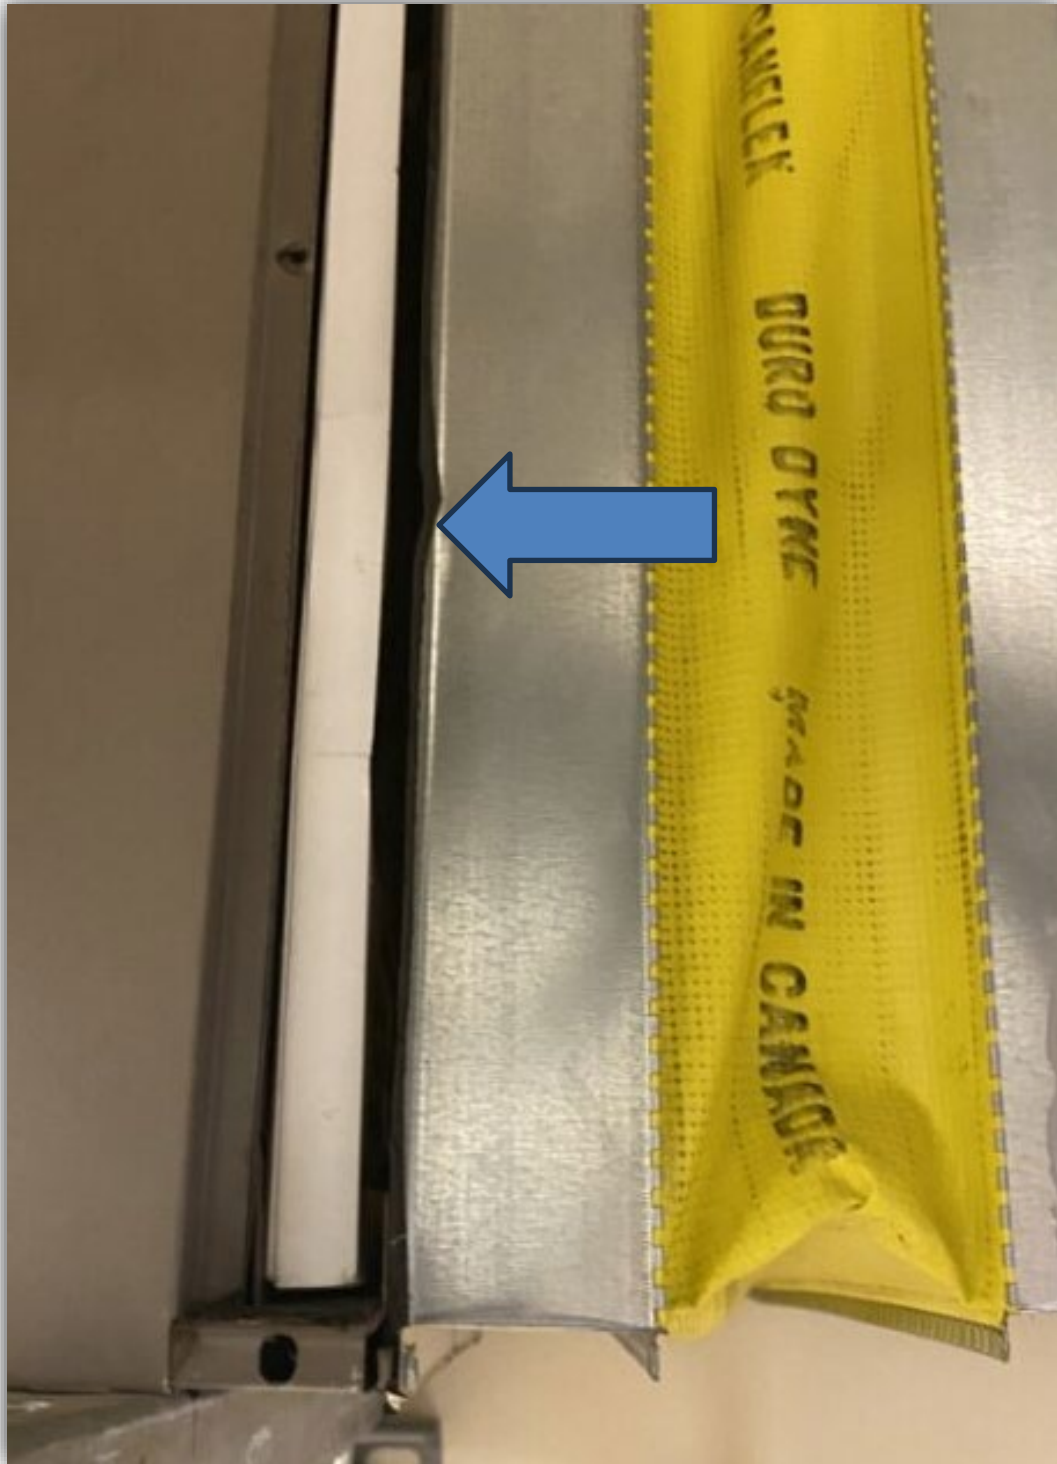
<p>Causes and contributing factors</p>	<p>It is highly likely that the removal of the condensate trap from the boiler resulted in flue gas entering the mechanical room, subsequently being drawn into the building air supply through the filter gap in the air handling unit, resulting in elevated CO levels in the occupied spaces.</p> <p>Contributing factors to the incident include:</p> <ul style="list-style-type: none"> • The operation of the mechanical system outside of the original design parameters imposed a significant load on the boiler, increasing the requirements for maintenance and potential for failure. • A lack of maintenance records and service history of the mechanical equipment indicates that the boiler may not have been serviced regularly during its lifespan. Lack of service and heavy demand likely contributed to improper function, including high CO and potential heat exchanger restrictions. • The alteration of the boiler venting so that combustion air was taken directly from the mechanical room, impeded the boiler combustion air supply, affecting combustion resulting in elevated CO levels. • The lack of CO detectors installed in the boiler room and occupied spaces prevented an early warning of elevated carbon monoxide levels.

Image 6 – Unsealed AHU filter rack with arrow showing the gap that drew in the boiler exhaust.

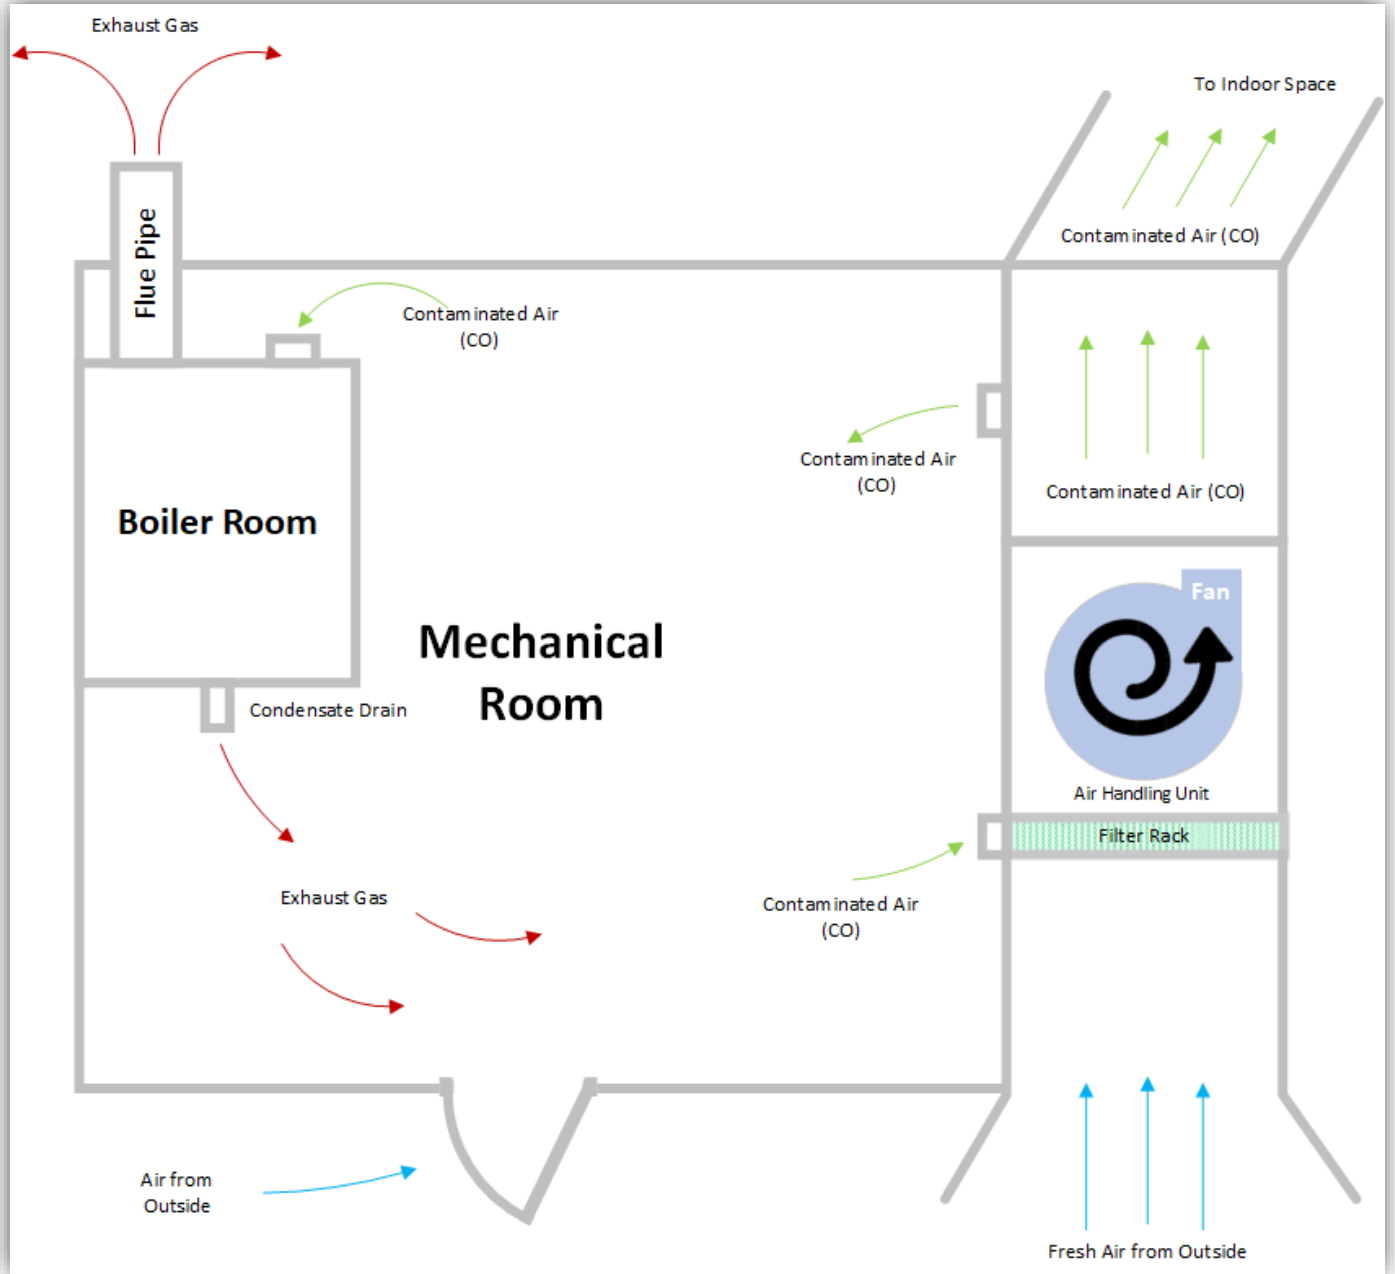
<p>Contaminated air from the Mechanical room was drawn into the boiler combustion air intake, which resulted in the boiler producing exponentially higher levels of CO due to a reduction in the available oxygen for combustion. This flue gas recirculation increased the level of CO in the boiler exhaust, the mechanical room, and eventually the office spaces below. This continued overnight and into Sunday morning.</p> <p>The building did not have any alarms to alert staff of elevated CO levels. Staff arrived Sunday morning, and after approximately an hour and a half, began to exhibit symptoms of CO exposure, including headaches, nausea, dizziness, and confusion. Eight staff members in total were affected. The contractor was called in and the staff evacuated to the outdoors their symptoms abated within two hours of being in the fresh air. There were no medical aids.</p> <p>The contractor returned to site with a flue gas analyzer and tested the boiler's flue gas. The technician found that the boiler was producing 4000 parts per million (PPM) of CO. After the boiler was shut down and the building was ventilated for a number of hours a detectible amount of CO was still measured in the occupied spaces and mechanical room.</p>

Image 7 – Diagram of mechanical room showing distribution path of CO from boiler into building.
