Incident Summary #II-1554403-2023 (#35579) (FINAL)

SUPPORTING INFORMATION	Incident Date	May 24, 2023	
	Location	Castlegar	
	Regulated industry sector	Electrical - Low voltage electrical system (30V to 1000V)	
	Impact	Qty injuries	0
		Injury description	N/A
		Injury rating	None
	Damage	Damage description	The polymer diffuser lens of a luminaire secured to the ceiling of a school gymnasium ignited and damaged the luminaire supply cable and conductors, damaged the luminaire and civil features of the ceiling system, damaged the gymnasium wood floor and floor finishings.
		Damage rating	Moderate
	Incident rating	Moderate	
	Incident overview	<p>At the end of the school day on May 24, 2023, students were occupying the school gymnasium and participating in after school activities without supervision. Smoke was detected in the gymnasium. The school principal was notified, system fire alarm was initiated, and students evacuated the school.</p> <p>The principal immediately contacted 911 emergency services, the principal obtained a fire extinguisher and attended the incident in the gymnasium and quenched the melting debris on the gymnasium floor.</p>

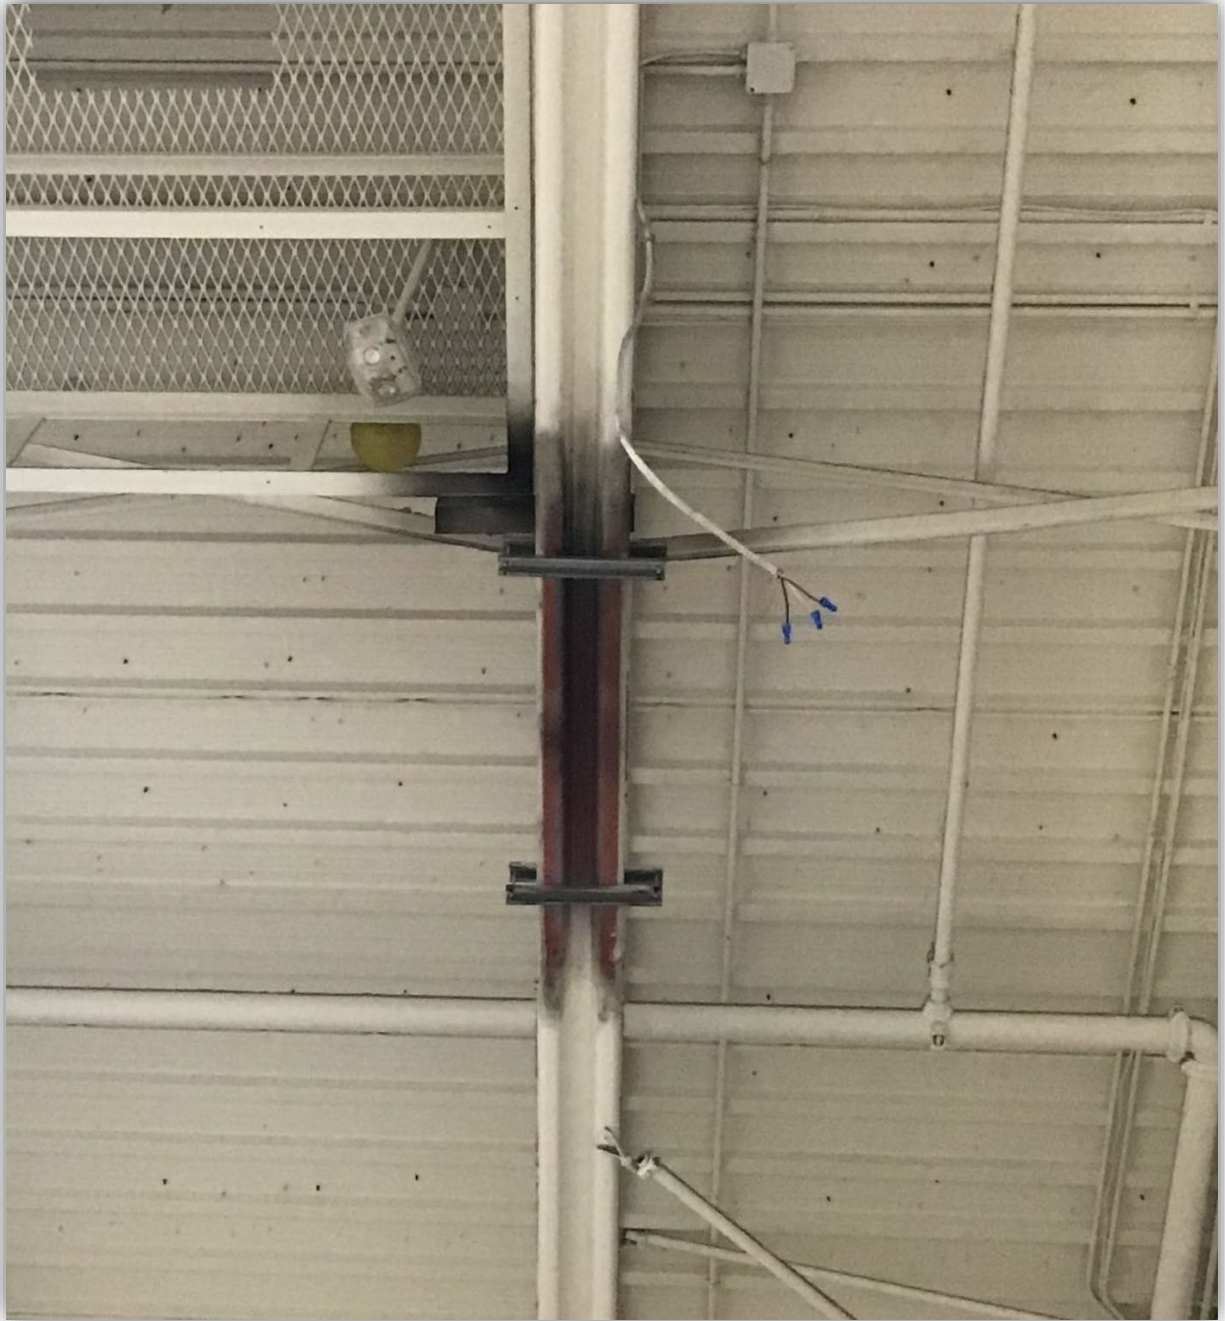
Image 1 - Heat and fire damage to area where luminaire was secured.

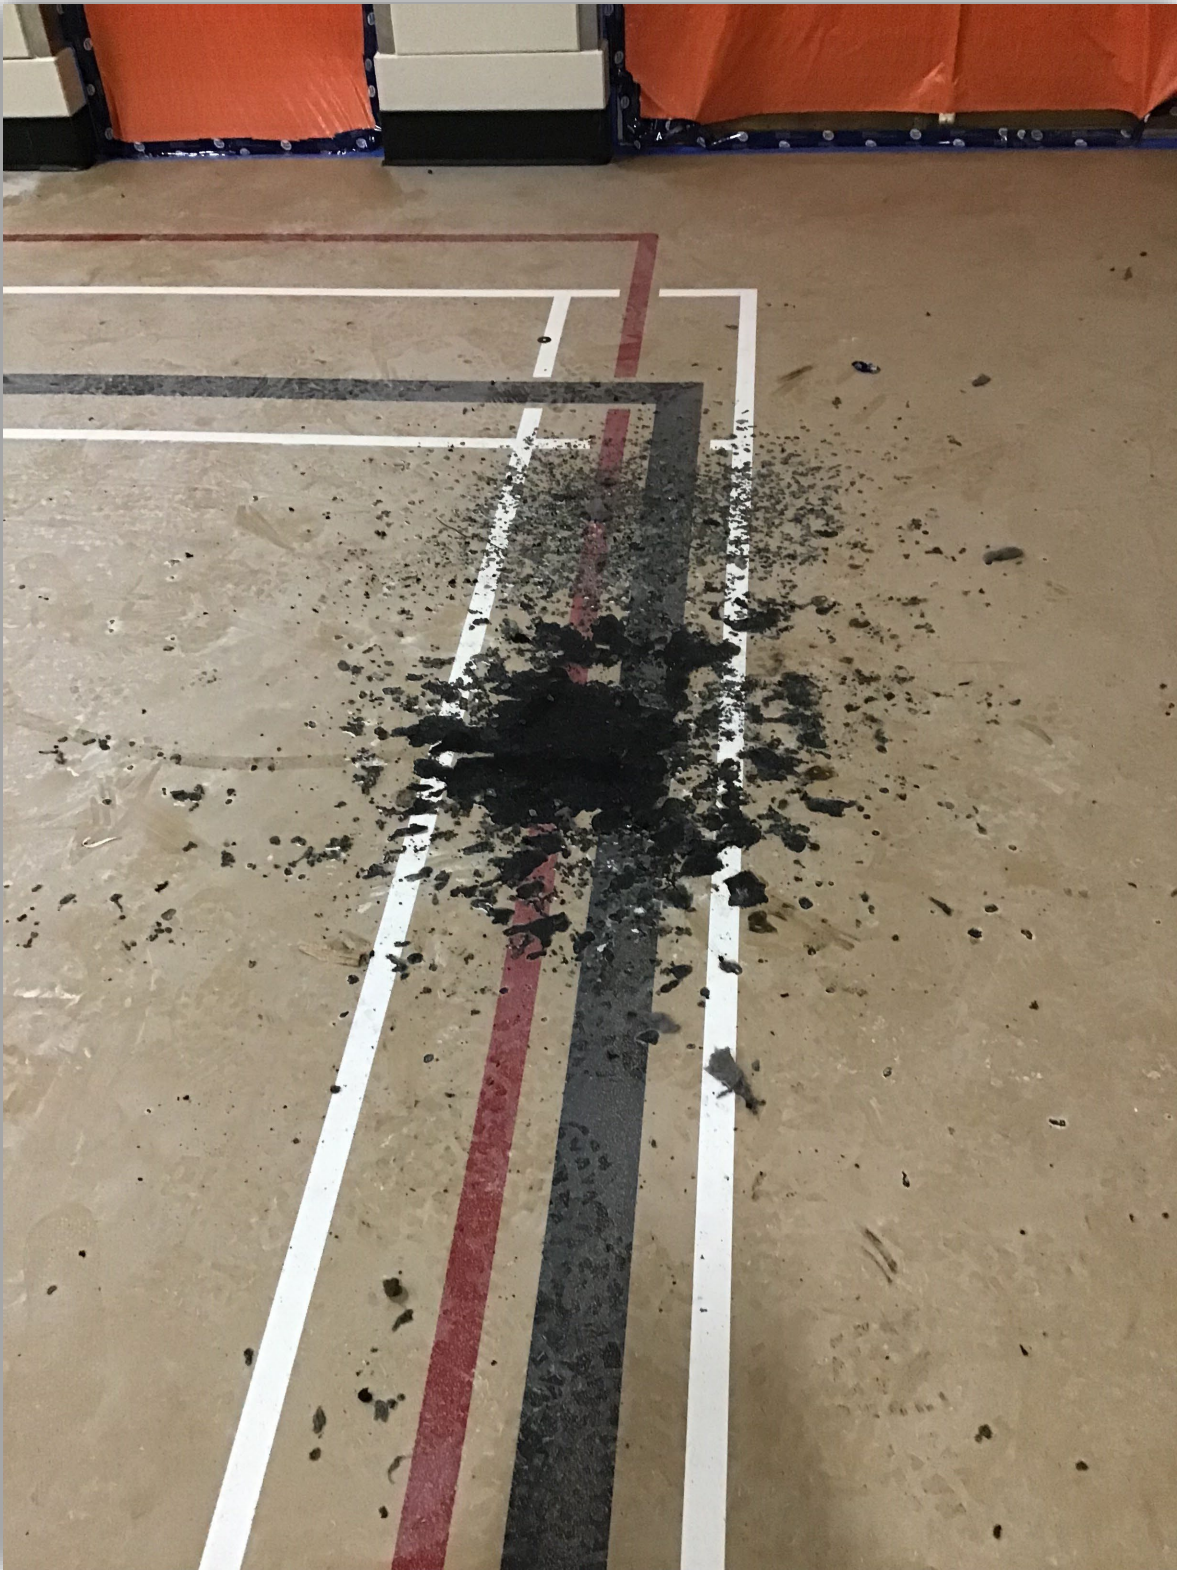
Image 2 - Floor damage directly below luminaire.

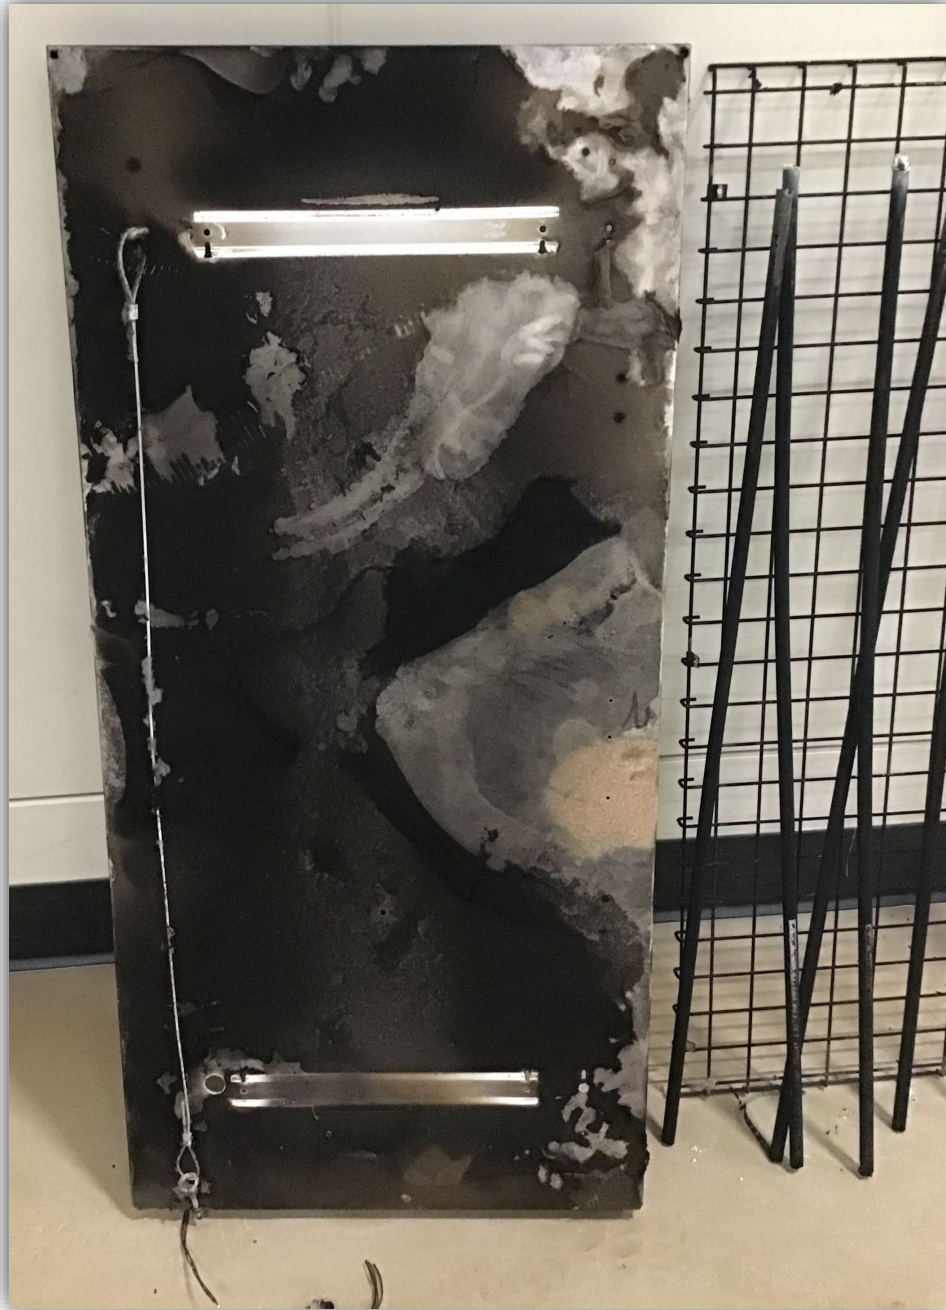
INVESTIGATION CONCLUSIONS	Site, system and components	Existing school gymnasium luminaires are supplied from two branch wiring circuits routed from a 225-ampere, 120/208-volt panel board. The luminaires are secured to the gymnasium ceiling rafter system and are fitted with wire cages to protect the luminaires from damage. The luminaires are controlled from wall mounted, low energy switching locations in the gymnasium. The luminaires originally housed four 54-watt T8 style fluorescent lamps. A recent energy efficiency upgrade was completed, and each luminaire was fitted with four 25-watt LED style lamps. Research revealed the retrofit lamps are approved and compatible with the luminaire.	
	Failure scenario(s)	The 25-watt LED lamps are constructed to physically duplicate the original fluorescent lamps: a glass tube fitted with metallic tube pins to engage and be energized from the luminaire lamp holders. A conductive strip fitted with LEDs is encased in the glass tube. Examination of the luminaire and retrofit lamps revealed that the glass tube can crack, remain energized and alight, but not drop out of the luminaire lamp holders. This cracked condition exposes the energized LED strip, and the glass tube and LED strip will contact the polymer lens. When energized and alight, the LEDs operate at high temperature. The temperatures thresholds will melt and ignite the polymer lens if the LED strip and lens are in contact.

Image 3 - Damaged luminaire, tubes, and cage – note that the polymer lens had completely melted away.

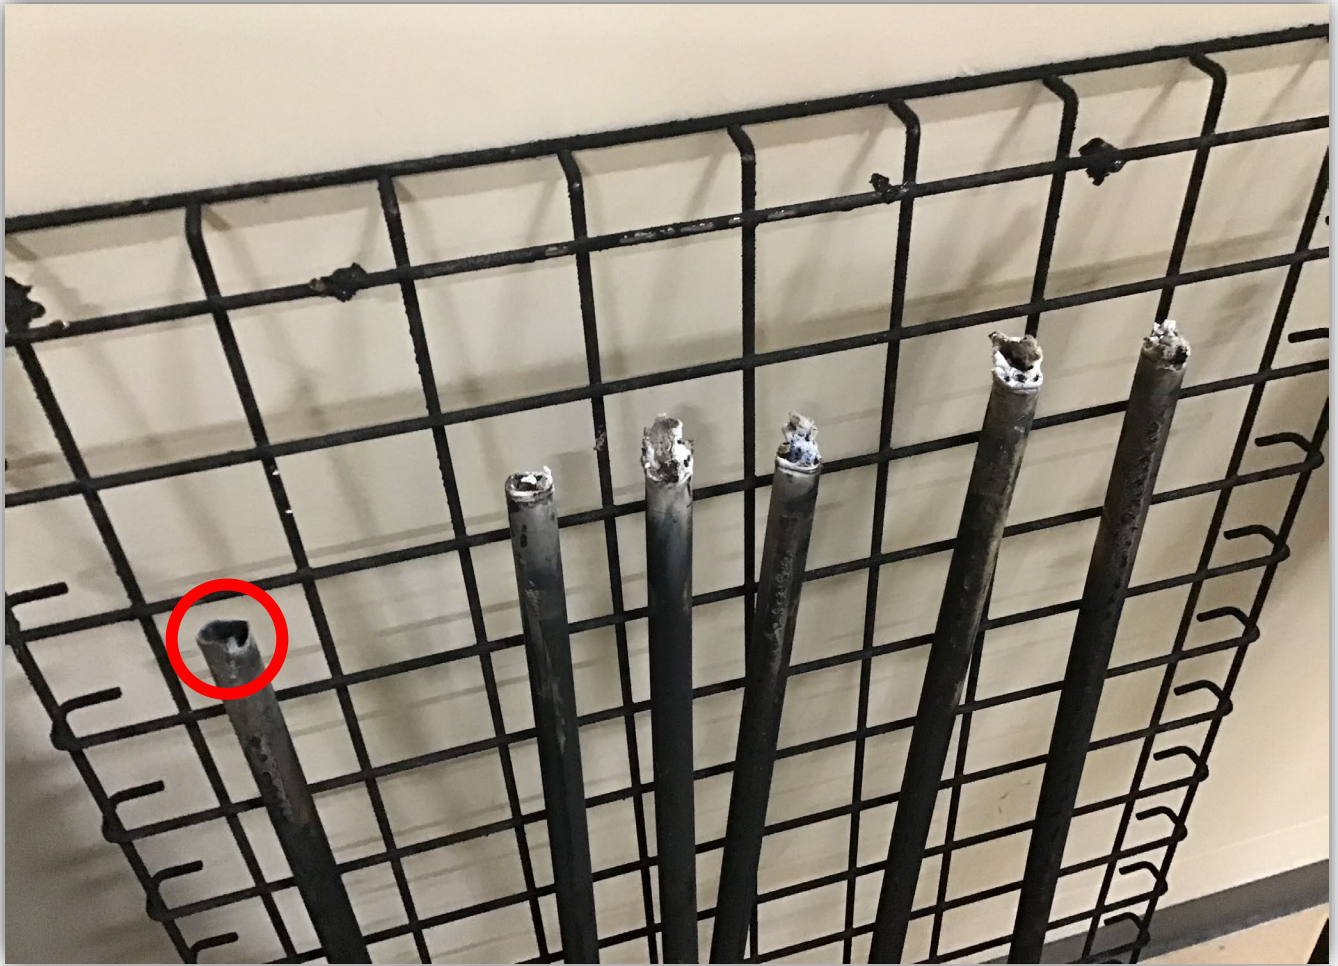
<p>Facts and evidence</p>	<p>Interview statements:</p> <ul style="list-style-type: none"> • The school has recently retrofitted multiple light fluorescent light fixtures with LED replacement tubes. • Students were in the gym prior to the incident and the light fixture was struck by a ball. <p>Site observations:</p> <ul style="list-style-type: none"> • The LED bulbs have a glass outer case that when broken may not deenergize the internal light strip. • The protective cage around the light had very close tolerances to the light fixture that may not protect it from a direct hit with a gymnasium ball. • The polymer light lens had started on fire and melted onto the gym floor below.
<p>Causes and contributing factors</p>	<p>The cause of the incident was likely the high temperature LED strip in the retrofit bulb remaining energized after being physically damaged and setting fire to the polymer diffuser lens.</p> <p>Contributing factors to the incident include:</p> <ul style="list-style-type: none"> • The physical protection of the light fixture in a gymnasium did not effectively protect the fixture from damage when struck with a ball which would be expected in the gymnasium. • The retrofit LED bulbs allow the internal LED strip to remain energized when the protective outer glass is broken exposing high levels of heat to the surrounding materials. • The existing polymer lenses of the lighting fixtures are not resistant to the heat produced by a damaged LED bulb. The original fluorescent tubes would not have remained energized or produced heat if they were to break due to the electrical circuit opening.

Image 4 - Cracked tubes.

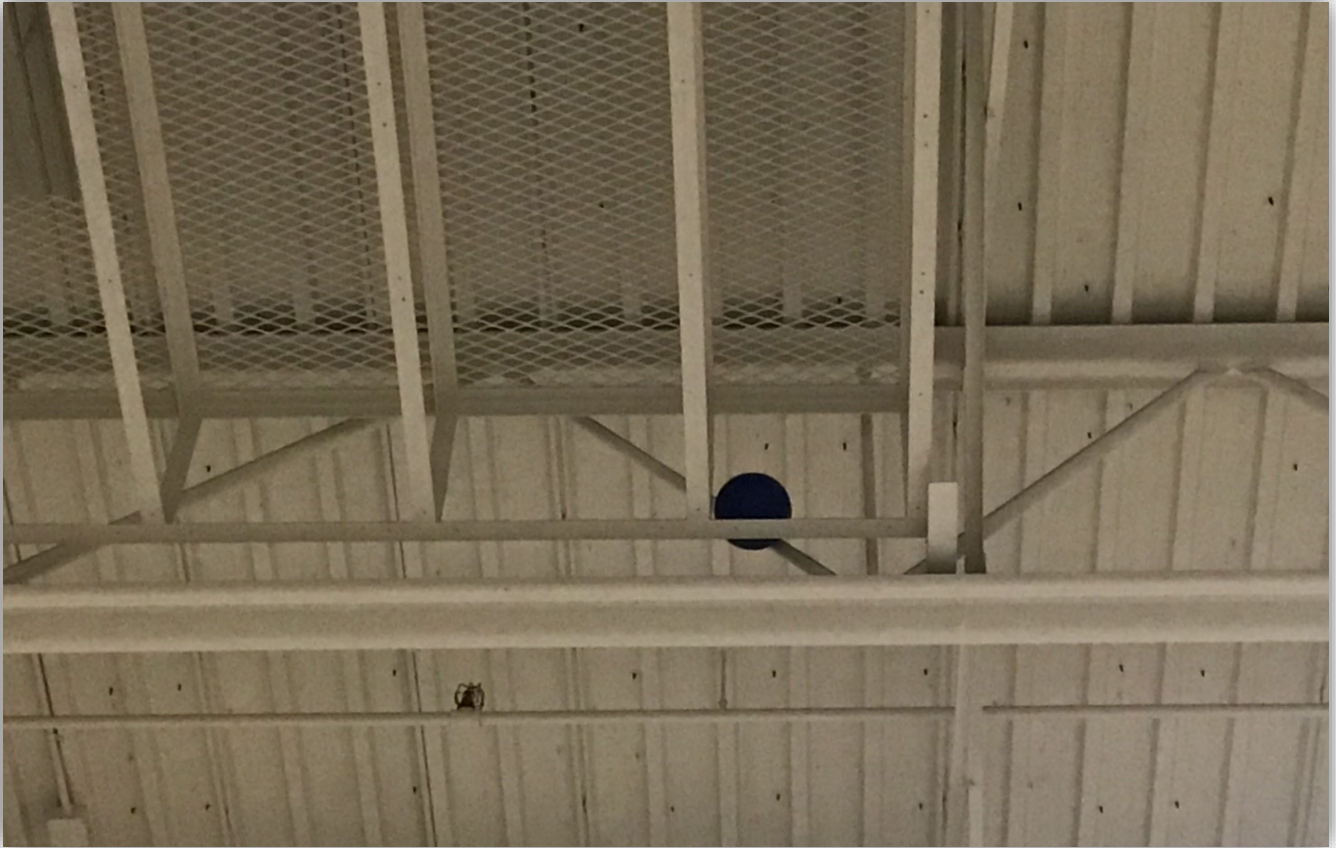
Image 5 - Example of balls kicked up and wedged to ceiling system.
