Client:	Kicking Horse Resort	Date:	October 20, 2021
Location:	Golden, BC	Requested By:	[REDACTED]
Lift Name:	Golden Eagle Express Gondola	Lift Hours:	n/a
Installation #:	157.004	Specification:	CSA Z98-14
Description:	Golden Eagle Express Gondola Hanger Arms and H-Frames

As requested, Non-Destructive Testing has been conducted on May 16-17, 2022, on the following:
- Golden Eagle Gondola - Grips, Hanger Carriers & Gondola Cabins

INSPECTION INFORMATION		Report #	NM22517-01
Client Name:	Kicking Horse Mountain Resort	Date:	May 17, 2022
Work Location:	Golden, BC	Requested By:	[REDACTED]
Lift Mfg:	Poma	Lift Hours:	n/a
Installation #:	157.004	Specification:	CSA Z98-19
Description:	Golden Eagle Express Gondola Grip Components

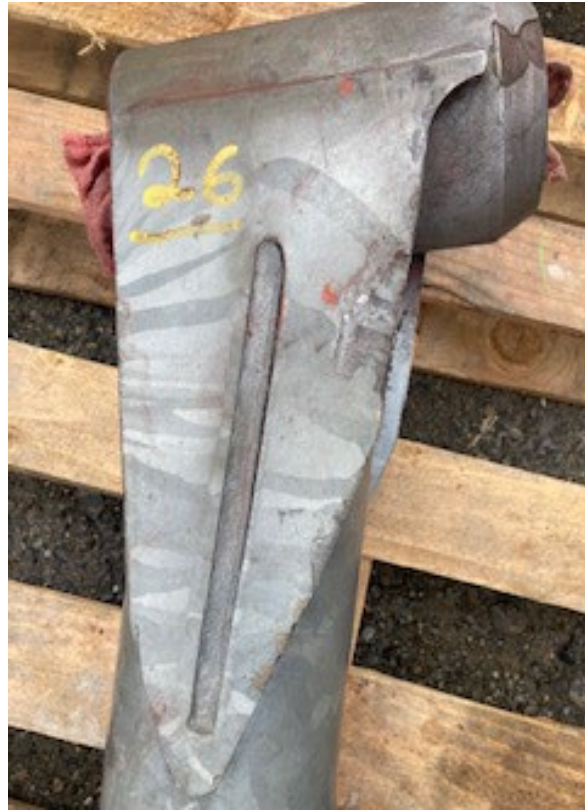
Above : Hanger Arm #26

No relevant indications were located at the time of this inspection.

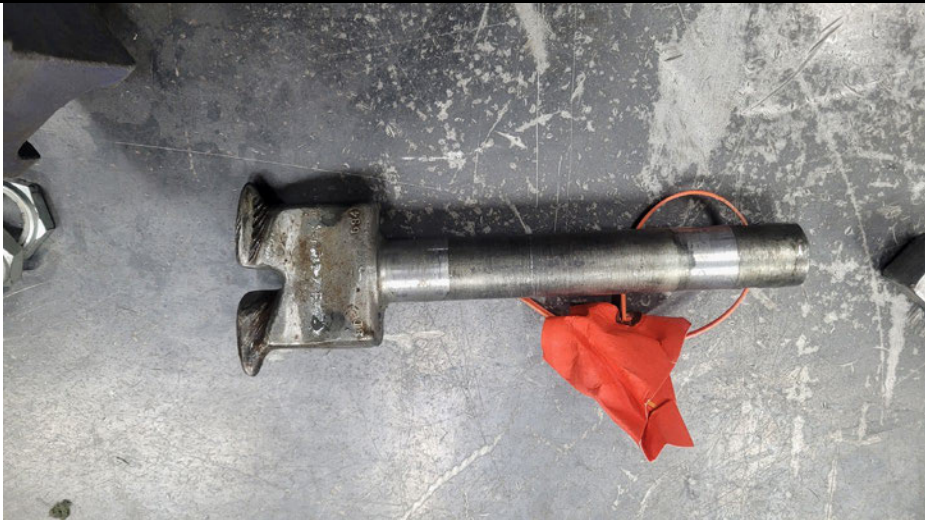
Equipment ID:	Description:	Results:	Comments:
Riblet grip	Spare grip	Accepted	No indication detected during inspection.

Results:	Accepted
-----------------	-----------------

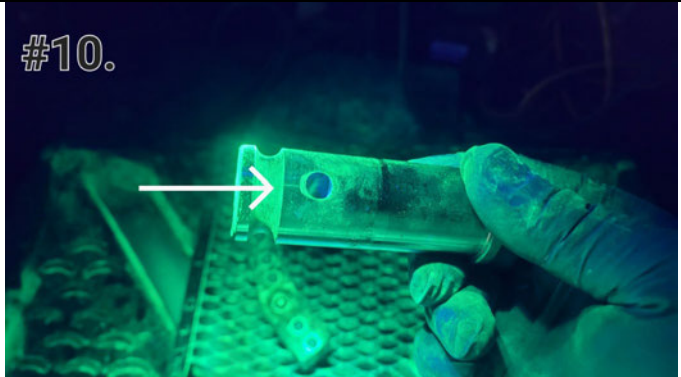
Grip #	Body	Jaw	# of Small Parts	Description:	Grip #	Body	Jaw	# of Small Parts	Description:
2	P	P	14		50	P	P	14	
4	P	P	14		52	P	P	14	
6	P	P	14		54	P	P	14	
8	P	P	14						
10	P	P	14	Indication on roller pin, see photo. Replaced.					
12	P	P	14						
14	P	P	14						
16	P	P	14						
18	P	P	14						
20	P	P	14						
22	P	P	14						
24	P	P	14						
26	P	P	14						
28	P	P	14						
30	P	P	14						
32	P	P	14						
34	P	P	14						
36	P	P	14						
38	P	P	14						
40	P	P	14						
42	P	P	14						
44	P	P	14						
46	P	P	14						
48	P	P	14						
					Work Deck

No relevant indications were located at the time of this inspection.
