Incident Summary (Reference #II-667666-2018)

SUPPORTING INFORMATION	Incident Date	March 4, 2018	
	Location	Fraser Valley, BC	
	Regulated industry sector	High Voltage Electrical System (greater than 750v)	
	Impact	Qty injuries	1
		Injury description	An electrical worker received an electrical shock which resulted in burns to his hands
		Injury rating	Minor
	Damage	Damage description	A high voltage underground termination elbow and termination junction were destroyed.
		Damage rating	Moderate
Incident rating	Moderate		
Incident overview	<p>An underground high voltage cable termination failed causing a partial power outage to a private utility servicing a mountainside resort and residential area.</p> <p>An electrical worker received a shock while trouble shooting the power outage on the underground high voltage distribution system. The electrician believed that the part of the system he was working on was de-energized when he made contact with an energized piece of equipment.</p>

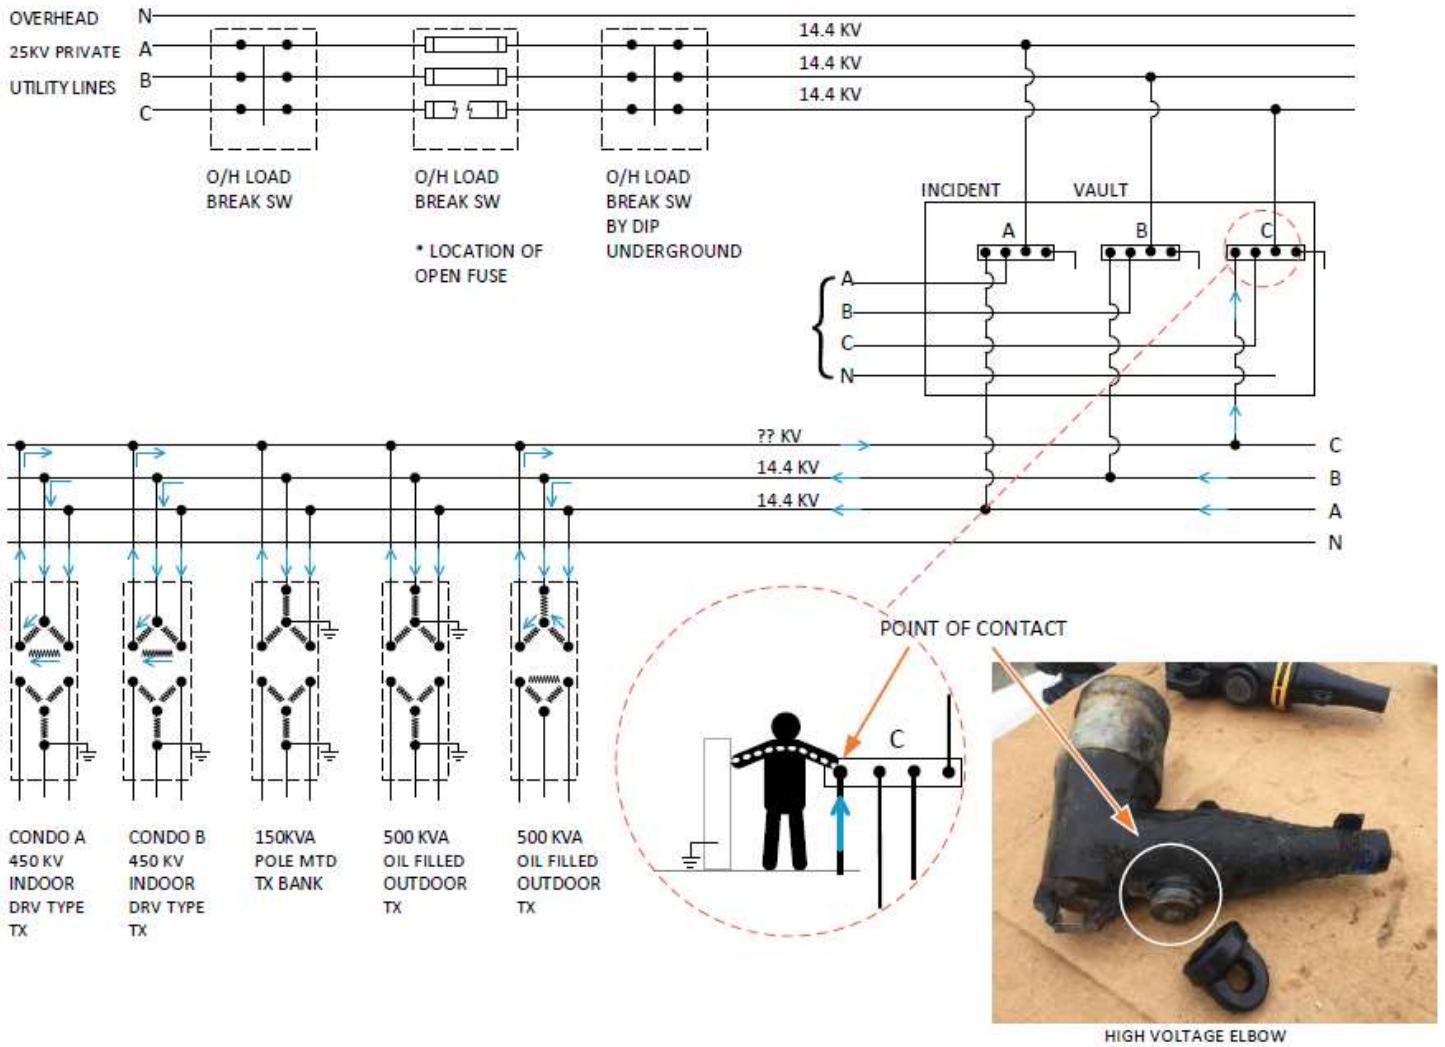
Diagram 1 – One-line diagram showing voltage potential, current flow, and the point of contact

- The ‘C’ phase cable that was removed was not the de-energized cable coming from the open fuse but rather a cable that was being back fed AC voltage through the primary windings of several transformers connected to the still energized A & B phase primary lines of the system.

- The cables and termination bus were not properly marked to identify which installation or portion of the installation they served.
 - The electrical worker did not anticipate a potential feedback through the primary windings of multiple transformers connected to the utility system. **-See Diagram 1**

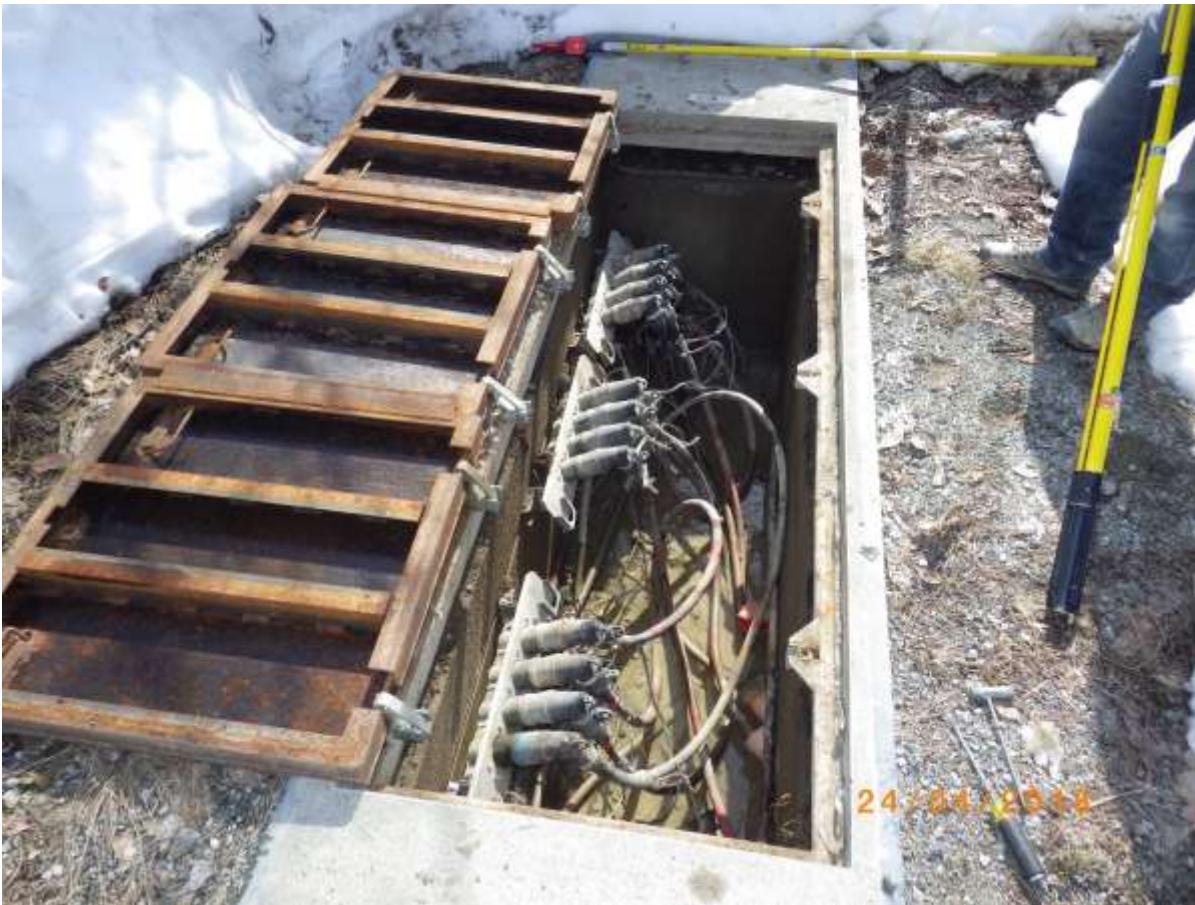
Picture 1

Vault where electrical worker was shocked.

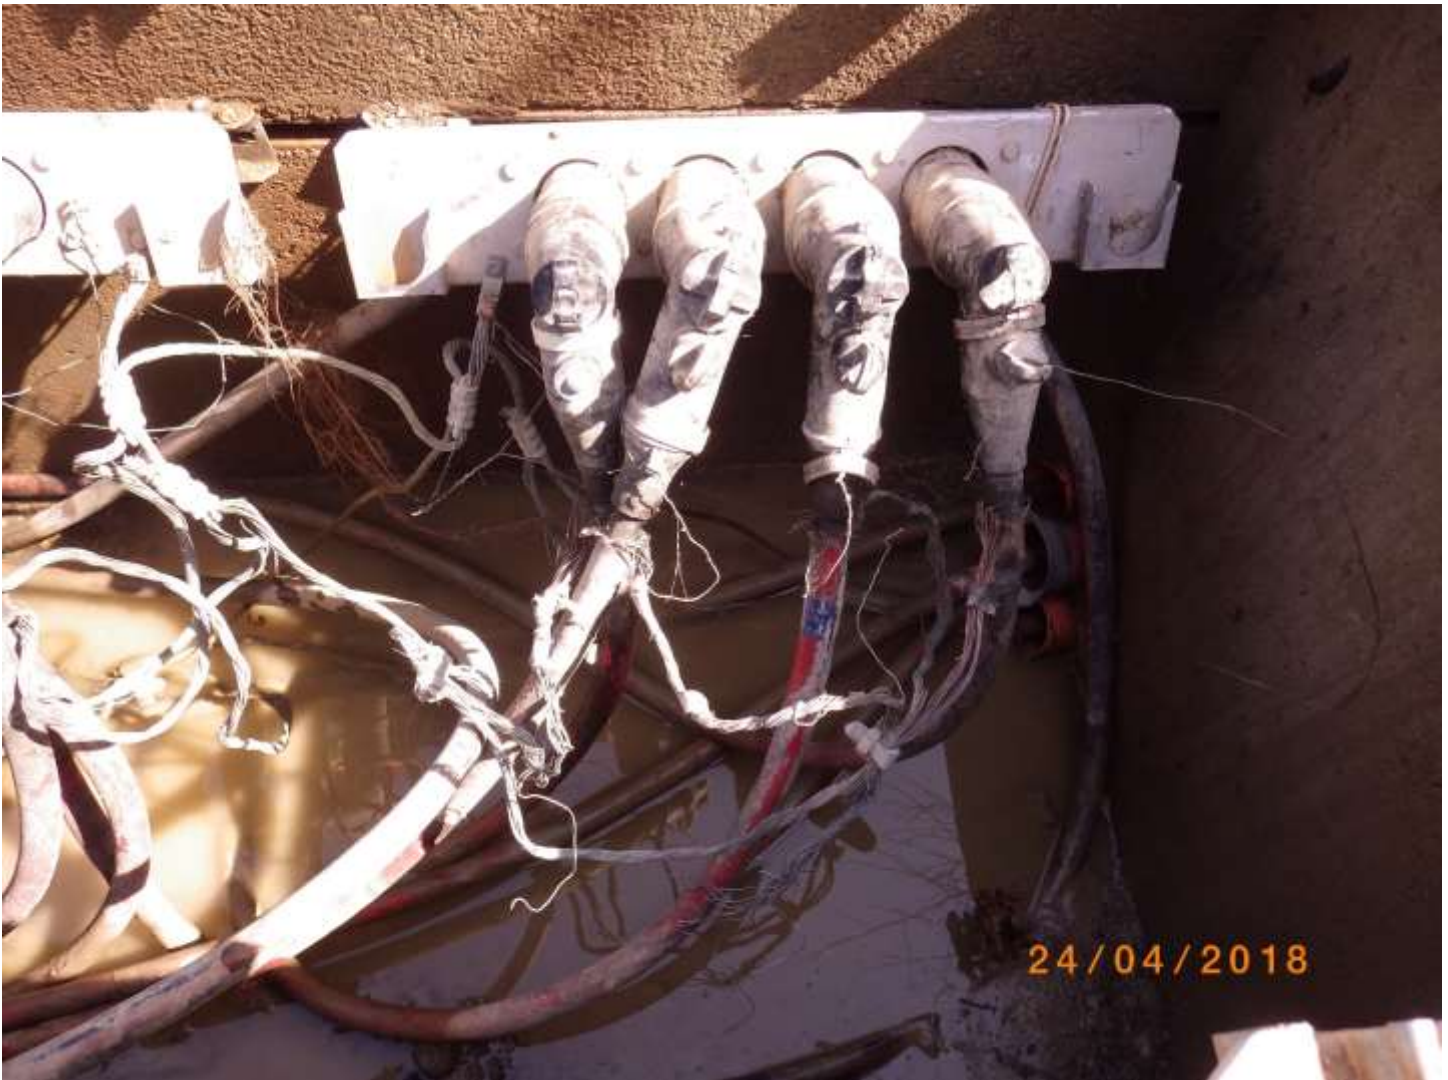
Picture 2

This group of high voltage elbow terminations is the 'C' phase in the in-ground vault. The worker attempted to remove and 'park' the far left elbow when he was shocked. Photo also shows standing water in the vault.

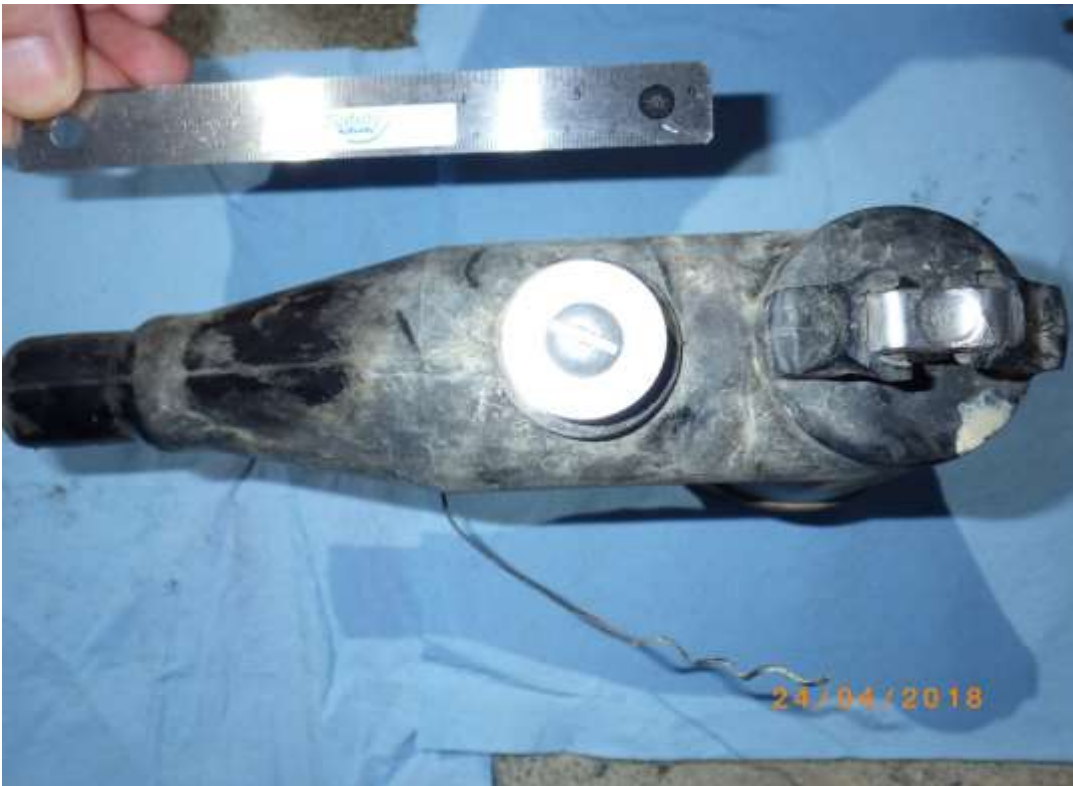
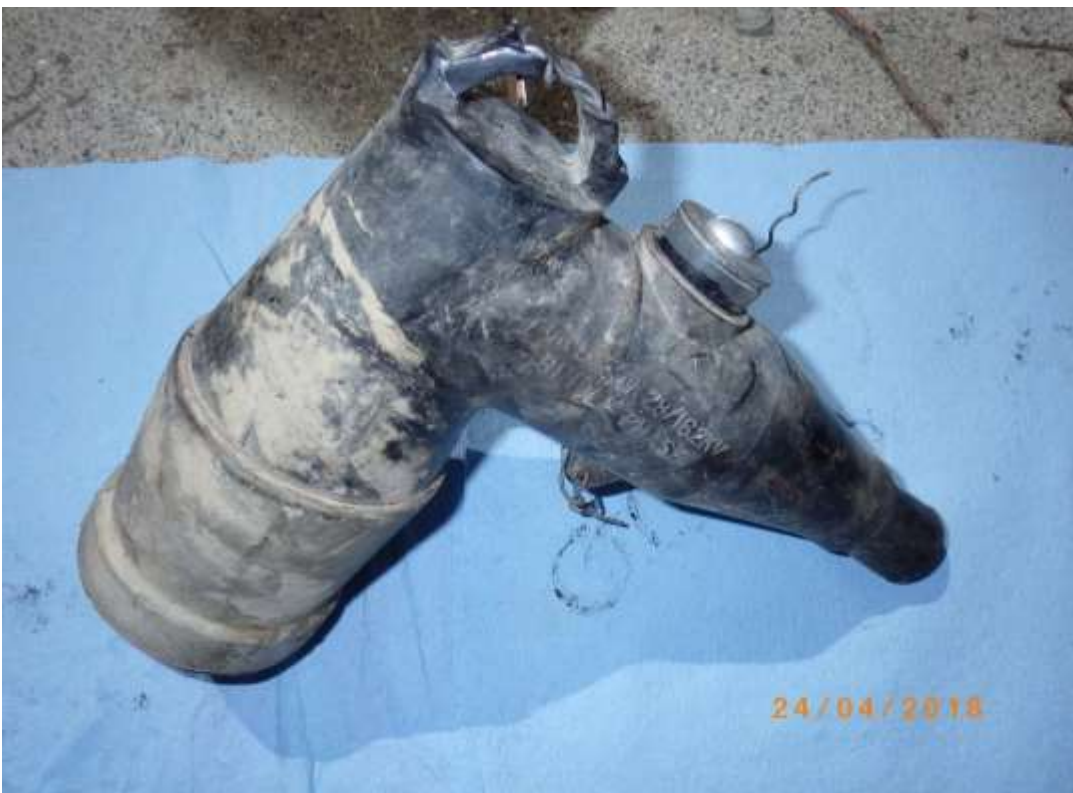
Pictures 3

- The electrical worker likely received a shock from the DC capacitive test port on the high voltage elbow of unknown DC voltage. The voltage would have been relative to the AC voltage back fed through the cable (up to 10% of the AC voltage).

- HV elbow that was the source of shock was visually observed to be dirty but under reasonable conditions of use and environment and displayed no evidence of being faulty. **-See Picture 3**

Location of DC capacitive test point on the removed high voltage termination elbow which the worker was attempting to 'park' when he was shocked. Insulated cap is removed for photo.

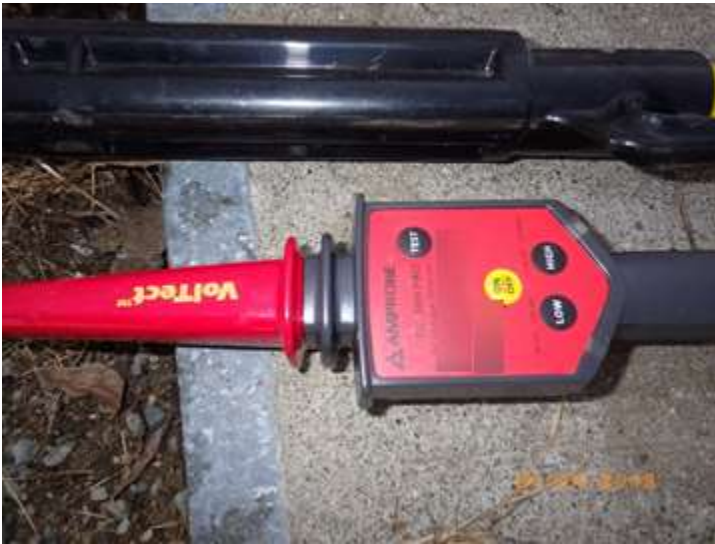
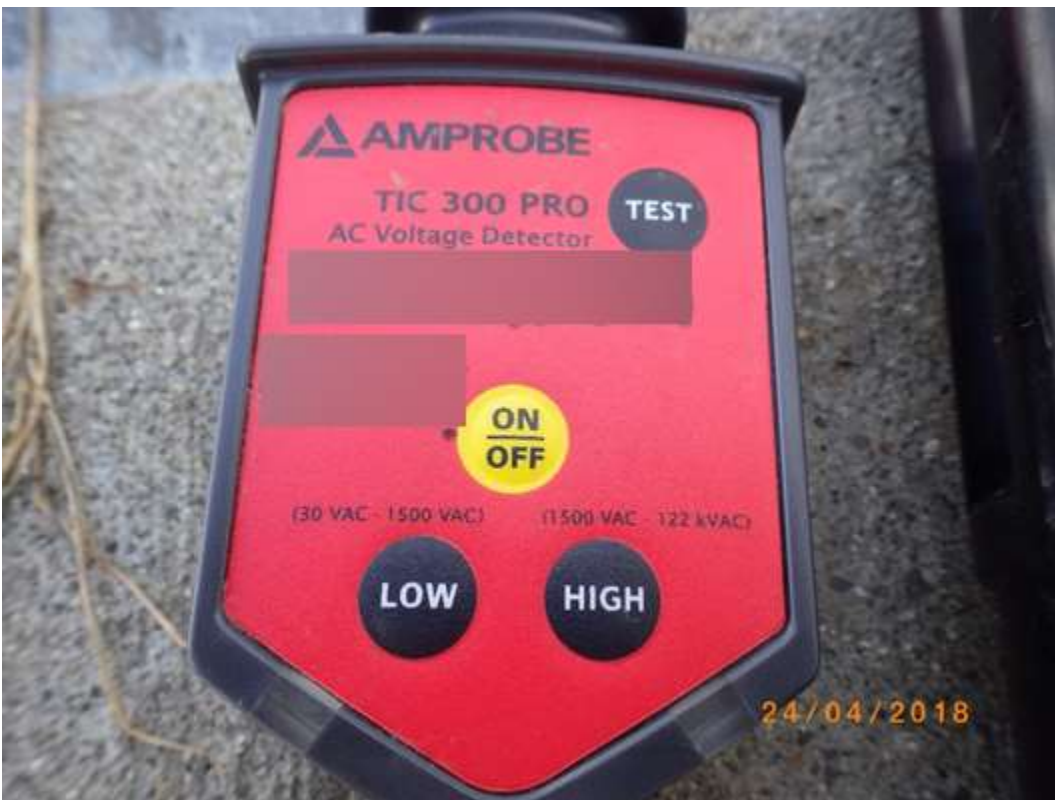
Pictures 4

- The tester may not have been set to the correct voltage setting to detect the range of voltage that may have been present on the cable. This may have been equal to or less than 1500V AC depending on the equipment and loads connected to the system which consisted of multiple transformers, motors, and other loads related to the resort and subdivision.

- Hot stick, voltage tester and HV gloves onsite the day of the incident as declared by the electrical contractor were provided for examination on April 25, 2018 and bore evidence of approval for use. The equipment appeared to be suitable for its intended use. **-See Picture 4**

Proximity voltage sensor that the worker used to test the high voltage elbow prior to attempting to remove and 'park' the elbow. Notice the two voltage settings. The tester may not have been set to the correct voltage setting to detect the range of voltage that may have been present on the cable.

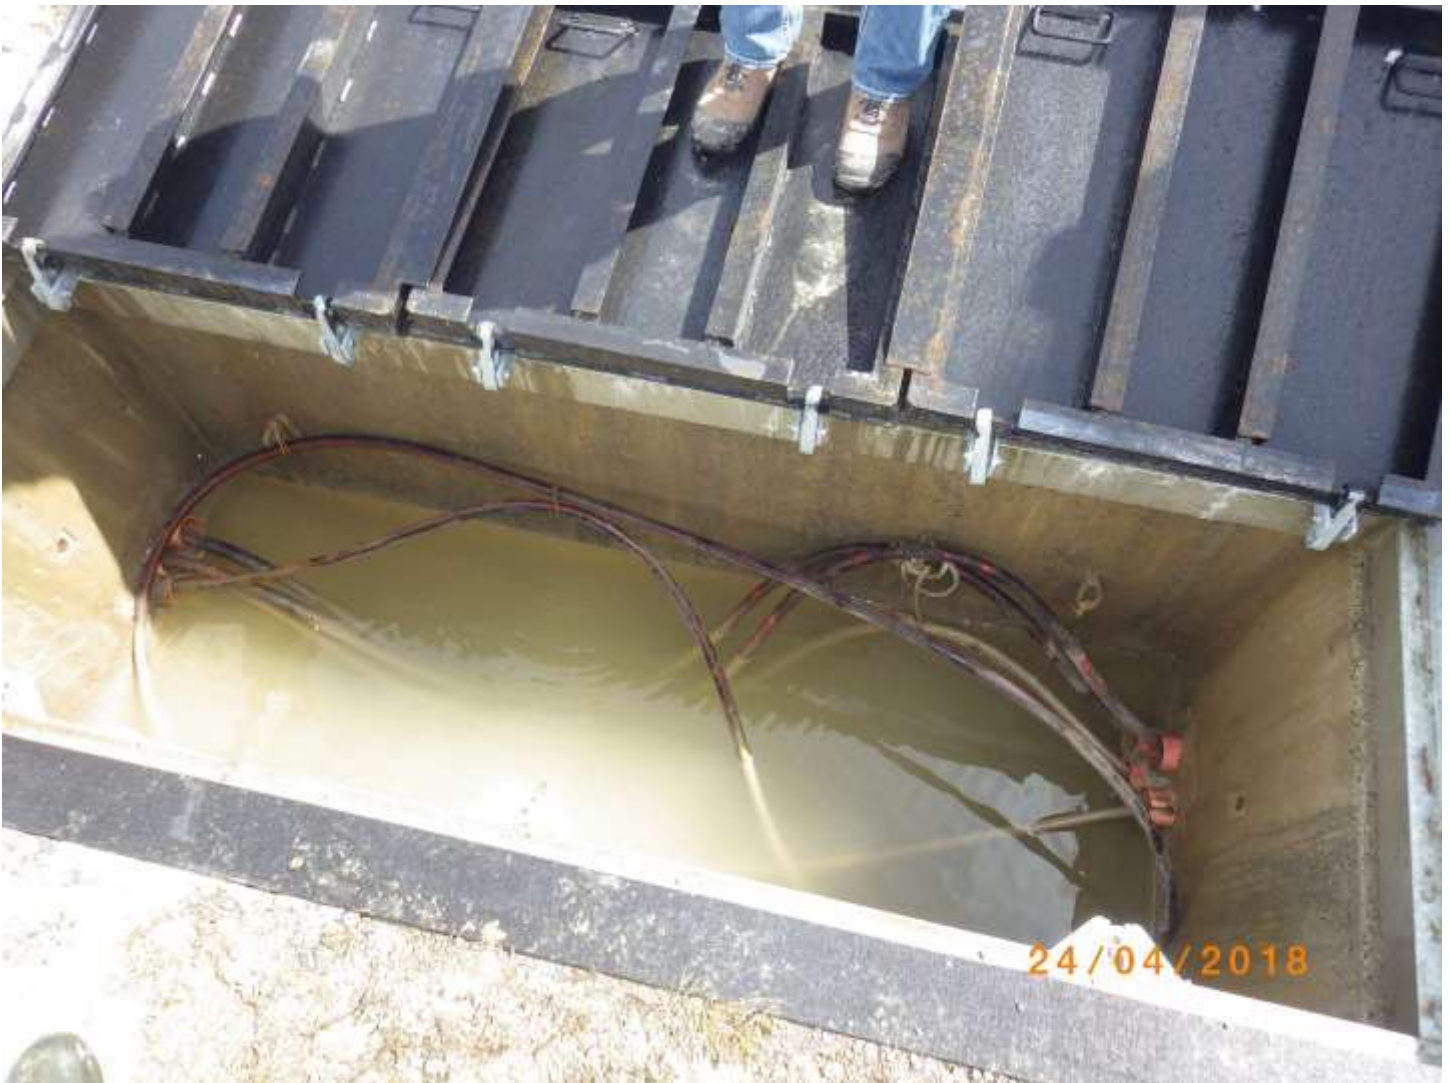
Picture 5

- It’s likely the cable termination failed due to improper drainage within the in-ground vault which caused water to enter and/or fill the vault. Water combined with contamination such as dust and dirt within the termination elbow caused high voltage

Downstream pull box opened to demonstrate the fluctuating water levels that may be present in below ground vaults. Improper drainage was observed in multiple in-ground vaults.

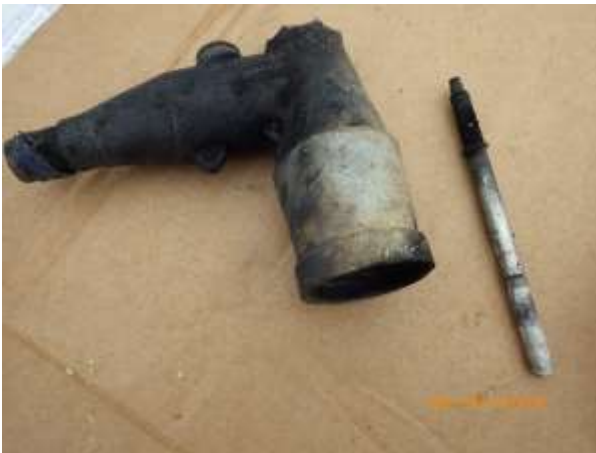
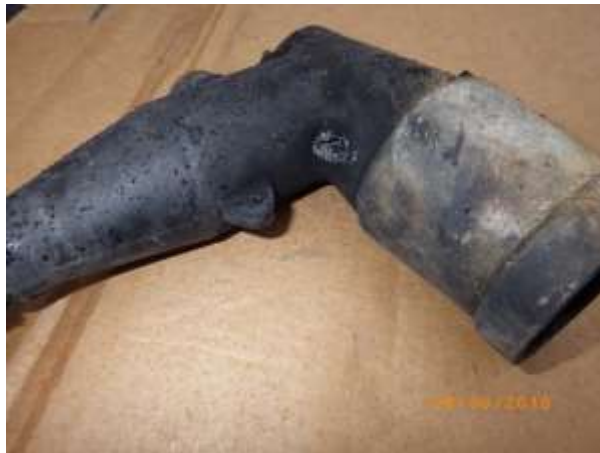
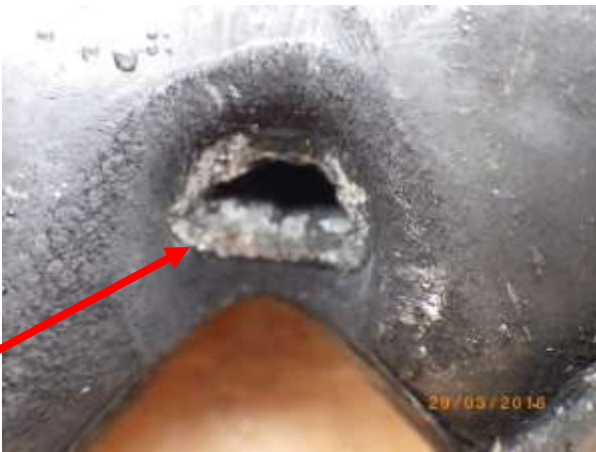
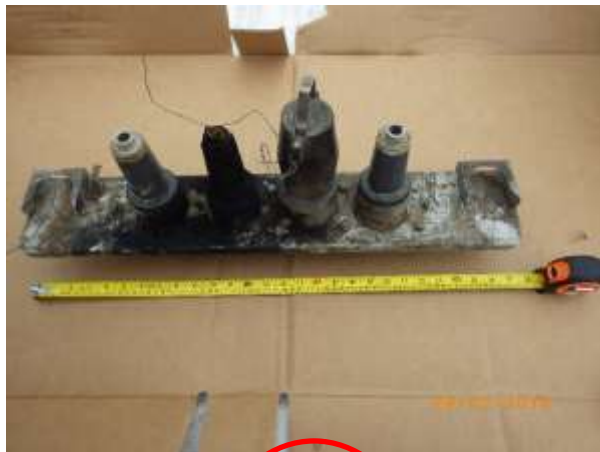
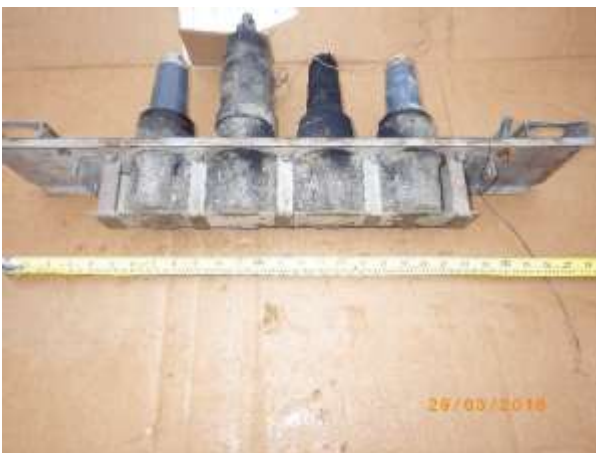
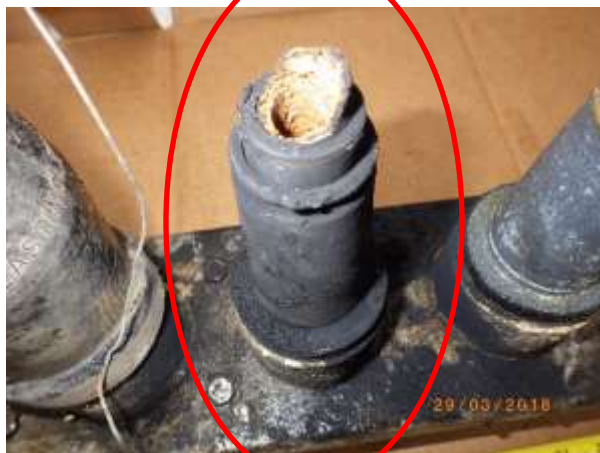
Pictures 6

- The failed cable termination:**
- The failed cable termination was located in a different in-ground vault from where the electrical worker was shocked.

- The high voltage elbow that was the source of the fault that initially caused the 'C' phase fuse to open and the resulting power outage was visually observed to have suffered catastrophic failure. It's possible that due to high voltage tracking over moisture and contamination the resulting electrical arc pierced through the rubber insulation of the elbow leaving a hole and destroying the bushing mounted on the load-break junction. **-See Picture 6**

Failed high voltage termination elbow and related damaged equipment at in-ground vault. The red arrow indicates the location of the high voltage fault to ground. The red oval shows the damaged junction termination port on the junction termination bus that was within the in-ground vault.
