## Incident Summary # II-694080

**Electric Shock Incident Investigation**

**Date: May, 2018**

**Location: Lake Cowichan**

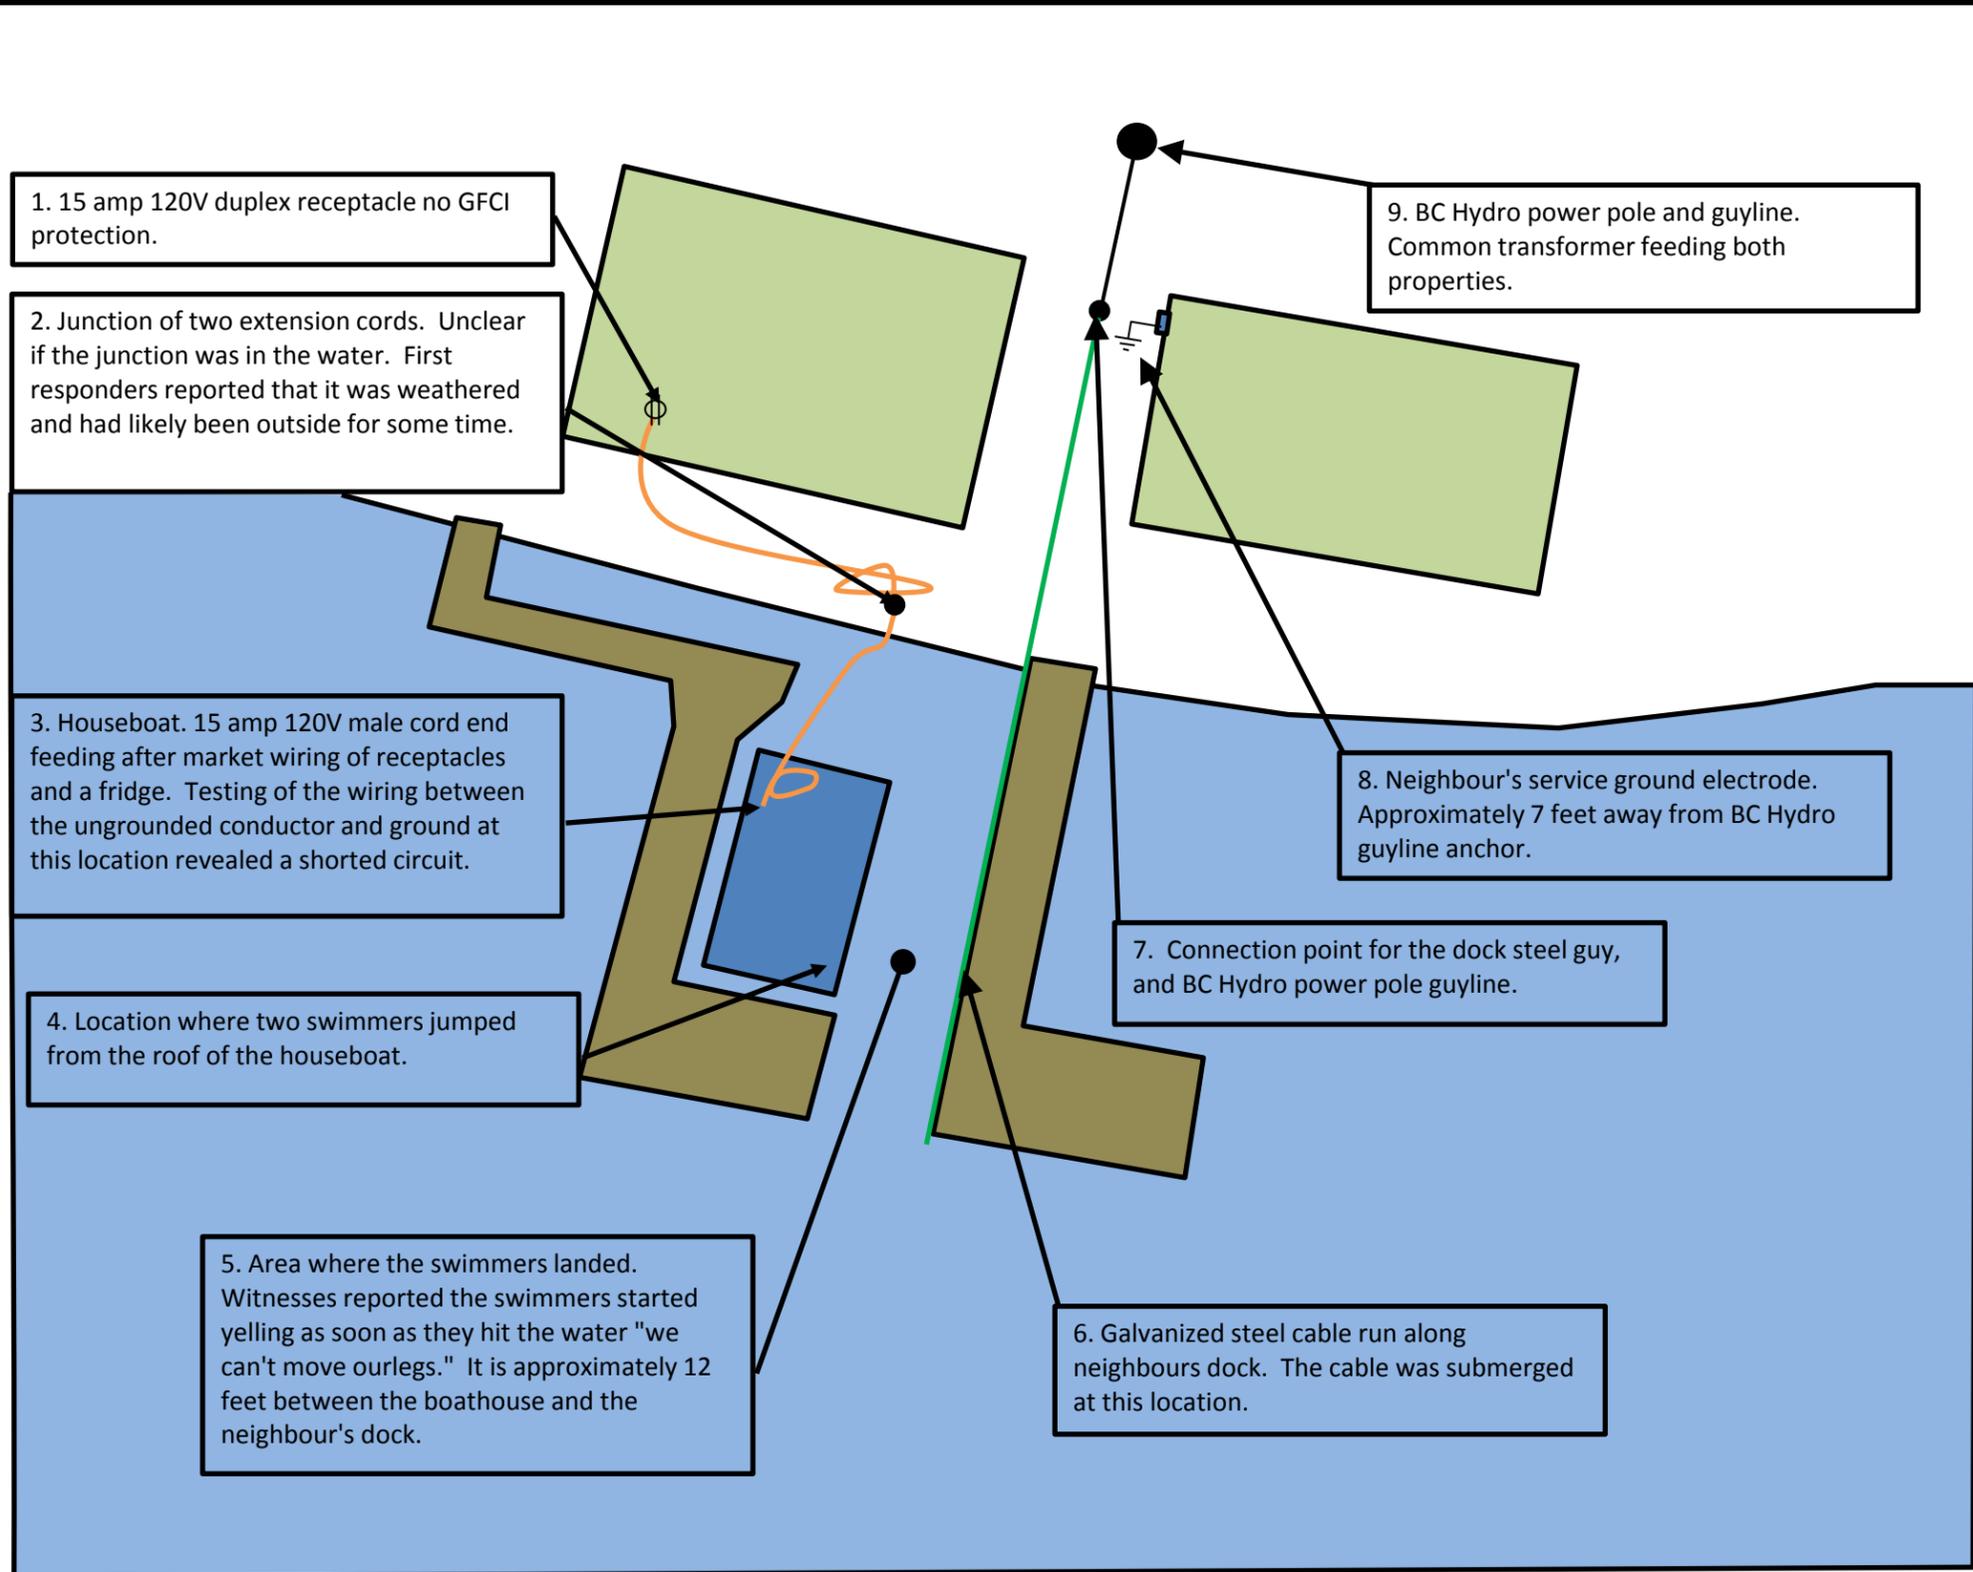
1. 15 amp 120V duplex receptacle no GFCI protection.

2. Junction of two extension cords. Unclear if the junction was in the water. First responders reported that it was weathered and had likely been outside for some time.

3. Houseboat. 15 amp 120V male cord end feeding after market wiring of receptacles and a fridge. Testing of the wiring between the ungrounded conductor and ground at this location revealed a shorted circuit.

4. Location where two swimmers jumped from the roof of the houseboat.

5. Area where the swimmers landed. Witnesses reported the swimmers started yelling as soon as they hit the water "we can't move our legs." It is approximately 12 feet between the boathouse and the neighbour's dock.

6. Galvanized steel cable run along neighbour's dock. The cable was submerged at this location.

7. Connection point for the dock steel guy, and BC Hydro power pole guyline.

8. Neighbour's service ground electrode. Approximately 7 feet away from BC Hydro guyline anchor.

9. BC Hydro power pole and guyline. Common transformer feeding both properties.

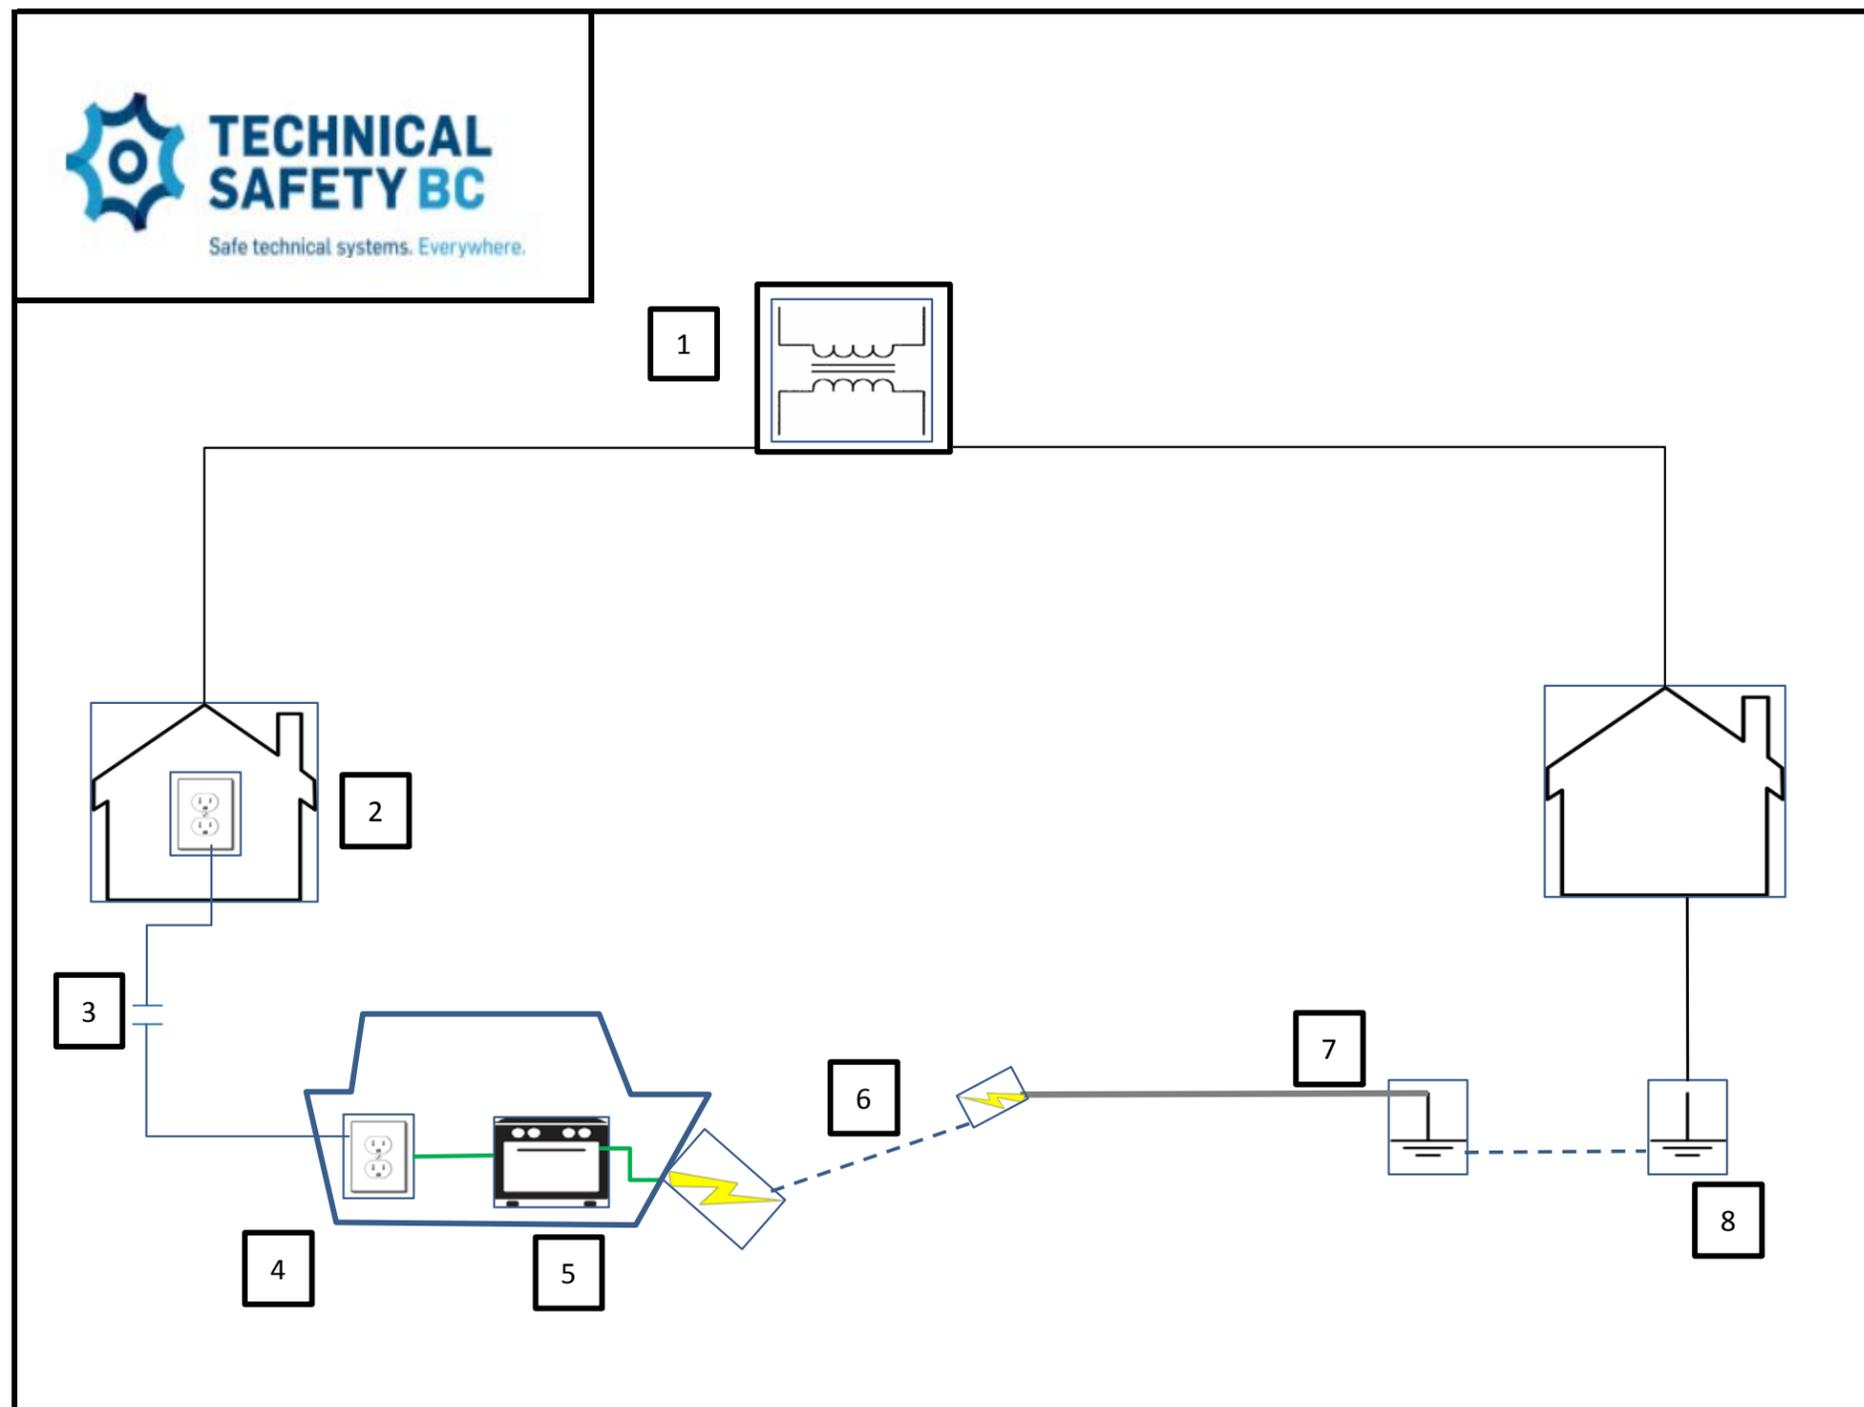
**Electric Shock Incident Loop Drawing**

1	Utility transformer, common to both properties.
2	Receptacle feeding the boathouse, no GFCI protection.
3	Junction of two extension cords. First responders reported that the junction of the two extension cords used to feed the boathouse was very weathered. It is likely that the ground pin was missing or the bonding connection was corroded enough to prevent the breaker from tripping.
4	120V AC receptacle. NMD90 wiring shorted to the metal device box on houseboat.
5	12/120V appliance connected to the boat hull through the 12V negative. The appliance was also on the same 120V circuit as the shorted receptacle which energized the housing of the appliance and subsequently the hull of the boat.
6	Swimmers jumped from the top of the houseboat and landed directly between the boathouse and the return path to ground.
7	Galvanized steel cable run up from neighbor's dock and anchored 7 feet away from the neighbor's service ground electrode. This cable was in the water approximately 12 feet from the houseboat. It acted as a return path to ground through the ground electrode and neutral of the neighbor's service.

8	Neighbor's service ground electrode.
