## Incident Summary (Posse file#5620262)

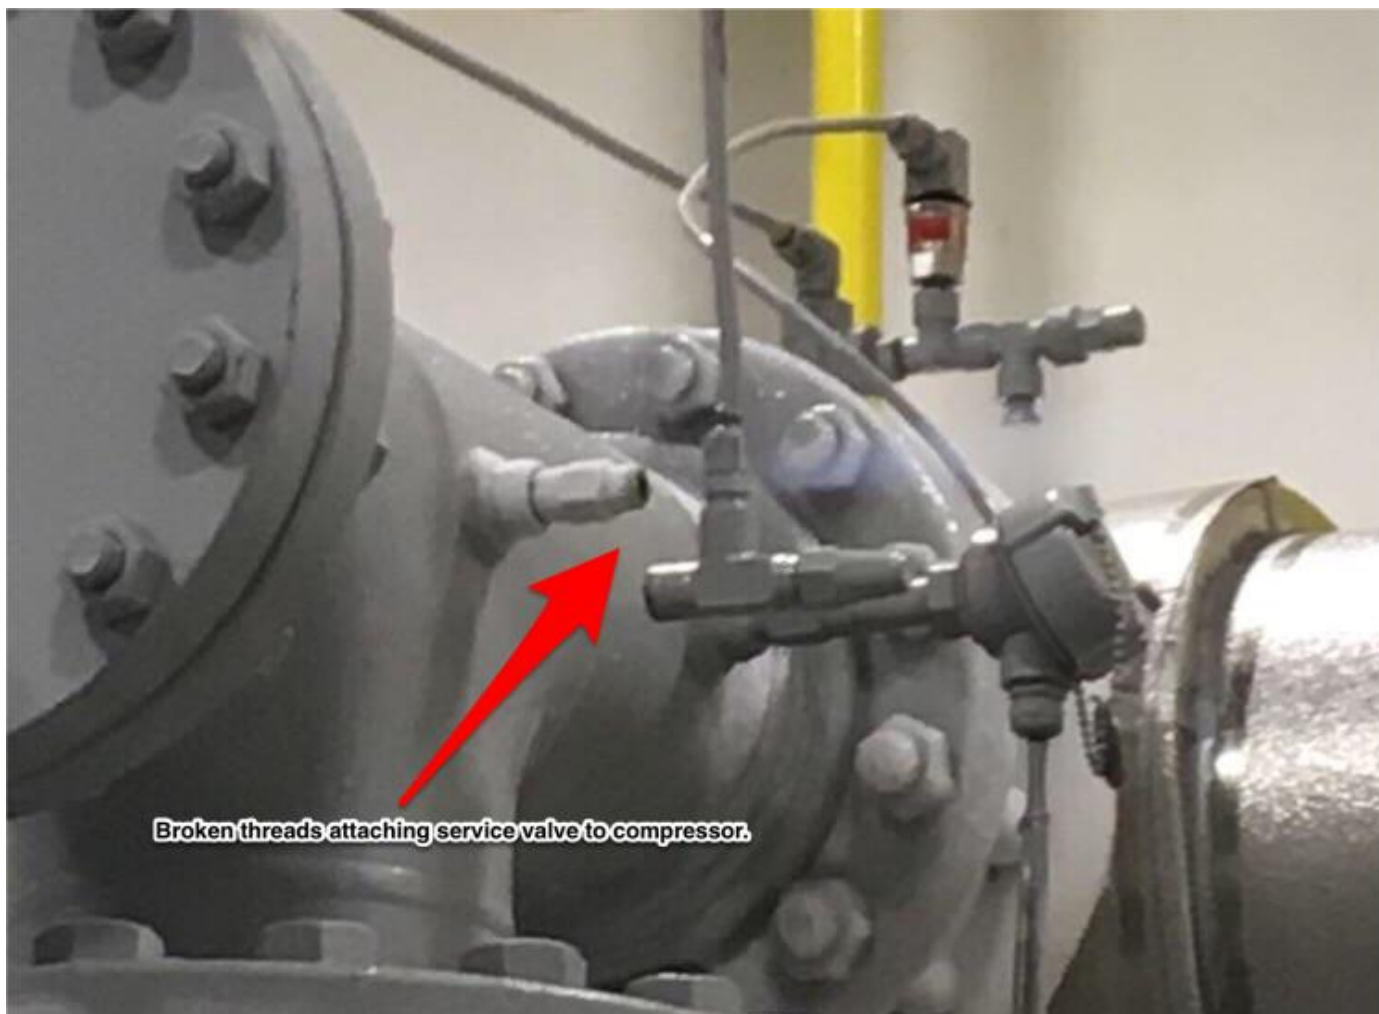
Failure scenario(s)		The threads of a ½” Service Valve on the piping of the Compressor of a New Ammonia Refrigeration Plant, cracked apart and released Oil and some Ammonia into the Mechanical Room. System shutdown was initiated once a leak was detected.	
	Facts and evidence		<p>Broken threads on a ½” Service Valve, see attached picture provided from the Licensed Contractor that was called in to repair the issue, the system was shut down by the attending Chief Engineer of the plant.</p> <p>The Licensed Contractor stated there has never been an issue with these types of valves, and possibly the threads were damaged during shipping of the new compressor to the plant or during construction.</p>	
	Causes and contributing factors		It is highly probable, that the broken threads of the ½” Service Valve on the compressor caused the leakage.

Broken threads attaching service valve to compressor.

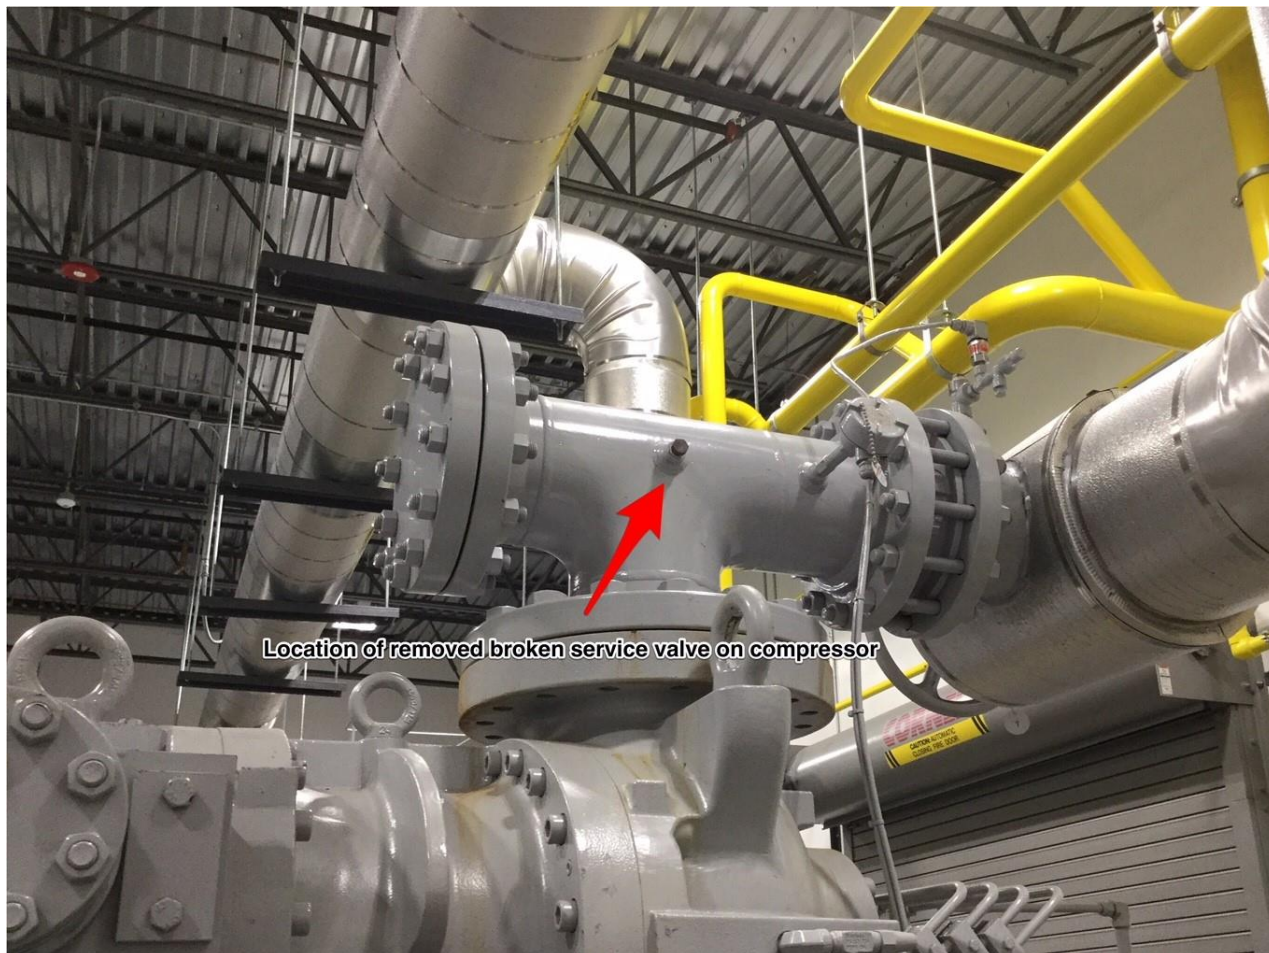
Location of removed broken service valve on compressor

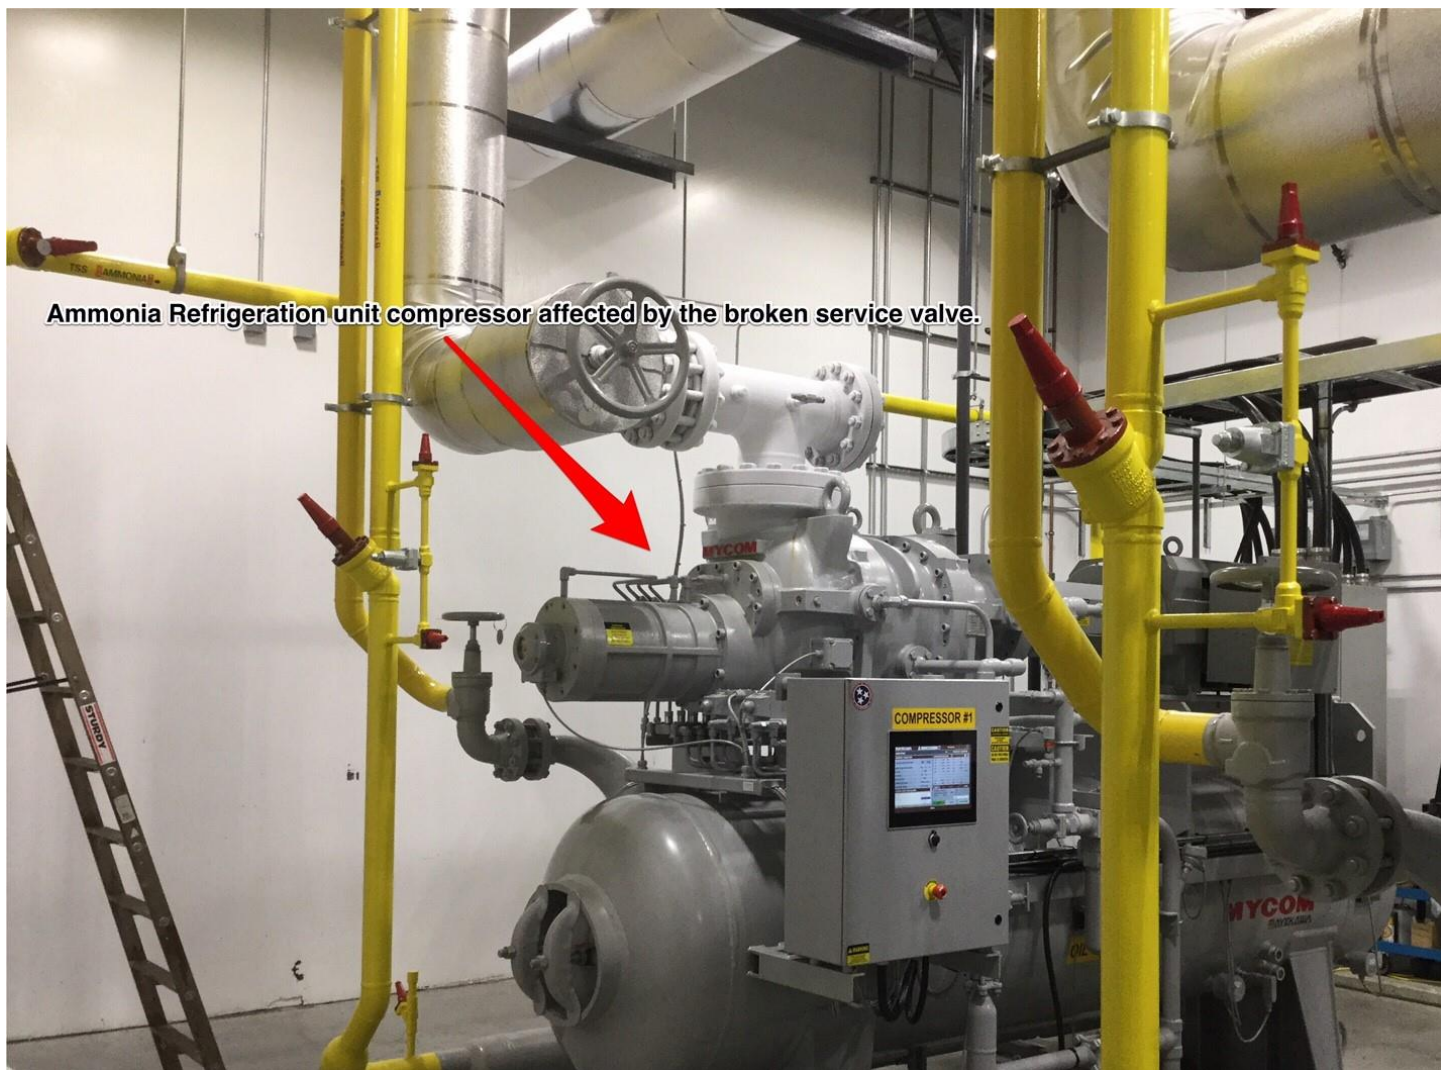
Ammonia Refrigeration unit compressor affected by the broken service valve.
