## Incident Summary #II-1660419-2024 (#43399) (FINAL)

SUPPORTING INFORMATION	Incident Date	January 14, 2024	
	Location	Interior	
	Regulated industry sector	Passenger ropeways - Above surface ropeway	
	Impact Injury	Qty injuries	0
		Injury description	N/A
		Injury rating	None
	Damage	Damage description	Components suspending ski lift chairs such as the haul-rope and sheave received abrasions. Deropement occurred.
		Damage rating	Moderate
	Incident rating	Moderate	
Incident overview	Haul rope deropement at unload station guide sheave, uphill (passenger) side.		
INVESTIGATION CONCLUSIONS	Site, system and components	<p>The passenger ropeway is an above surface double chairlift.</p> <p>The carriers (chairs) are suspended from a haul rope, which transports ski and snowboard passengers uphill. The passengers unload carriers at the top, unload station, by sliding away from their chair at a specific point on an inclined snow ramp.</p> <p>The unload (top) station of the ropeway consists of an attendant, safety system controls, passenger unload ramp, return sheave (bullwheel) and guide sheaves.</p> <p>The guide sheaves are a two-wheel sheave assembly, used to prevent misalignment of a haul ro

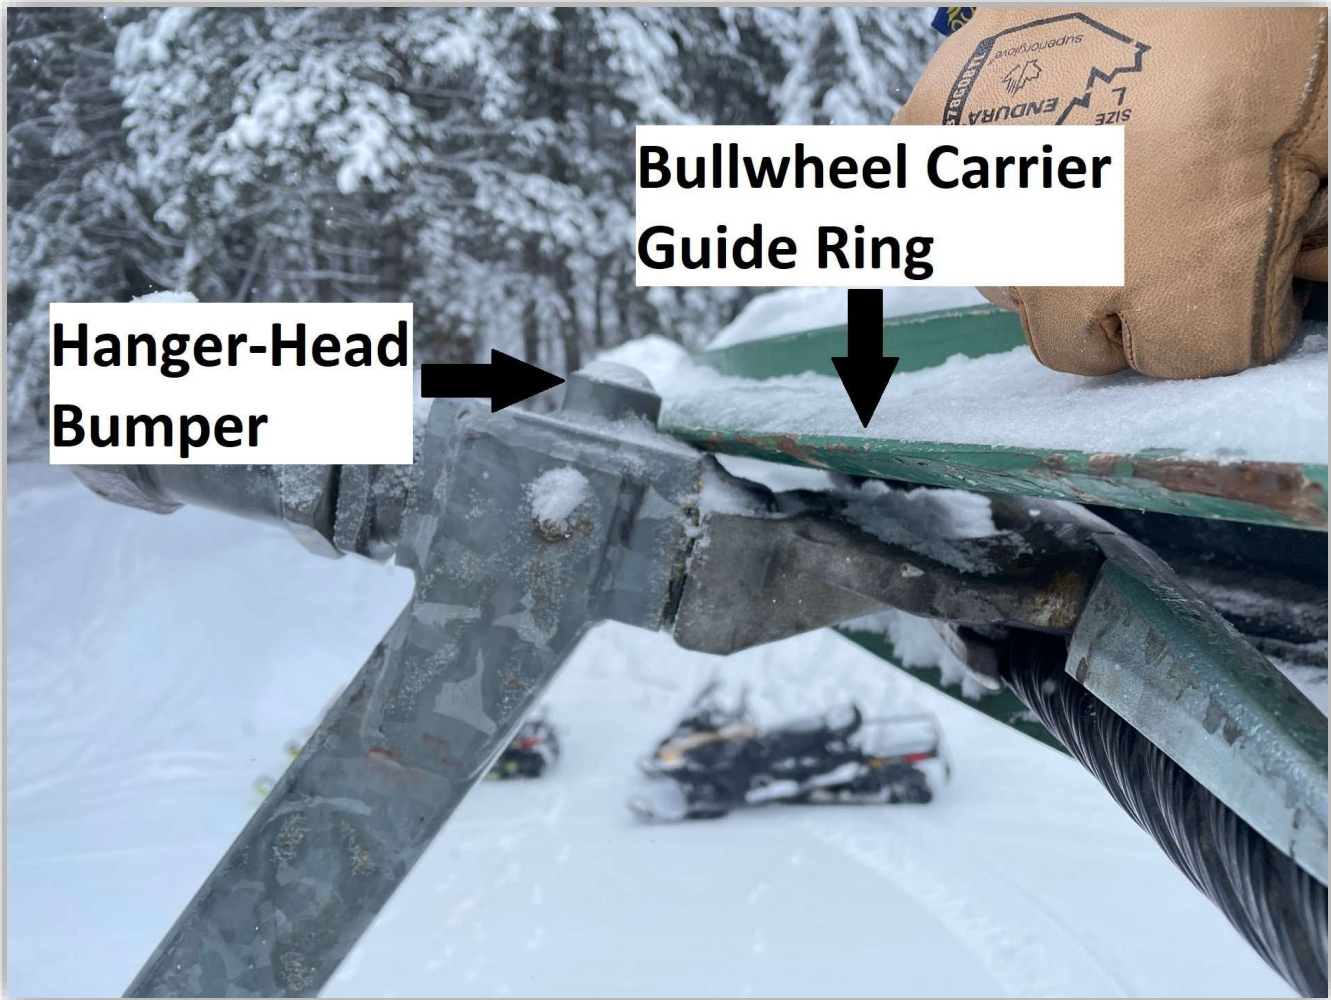
<p><b>Manufacturer and Operation Contractor Findings:</b></p> <ul style="list-style-type: none"> <li>• Discovered the hanger head bumper could catch the carrier guide ring and force haul rope from guide sheaves if carrier swung sideways.</li> <li>• The carrier guide ring on the bullwheel required modification to prevent hanger head bumpers from catching and prying haul rope from guide sheaves.</li> <li>• Similar vintage ropeways have measures to prevent the hanger head bumper from getting caught by a swinging carrier on the bullwheel guide ring.</li> </ul> <p><b>Industry Standards:</b></p> <ul style="list-style-type: none"> <li>• Haul rope deropement is not common or routinely expected/tolerated during passenger unloading of carriers.</li> </ul>
<p>Causes and contributing factors</p>	<p>The cause of the deropement incident was the carrier bumper getting caught in the bullwheel when unloading passengers caused the carrier to swing from side to side. Other passenger ropeways of a similar vintage have a mechanism in place to prevent the bumpers from getting caught in the bullwheel, whereas this chairlift did not.</p> <p>This was not an isolated incident and had occurred several times over the past 6 years.</p> <p>Contributing factors to the incident included:</p> <ol style="list-style-type: none"> <li>1. A poorly maintained passenger unload ramp increased falls/collisions, and therefore carrier swinging, during unloading, which likely increased the frequency of deropements.</li> <li>2. Repeated delays by the operator in working with the manufacturer and/or an engineer to improve the design following previous deropements allowed continued operation in a state where deropements were likely to occur.</li> </ol>

Image 1 – Original Bullwheel Guide Ring configuration.

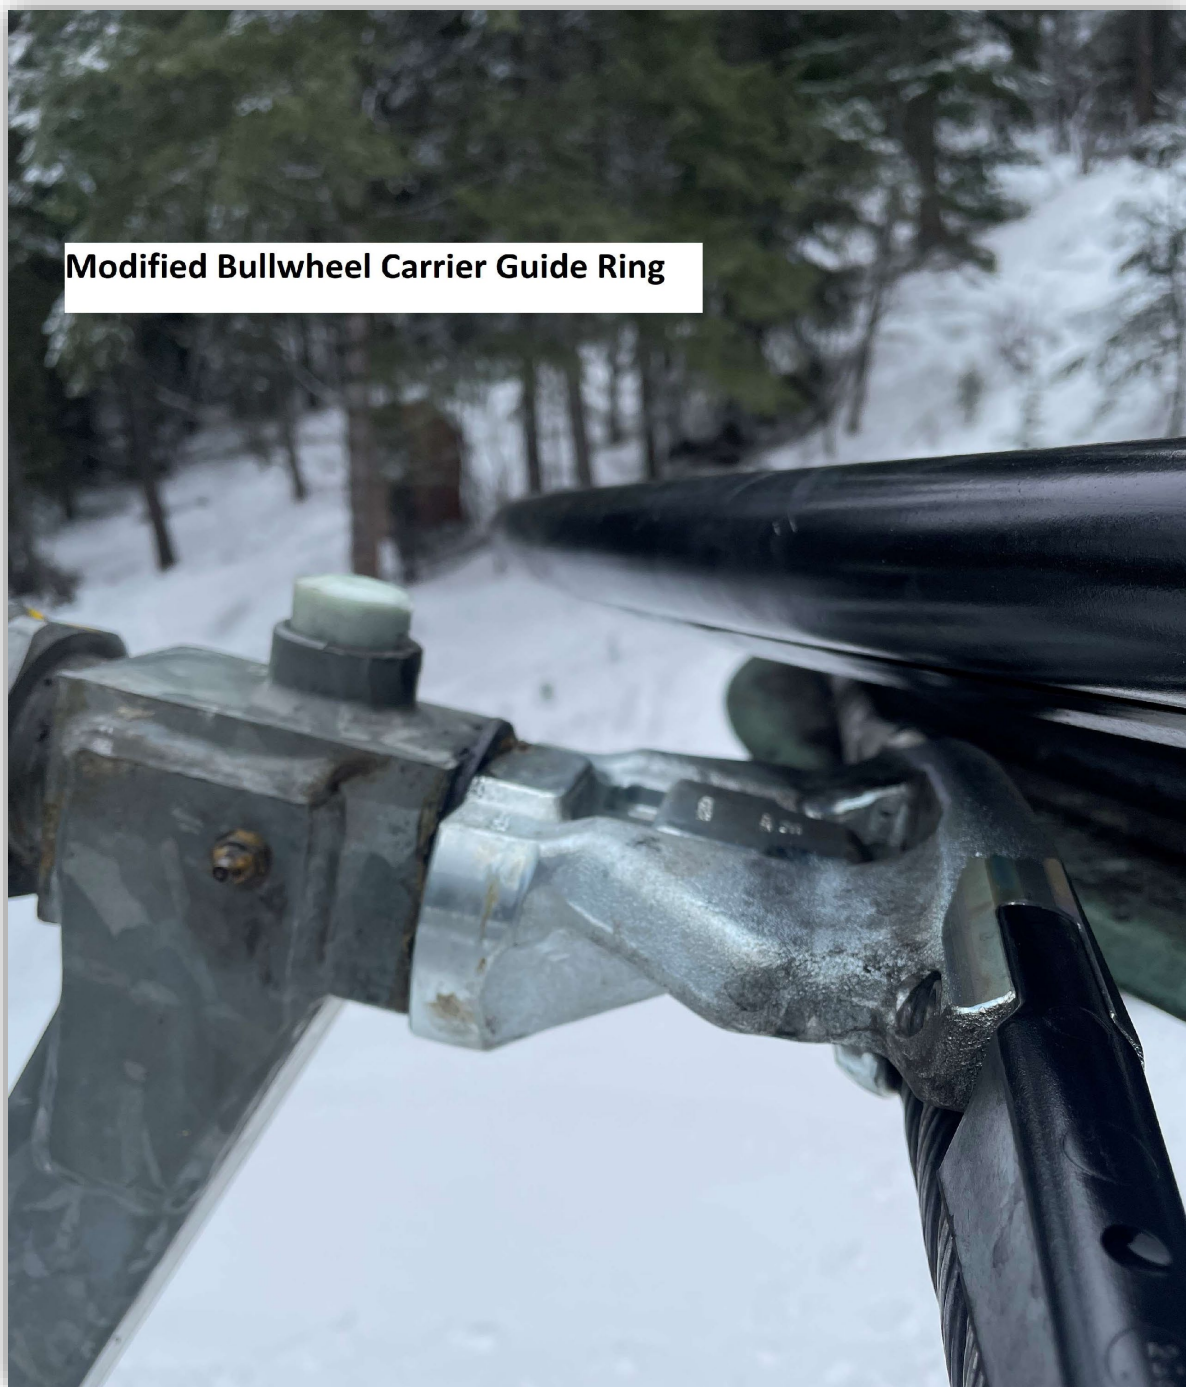
Image 2 – Modified Bullwheel Carrier Guide Ring.
