Incident Summary #II-952859-2019 (#16111) (FINAL)

SUPPORTING INFORMATION	Incident Date	December 9, 2019	
	Location	Vancouver, BC	
	Regulated industry sector	Elevating devices - Elevator	
	Impact	Qty injuries	1
		Injury description	The male user sustained minor abrasions
	Damage	Injury rating	Minor
		Damage description	The elevator car, hoistway door and some control systems sustained damage due to impact from a motorized scooter and from rescue efforts.
		Damage rating	Major
Incident rating	Major		
Incident overview	The elevator hoistway door safety retainer failed during forceful impact by a male riding an electric scooter.		
INVESTIGATION CONCLUSIONS	Site, system and components	<p>The equipment involved was a Schindler 3300 Hydraulic elevator. The elevator hall doors are responsible for enclosing the elevator shaft and to open and close to allow users to enter and exit the elevator car. The elevator hall door hangs on a metal track by using rollers to allow the door to slide freely back and forth. The bottom of the doors have retainer brackets known as "gibs" and a safety retainer which slide in a slotted door track below known as the sill. The gibs (2 in this installation) are

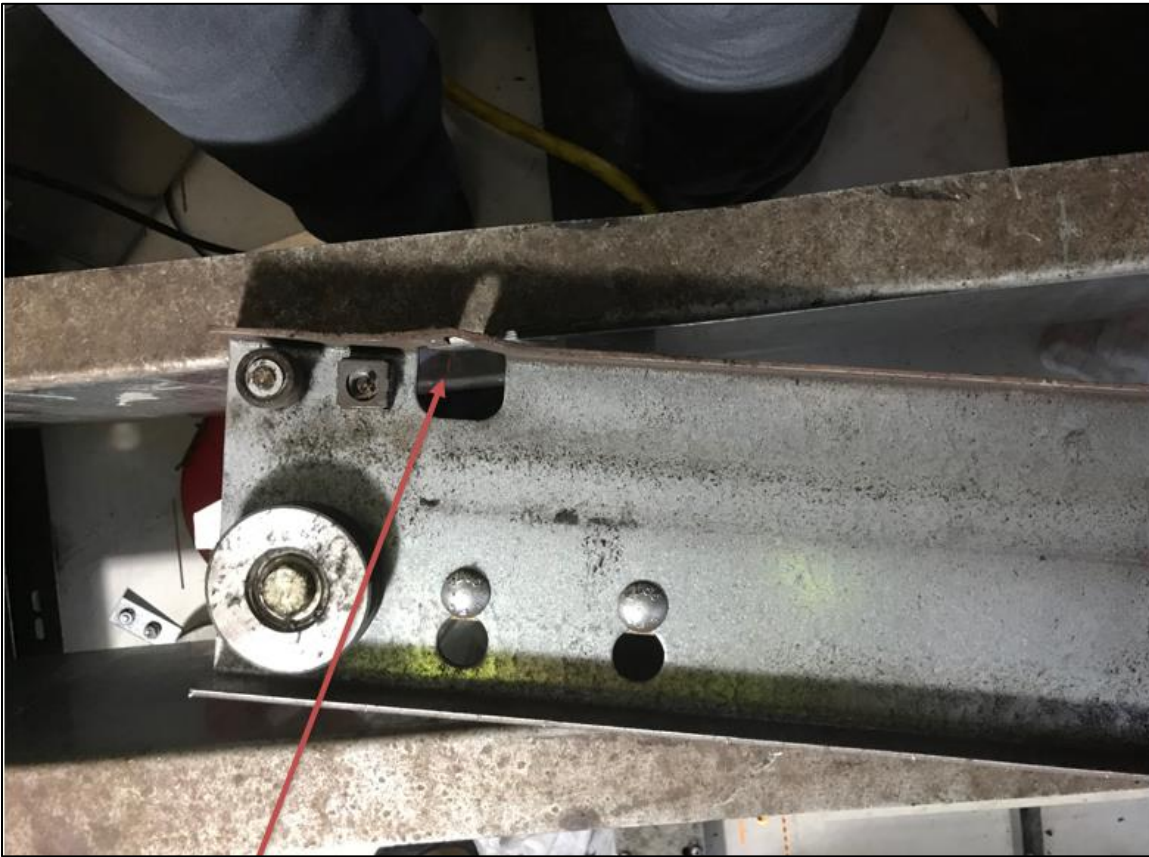
Photo 1: Door Hanger Damage

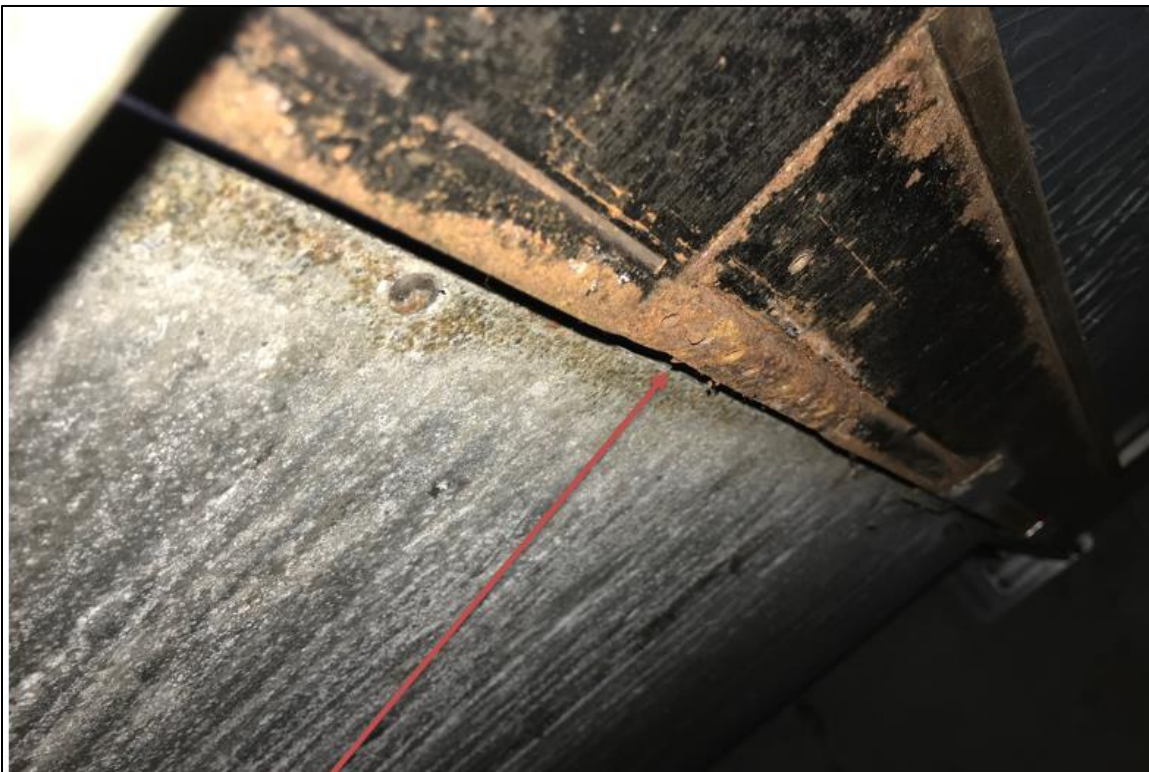
Photo 2: Corrosion of Lower Door Section

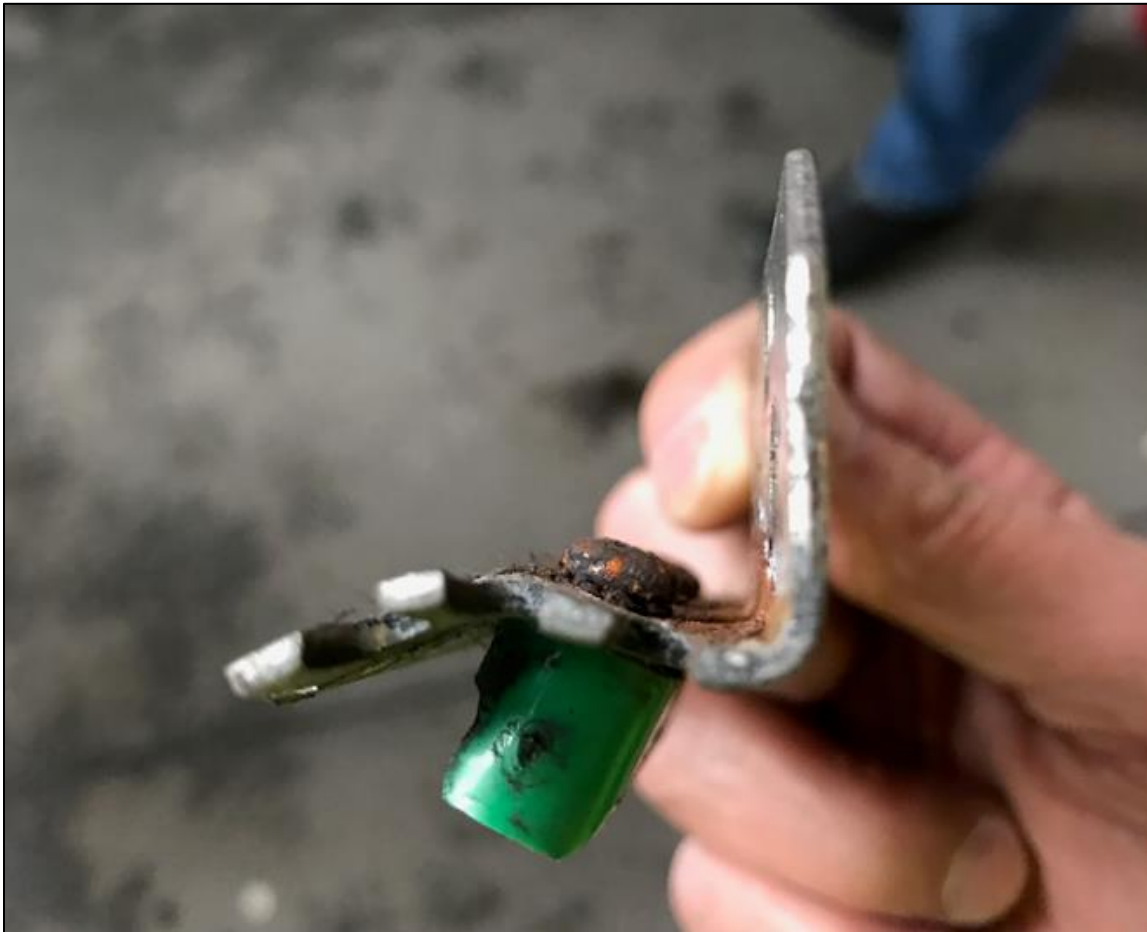
Photo 3: Door Gib - Devices on bottom of sliding door panels which fit into sill grooves and hold the door panels in alignment.

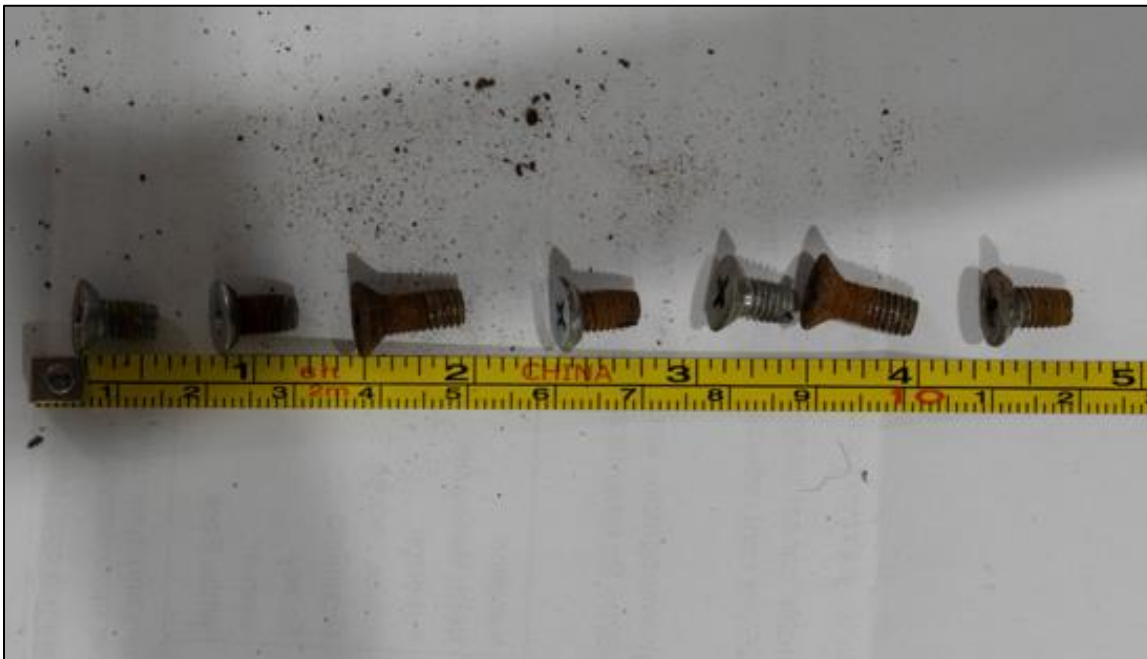
Photo 4: Door gib mounting screws – exposed threads show corrosion

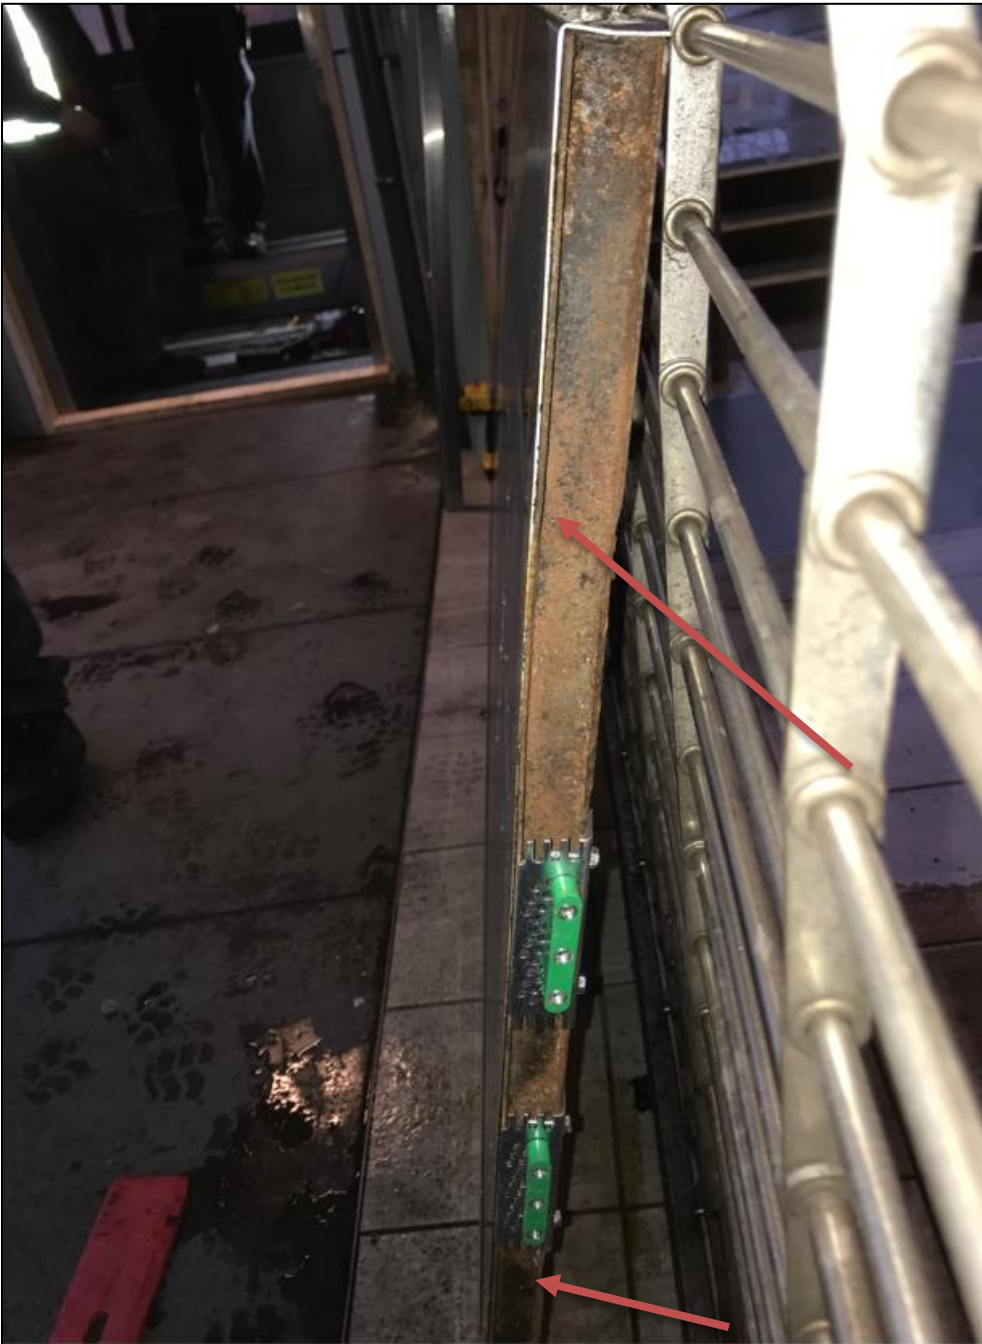
Photo 5: View of bottom of elevator door – corrosion present on bottom and some damage from impact
