## Incident Summary Report II-663374-2018 (6288)

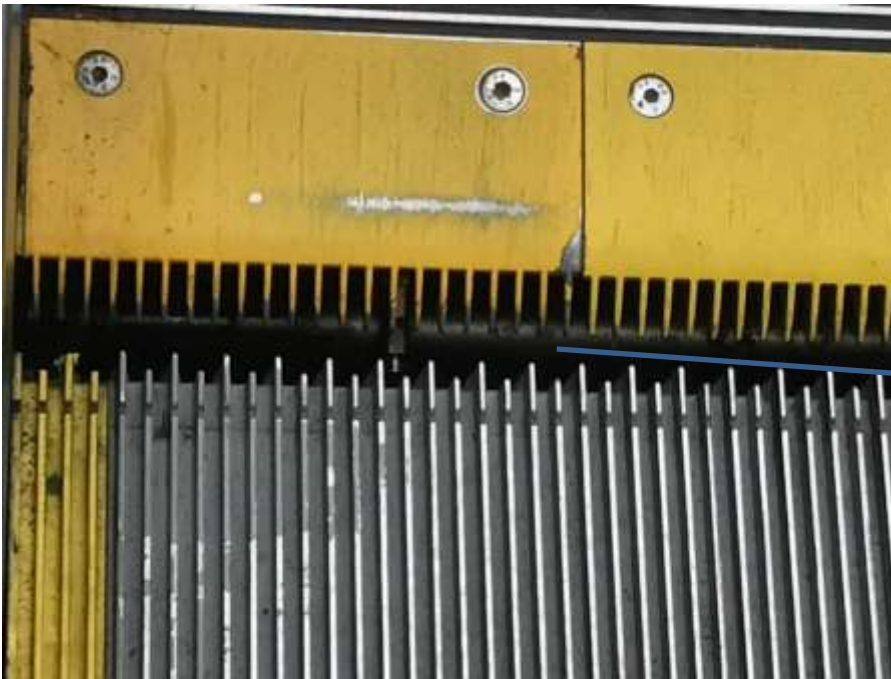
Step piled up on top of another. Visible gap between steps.

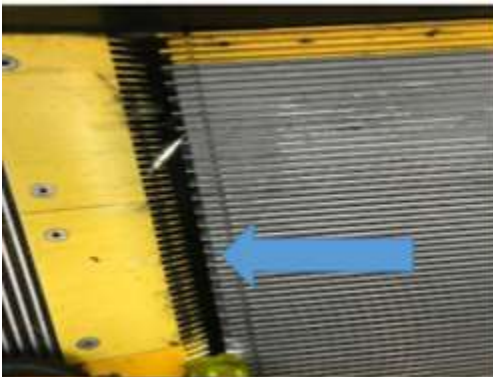
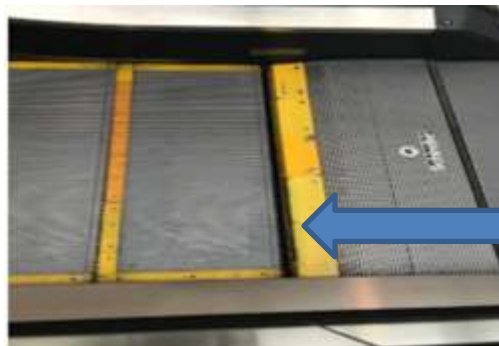
Showing the gap from a different angle

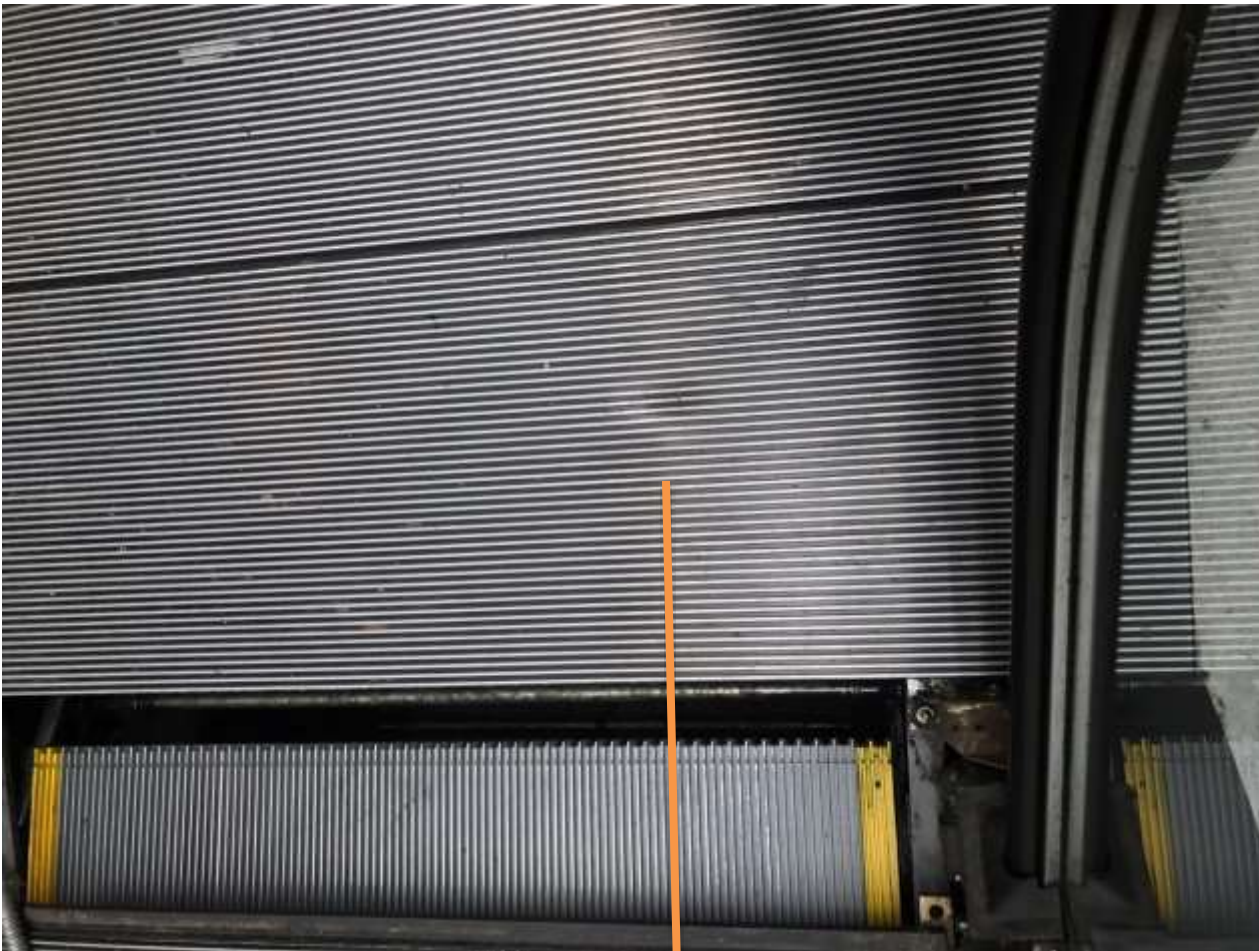
Failure scenario(s)	The escalator controller shut the system down due to a "missing step" switch being activated. A gap between two escalator steps was larger than the allowed manufacturer's specification, resulting in the controller faulting out as designed.	
	Facts and evidence	<p>During a Site visit:</p> <ul style="list-style-type: none"> <li>- 2 steps were fractured completely due to the pileup, the step chain was damaged due to the incident.</li> <li>- Photos of the gap between steps</li> <li>- The last fault log in the escalator controller indicates a missing step switch being activated.</li> <li>- Indentation on the landing plate indicating a heavy impact to the plate.</li> </ul>	
	Causes and contributing factors	It is highly likely that the visible indentation on the landing plate indicates a heavy impact, possibly causing the steps to not be aligned and piling up at the bottom landing.

Indentation in landing plate
