Incident Summary #II-1213103-2021 (#22551) (FINAL)

SUPPORTING INFORMATION	Incident Date	June 21, 2021	
	Location	Abbotsford	
	Regulated industry sector	Boilers, PV & refrigeration - Refrigeration system	
	Impact	Qty injuries	2
		Injury description	One individual received first and second-degree chemical burns on their head, ear, neck, and upper chest from contact with ammonia.
			A second individual received first and second-degree chemical burns on their forearm and bicep of their left arm from contact with ammonia.
	Injury rating	Moderate	
	Damage	Damage description	Approximately 6.7 lbs of ammonia leaked from the refrigeration system into the mechanical room of the facility
		Damage rating	Minor
	Incident rating	Moderate	
Incident overview	An industrial food processing facility, which uses ammonia in a refrigeration system to cool large coolers, chillers, and freezers, had an ammonia leak at an auto-purger in the mechanical room. While attempting to isolate the equipment and stop the leak, an employee of the facility was exposed to ammonia and received chemical burns. A technician working for a refrigeration contractor arrived later and was also exposed to ammonia and received

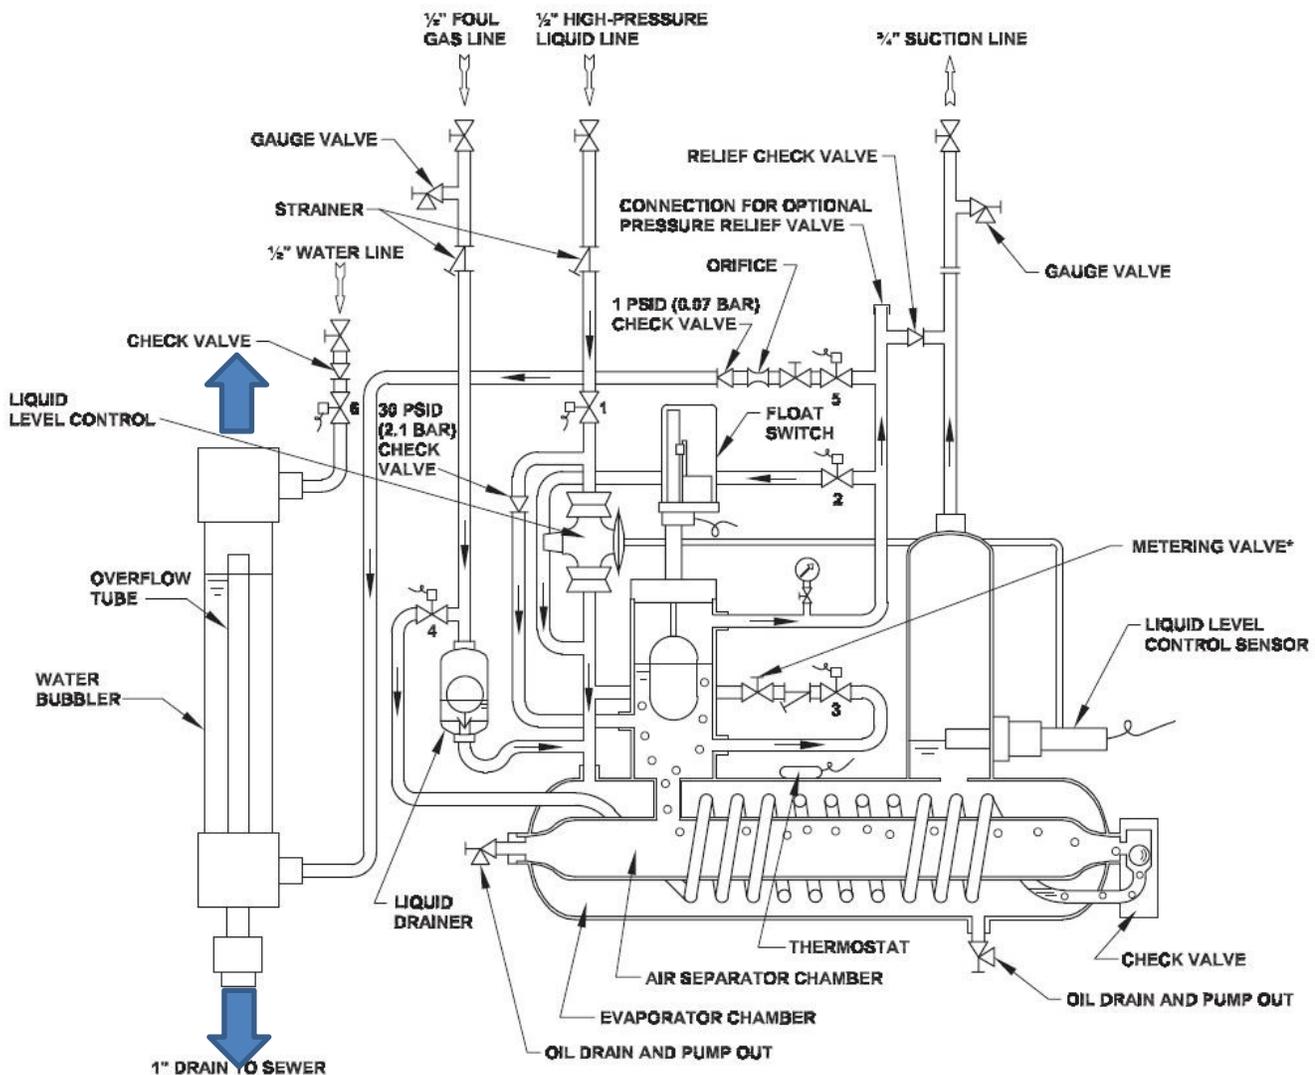
INVESTIGATION CONCLUSIONS	Site, system and components	<p>The facility incorporates an industrial refrigeration system using ammonia as the refrigerant. The system has a refrigeration capacity of 918 tons and a total refrigerant charge of approximately 15,000 lbs of ammonia. The facility has sensors to monitor for ammonia leaks, alarms which indicate when ammonia has been detected and exhaust fans to ventilate ammonia from the space.</p> <p>Ammonia in a refrigeration system exists in both liquid and a gas form. It is toxic and produces a strong odor. When ammonia contacts moisture it forms ammonium hydroxide which is very caustic. Exposure to ammonia may result in irritation to the eyes, mouth, throat, and lungs, burns to the skin, and in high concentrations can be immediately fatal.</p> <p>The refrigeration system utilizes an auto-purger which is an automatic electronically controlled device for purging non-condensable gas (air) from the refrigerant system, (Image 2). Air is removed from the system to reduce internal pressures and increase operating efficiency. The auto-purger takes momentary samples of gas from multiple points in the refrigeration system, condenses any ammonia vapor in the gas sample back to a liquid, and separates out the air. When enough air accumulates in the auto-purger it is purged out of the device through a water bubbler tube. The air bubbles up through a column of water in the tube which absorbs any residual ammonia before purging it out into the mechanical room. During, and shortly after purging, fresh water is automatically added to the tube to flush any ammonia laden water out through an open overflow tube to a floor drain (Image 1).</p>

Image 1 – Diagram from auto-purger installation and operation manual showing auto-purger function. Blue arrows indicate locations of ammonia release. (*Manufacturer's installation and operating instructions*)

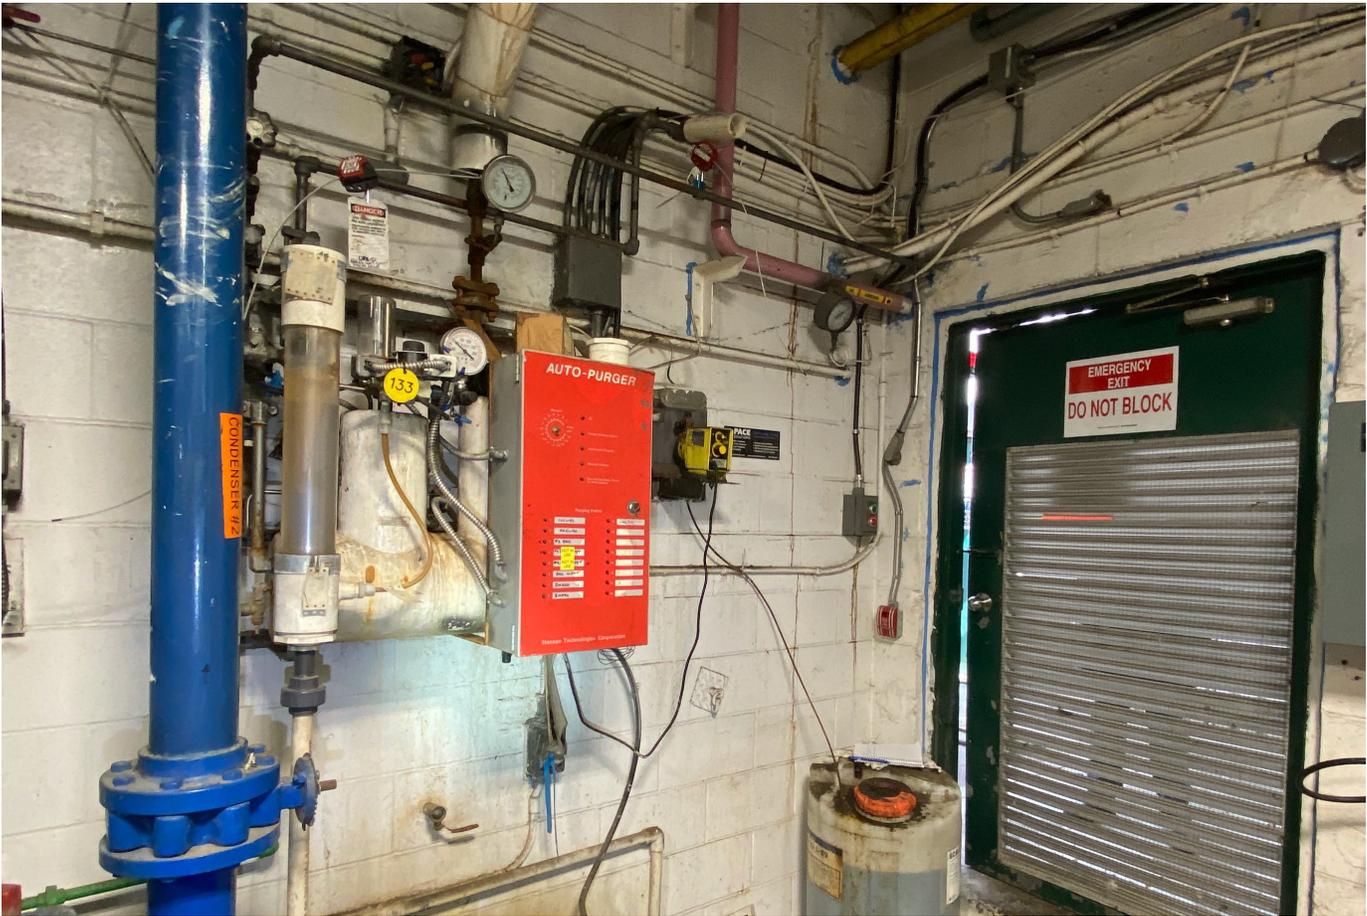
Image 2 – Auto purger installation in mechanical room.

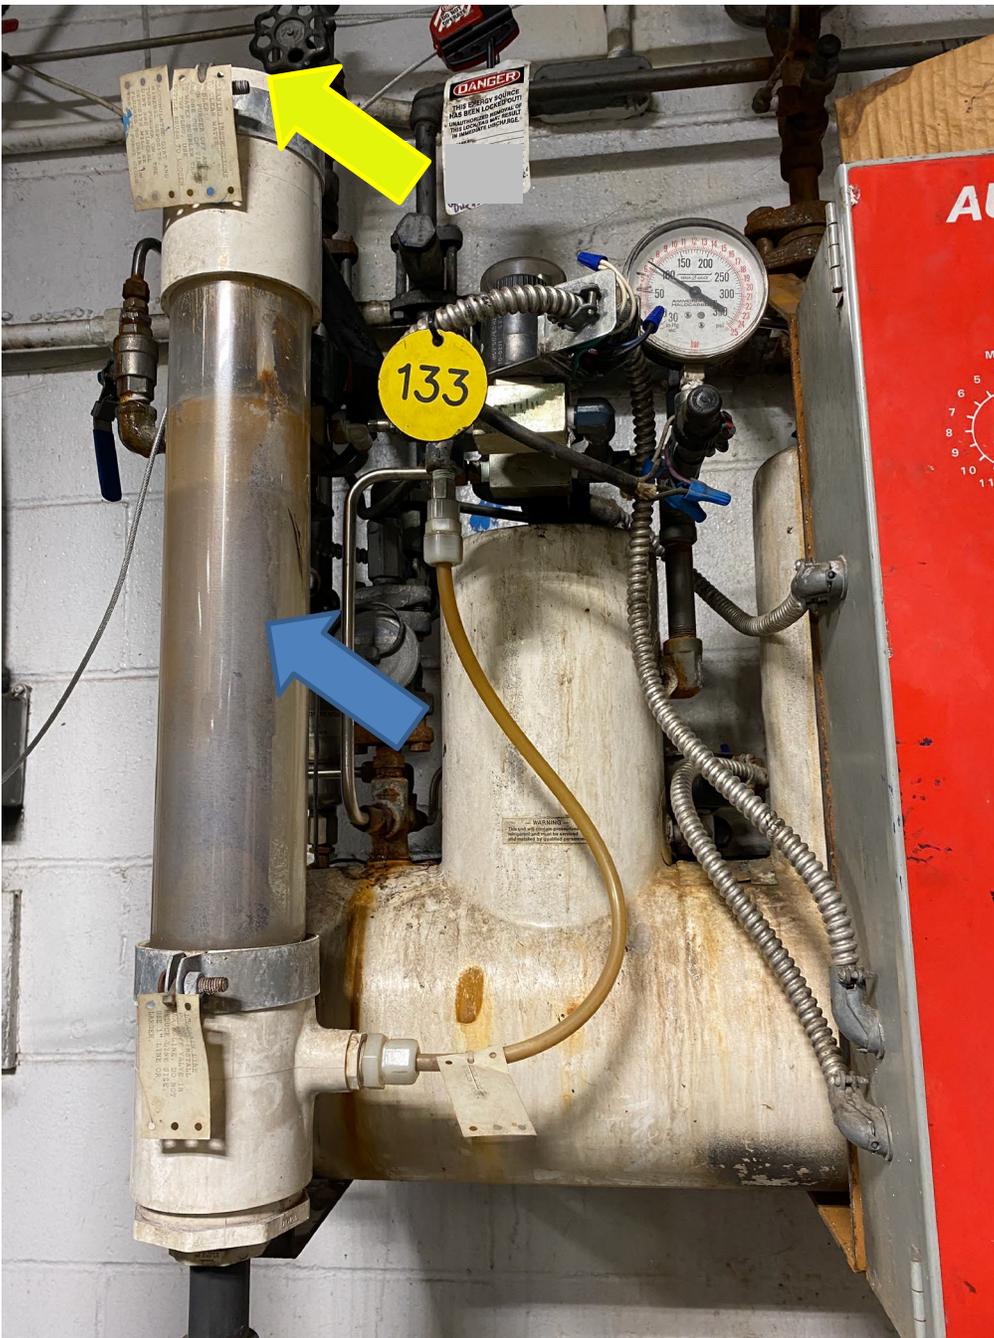
- The cap which was supposed to be in place was not installed on the top of the water bubbler tube, and after closing the valve, the liquid in the bubbler tube sprayed out the top, covering the employee.

Image 3 – Blue arrow indicating water bubbler tube. Yellow arrow indicating location the water bubbler tube cap should be installed.

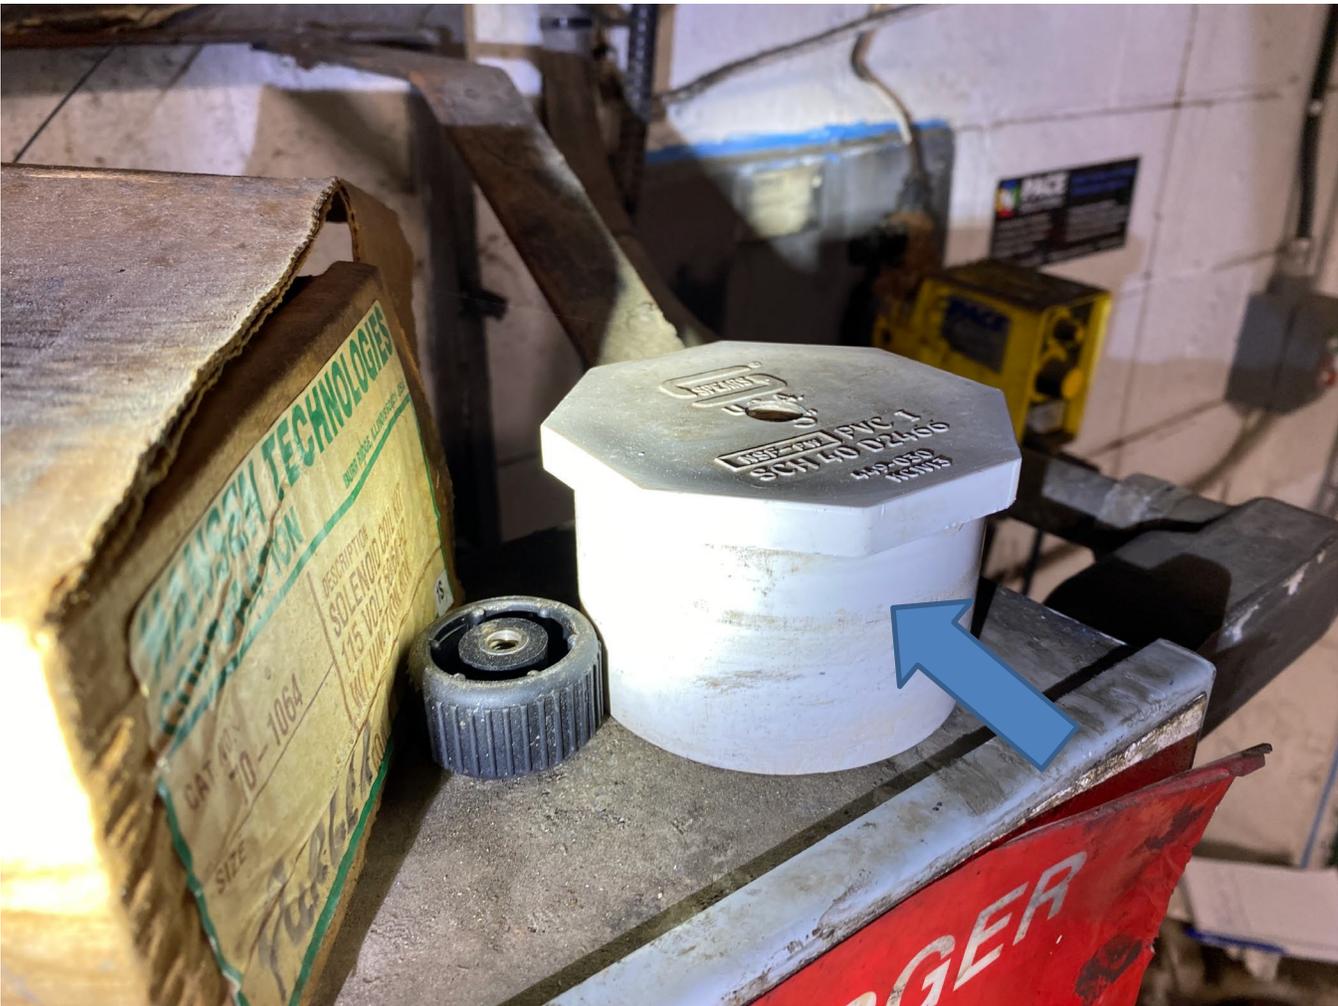
- No other electrical disconnect switches were in the vicinity of the unit that would turn the appliance off.
- The top cap for the water bubbler tube was removed and found sitting on the top of the auto-purger cabinet, which allowed the water/ammonia mixture to splash out injuring workers.

Image 4 – Blue arrow indicating water bubbler tube cap in its found location after the incident.

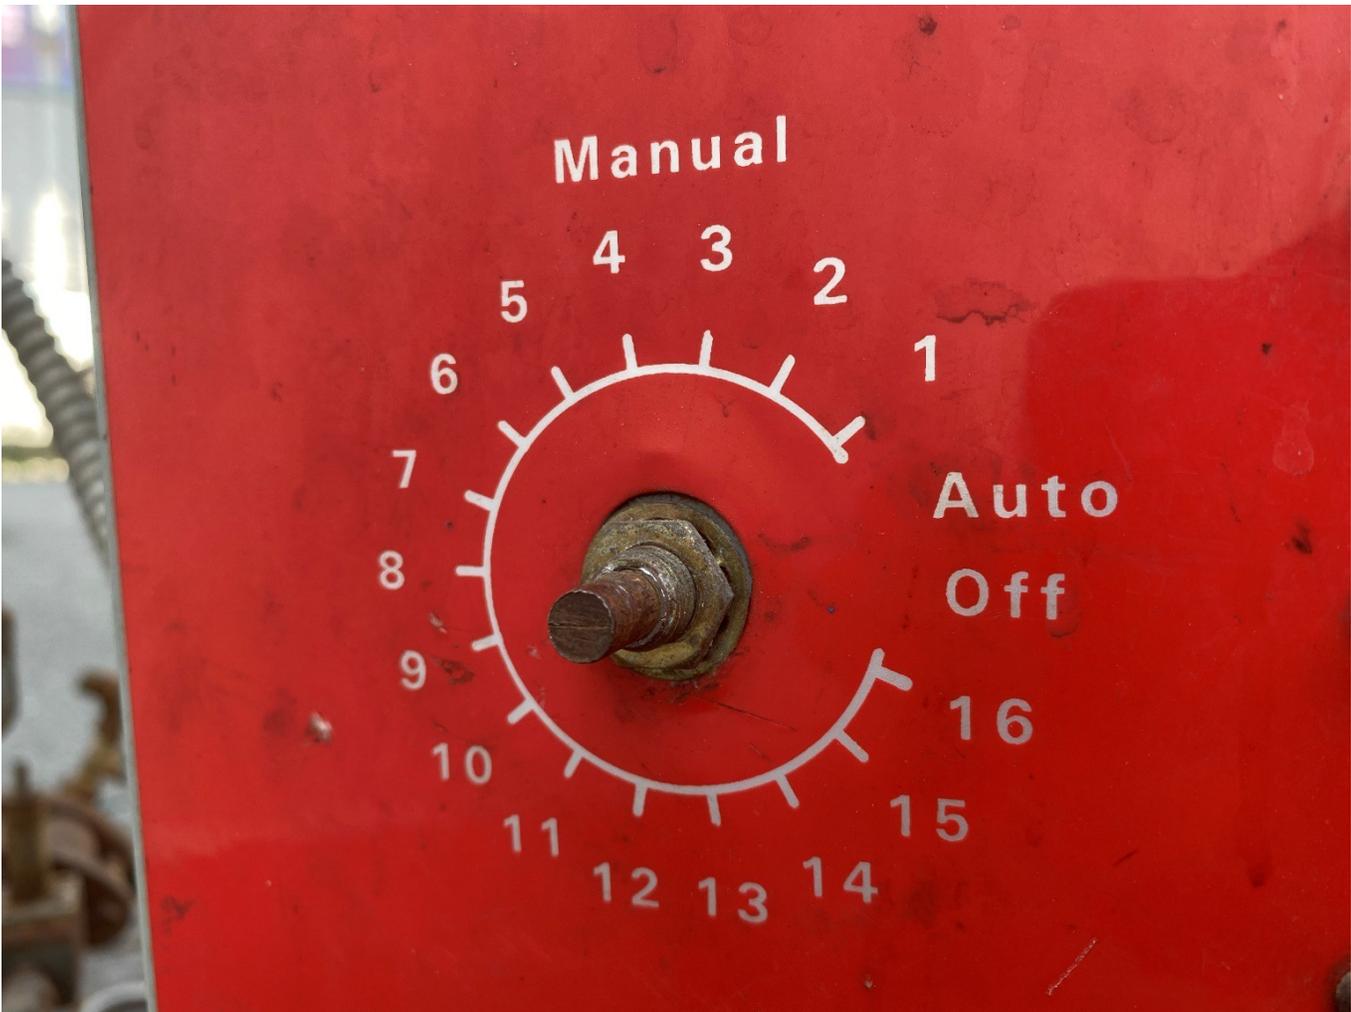
- The auto-purger control knob was missing from the front of the appliance, and only a small, scribed line on the switch shaft, indicated the switches position. The control knob has 18 different set positions, including off, auto, and 16 different positions for manual purge point operation.

- The manual switch that was missing the knob could not be rotated by hand and required a pair of pliers to rotate. It was not evident how to turn the auto-purger off and required tools to do so.
- The check valve on the high-pressure liquid line had a damaged seal that had broken apart upon disassembly, indicating it had not been replaced during routine maintenance in some time, and was possibly not functioning correctly, ([Image 8](#)).
- The relief check valve was saturated in oil, and when the valve was disassembled, the oil seal was found to be deformed. This deformation

Image 5 – Auto-purger control switch with missing knob. The end of the switch shaft has a slight scribed line indicating the switches set location. It is horizontal indicating it is in the “Off” location. When tested the shaft could not be turned by hand and required tools to rotate.

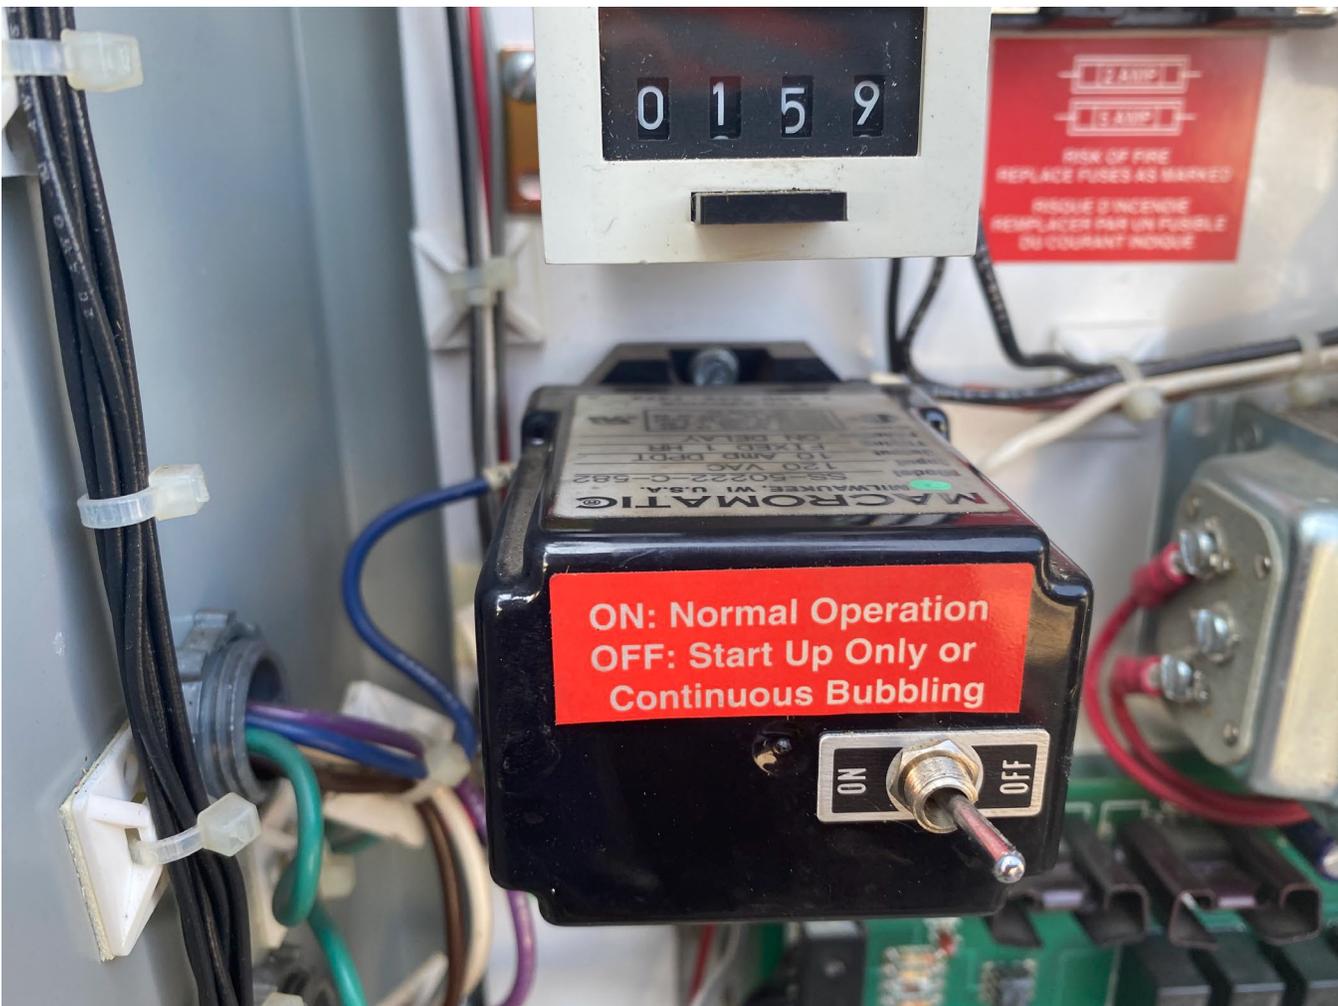
- The auto-purger was set to continuous bubbling operation. This would not shut off the purge solenoid after 1 hour, allowing continuous leaking of ammonia.

Image 6 – Auto purger time delay relay switch as found in the “Off” setting for startup or continuous bubbling. In this position the auto-purger would not shut the purge solenoid if it purged for longer than 60 minutes. If set to normal operation the purge solenoid would have deactivated after 60 minutes possibly reducing the amount of ammonia released.

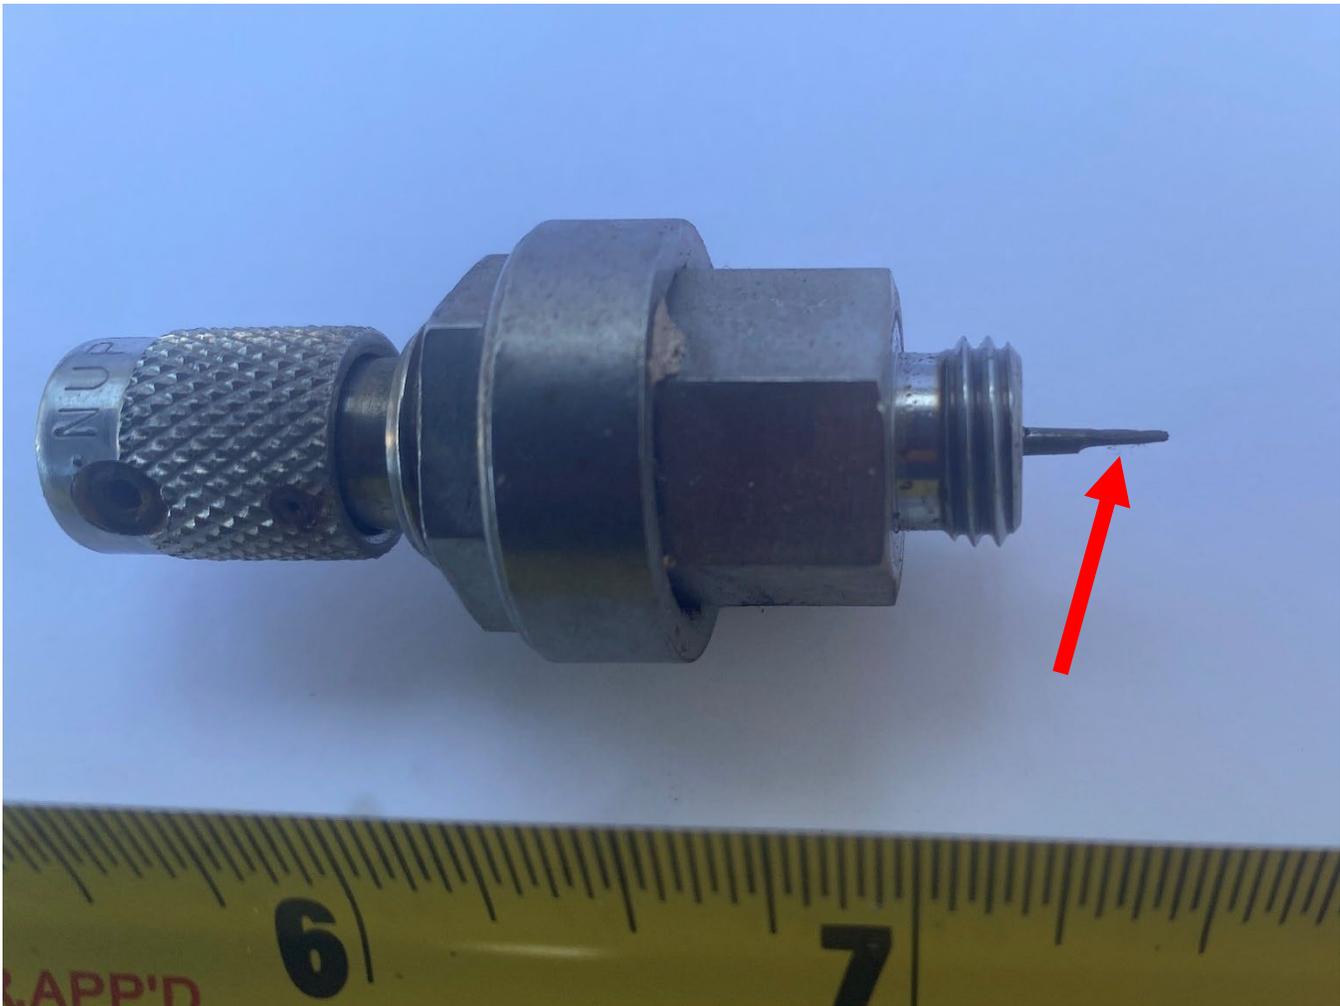
- The metering valve taper was worn and had a flat side narrowing considerably, indicating the unit had been in service for an extended amount of time, and the component had not been replaced as a result of routine maintenance or repair. ([Image 7](#)).
- A large amount of scale was found in the bottom of water bubbler and on the outside of drain tube, indicating the bubbler has not been descaled in sometime.

Image 7 – The auto-purger metering needle valve. Red arrow showing worn taper indicating extended time in service.

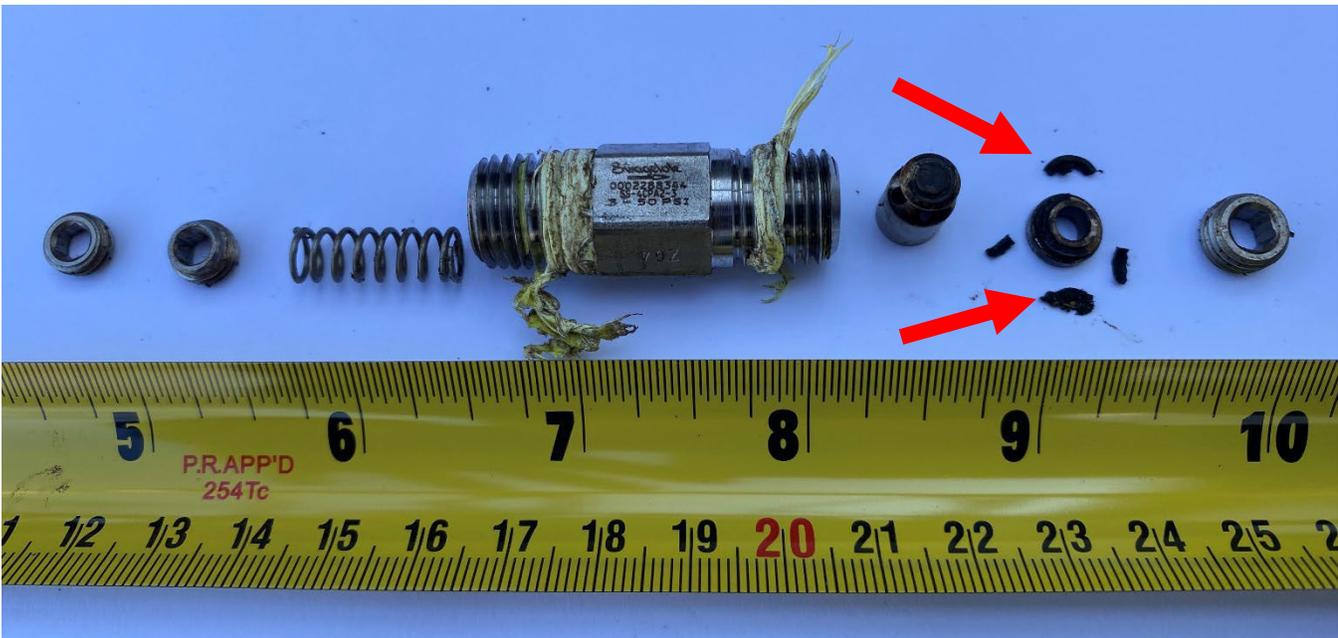
Image 8 – The auto-purger check valve showing damaged valve seal.

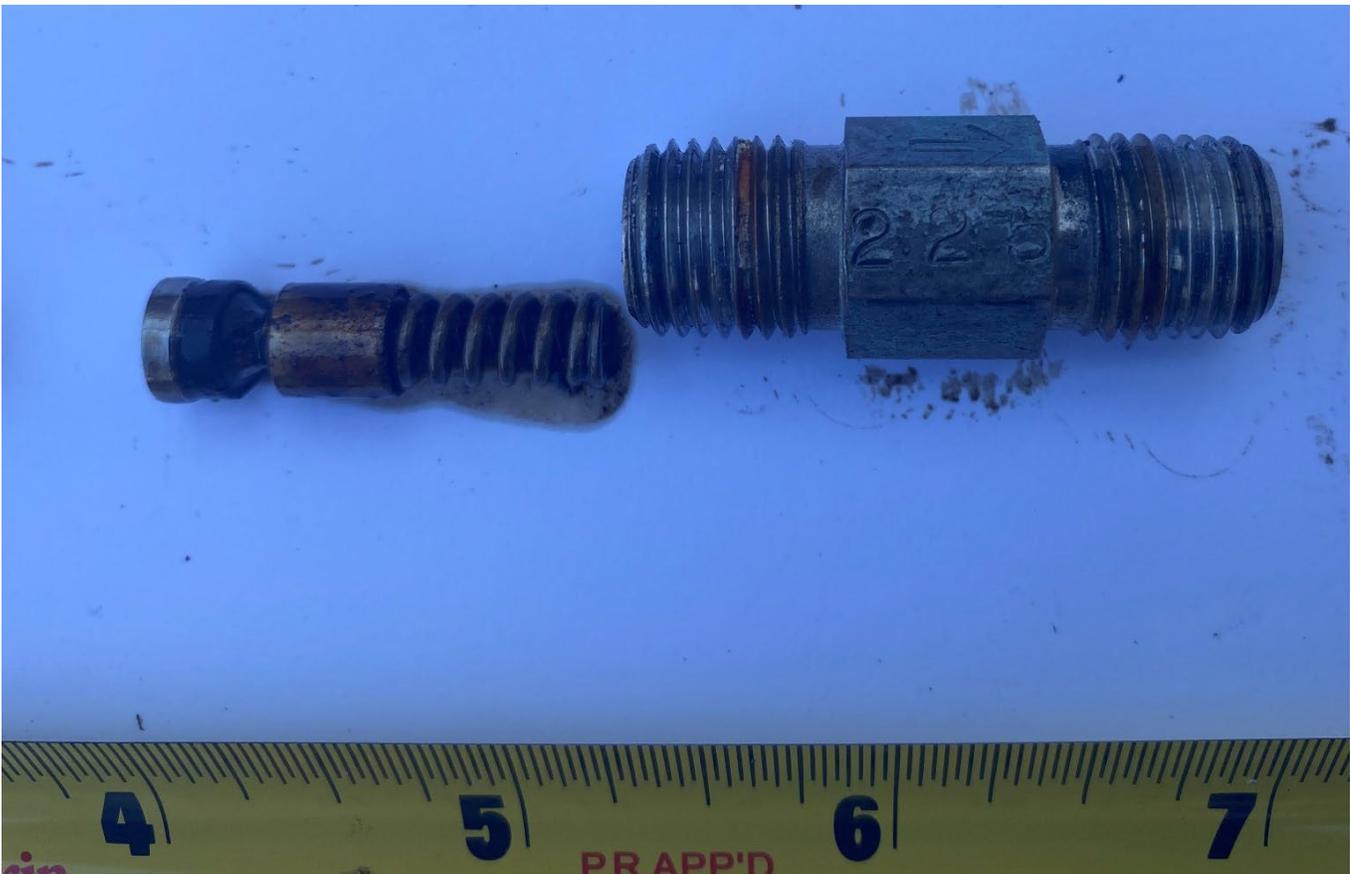
indicates the seal was not functioning correctly, resulting in high levels of oil accumulating inside the unit, possibly inhibiting the condensing action of the heat exchanger, allowing ammonia vapor to pass through as non-condensables. ([Image 9](#))

Image 9 – The auto-purger relief check valve showing oil saturation of the internal components.
