Incident Summary (Reference # 5616714)

SUPPORTING INFORMATION	Incident Date		June 06, 2017	
	Location		Abbotsford	
	Regulated industry sector		Gas – Natural Gas System	
	Impact	Injury	Qty injuries	0
			Injury description	NA
			Injury rating	None
	Damage	Damage description	Major structural damage to rear of three story home. Fire and smoke damage inside.	
			Damage rating	Major
	Incident rating		Major	
	Incident overview		A fire occurred at a single family residential home. The fire originated from the location of a newly installed natural gas fireplace and barbeque.	
INVESTIGATION CONCLUSIONS	Site, system and components		<p>A new gas line was installed from the gas meter on the side of the house to a new gas range, fireplace and outside barbeque box in the new basement suite on the first floor of the home. The gas line was run in corrugated stainless steel tubing (CSST) from the meter, then it converted to black iron pipe and brass shut off valves before the fireplace and barbeque box.</p> <p>CSST is a flexible tubing that is jacketed with a yellow outer sheathing. CSST connections are made with proprietary brass compression style fittings which may adapt to threaded fittings to a

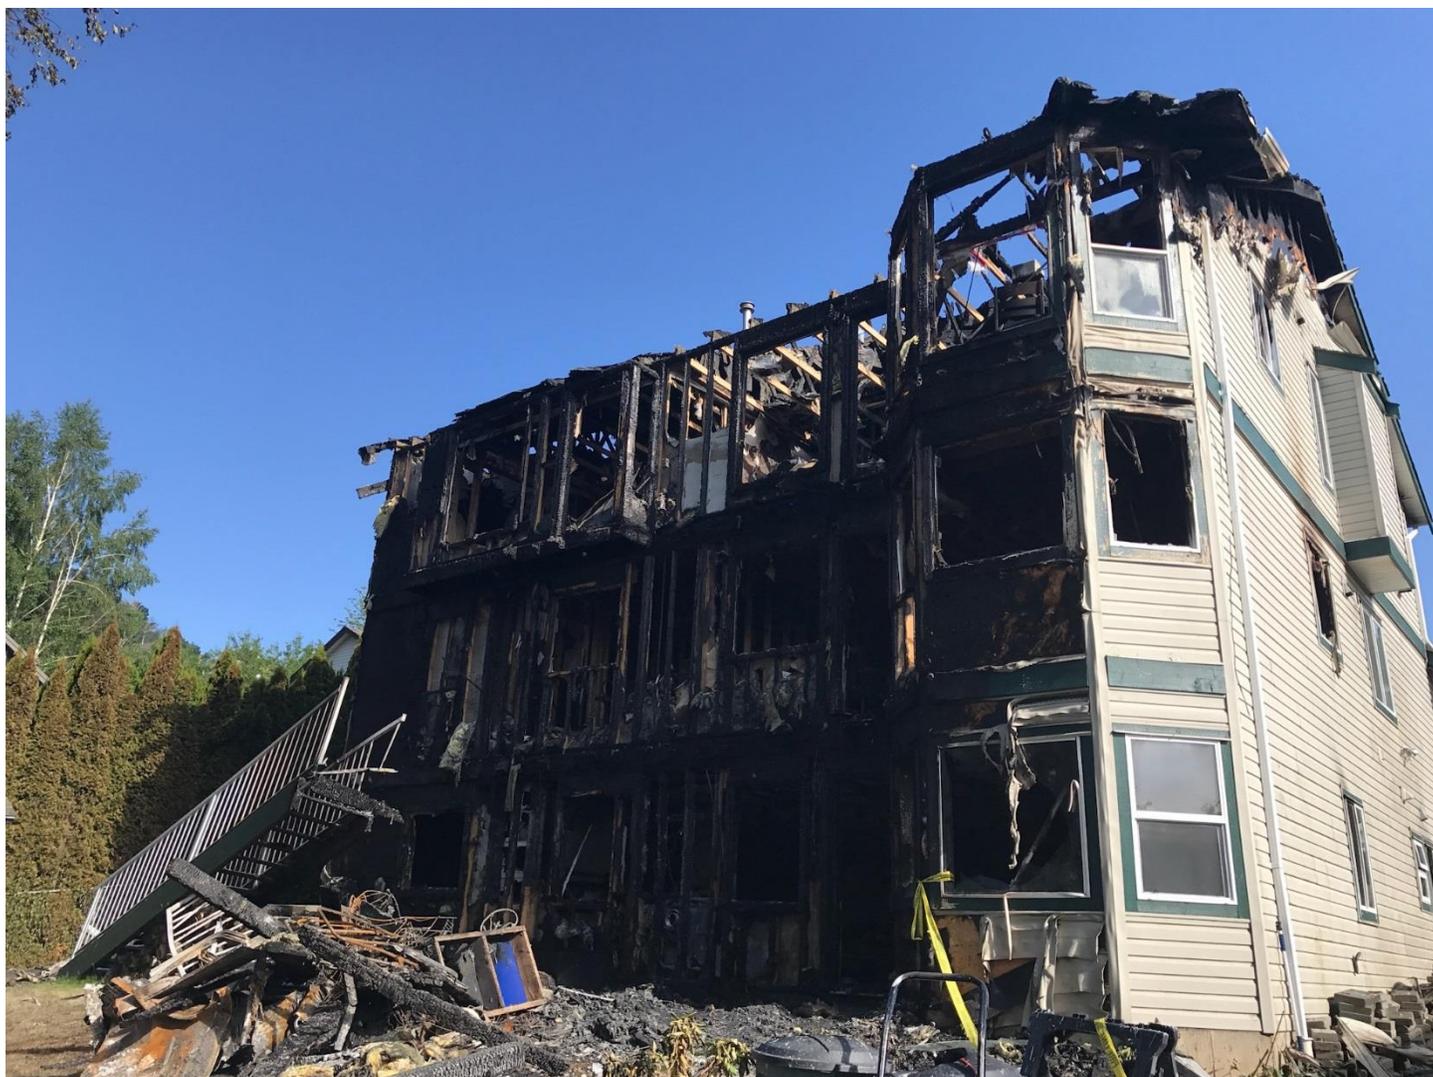
Rear of house.

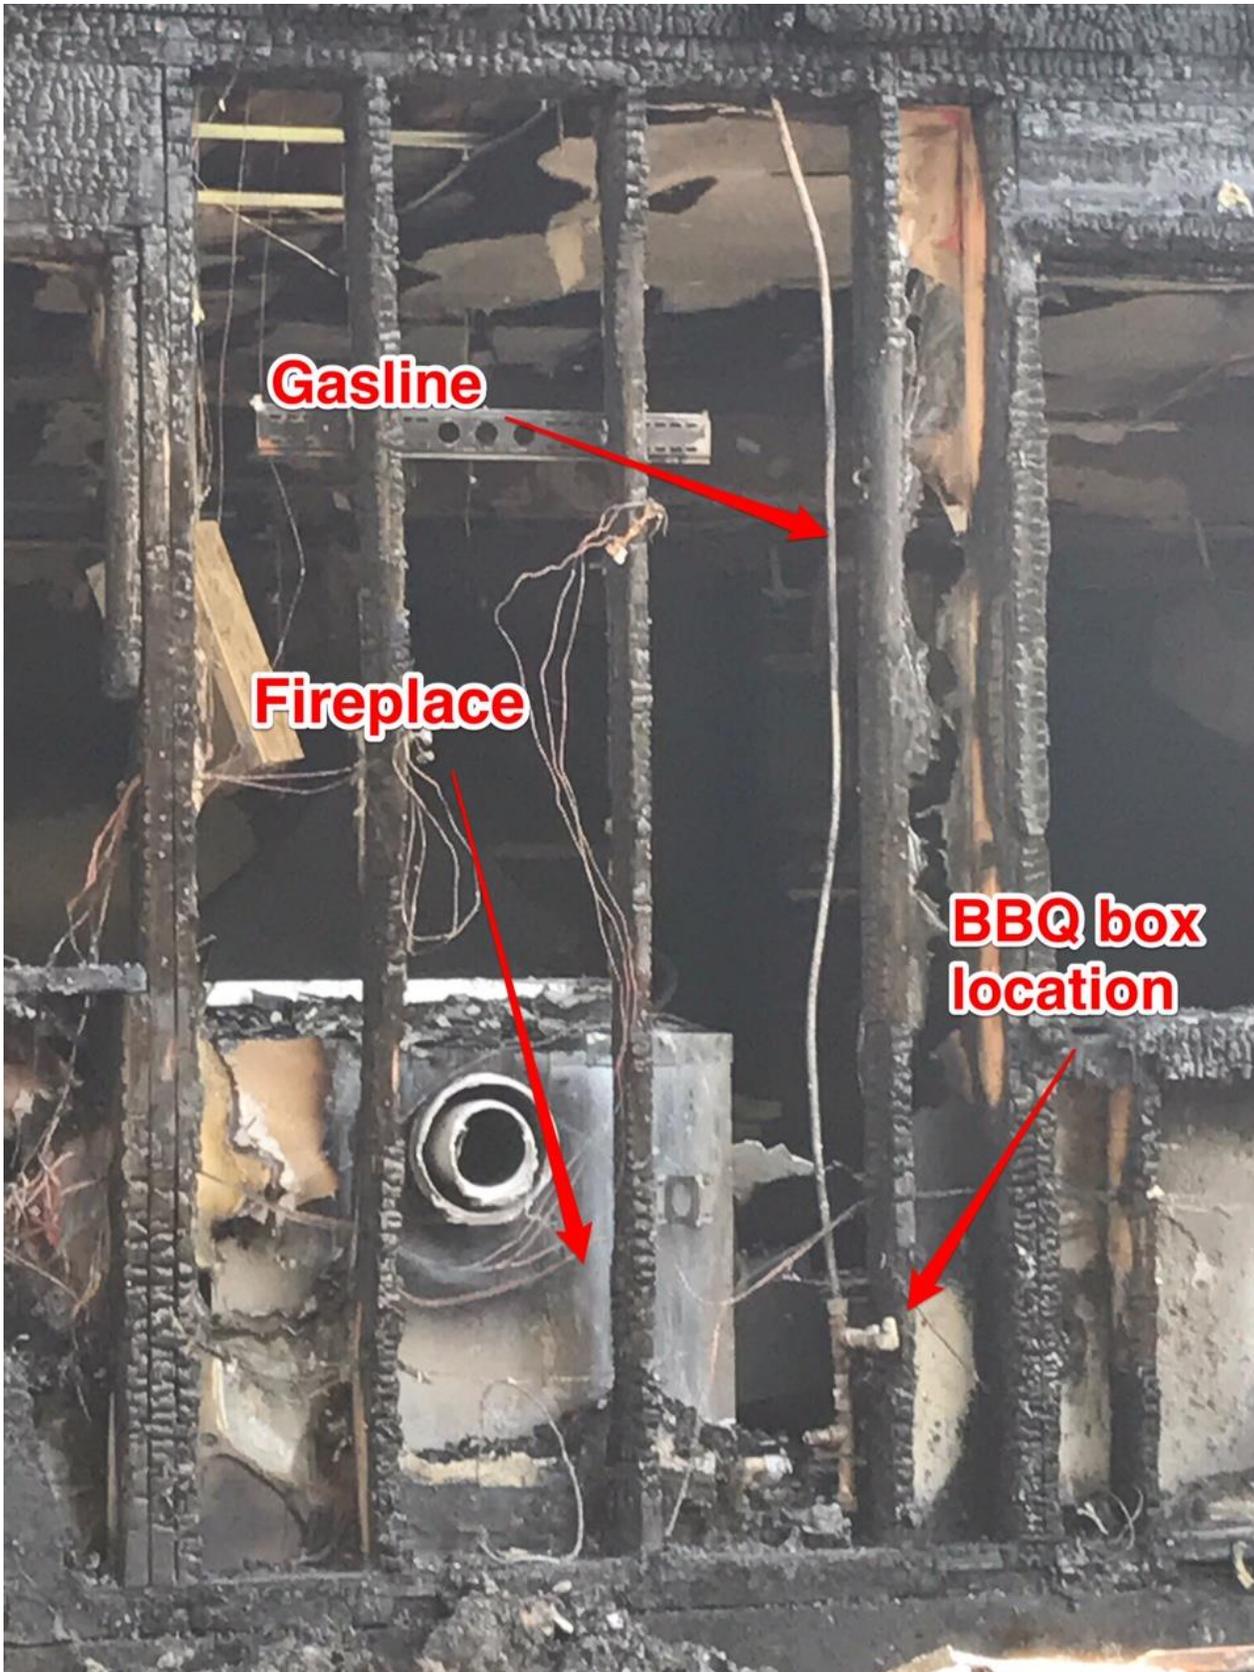
Rear of house first floor
