Incident Summary #II-821645-2019 (#11290) (FINAL)

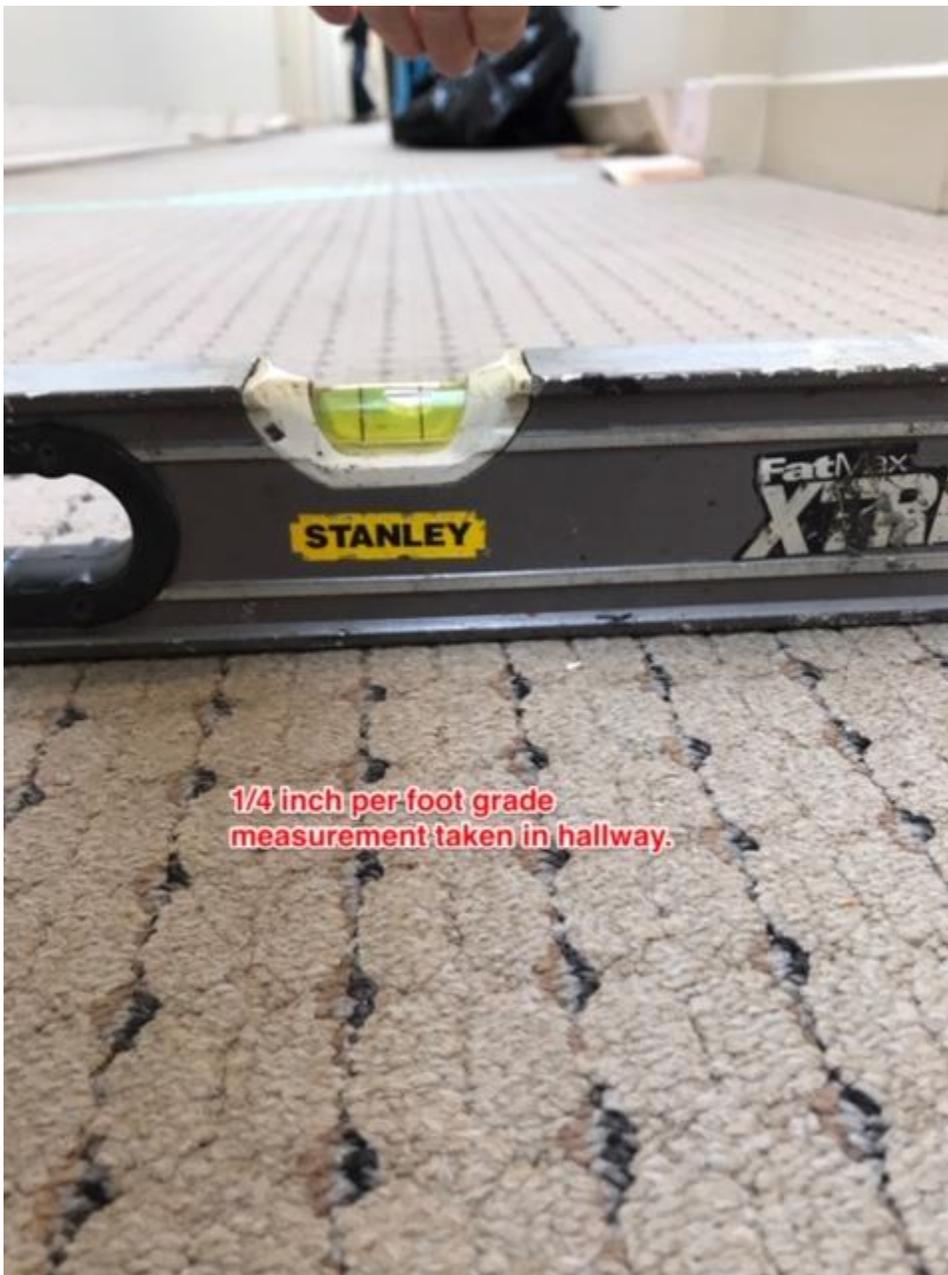
Photo 5

Failure scenario(s)	The building in question was built in 1989 has been settling over time putting strain on the black iron natural gas piping located throughout the building. The strain on a horizontal section of pipe serving a gas fireplace eventually caused the pipe to break, releasing a significant amount of gas into the fireplace cavity. The standing pilot on the fireplace provided a ready source of ignition that resulted in a fire that burned behind the fireplace cavity before making its way to the roofline, causing major damage to the suite and roof.	
	Facts and evidence	-There is evidence that the building is settling on a downward angle towards the affected suite. This is supported by visible stress fractures found throughout the building. A 2 foot level placed in the common hallway indicated a ¼ inch per foot downward grade towards the affected suite. This downward grade was found to be

<p>consistent on each floor of the 4 story building and for the length of the hallway. (photo 5)</p> <ul style="list-style-type: none"> -The building is located on the shore of a body of water. The angle of the downward slope is in the direction of the shoreline. -The isolation valve connected to the pipe was found to be in direct contact with the top of the access opening of the fireplace surround providing a point of strain capable of breaking the pipe. (photo 2) -The break in the pipe occurred at the location of a thread, a weak point in the integrity of the pipe. (photo 1) -Upon investigation the horizontal length of black iron pipe connected to the 90 degree elbow fitting that served the fireplace in question was found to be on a downward angle, (approximately 75 degrees). Upon further examination a hole/fracture on the threads of the pipe was found.(photo 1) -The Fortis technician who arrived on scene with the first responders performed a leak test on the horizontal pipe in question and found evidence of a leak -The fireplace in question incorporates a standing pilot (source of ignition) in close proximity to the location of the leak. (photo 4) -Statement from the tenant who witnessed the event corroborates that the fireplace was the source of ignition and the genesis of the fire was in the fireplace cavity -The adjacent suite revealed a similar pipe and fireplace configuration to the affected suite. The valve in this case was pressed tight against the top of the access opening, placing strain on the pipe and 90 degrees elbow connected to the riser. (photo 6) -Other suites observed in the building showed the horizontal pipe entering the fireplace access opening to be at different locations in terms of its orientation within the access opening
