## Incident Summary Report II-711928-2018 (7781)

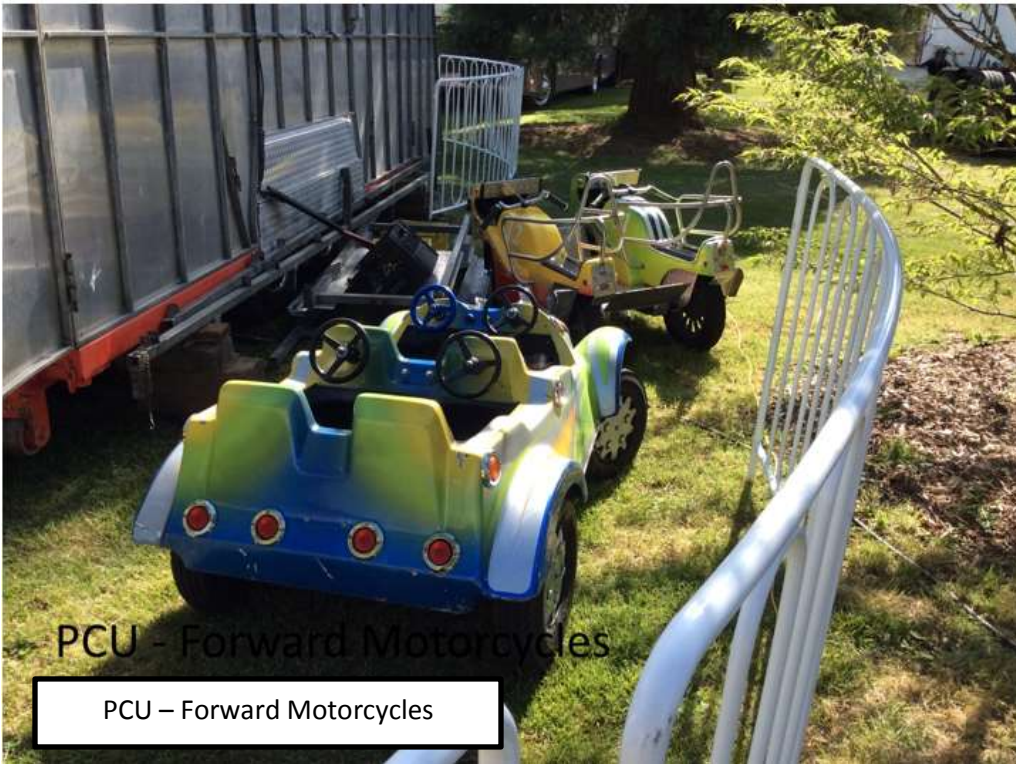
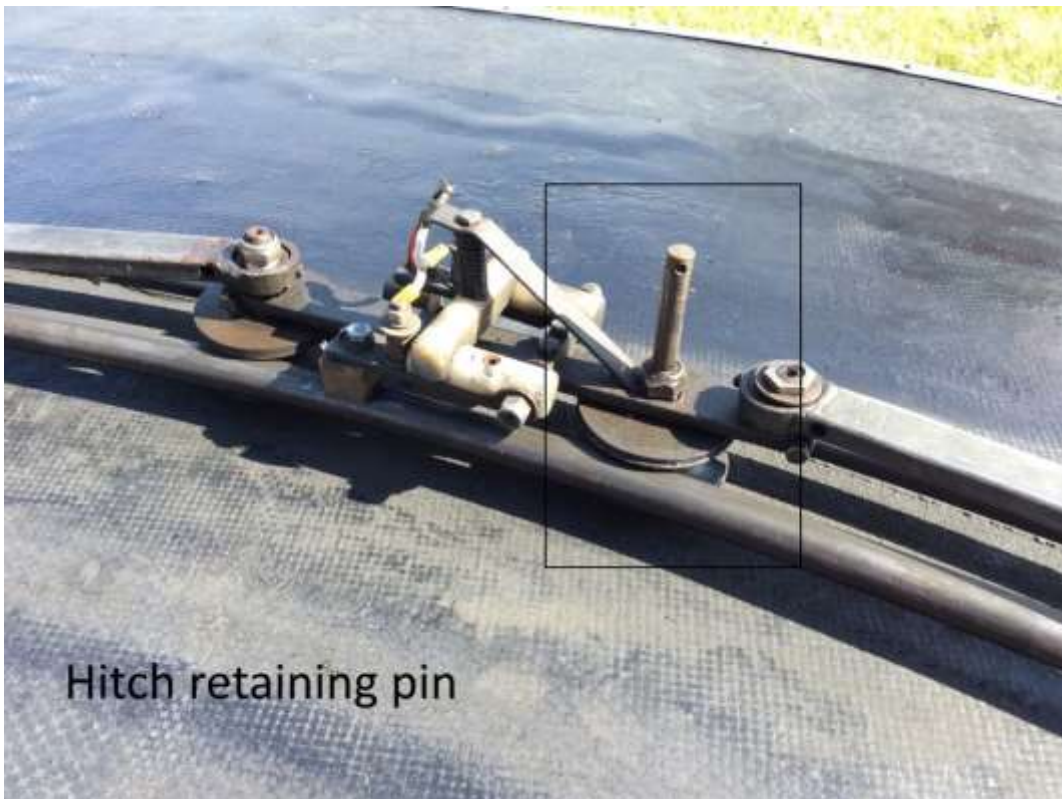
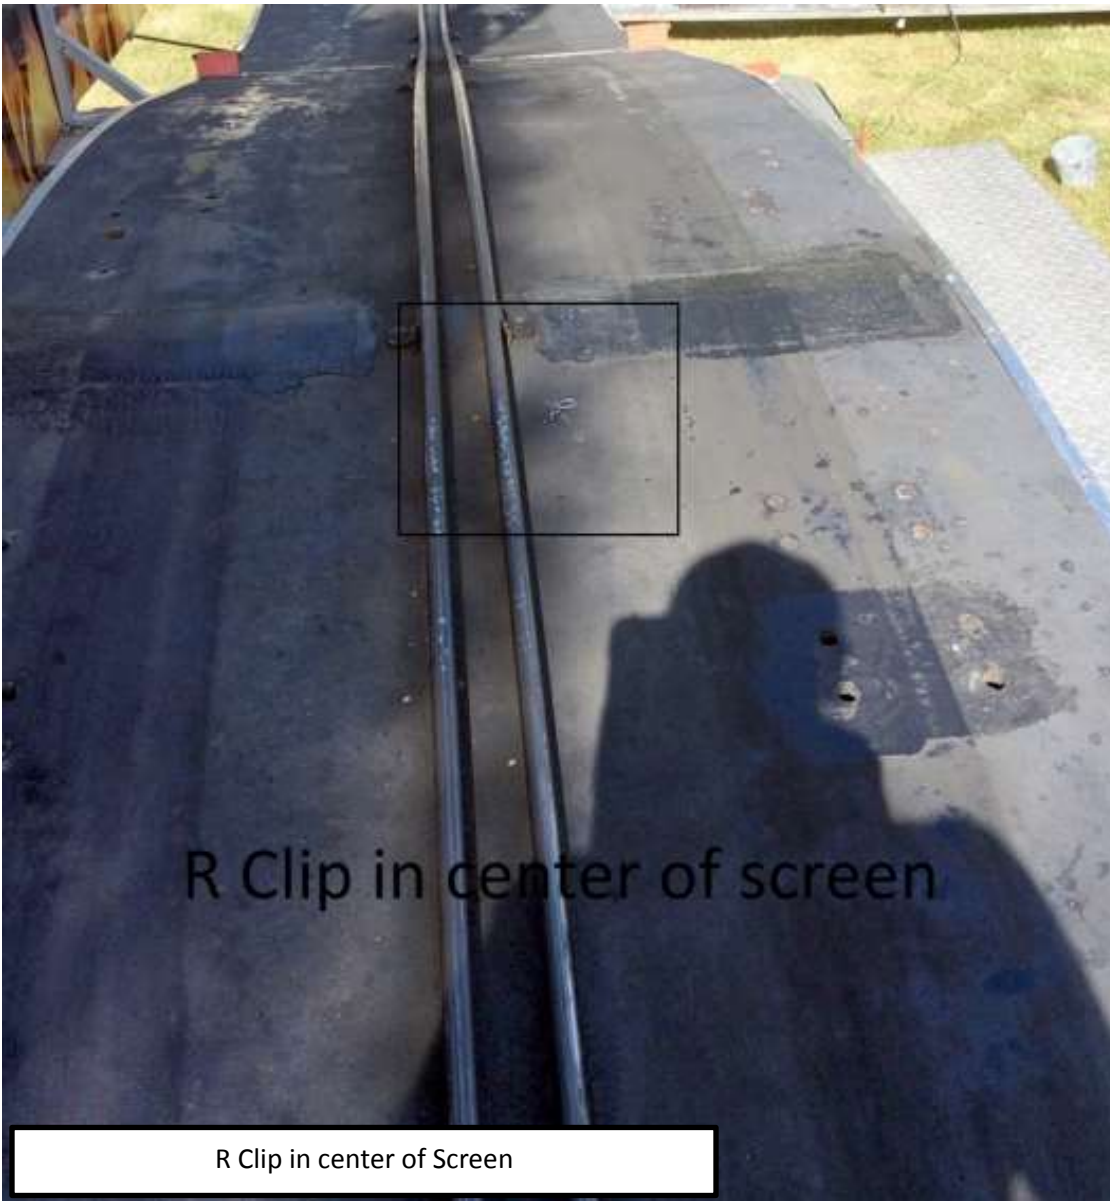
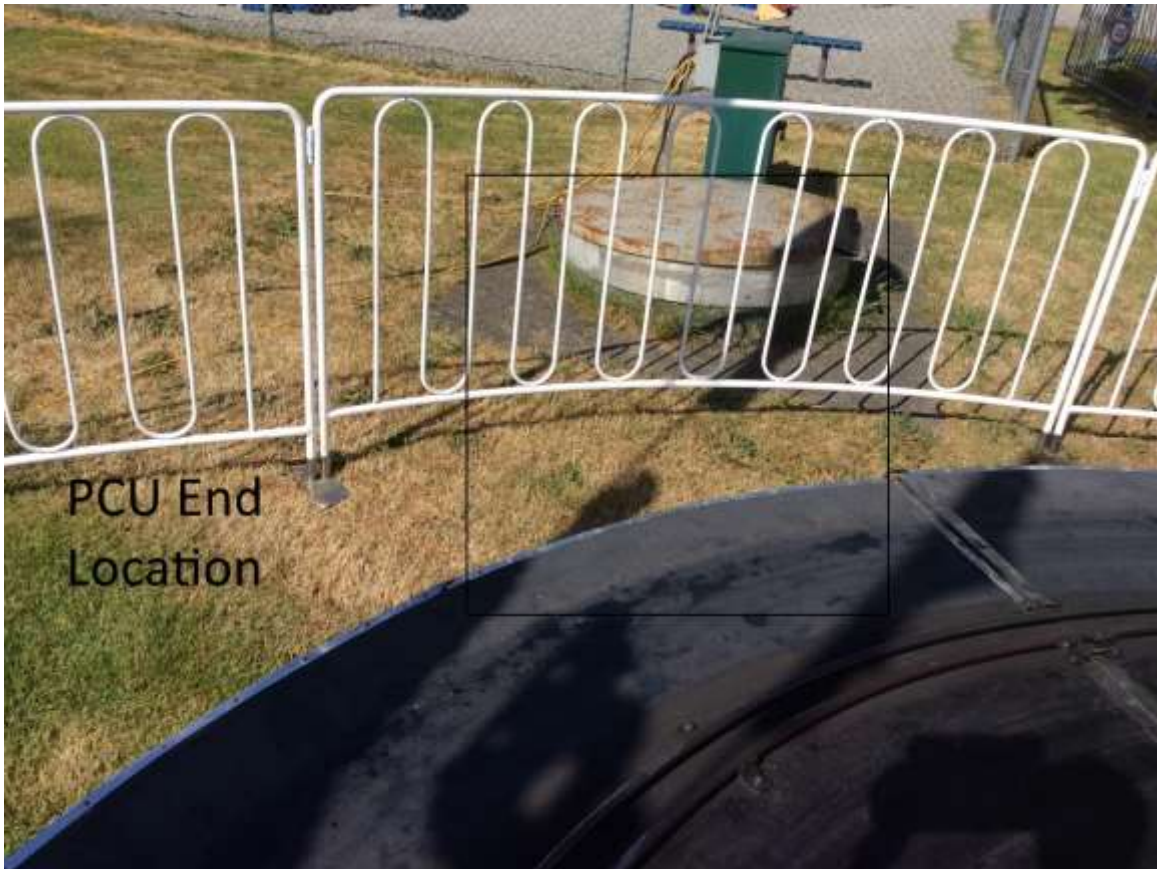
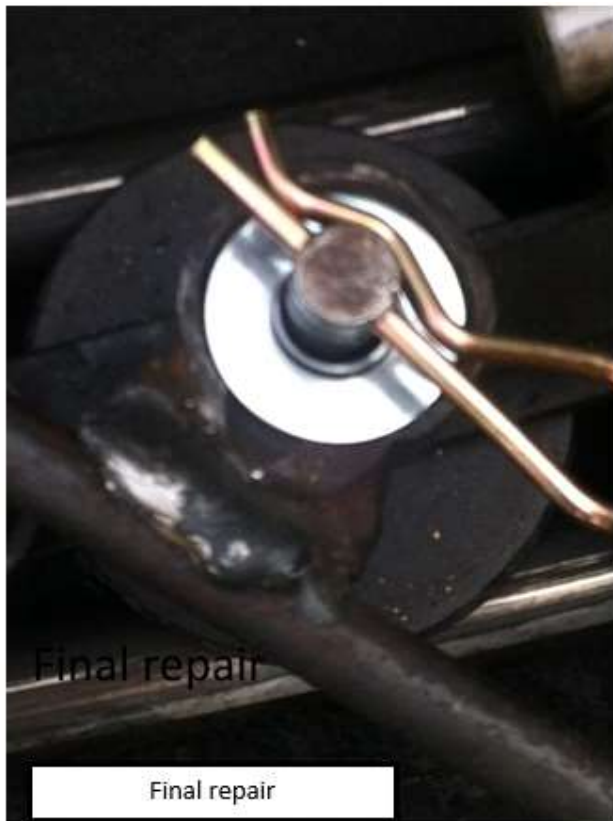
Photos or diagrams (if necessary)

<b>SUPPORTING INFORMATION</b>	Incident Date	May 25, 2018	
	Location	Ladner, BC	
	Regulated industry sector	Amusement Ride	
	Impact	Qty injuries	1
		Injury description	One person was reported to be shaken up by the event
		Injury rating	None
	Damage	Damage description	An Undersized “R” clip became bent and deformed, and was forced out of the hole on the retaining pin.
		Damage rating	Major
Incident rating	Major		
Incident overview	It was reported to Technical Safety BC that a retaining clip ( “ R” clip) fell out of its intended position allowing the Passenger Carrying Unit ( PCU) to detach from the rides power train. The now free PCU coasted downhill, and was able to leave the ride track. The PCU and its rider came to rest against a ride fence at the bottom of the ride track hill.		
<b>INVESTIGATION CONCLUSIONS</b>	Site, system and components	The individual PCU’s are connected together with hitches that a fastened with a retaining clip known in the industry as a “R” clip. The PCU train is pulled along the track by an electric motor at the front of the train. The ride track has a hill incorporated to it as a ride feature. This ride is designed for small children.

Failure scenario(s)	During the assembly of the ride, ride erection personnel inserted an undersized retaining clip into the hitch of the PCU. Pre-operational inspection failed to identify this undersized part. During operation of the ride forces on the undersized clip caused the retaining clip to bend. The vibration and motion at the hitch caused the retaining clip to eventually come free from its intended position allowing the PCU to separate from the train.	
	Facts and evidence	<ul style="list-style-type: none"> <li>• A signed “Daily Maintenance Checklist” had been completed.</li> <li>• A signed “Set up Inspection Checklist” had been completed.</li> <li>• A bent or deformed “R” clip was found at the PCU dislocation point.</li> <li>• An undersized “R” clip was installed, based on the receiver hole size on the retaining pin.</li> <li>• See attached photos from site investigation.</li> <li>• Operator confirmed with the manufacturer the correct size of retaining clip. The confirmed OEM retaining clip was of a larger dimension than the one evaluated at the site.</li> </ul>

Causes and contributing factors	It is highly likely that the incorrect size of the retaining clip resulted in the separation of the PCU and allowed the resultant collision of the PCU with ride fence to occur. It is likely that either the device was not inspected or an incomplete inspection of the device was performed prior to the operation of the device. A lack of knowledge by Maintenance/ Operations personnel may have been a contributing factor. Inadequate supervision may also have been a contributing factor.
