Incident Summary #II-1629847-2023 (#41057) (Final)

SUPPORTING INFORMATION	Incident Date	November 3, 2023	
	Location	Salmon Arm	
	Regulated industry sector	Electrical - High voltage electrical system (greater than 1000V)	
	Impact	Qty injuries	0
		Injury description	N/A
	Damage	Injury rating	None
		Damage description	High voltage 25kv unit sub-station was wetted and tripped the 'Utility' system overcurrent protection upstream from the high voltage equipment. The overcurrent protection for the high voltage unit sub-station failed to operate.
		Damage rating	Insignificant
	Incident rating	Insignificant	
Incident overview	An existing high voltage unit sub-station with a faulty main overcurrent disconnecting means became wetted from a cut water line which did not trip which resulted in tripping the utility supply overcurrent protection upstream.		
INVESTIGATION CONCLUSIONS	Site, system and components	A 25kv 3-phase high voltage unit sub station transforms the high voltage to end user voltage rated at 120/208volt 3-phase 4-wire. This end user voltage then provides a mall and the different tenants with power for lighting, receptacles, and heating. Both the high voltage and the low voltage

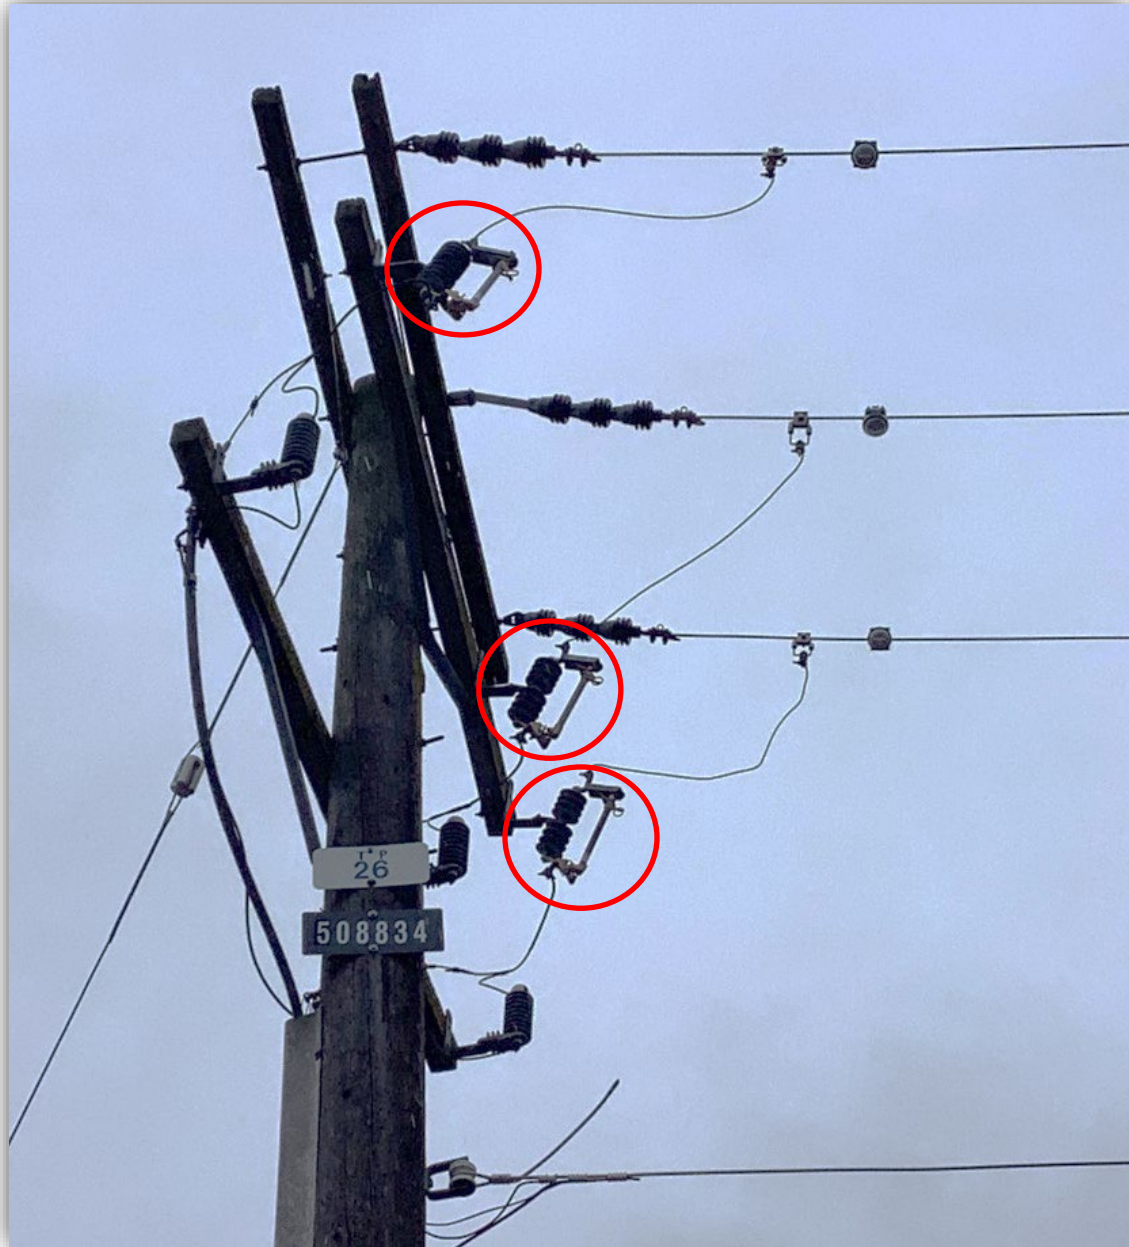
Image 1 - Existing utility cut-outs located outside back of mall in alley. Originally not fused (now has 40T fuses installed).

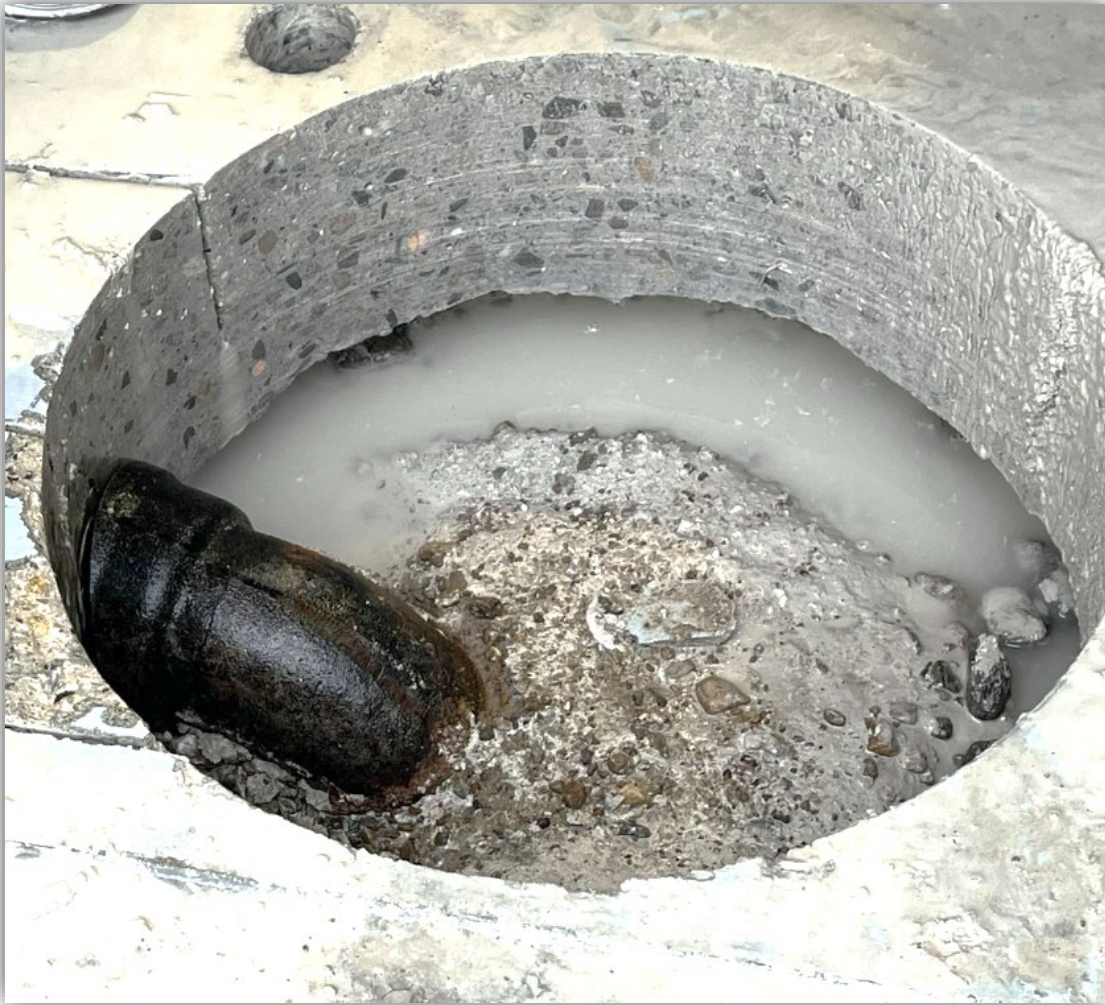
Image 2 - Original coring hole that hit watermain's cast iron pipe fitting that was encased in concrete.

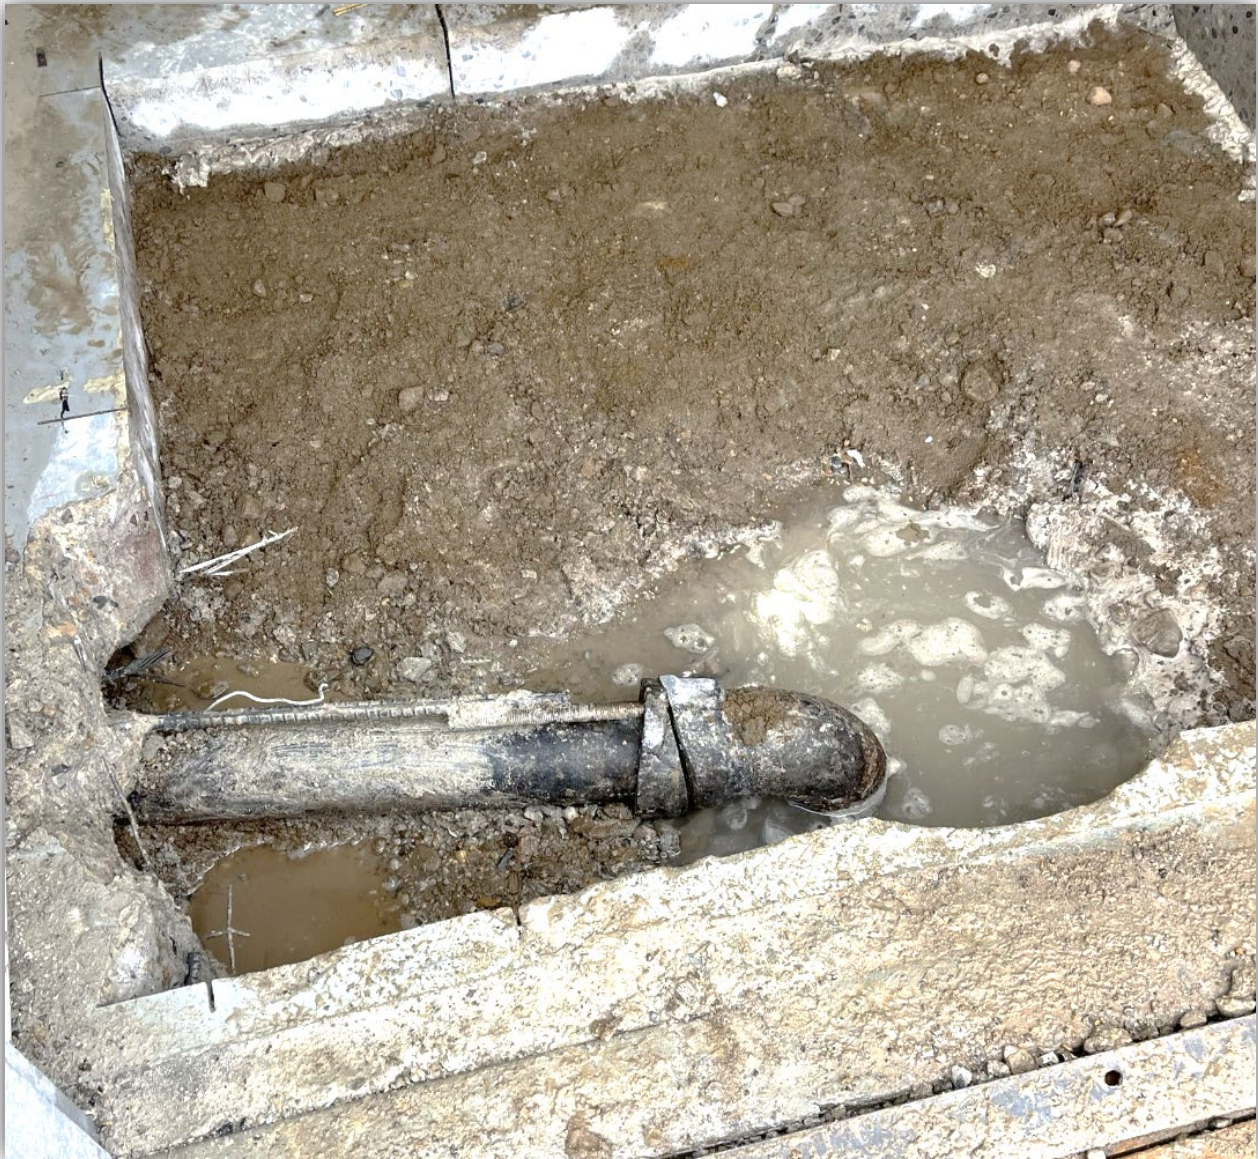
Failure scenario(s)	During saw cutting of a concrete floor, a water main 'elbow' in the concrete floor was cut and sprayed water in the air and over the plastic partition barrier the contractor installed to protect the high voltage equipment from moisture from the saw cutting process. The water land on top of the high voltage unit sub-station equipment and entered the equipment running down 25kv bussing between the main breaker section and the utility metering section. The water provided a path between phase and ground creating a short circuit condition. The main overcurrent in the high voltage unit sub-station failed to trip, which resulted in the Utility supply overcurrent protection to trip which was located off the property.

Image 3 - Remaining floor cut open, exposing damaged waterline. Saw cut can be seen to cast iron elbow on the top, where it runs horizontally.

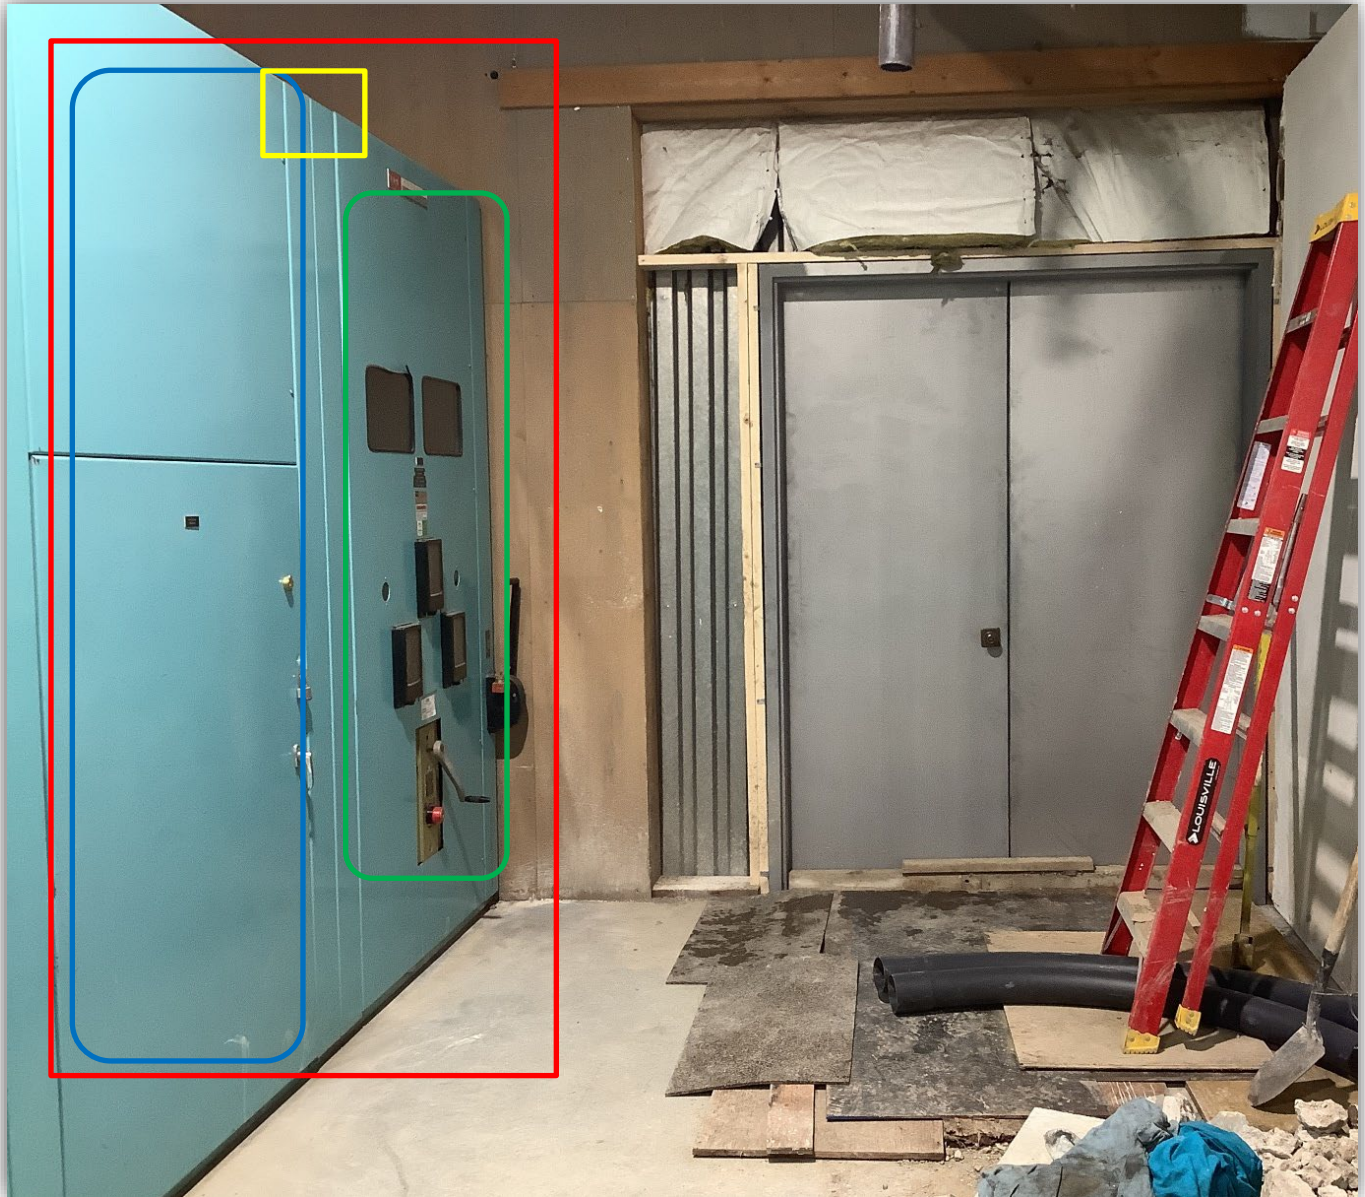
Image 4 - Saw cut area in front of man-doors covered with plywood

Red: Main High Voltage equipment located to left of the door.

Blue & Green: Utility metering section located to left side of main switch compartment.

Yellow: Water entered through the topside of high voltage equipment between the 2 sections.

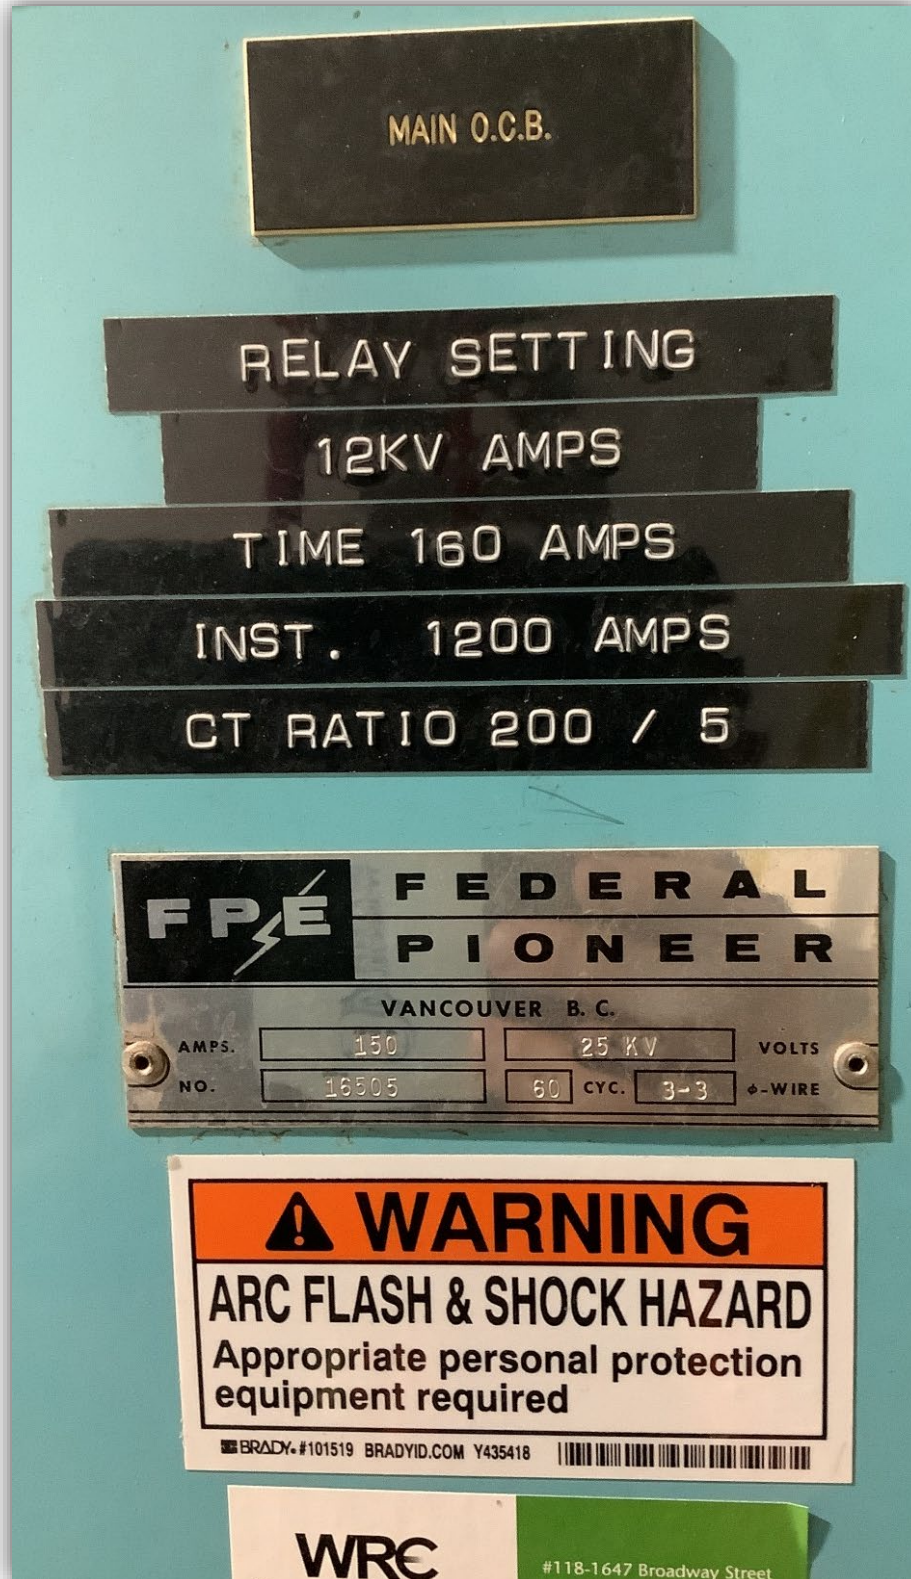
Image 5 - High Voltage Unit Sub-station labelling.

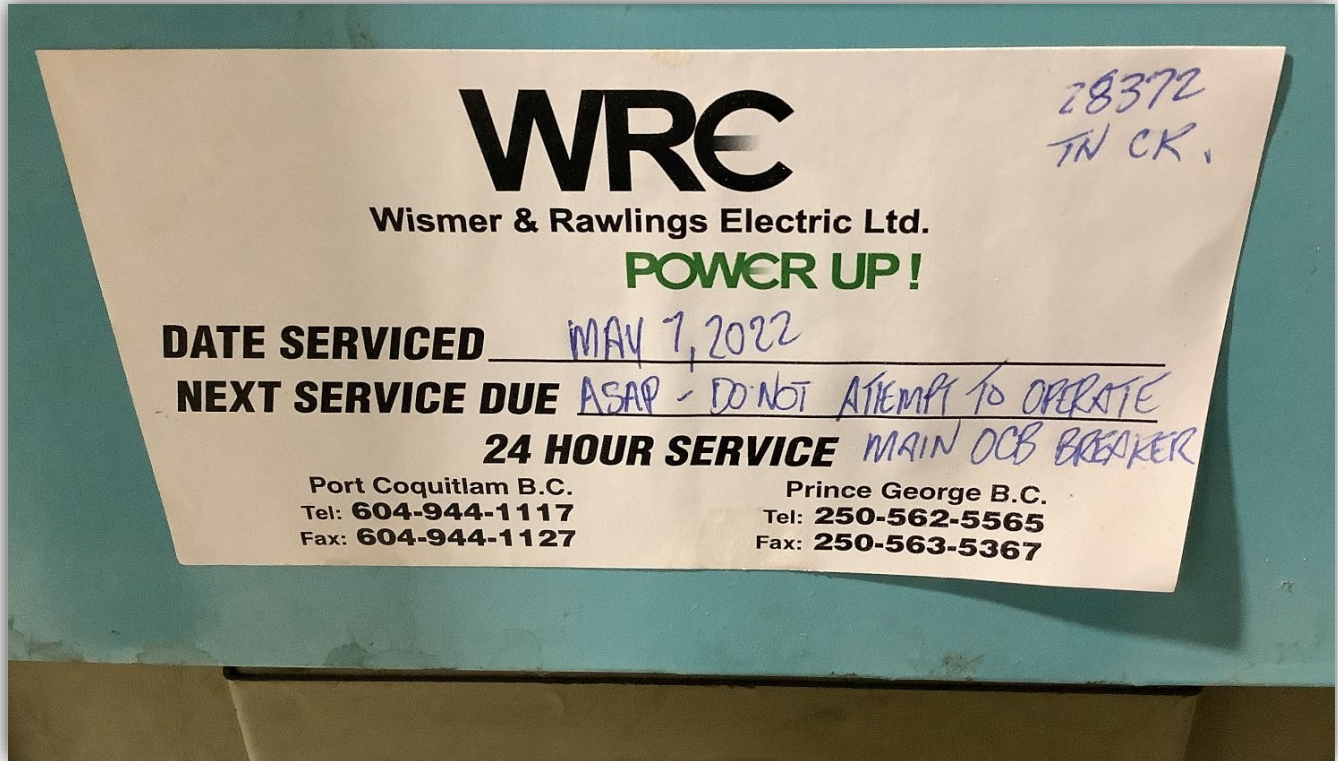
<p>Facts and evidence</p>	<ul style="list-style-type: none"> • The high voltage unit was serviced in May of 2022 when it was noted the main 25kv breaker was inoperable noting numerous failed plastic parts, dried lubrication, and brittle components. • No prior servicing of the high voltage equipment was noted or known from original time of installation. • During the preparation phase, the Contractor obtained the services of a locator company and all drawings available for any underground in the area where trenching was noted to be performed, the plans and locates failed to be accurate. • A copy of service report from the high voltage service company supported the main breaker was faulty. A label applied to main disconnected noted 'Do Not Operate'. • Design of replacement service was acted on and put in motion with engineering and utility supply design. • During saw cutting of floor, a watermain was hit and sprayed water over the plastic barrier entering the high voltage equipment. • Main breaker failed to operate resulting in the utility supply overcurrent tripping upstream that was located off the property. • Initial discussion with utility noted: Utility cut-outs at customers pole were solid blades with no fusing installed, 2- 65T fuses upstream did not blow, 3- utility re-closures at other location saw the fault and tripped with automatic Utility re-attempts to re-energize prior to locking out. • Follow up discussion with utility noted: 1- the 65T fuses upstream 'did' trip and performed their function properly. • The only safety devices that operated were 'Utility owned' equipment, 'duty holders' safety devices failed.

<p>Causes and contributing factors</p>	<p>It is very likely the 'faulty' main breaker failed to open when the cutting of the water main, and the water spraying on top of the high voltage equipment, caused a fault to occur within the high voltage equipment resulting in the utility supply overcurrent devices to act as the safety device for de-energization regulated electrical equipment at the mall.</p>

Image 6 - Testing company label applied May 7, 2022 noting "DO NOT attempt to operate main OCB breaker".

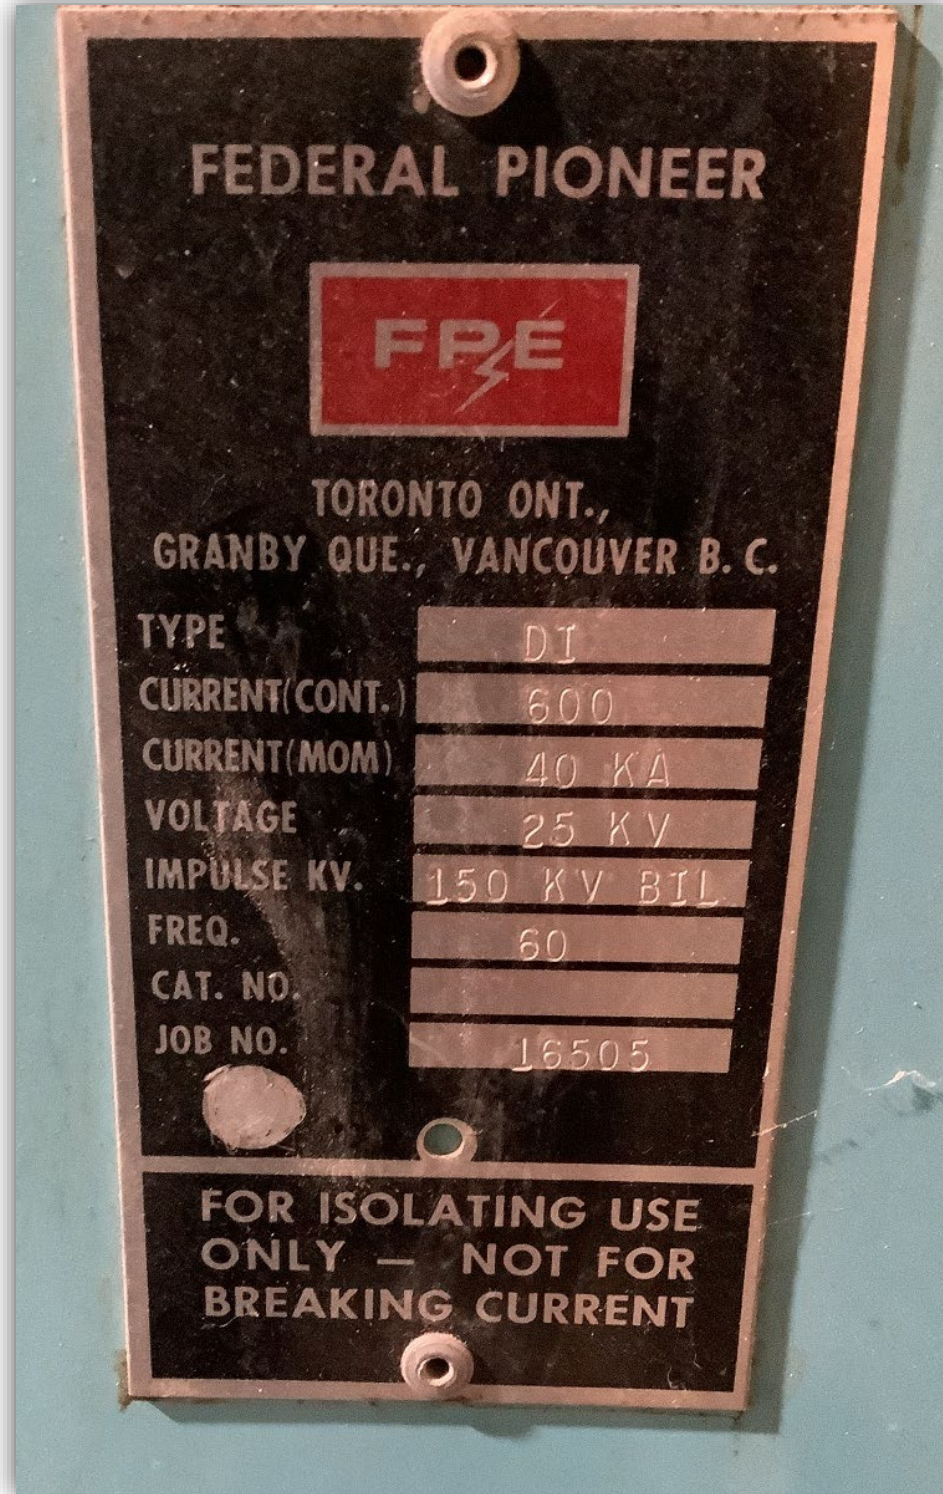
Image 7 - Additional equipment label.
