Incident Summary #II-1660116-2023 (#43359) (FINAL)

SUPPORTING INFORMATION	Incident Date	January 12, 2024	
	Location	Oak Bay	
	Regulated industry sector	Gas - Natural gas system	
	Impact	Qty injuries	0
		Injury description	N/A
	Damage	Injury rating	None
		Damage description	Fire damage to the enclosure containing a direct vent fireplace. Fire damage to fireplace controls and valve train. Fireplace was a total loss due to removal as part of the investigation.
		Damage rating	Moderate
Incident rating	Moderate		
Incident overview	A fire started resulting in damage to the fireplace enclosure containing a direct vent gas fireplace in a home.		
INVESTIGATION CONCLUSIONS	Site, system and components	<p>A direct vent fireplace uses two pipes, one to take in all of the air for combustion directly from the outdoors and another to expel all of the flue gasses directly to the outdoors.</p> <p>The direct vent fireplace was installed into an enclosure with all clearances to combustibles maintained as shown in the installation instructions. Fireplace is prewired from the factory with final connection to the house wiring using an AC – DC adaptor.</p> <p>The fuel supply was a ½” black iron line @ 2

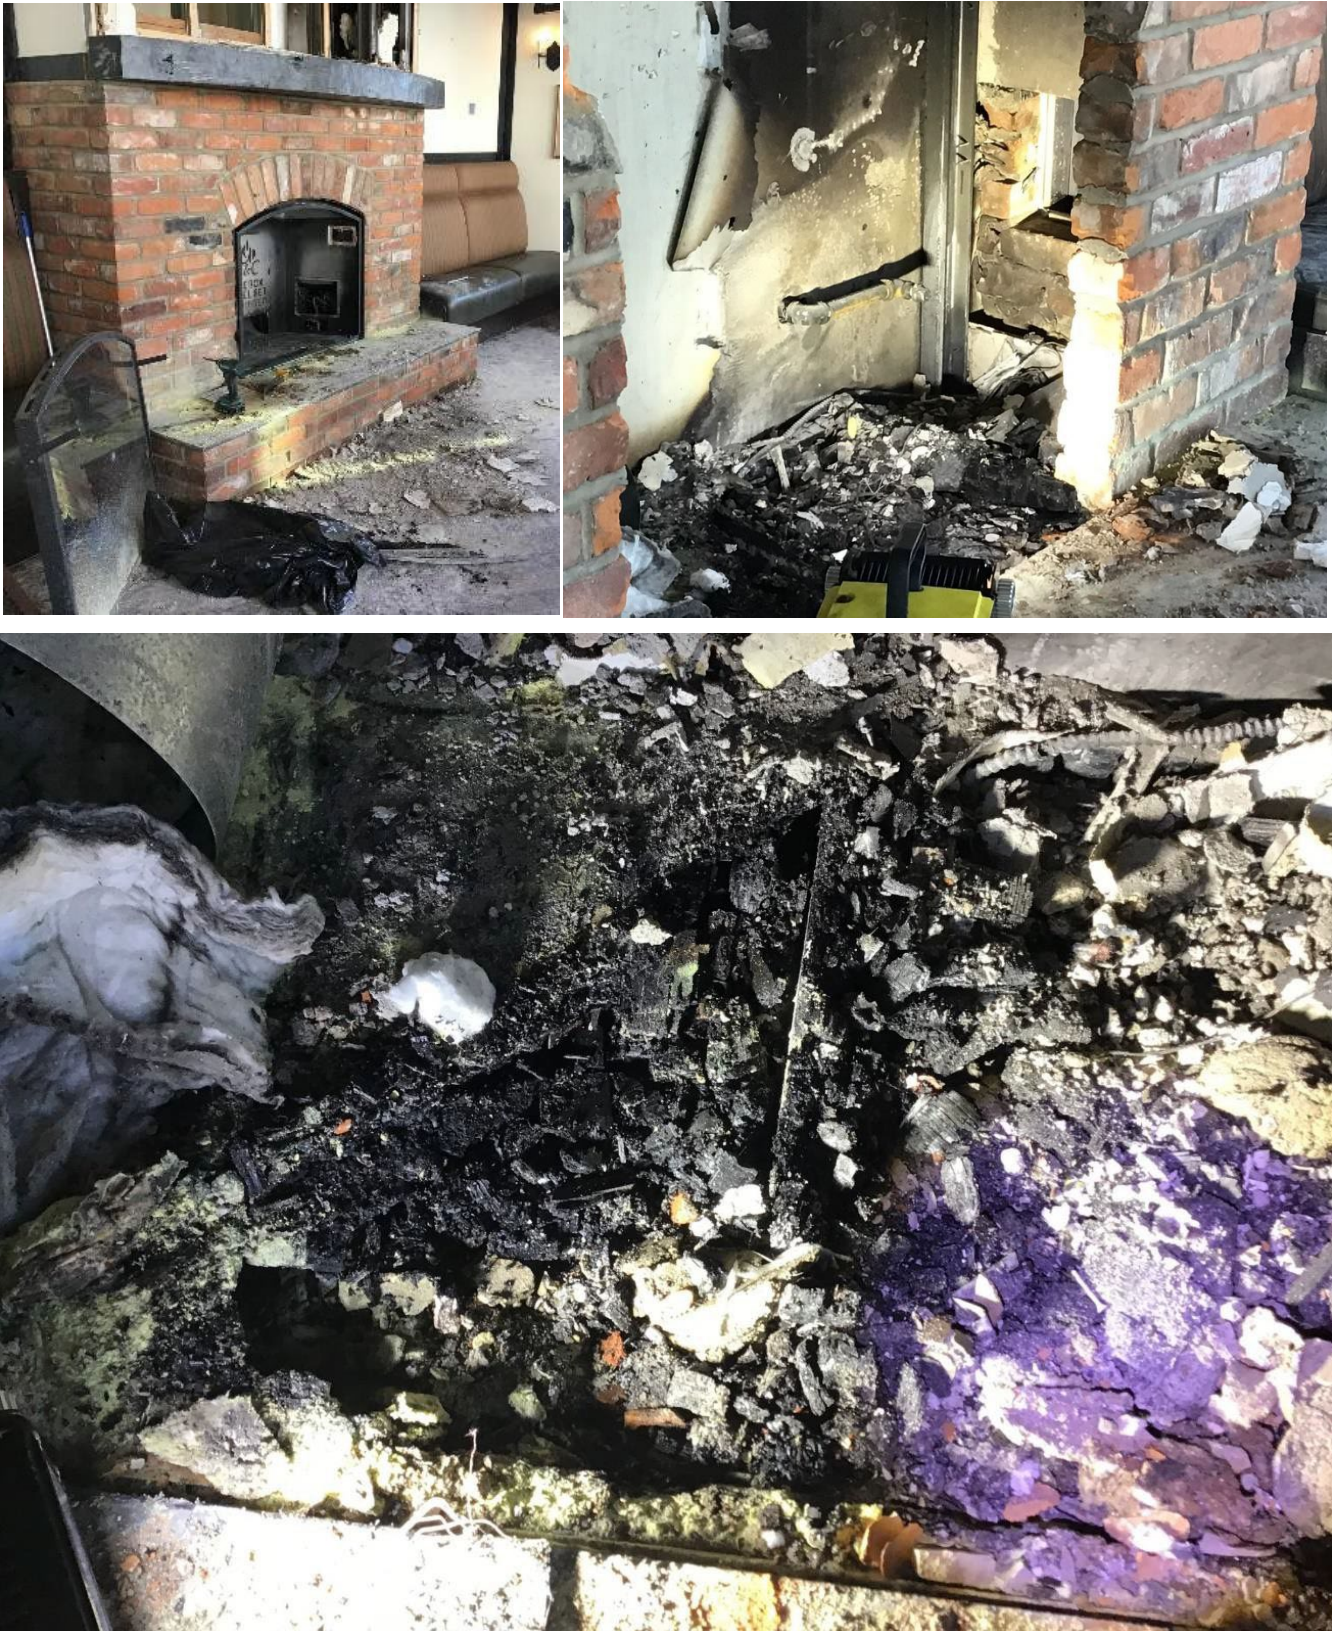
<ul style="list-style-type: none">• There was observed a smell associated with "burning dust" noted the night prior to the fire. The fireplace was turned off overnight and restarted the day of the incident. A subject matter expert retained by the insurance underwriter has attributed the most probable cause as Pyrolysis of the accumulation of dust under the fireplace.
Causes and contributing factors	It is possible that the long-term operation of the fireplace eventually caused pyrolysis of the combustible wood installed underneath that started a fire causing the damage.

Image 1 - Top left, top right, and lower showing plywood base with fireplace.

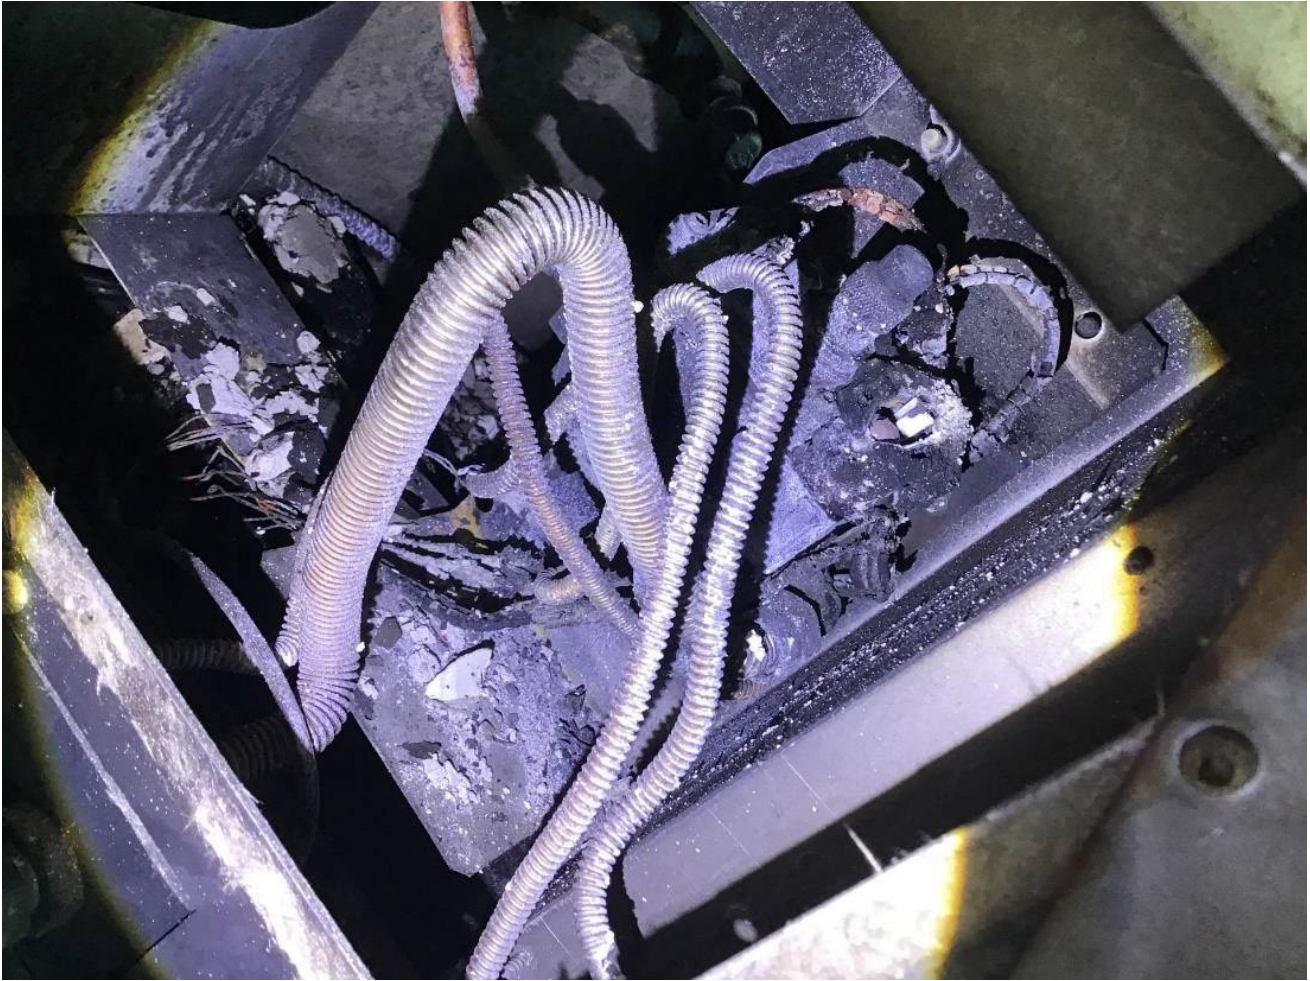
Failure scenario(s)	A fire originating in the fireplace plywood sub- base impinged on both the pressure regulator and the gas control valve resulting in a release of gas. Fire department noted that intensity of fire was diminished by 90% when the fuel supply was turned off.	
	Facts and evidence	<p>Site examination:</p> <ul style="list-style-type: none"> The fire appears to have originated under the gas train and control module. There was observed damage to the service regulator and gas control valve. The greatest amount of charring on framing members was observed in this location. The entire sub-base under the fireplace suffered fire damage as well. Service regulator was found missing both the seal cap and adjuster plunger. This could have resulted in the vertical release of 2 psi gas due to a diaphragm failure caused by excessive temperature.

Image 2 - Right side view showing location of gas control valve.
