Incident Summary #II-990977-2020 (#16844) (FINAL)

SUPPORTING INFORMATION	Incident Date	March 10, 2020	
	Location	Peace River Region	
	Regulated industry sector	Boilers, PV & refrigeration - Refrigeration system	
	Impact	Qty injuries	0
		Injury description	None
		Injury rating	None
	Damage	Damage description	Extensive damage to multiple buildings and equipment.
		Damage rating	Major
	Incident rating	Major	
Incident overview	A gas plant facility fire detection alarm on this date was acknowledged by an on call operator at approximately 04:50 am. Fire destroyed this plant facility comprised of a compressor, inlet separator, treater and other processing equipment.		
INVESTIGATION CONCLUSIONS	Site, system and components	<p>A pressure vessel known as a “treater” lost containment of process fluids called emulsion. The emulsion is a mixture of fluids such as both natural occurring and drilling well waste water, together with oil and/or condensate (depending on the geological formation by-products) along with natural occurring gas found in the geophysical formation extracted from a drilling well.</p> <p>This emulsion is transported from the well via pipeline to plant facilities such as this

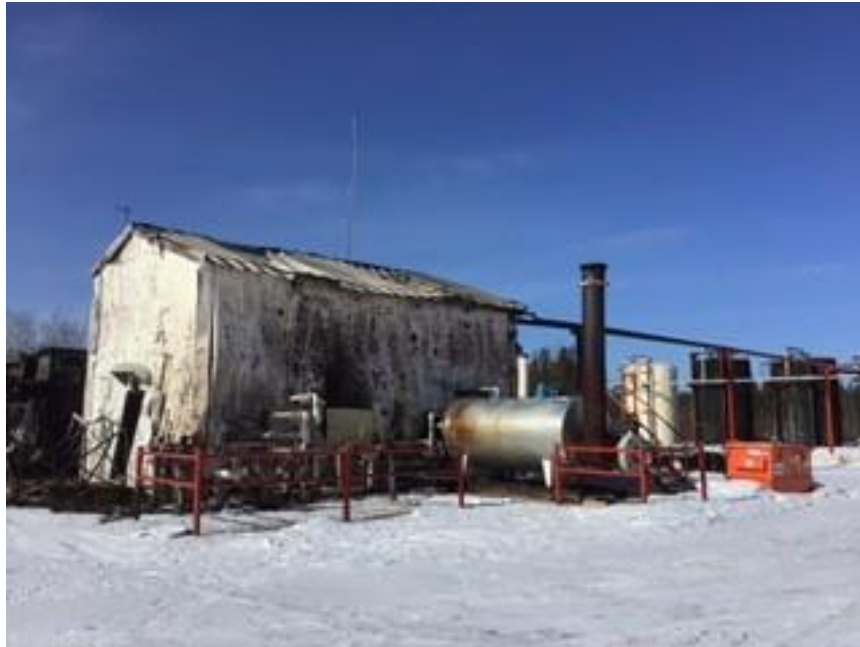
Looking from South East End of facility

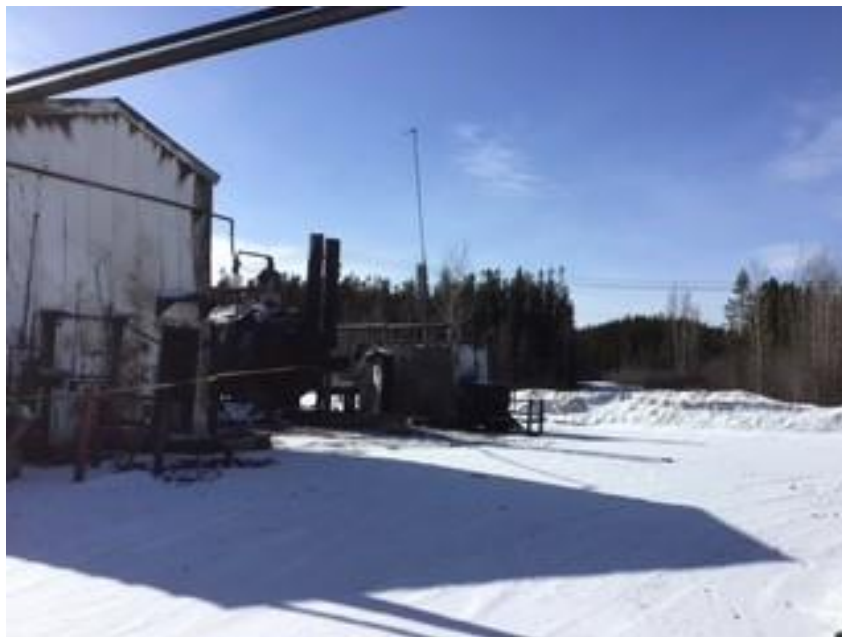
Looking From North East End of Facility

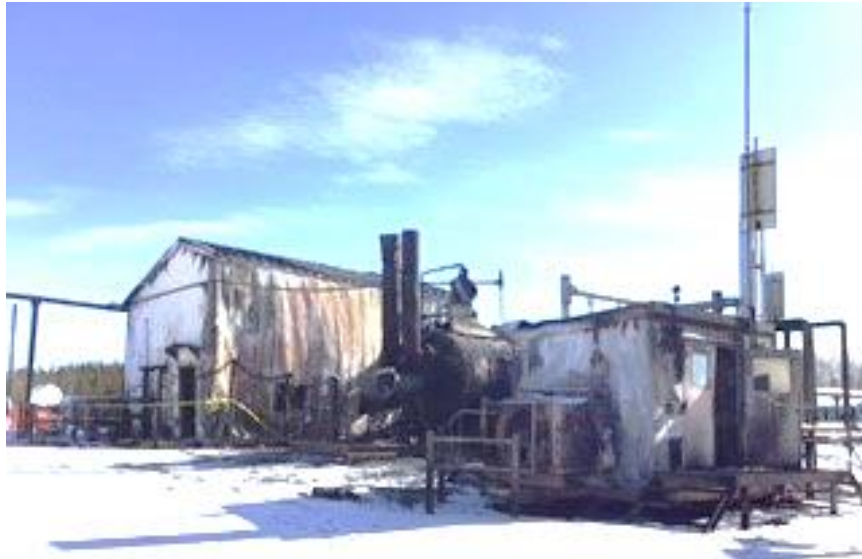
Looking from North West End of Facility

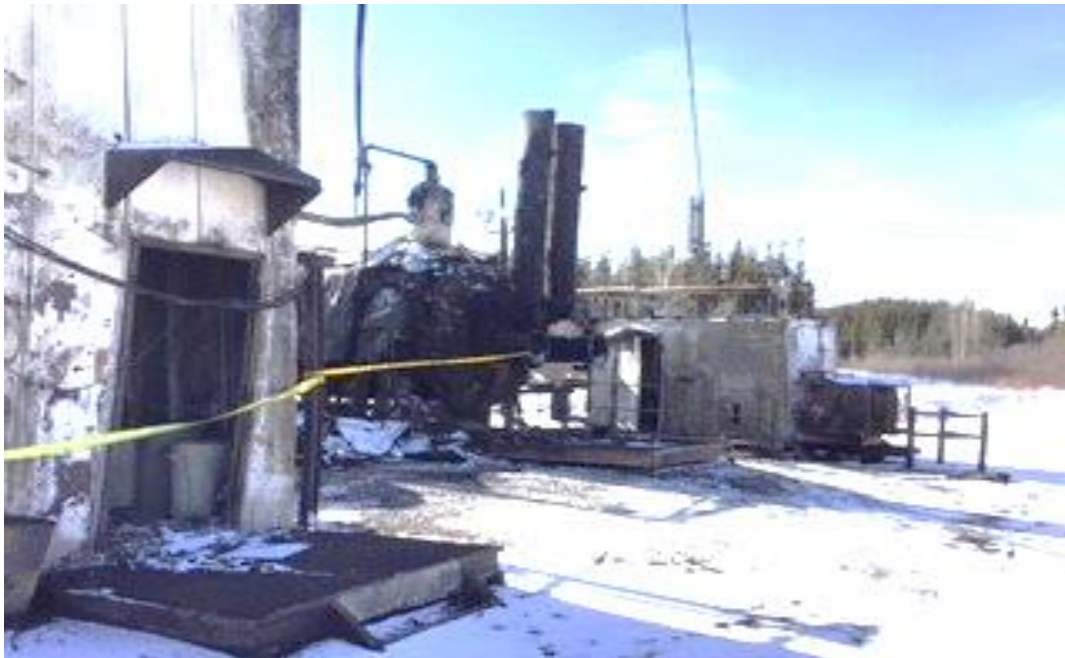
Treater is Middle Unit

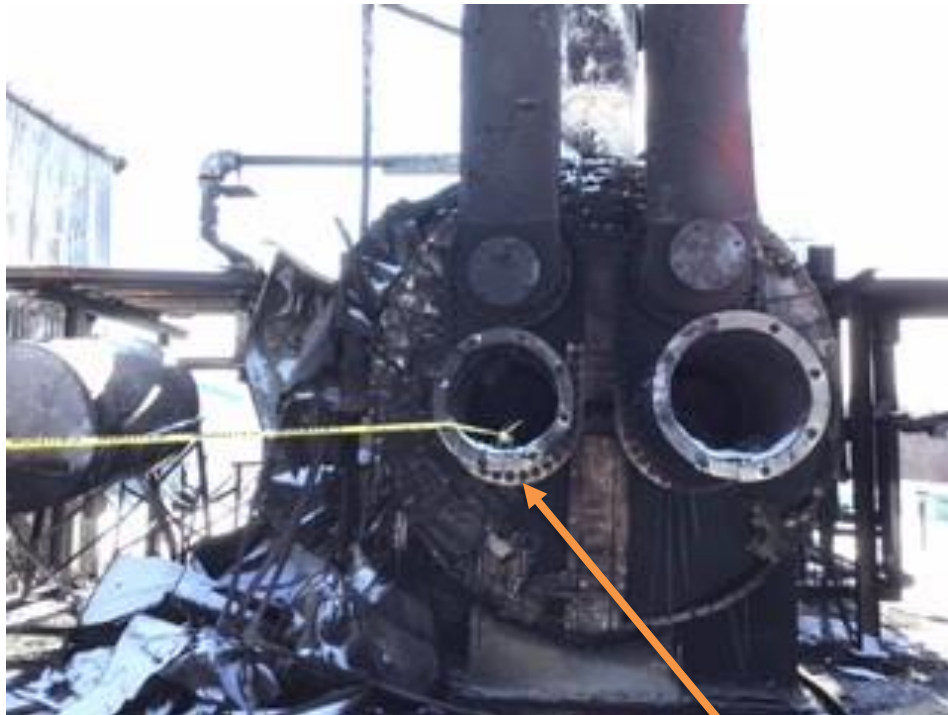
<p>Facts and evidence</p>	<ul style="list-style-type: none"> • Owner's report describes that the firetube was not supported properly inside the treater, contributing to the firetube gasket miss-alignment and gasket failure; allowing the emulsion to leak out onto the ground and which vapours likely ignited from the burner assembly. • Owner's report includes photographic evidence of the treater flange and gasket misalignment. • Extensive Heat Damage near burner end of treater support legs may be further indication of the fire's heat concentration where the treater fire likely started nearby at the burner assembly. • Photos taken by attending Boiler Safety Officer of complete loss of plant facility.
<p>Causes and contributing factors</p>	<ul style="list-style-type: none"> • It is plausible that the increased operating pressure on the treater fire-tube gasket, which seal was likely already compromised by the improperly supported fire-tube, contributed to the gasket failure. It is plausible that the fire tube gasket failure allowing the flammable emulsion fluid vapours to come in contact with the hot treater burner

Treater Burner End – note vertical firetube smoke stacks. The burner firetube gasket flange may have been source of emulsion leakage, of which, emulsion vapours likely were ignited by the burner assembly.

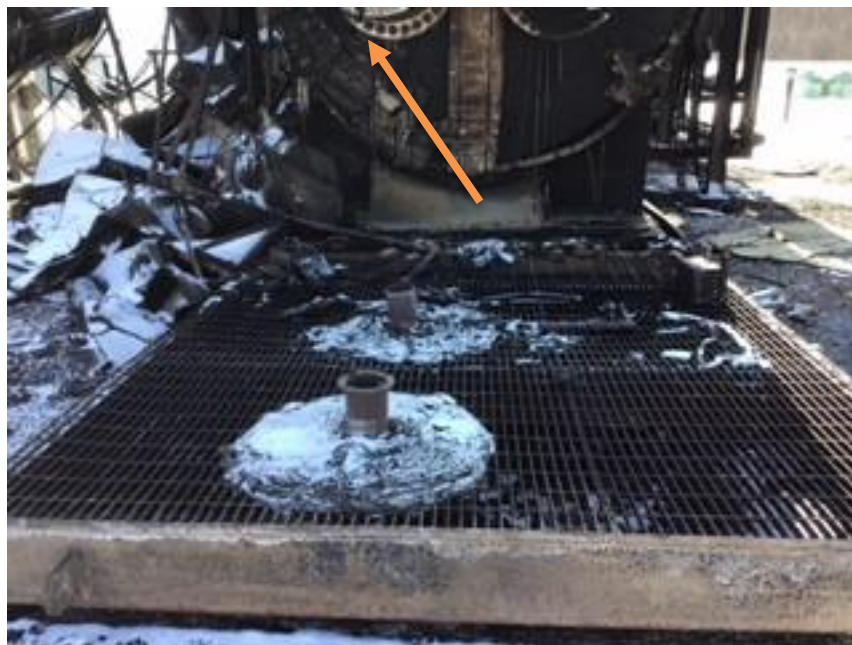
Bottom of Treater Burner End – Orange arrow shows side of flange gasket affected.

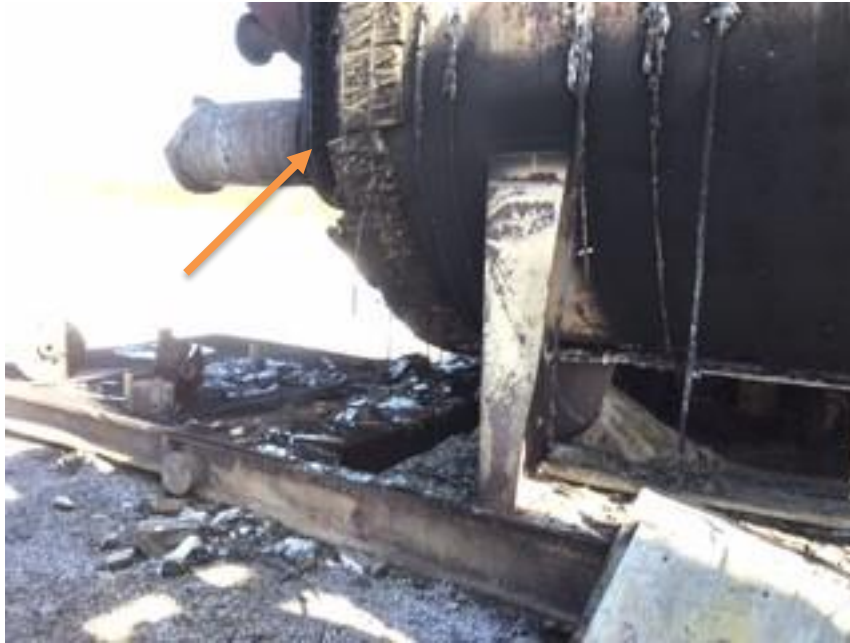
Treater Burner End skid and Support Brace

Note: Extensive Heat Damage likely in focal area of fire ignition.

Orange arrow points to flange gasket – firetube gasket on other side of burner assembly may be source of emulsion leakage.
