## Incident Summary #II-915189-2019 (#15006) (FINAL)

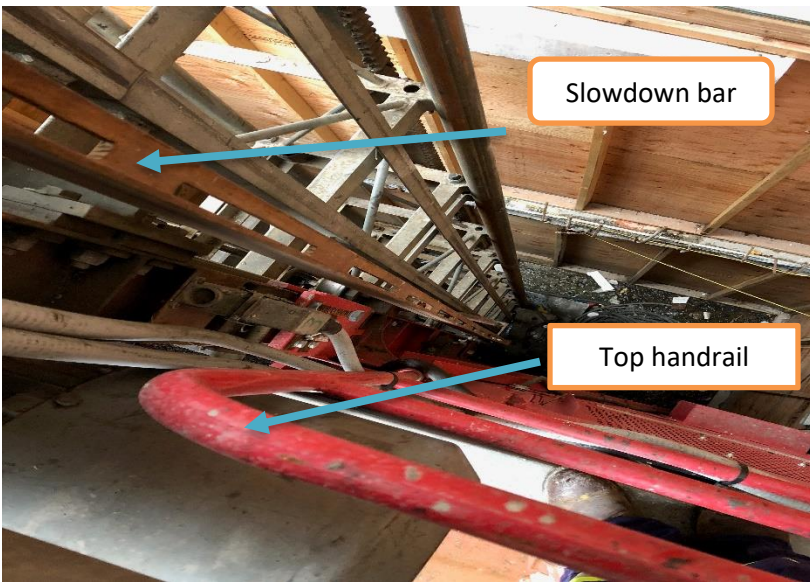
Slowdown bar mounted to bracket which attaches to mast.

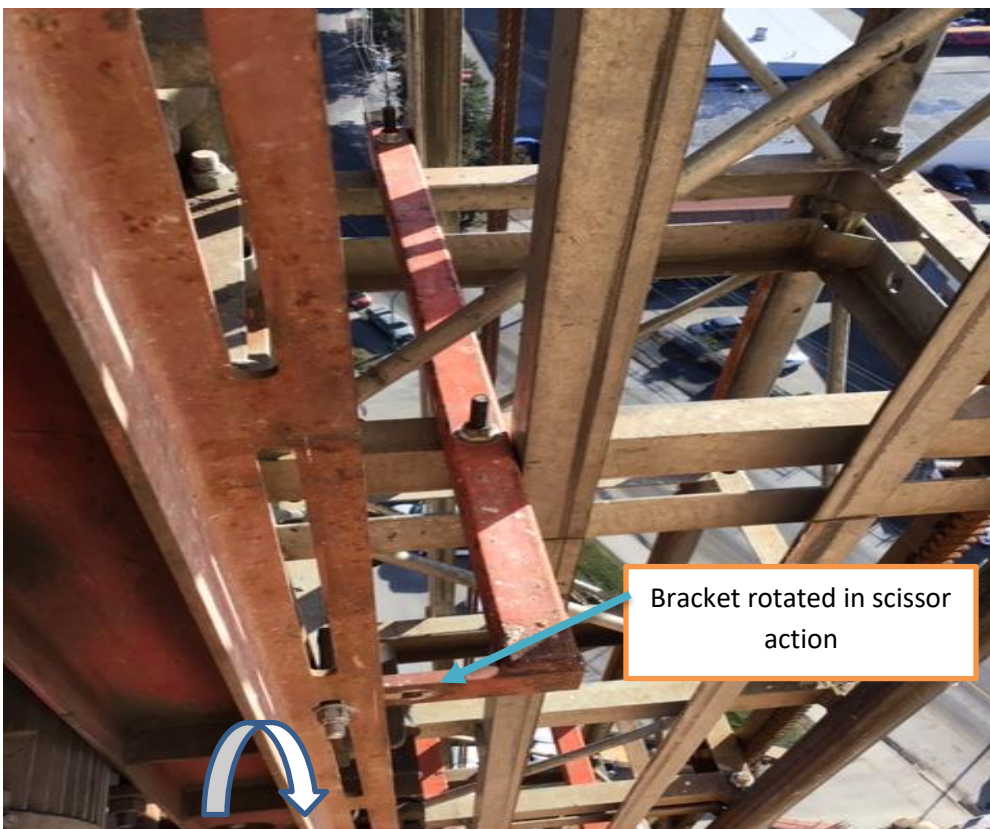
Failure scenario(s)	The Mechanic did not have an apprentice to operate the hoist. Mechanic was operating the hoist with his right hand while gripping the slowdown bar with his left hand. The lower mounting bracket of the slowdown bar assembly was attached while traveling in the up direction.	
	Facts and evidence	As per mechanic he was alone on car top. As per Polygon incident investigation report mechanic was on car without other workers. As per mechanic he was resting his left arm on the top handrail while holding the slowdown bar as he operated the hoist in the up direction. As per report the lower mounting bracket of the slowdown bar assembly was not removed prior to repositioning the hoist to re secure the slowdown bar assembly.	
	Causes and contributing factors	The mechanic was independently operating the hoist in up direction while holding slowdown bar in his left hand. The mechanic did not remove the lower mounting bracket. It is very likely that the mechanic did not have a clear line of sight while traveling in the up direction. It very possible that the mechanic could not see the clearance between the tower brace and the slowdown bar assembly lower mounting bracket.
