**KAMLOOPS REFRIGERATION SYSTEM FATALITY  
(RCMP File No. 2022-17544)**

**BALL VALVE EVALUATION**

File Number: 60516984 (605-J023973)  
EGBC Permit Number: 1001973  
Date: September 22, 2022

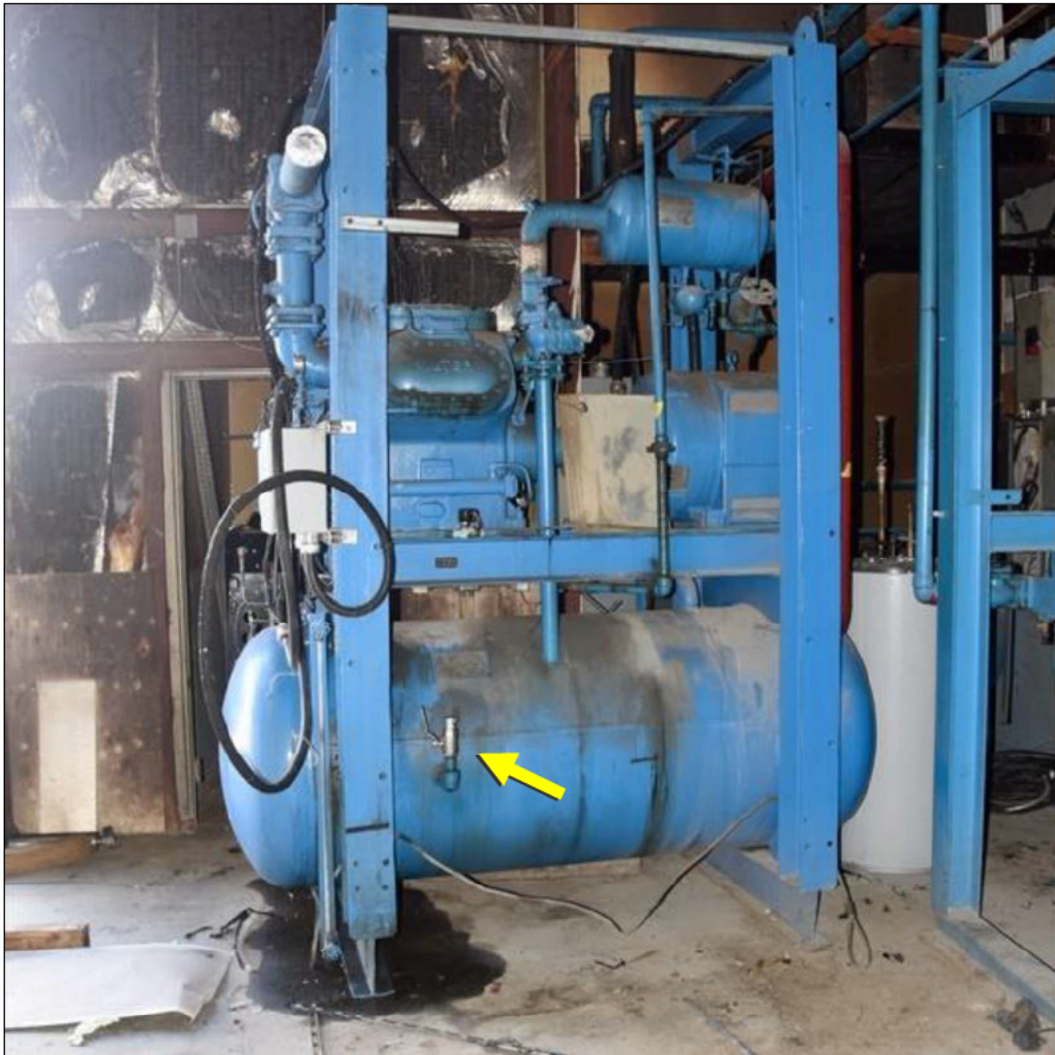
The operating lever is bent downward by approximately 20 degrees, as shown in Figure 3. The valve lever was originally bent outward at site (Figure 1) and was likely bent inward by the refrigeration technician to facilitate removal of the valve. The sliding locking mechanism is deformed and contains a single bent tab. Close-up views of the bent locking

**Figure 1** Overall view of subject valve installed vertically on ammonia tank (arrow). Lever is in "open" position with outlet side of valve in the upward position (site photo).

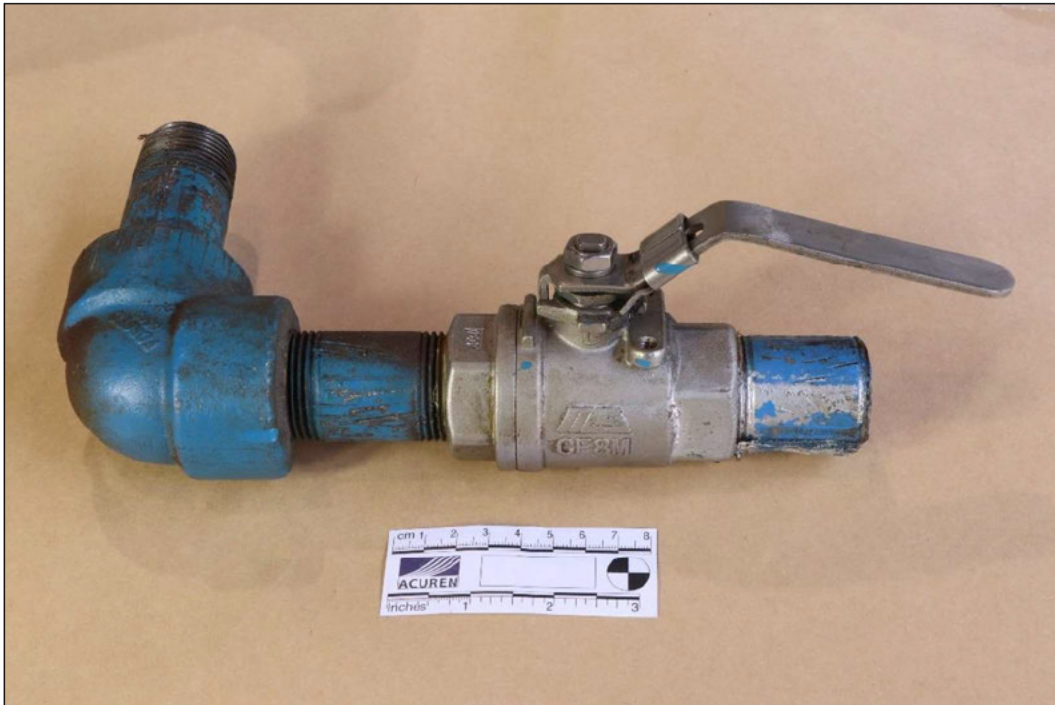
Overall views of the subject valve as received are shown in Figures 2 - 5. The valve is attached to a threaded nipple on one side and a threaded pipe, which had been cut with a saw, on the other side (Figure 2). This valve was arbitrarily labelled #1. The valve was originally mounted vertically on the tank with the outflow side of the valve containing the short section of cut pipe. The valve is marked with the following cast-in identification:

**Figure 2** Overall view of subject valve with attached fittings and pipe segment. Valve was mounted vertically with pipe segment in the "up" position.

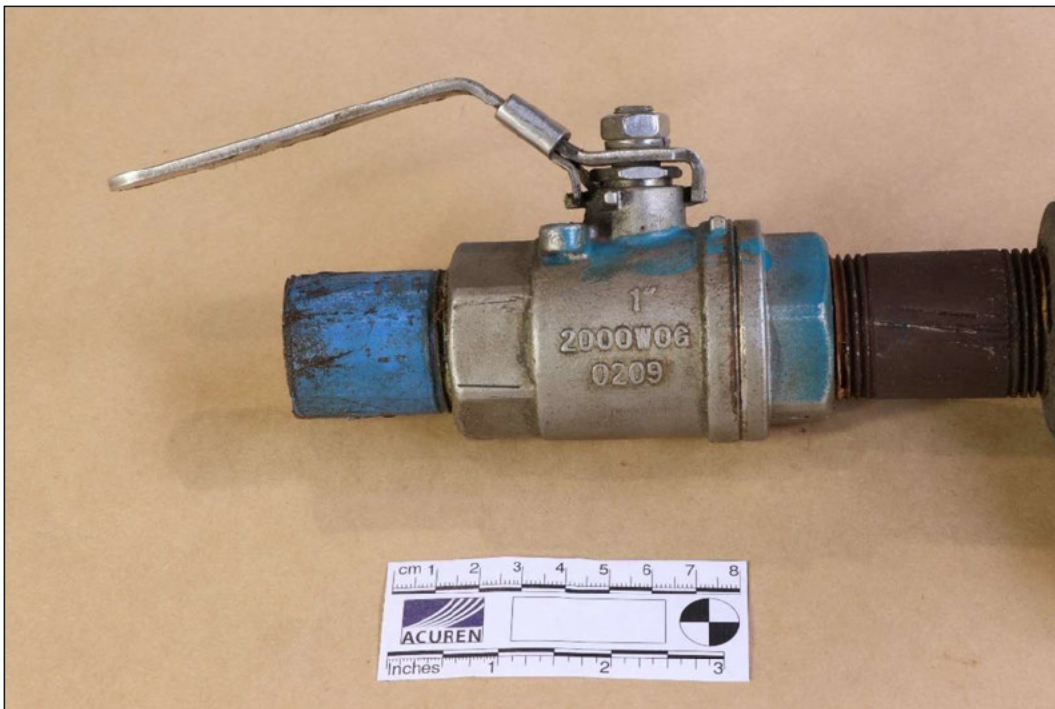
**Figure 3** View of valve showing downward permanent bend in lever of approximately 20°.

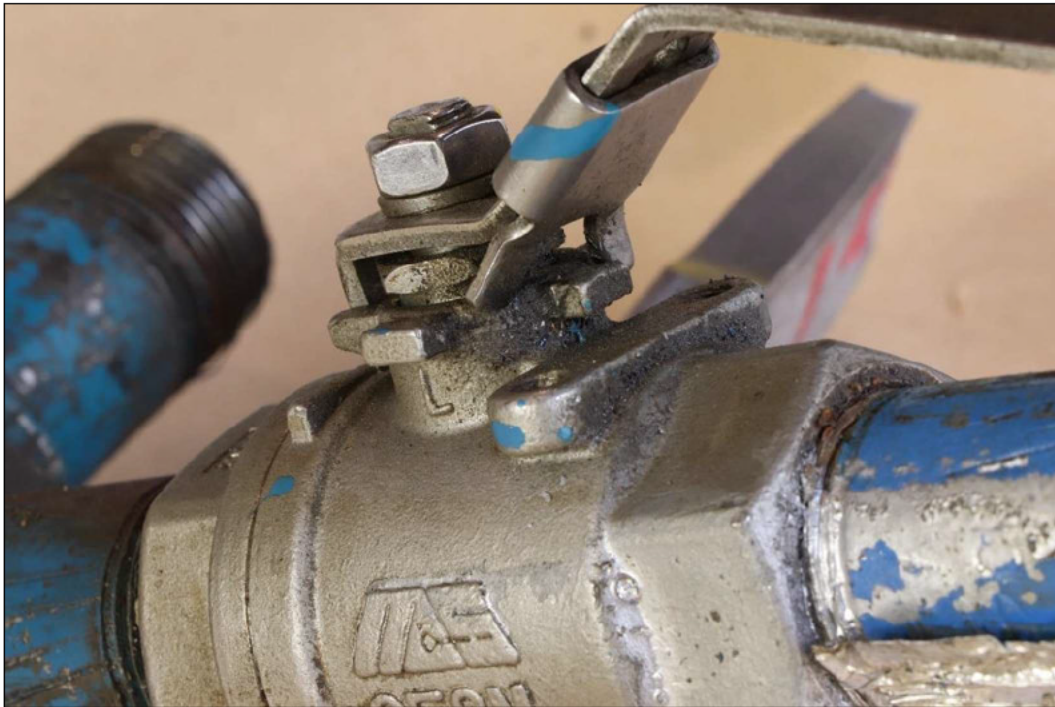
device are shown in Figures 4 and 5. The deformation of the tab occurred when a relatively large force was applied to the lever while it was moved from the fully closed position to the fully open position. The observed deformation prevents the locking tab from engaging properly.

3. The damage to the locking device is documented in Figures 4 and 5. The deformation damage was created by overstressing the tab past the yield strength of the austenitic stainless-steel locking tab material while moving the valve handle from the fully closed to the fully open position.

**Figure 4** View of deformed locking tab showing deformation preventing proper sliding and positioning of the locking tabs; however, the valve can be opened and closed normally.

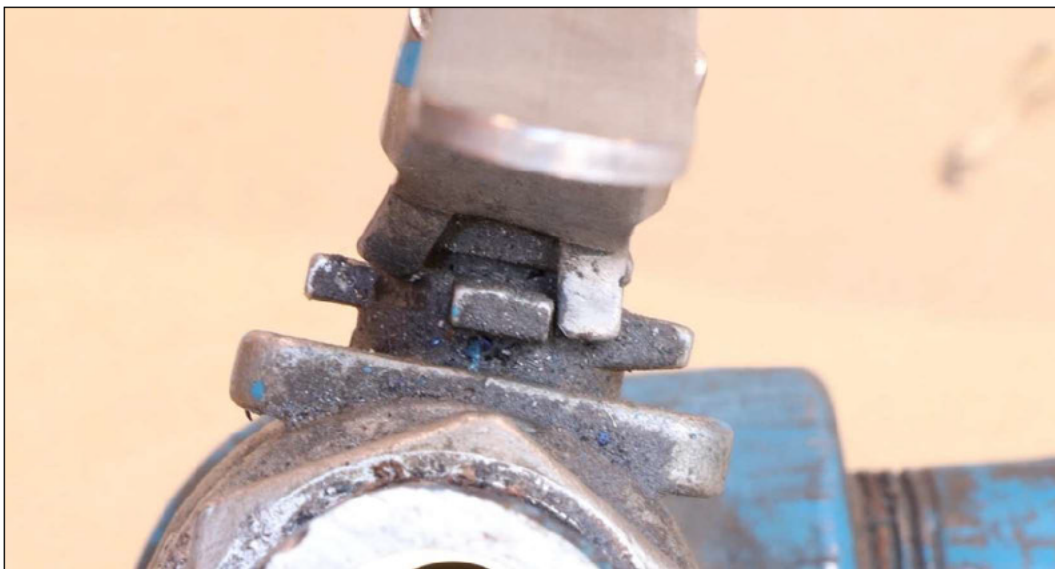
**Figure 5** Close-up view of deformed locking tab. Tab can slip by cast-in stop.

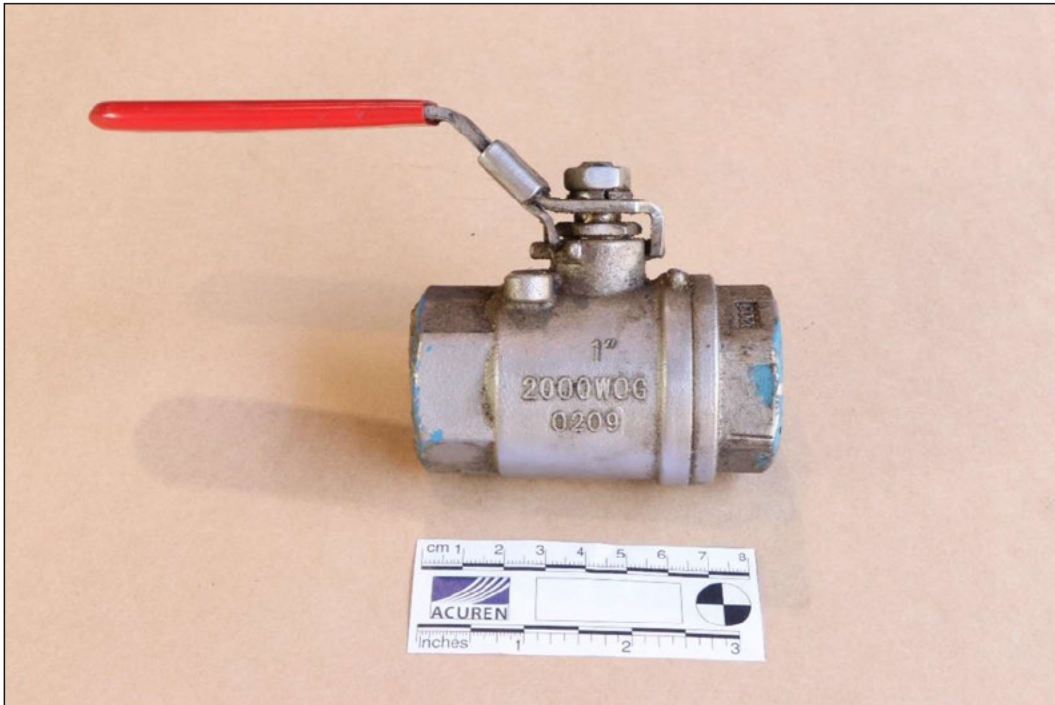
A second identical valve from the tank piping is shown in Figure 6. This valve was arbitrarily labelled #2. The lever is not bent with this valve and the locking mechanism is intact (Figure 7). The #2 valve lever is roughly parallel to the longitudinal axis of the valve body.

**Figure 6** Undamaged valve #2 showing straight lever.

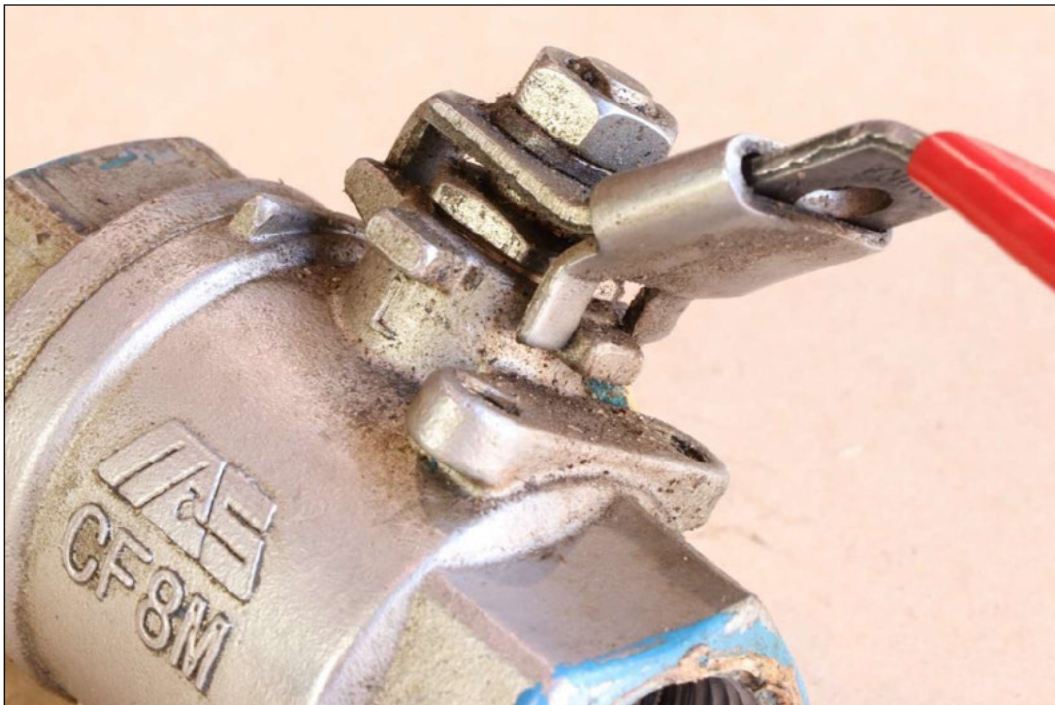
**Figure 7** Undamaged locking device on valve #2.

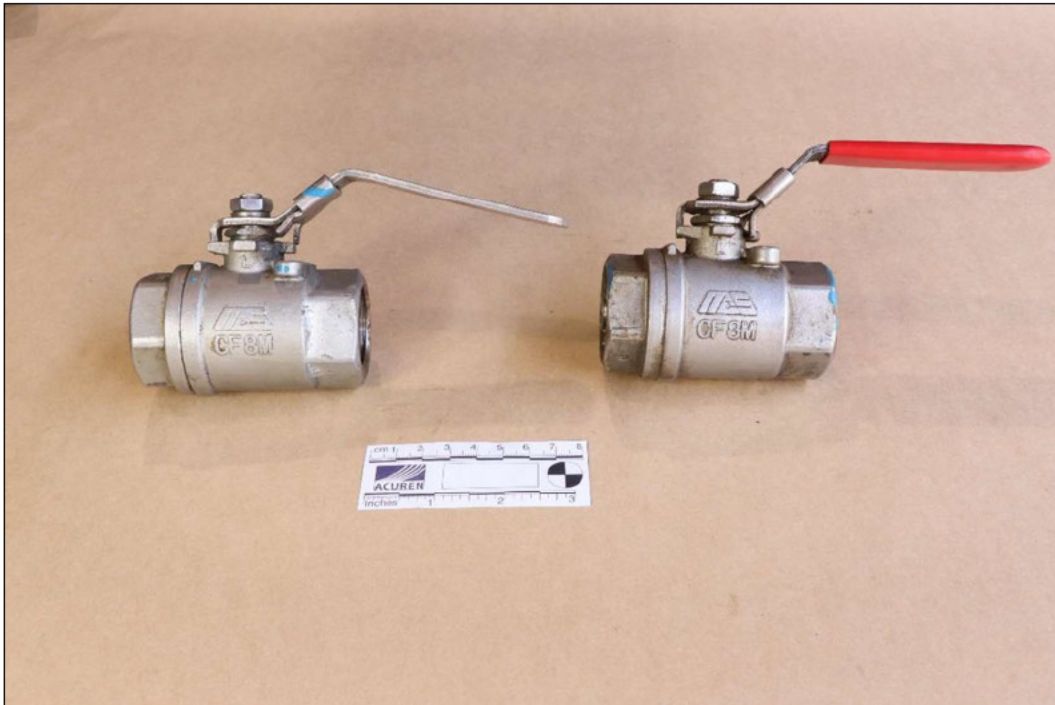
The nipple and pipe ends were removed from the #1 valve with a pipe wrench. The nipple and pipe appeared to be properly installed and took considerable force to remove them. The #1 valve and #2 valve are shown side by side in Figure 8. The only visible difference between the two is the bent lever and the deformed locking device with the subject #1 valve.

**Figure 8** Subject Valve #1 and Valve #2 side by side showing permanent bend in Valve #1 lever.

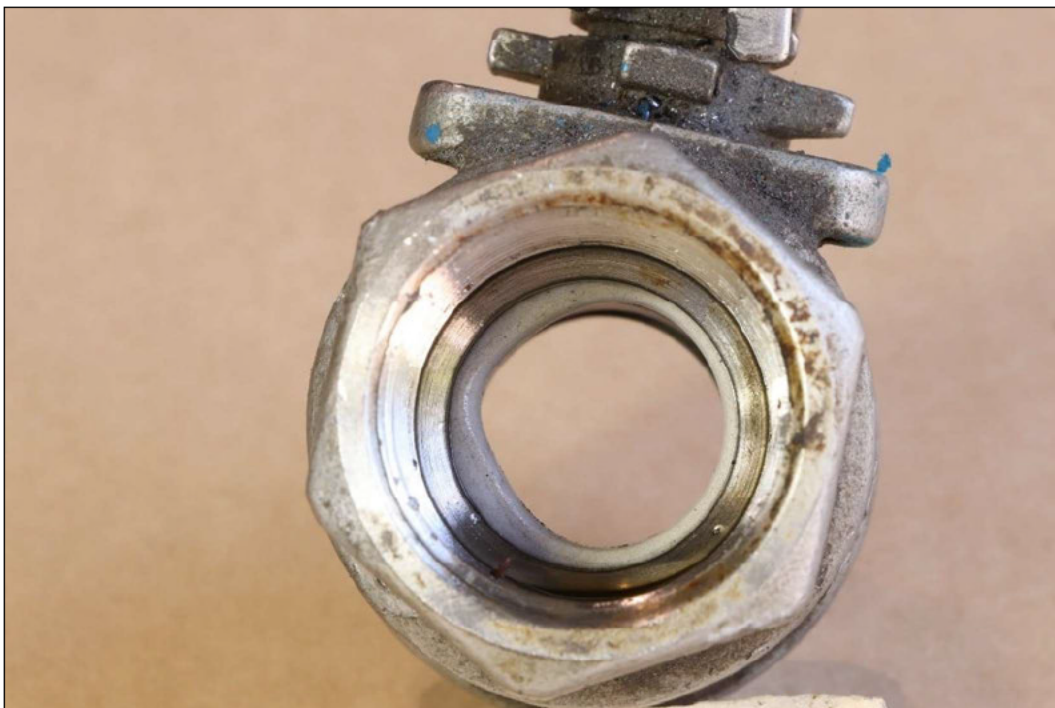
The interior of the valve was examined through both end openings. The plastic seal on the exit end of the valve (cut pipe) was deformed and extruded past the opening as shown in Figure 9. The inlet side of the valve appeared normal with the seal opening concentric (Figure 10).

**Figure 9** Deformation in outlet seal partially blocking 1" diameter hole.

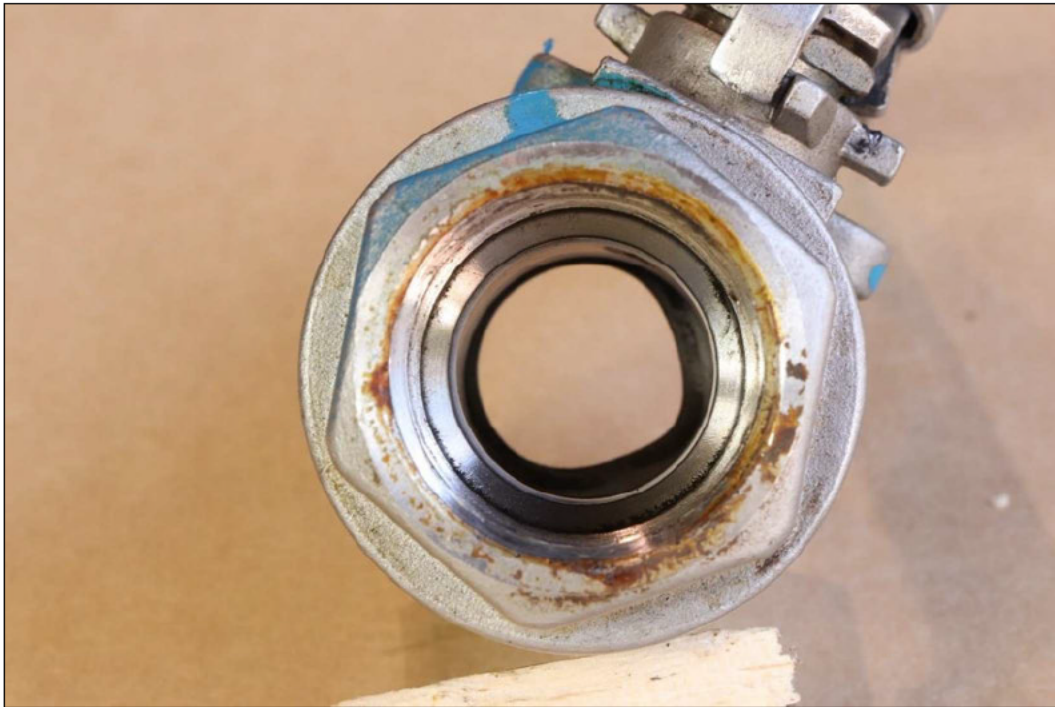
**Figure 10** Concentric seal on inlet seal.

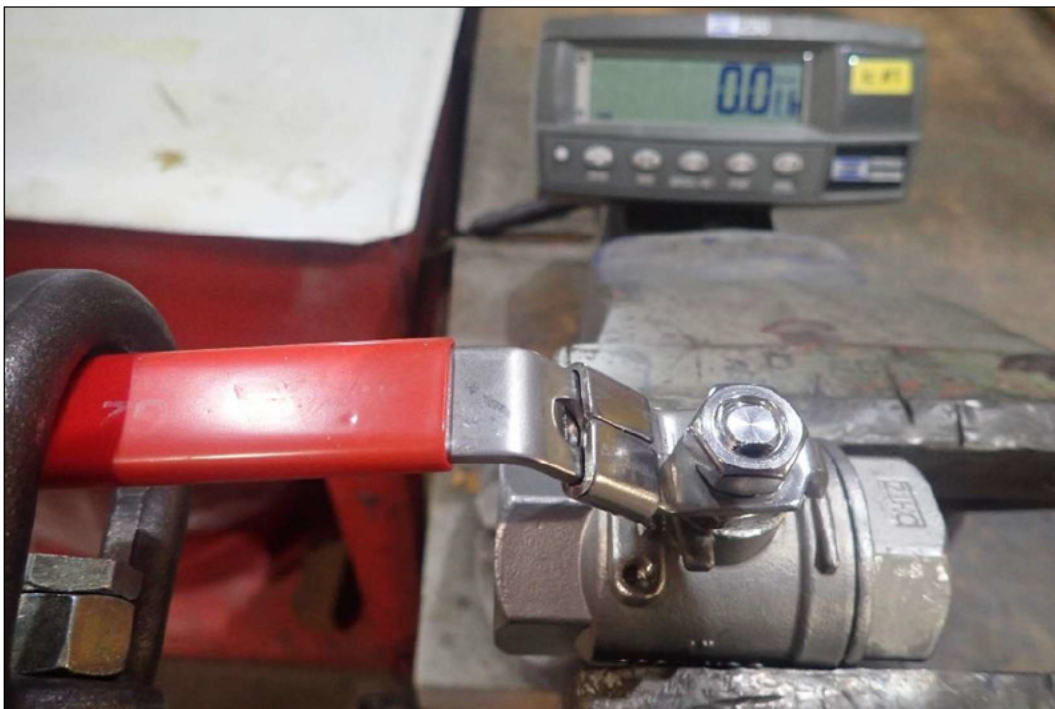
The loads required to close the subject valve under various loading conditions were measured using a load cell applied approximately 1" from the end of the lever (Figure 11). The lever was straightened to the parallel position (equal to a new valve) prior to the test. The tests produced the following results (video recorded in some instances and examined one frame at a time):

**Figure 11** Load measuring system used for determining operating loads on valve.

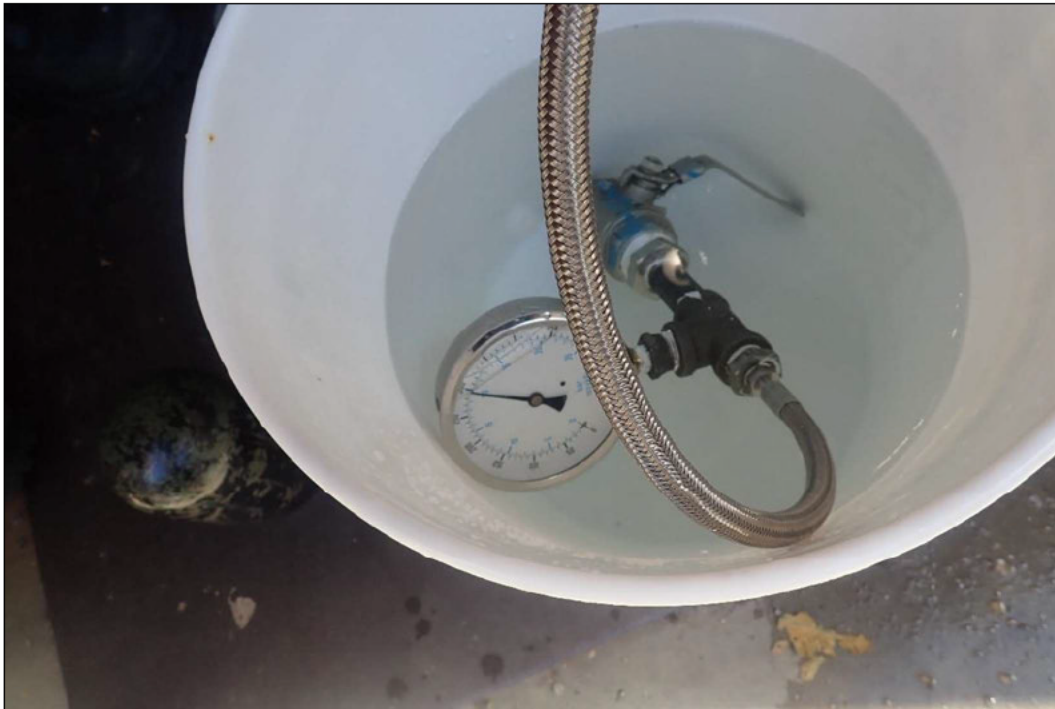
The valve was subjected to pressure tests using compressed nitrogen gas. The valve was connected to a calibrated 500 psi pressure gauge and tested in 50 psi increments up to 300 psi. A typical leak test is shown in Figure 12. The pressurized valve was placed in a bucket of water and examined for leaks at each pressure increment. No leaks were found with the valve at any pressures up to the maximum 300 psi.

**Figure 12** Typical leak test @ 200 psi.

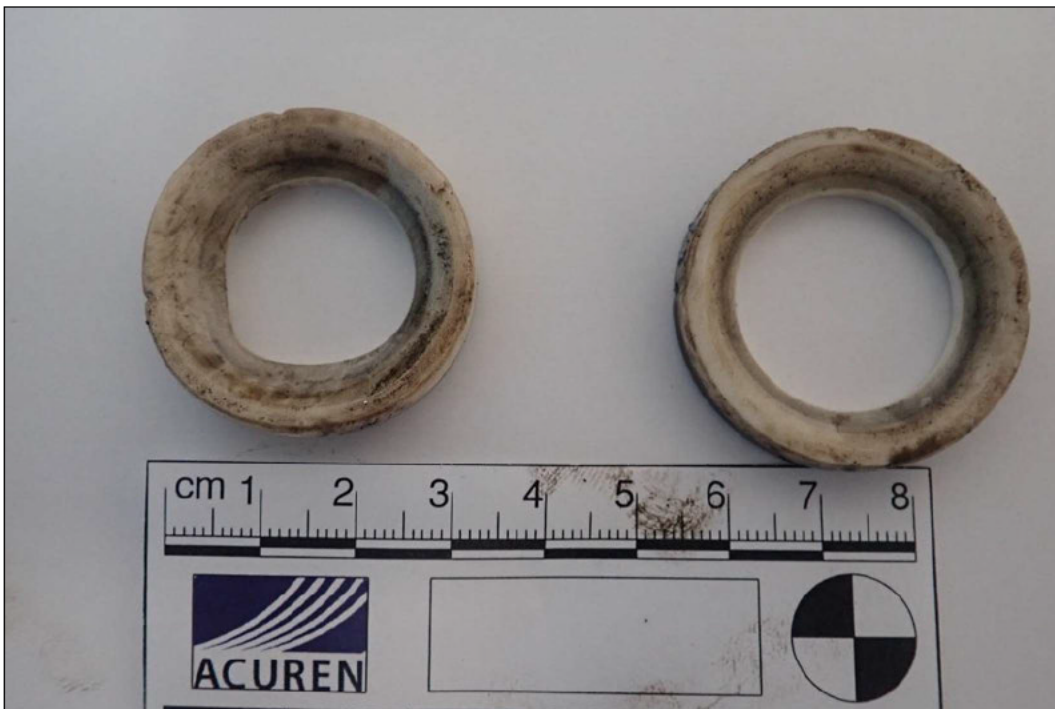
The seals from the outlet and inlet sides of the valve are shown in Figure 13. The exit seal (left side of photograph) is permanently deformed while the inlet side is concentric. Both seals contain considerable amounts of dirt and oil on the sealing surfaces.

**Figure 13** Seals removed from subject valve. Deformed outlet valve is on left.

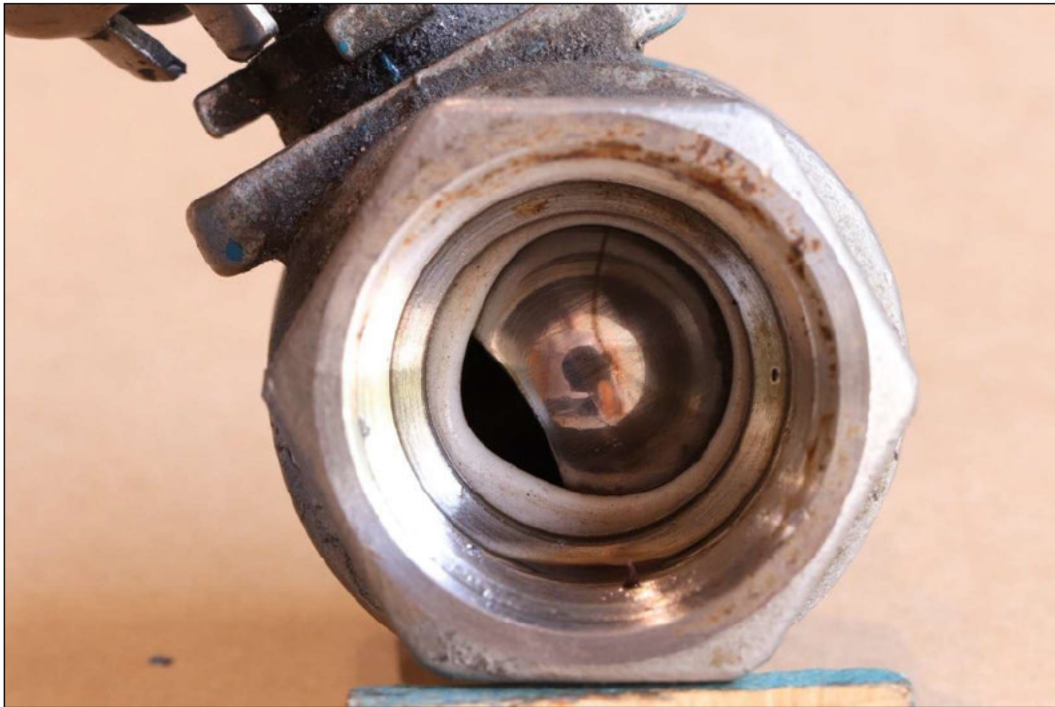
A close-up view of the deformed exit side seal is shown in Figure 14 with the ball and lever at the 45 ° position. The deformation on the seal is most pronounced at the partial ball opening position (arrow, Figure 14).

**Figure 14** Valve opening at 45° lever movement. Note maximum seal deformation is at location of partial opening.

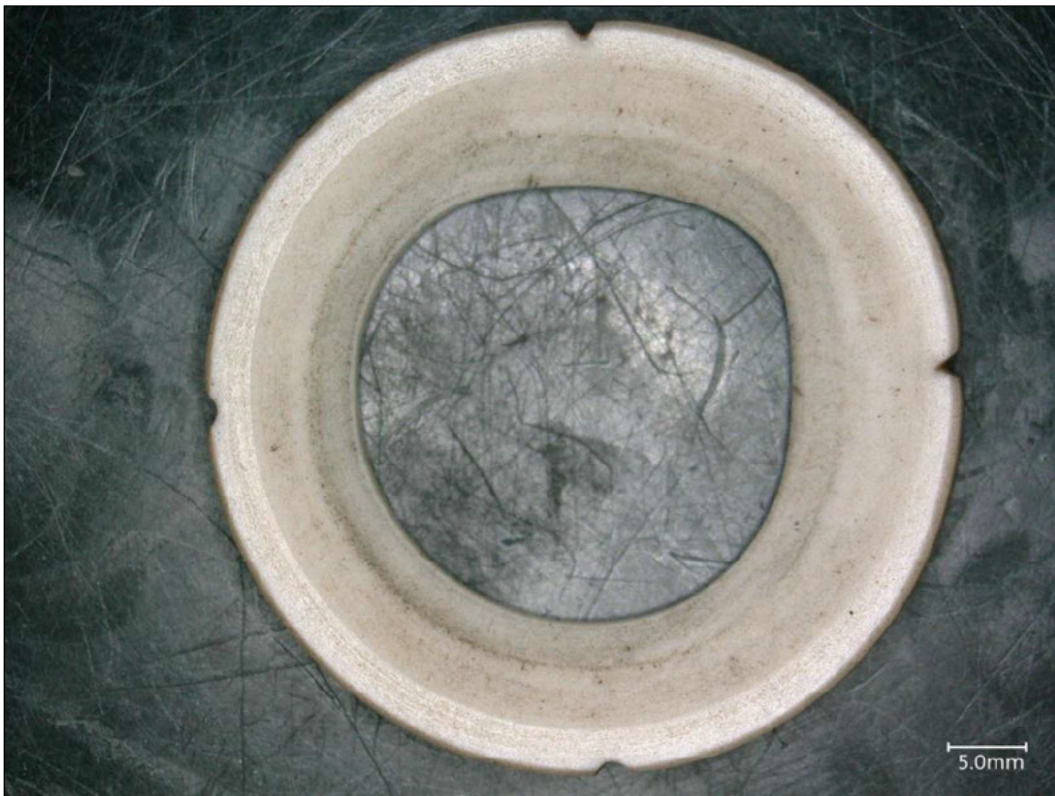
A Keyence microscope was used to examine the deformed seal at high magnification. Slight tearing is visible at the location shown with the arrow in Figure 15. A closer view of the tear is shown in Figure 16. The small inside edge tear has taken place at a point of high edge tensile stress adjacent to the most deformed part of the seal. This type of tearing would only occur under high strain rate loading conditions. Slow strain rate loading, such as that produced by long-term sustained loads, would likely extrude the seal material, but not cause tearing.

**Figure 15** Close-up view of cleaned outlet seal. Most severe deformation is at upper right. Small tear is at arrow.

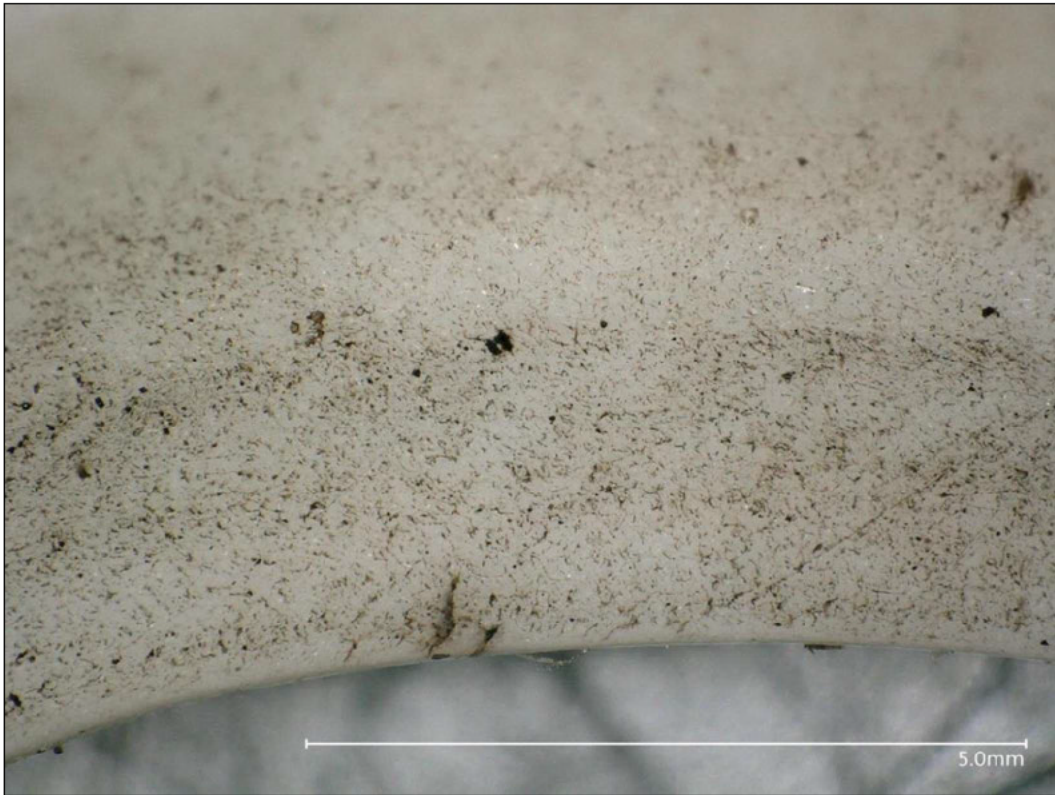
**Figure 16** Close-up view tear shown at arrow in Figure 15.

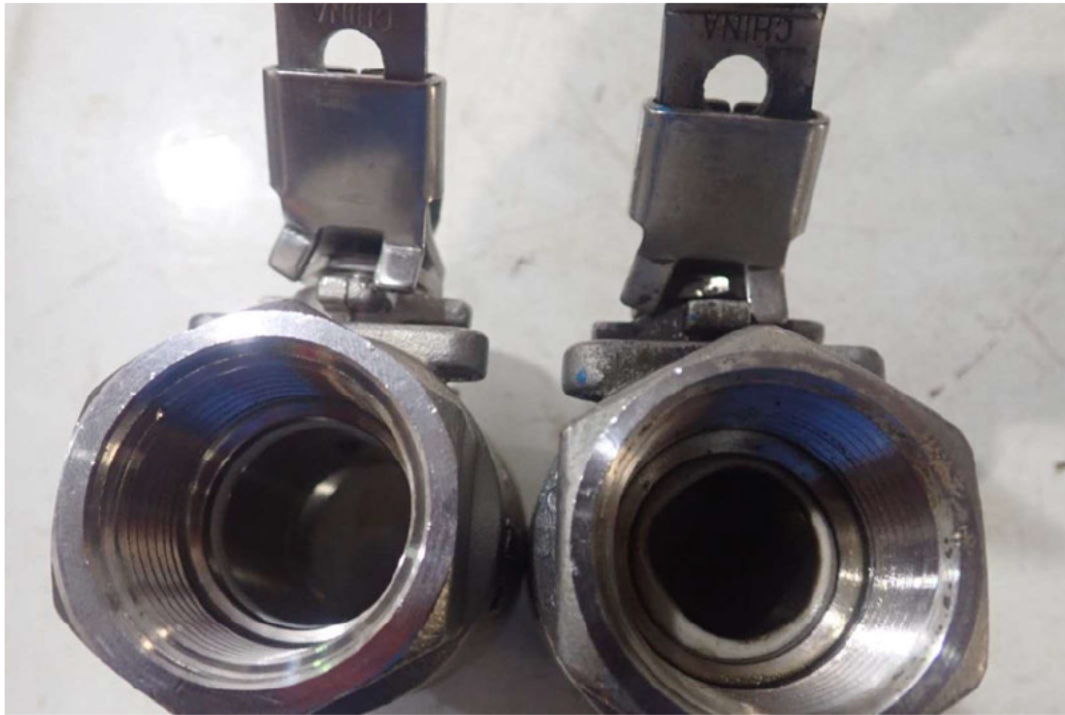
4. Simulation tests showed that locking tab damage identical to that found with the subject valve could be created by applying the full effort of a man to the lever (using one arm) with the lock in the "locked" position. The condition of the locking tab on the subject #1 valve (right side) and the #2 valve after simulating the locking tab damage mechanism is shown in Figure 17.

**Figure 17** Simulated overload of locking device on #2 valve (left side). Subject #1 valve shown on right for comparison.

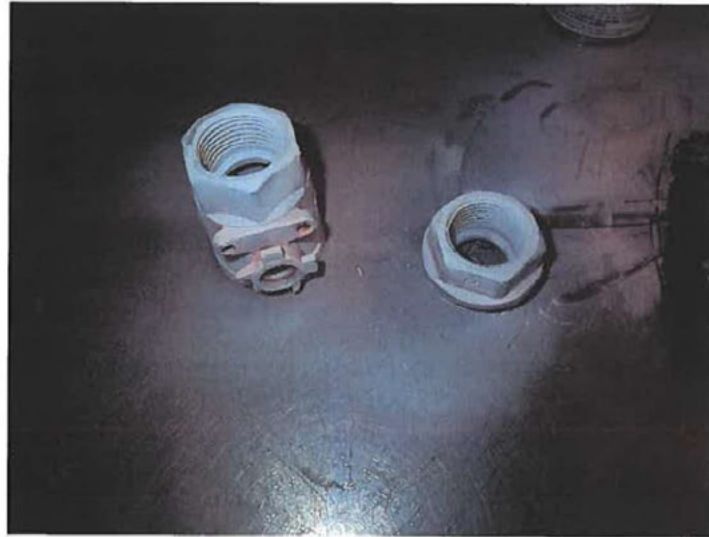
*Photo 1:*

An overview of the LPI results of the stainless-steel valve.

No indications were found.
