Incident Summary (Reference #5620327) (Final)

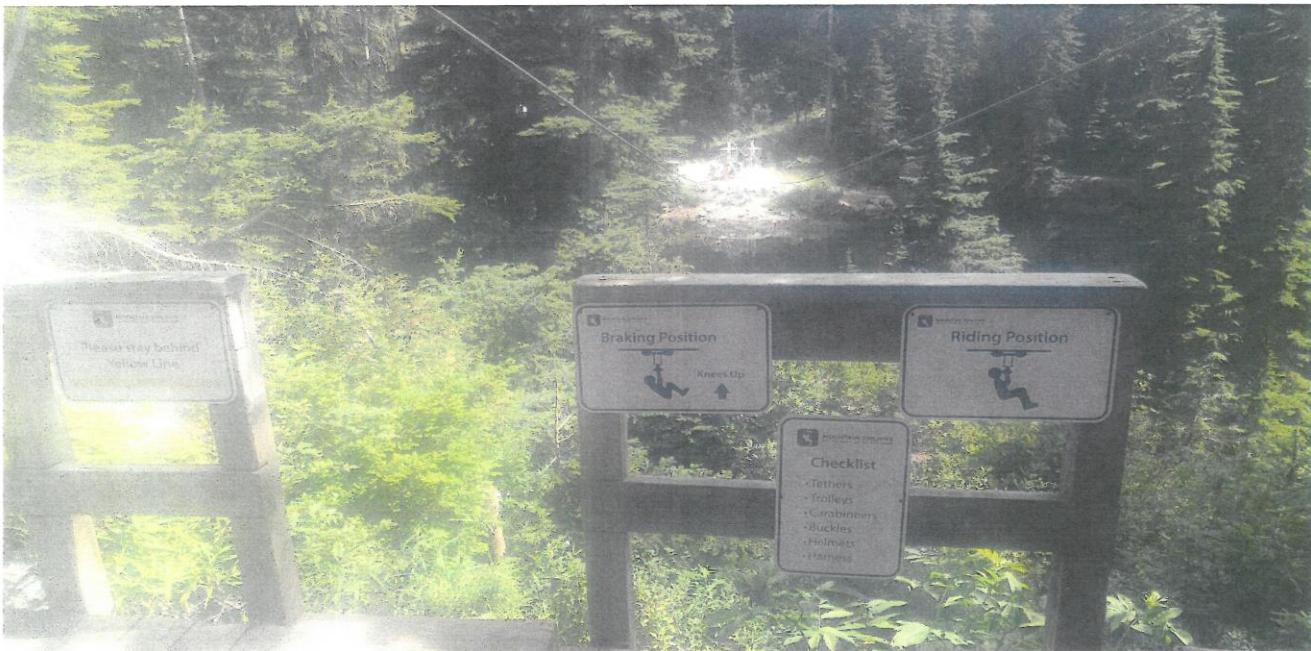
SUPPORTING INFORMATION	Incident Date	August 20, 2017	
	Location	District of North Vancouver	
	Regulated industry sector	Amusement devices, Zipline	
	Impact	Qty injuries	1
		Injury description	Tibia fracture
		Injury rating	Moderate
	Damage	Damage description	None
		Damage rating	NA
	Incident rating	Moderate	
Incident overview	Zipline rider collided with guide in the landing area.		
INVESTIGATION CONCLUSIONS	Site, system and components	<ul style="list-style-type: none"> • 2 parallel ziplines ropes approximately 90 m long. • Previous inspection records indicate an average rider speed of 10.9 m/s. • Brakes at landing consist of a configuration of helical springs with no trolley capturing mechanism and no spring recoil holding feature (part of the ride experience is that the rider's trolley engages the springs and then is recoiled back out of the landing area). • The riders are instructed by the zipline guides to assume a "braking position"(knees up both hands on the trolley handle) as they approach the landing area. Signage at the launch area illustrates this, "braking position".

Photo of Signage at Launch Area
