## Incident Summary #II-1534829-2023 (#34432) (FINAL)

SUPPORTING INFORMATION	Incident Date	April 13, 2023	
	Location	Castlegar	
	Regulated industry sector	Gas - Natural gas system	
	Impact	Qty injuries	1
		Injury description	The owner experienced smoke inhalation while extinguishing the fire.
	Damage	Injury rating	Minor
		Damage description	Fire caused high heat and melting damage to internal wiring, circuit boards and other internal components inside an on-demand water heater. Fire melted the attached venting and combustion air piping attached to the appliance and caused smoke damage to the mechanical room.
		Damage rating	Moderate
	Incident rating	Moderate	
Incident overview	A three-year-old natural gas on-demand water heater used to supply domestic hot water in a residential home had been experiencing operational issues. After service by an apprentice technician, a fire occurred inside the appliance causing damage to internal components and the attached venting and combustion air piping.

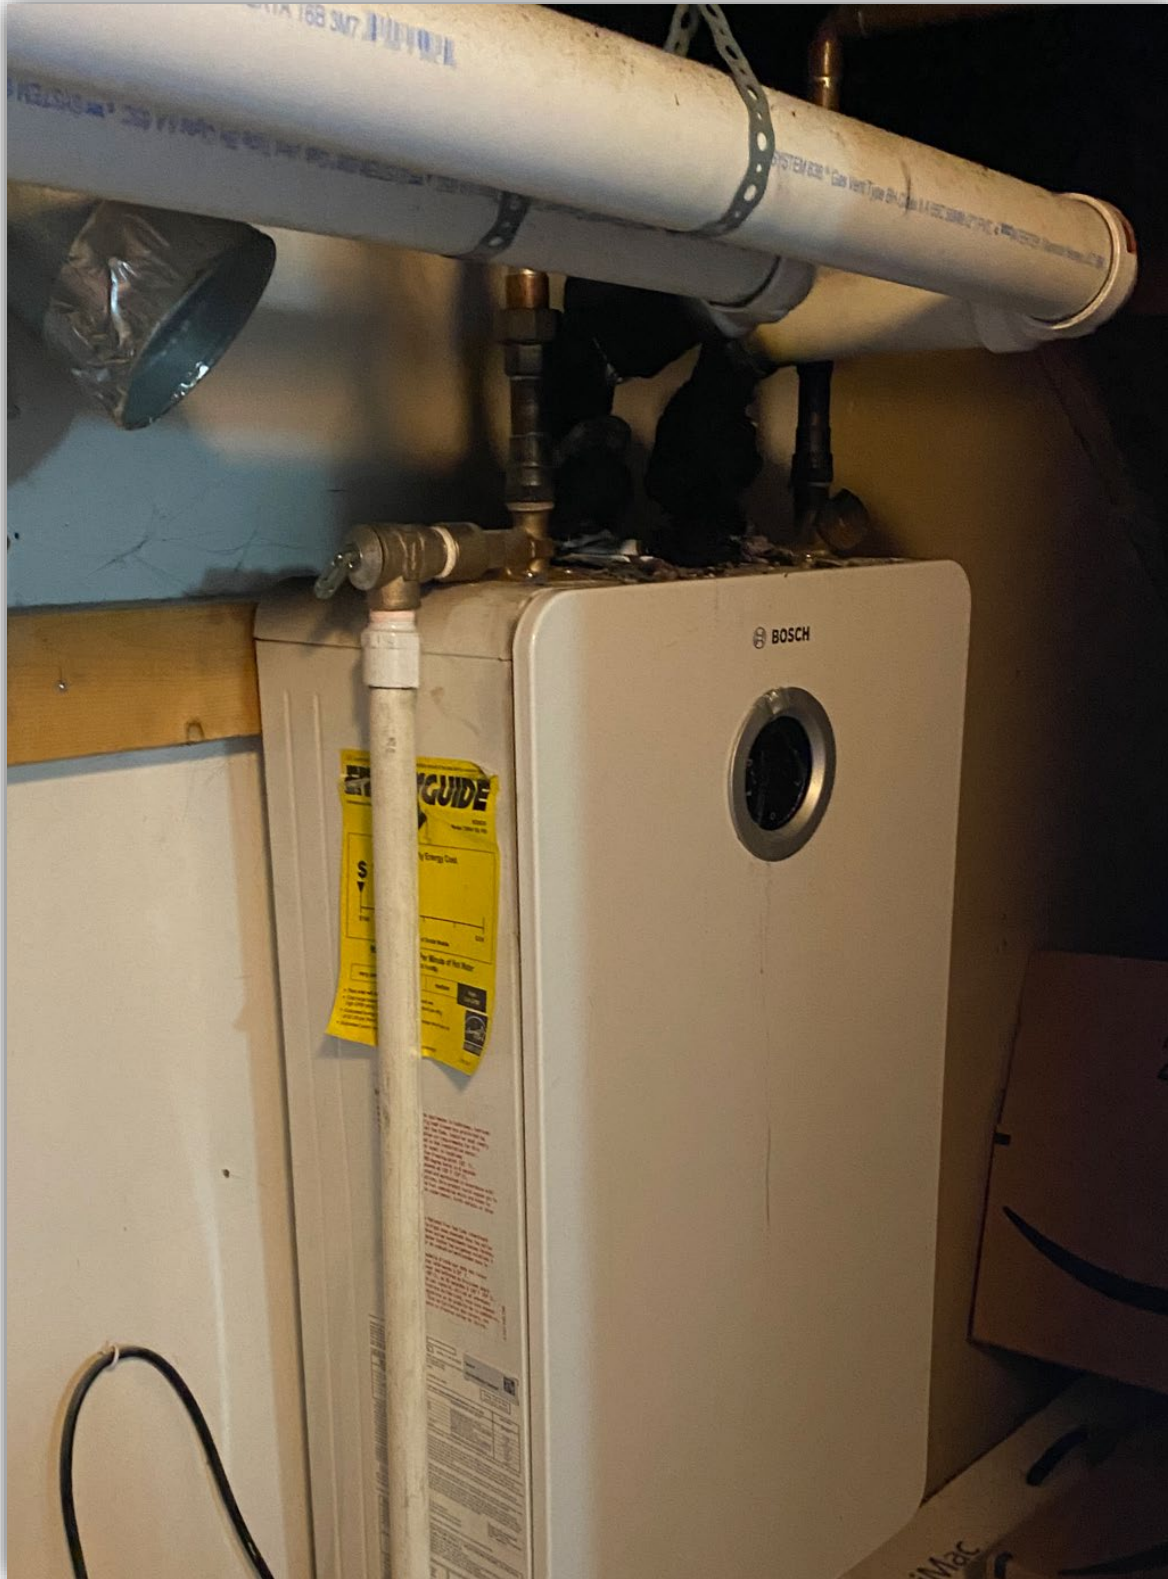
Image 1 – On-demand water heater installed in the mechanical room.

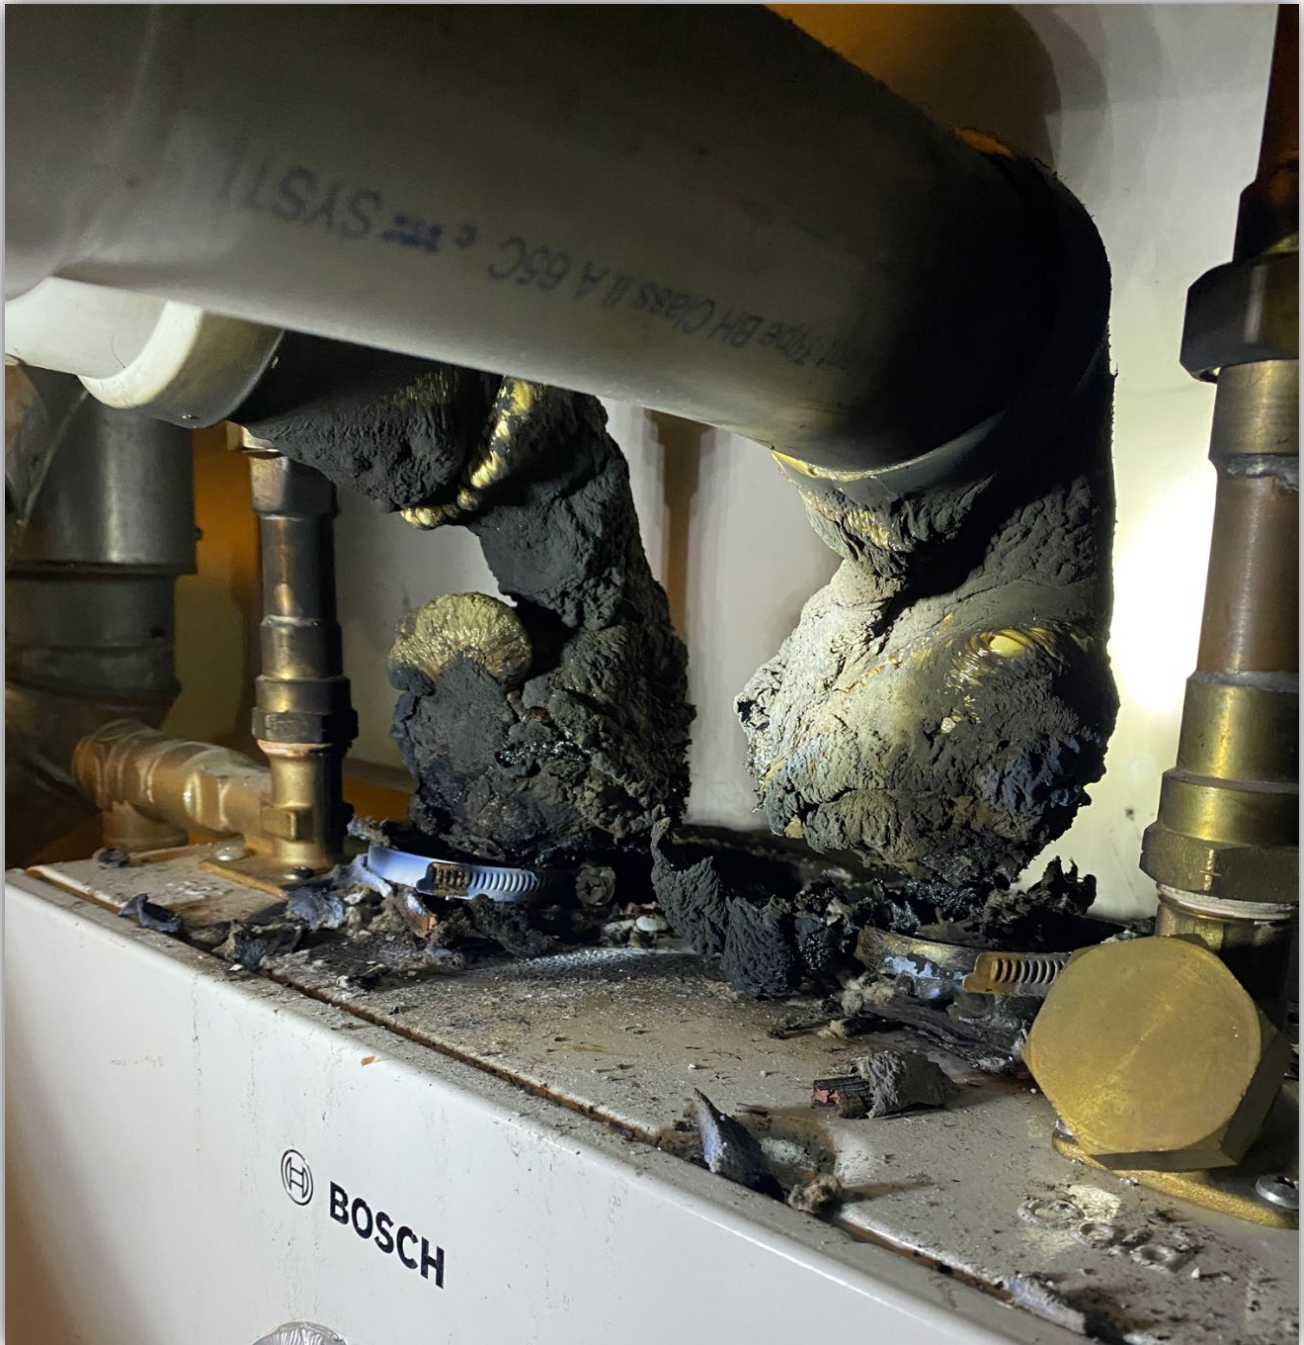
- Significant fire damage was observed to the connected PVC venting and combustion air piping which were melted to the point they were mostly detached from the appliance.
- The water heaters internal wiring and control board was damaged and melted by the fire.

Image 2 – Fire damaged venting and combustion air PVC piping.

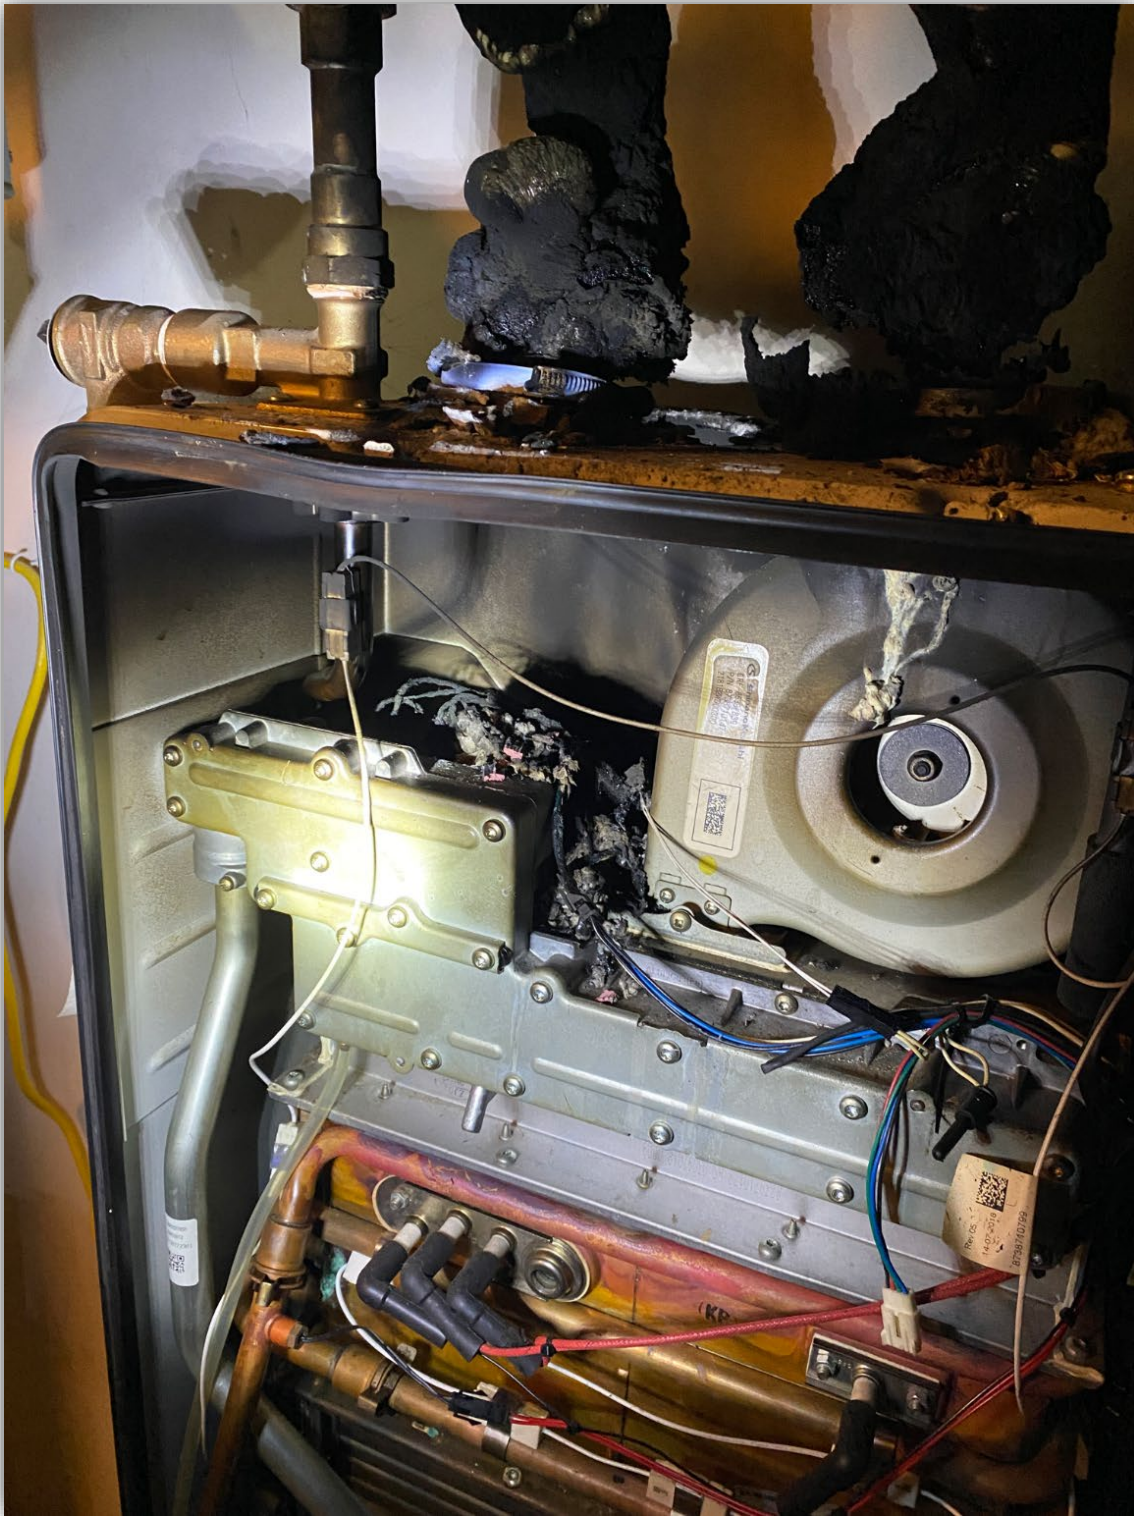
Image 3 – Heat and fire damaged internal components inside the water heater.

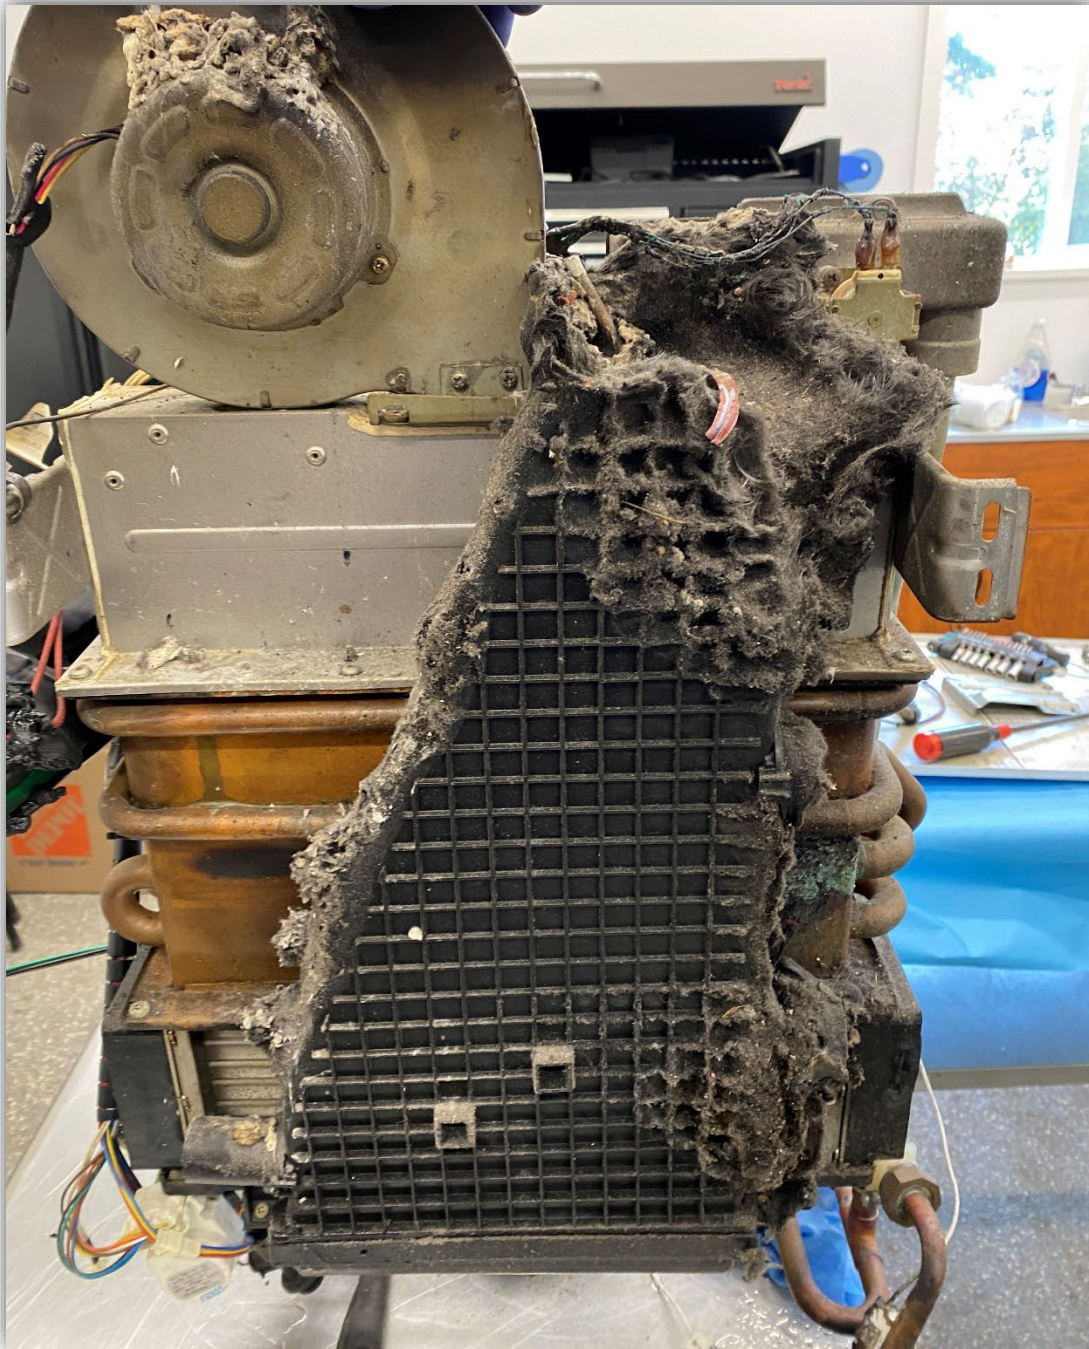
- The flue gas collector duct is made of a fibrous composite material that was damaged and deteriorated originating from the area the hot combustion products would have exited the hole in the combustion chamber.

Image 4 – Damaged composite flue gas collector duct at rear of appliance after removal from appliance case.

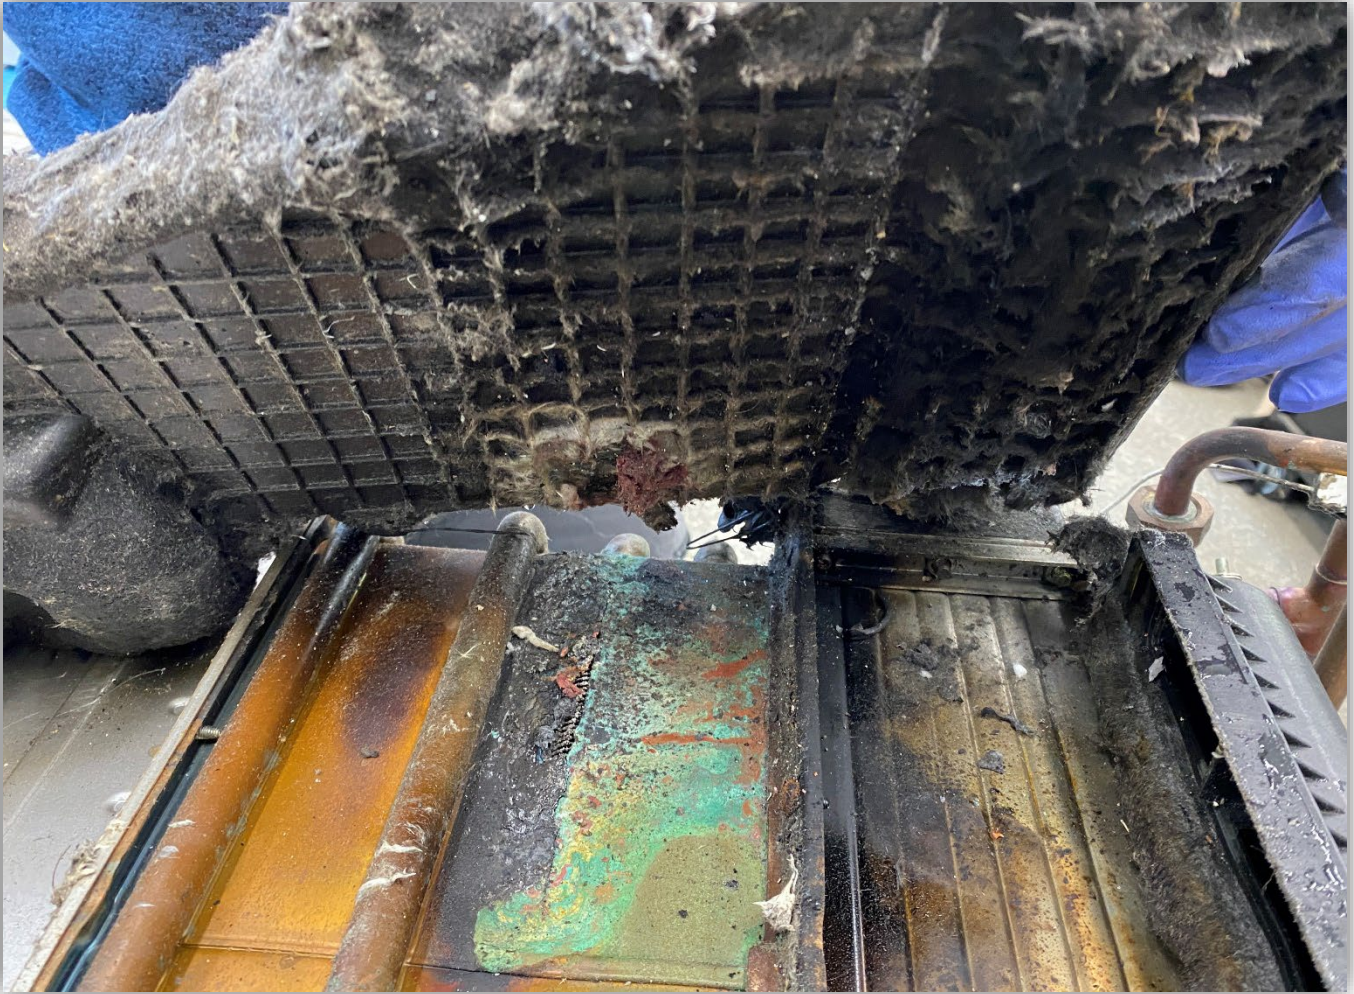
- In the area of the restriction there was a hole in the back of the combustion chamber that was not evident from the front of the appliance.
- The area of the hole was covered by the appliance flue gas collector duct which conveys the flue gasses from the bottom of the appliance after the heat exchangers, to the flue gas connection outlet at the top of the appliance.

Image 5 – Damaged flue gas collector duct and rear of combustion chamber.

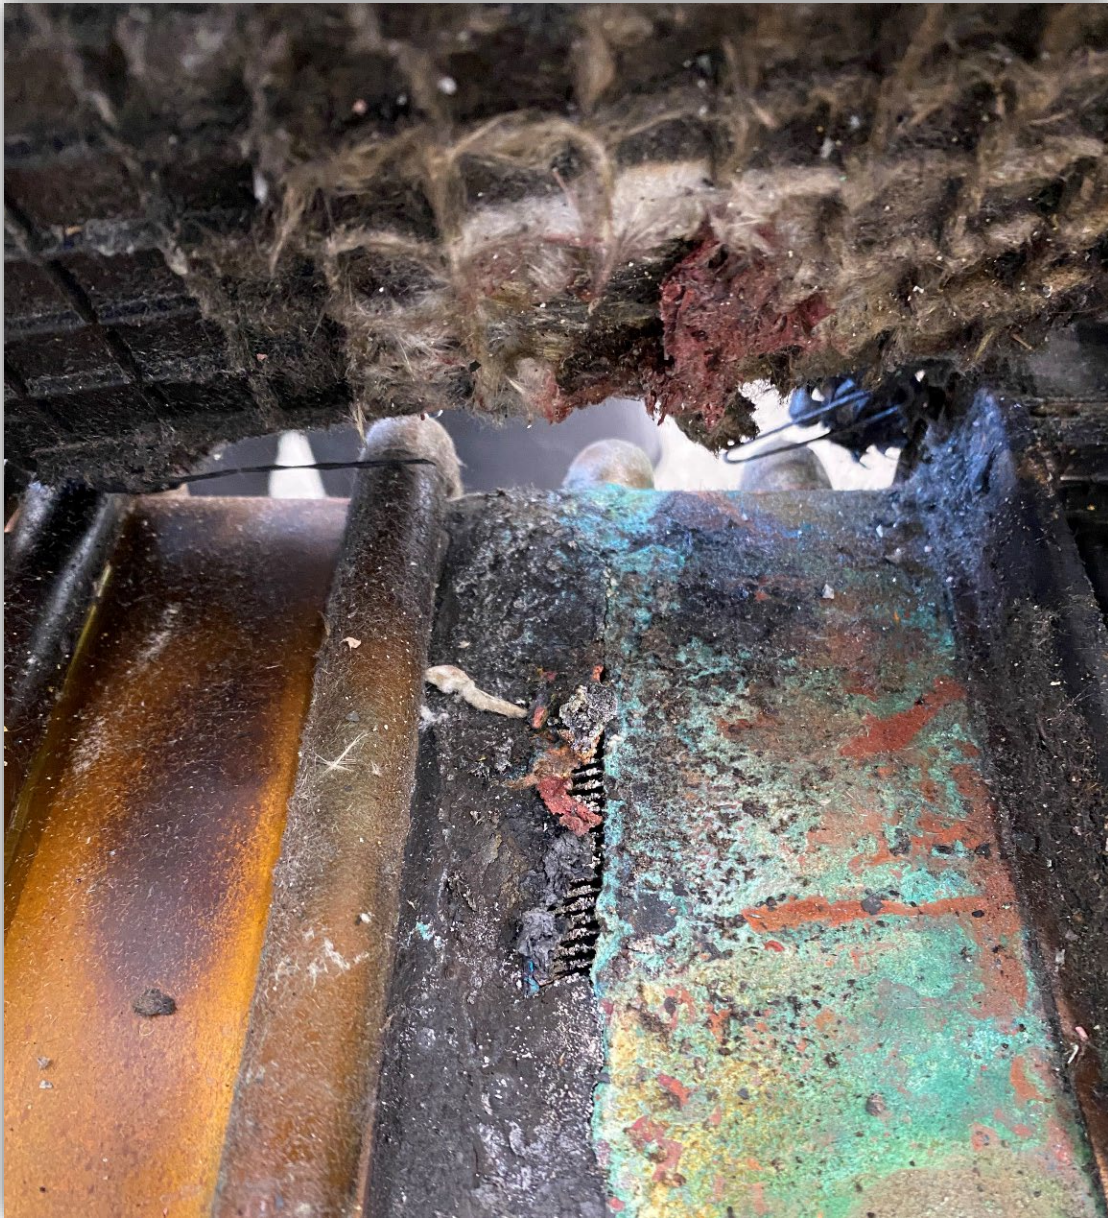
The restriction of the heat exchanger passages from a possible internal water leak caused overheating, corrosion, and created a hole in the back of the appliance's combustion chamber. The hole allowed high temperature combustion products to escape the combustion chamber which in turn resulted in the internal damage and fire.

Image 6 – Closeup of damage and hole in the combustion chamber.

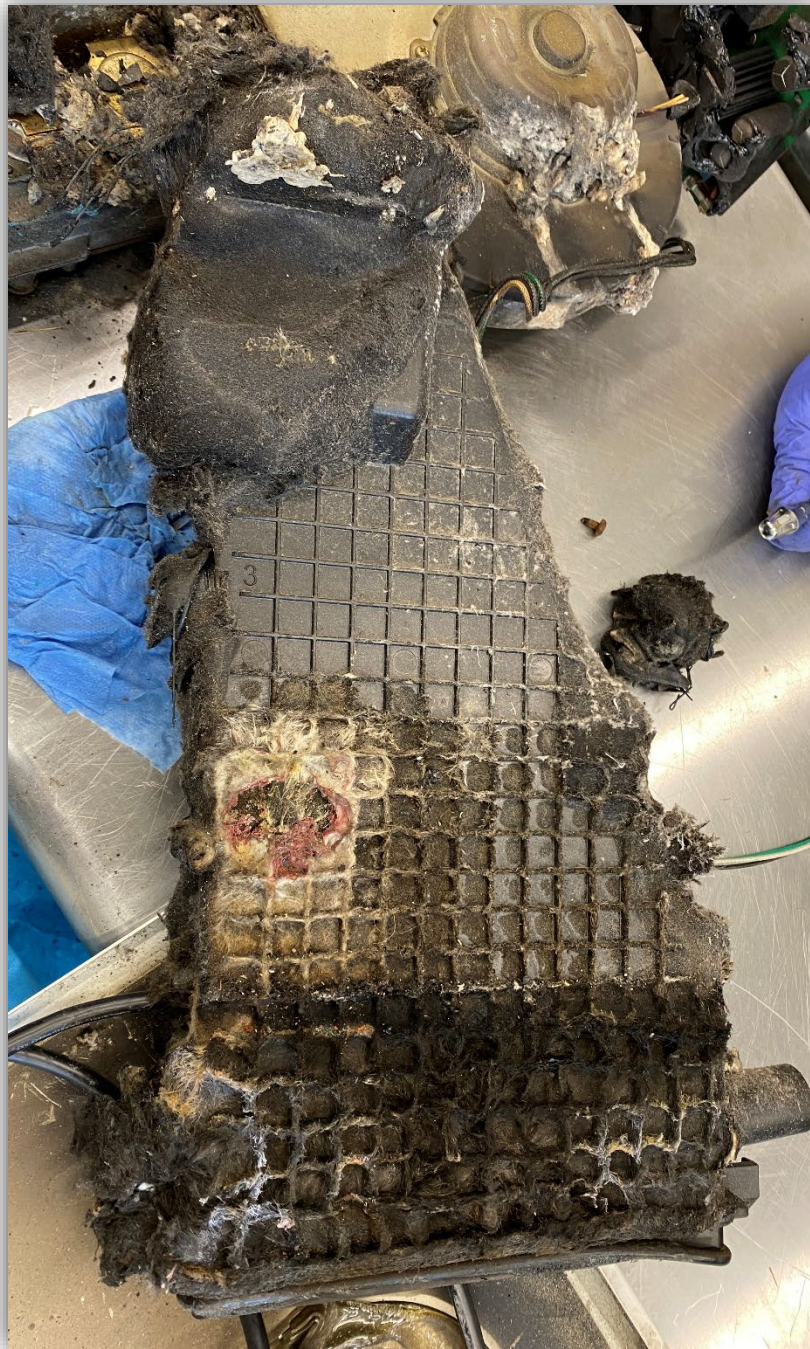
Image 7 – Damaged composite flue gas collector duct.

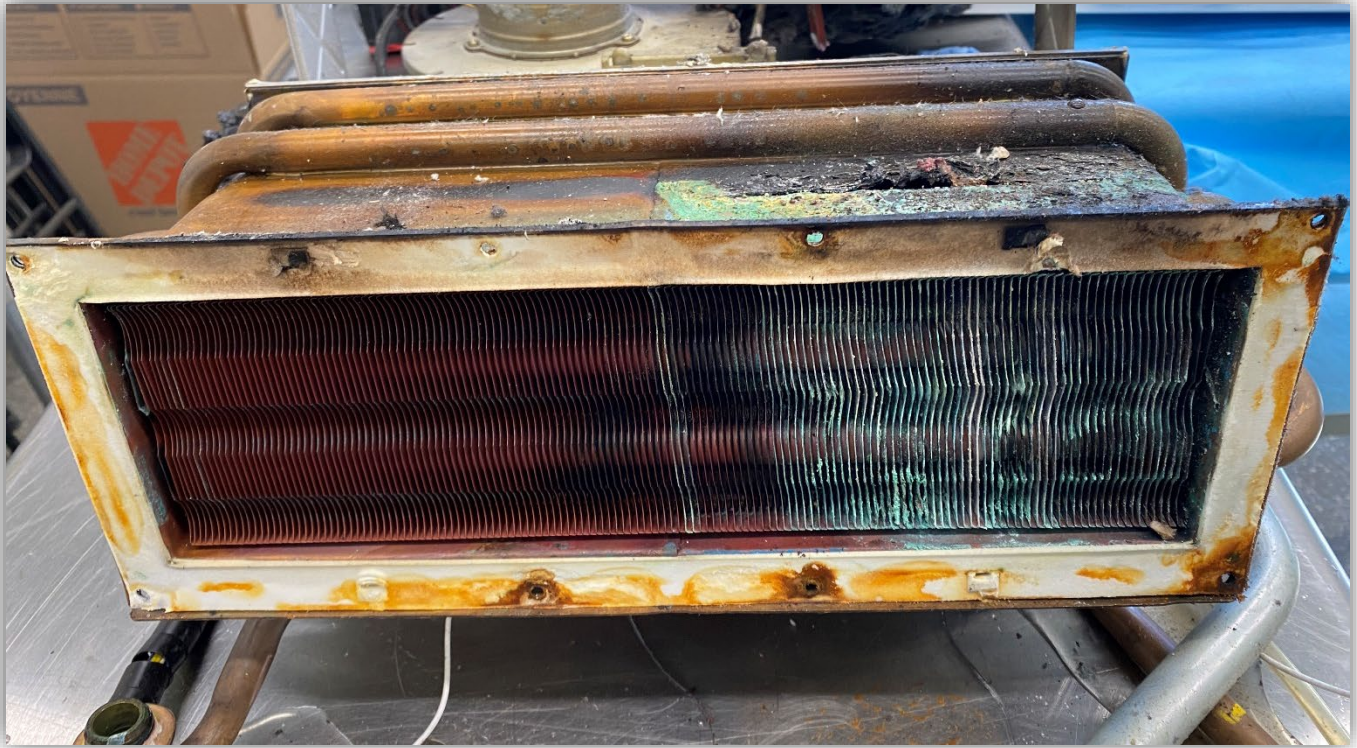
Image 8 – Combustion chamber with primary heat exchanger finned tubing.

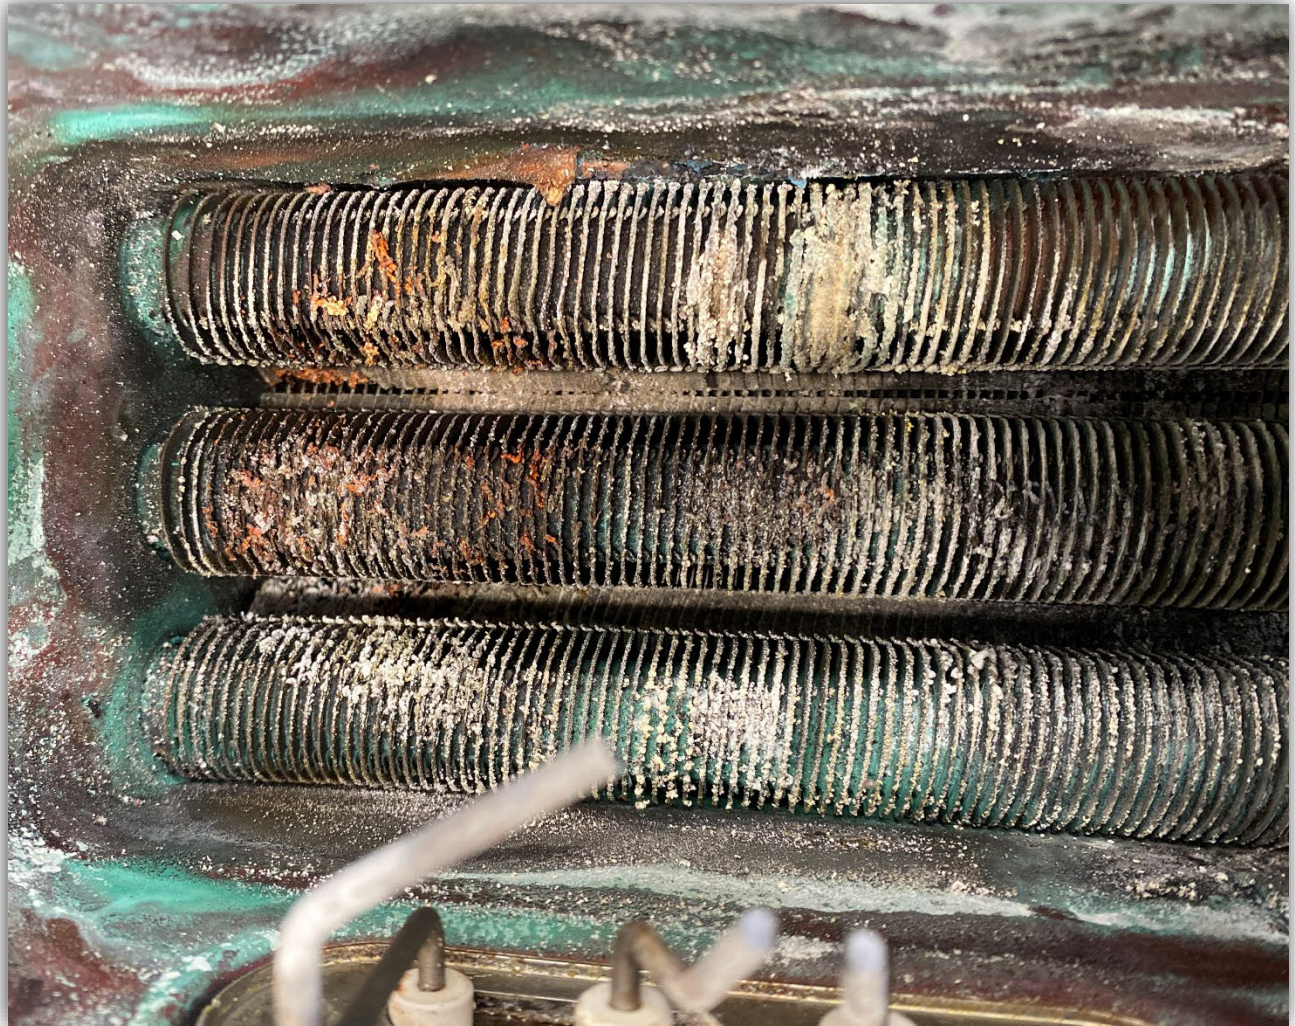
- The appliance was taken to a facility to be disassembled and examined by investigators.
- The primary heat exchange showed signs of corrosion and scale buildup on the tube fins which would restrict the flow of flue gasses through them.

- The corrosion on the heat exchanger fins and combustion chamber suggest water may have been present inside the combustion chamber from a possible leak from one of the heat exchanger tubes.

Image 9 – Corrosion and scale buildup on the internal primary heat exchanger tube fins restricting flue gas flow.

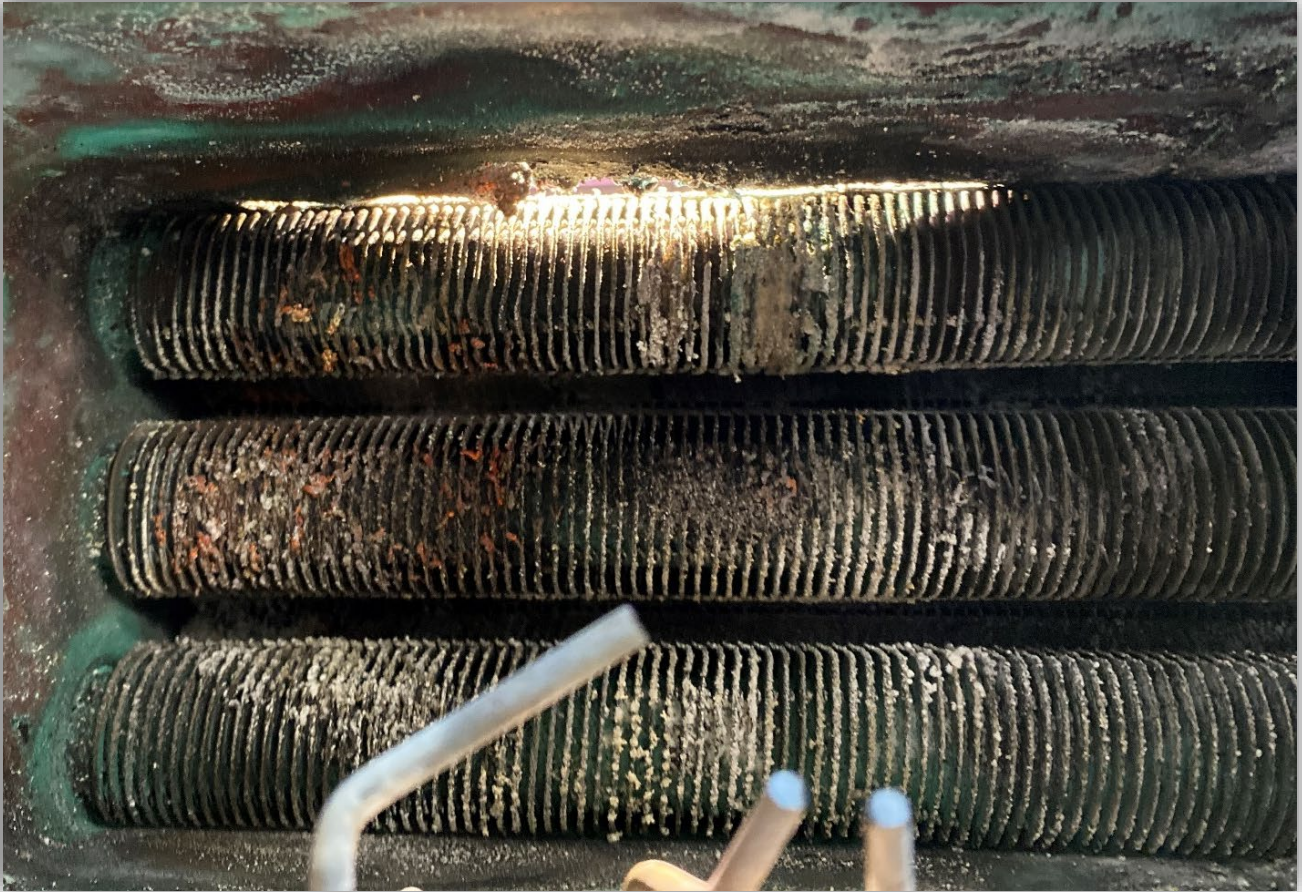
Image 10 – Primary heat exchange tubes with light shining through the hole in the combustion chamber.
