Incident Summary #II-1656307-2024 (#42977) (FINAL)

SUPPORTING INFORMATION	Incident Date	December 28, 2023	
	Location	Chilliwack	
	Regulated industry sector	Electrical - Low voltage electrical system (30V to 750V)	
	Impact	Qty injuries	0
		Injury description	N/A
	Damage	Injury rating	None
		Damage description	A four-inch wood screw penetrated the armoured jacket of a four-conductor Armoured Conductor Wet Underground (ACWU) unfused service cable installed in the exterior wall. The screw drilled through an aluminum ungrounded conductor and the neutral conductor creating a short circuit condition.
		Damage rating	Moderate
Incident rating	Moderate		
Incident overview	Unaware of the location of the unfused ACWU service cable in the exterior wall where it rose up from the concrete slab and into the electrical combination panel, the homeowner installed shelving in the attached car garage using four-inch wood screws to secure wood wall brackets at the bottom of the wall where baseboard trim was installed. One of the screws penetrated the armoured jacket of the unfused service cable causing the described damage. The armoured cable was not protected from mechanical damage immediately behind

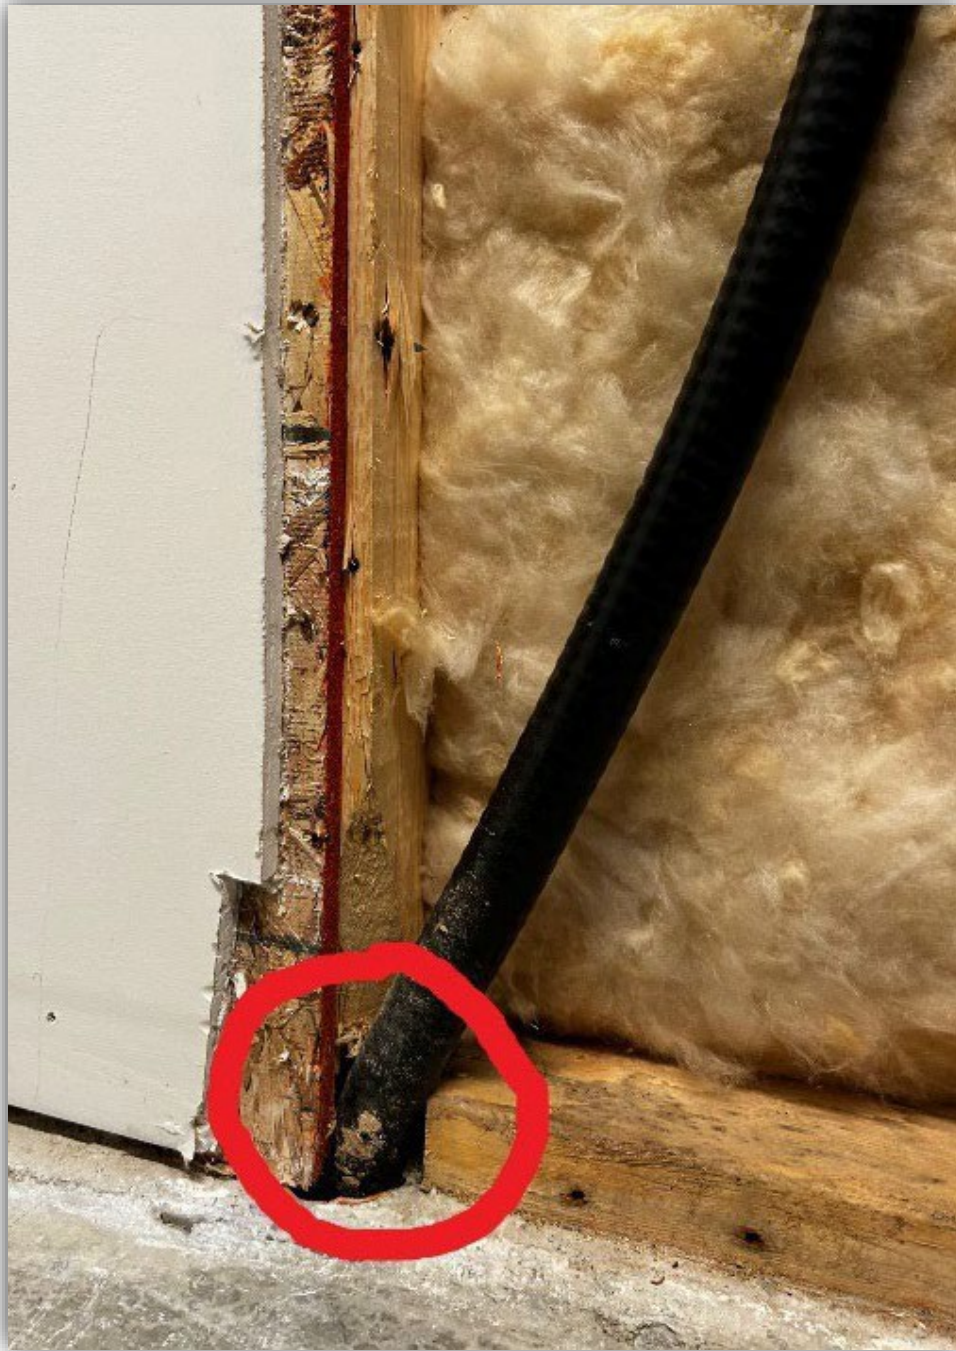
It is certain that the location where the wood screw penetrated the ACWU cable would have been prevented had supplemental mechanical protection been installed as per 2021 Canadian Electrical Code rules.

Image 1 - Location where wood screw penetrated the ACWU cable.

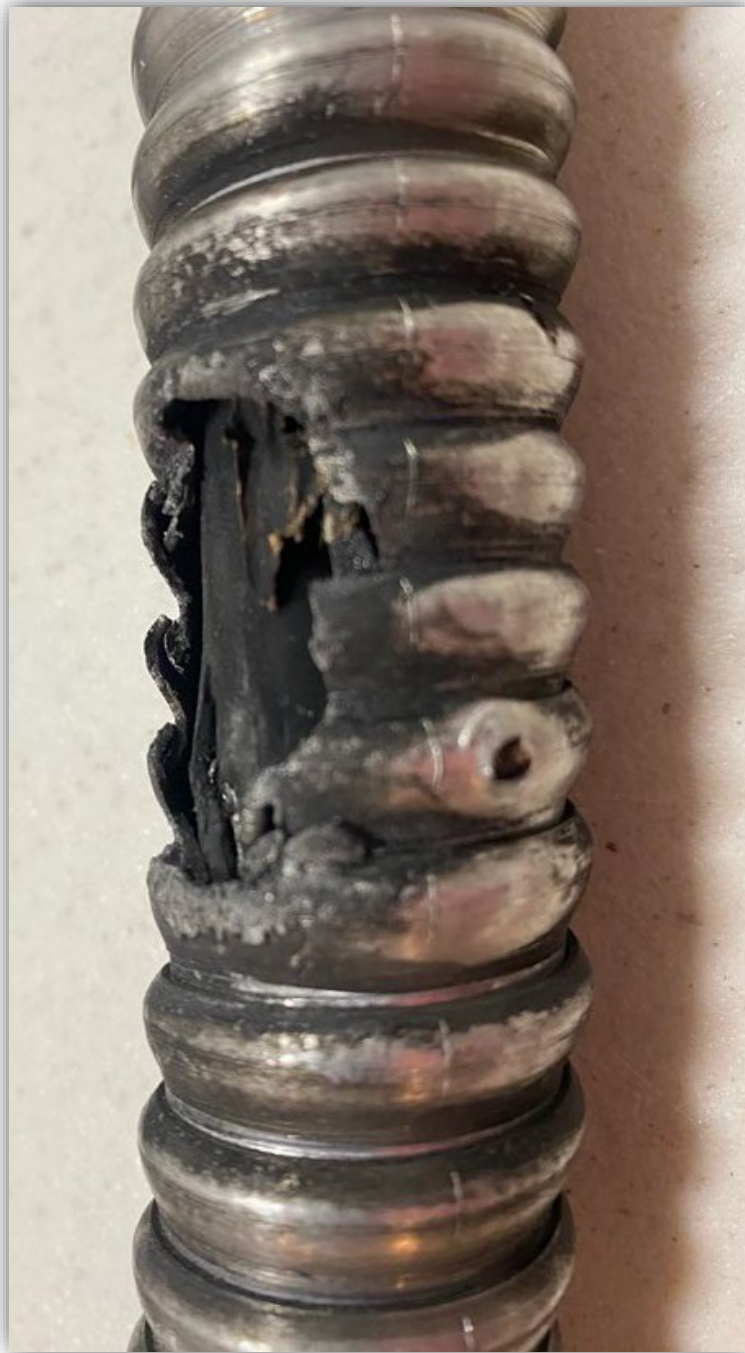
Image 2- Rubber outer jacket of cable removed showing entry point of wood screw and area where armoured jacket melted due to the generated heat from the short circuit.

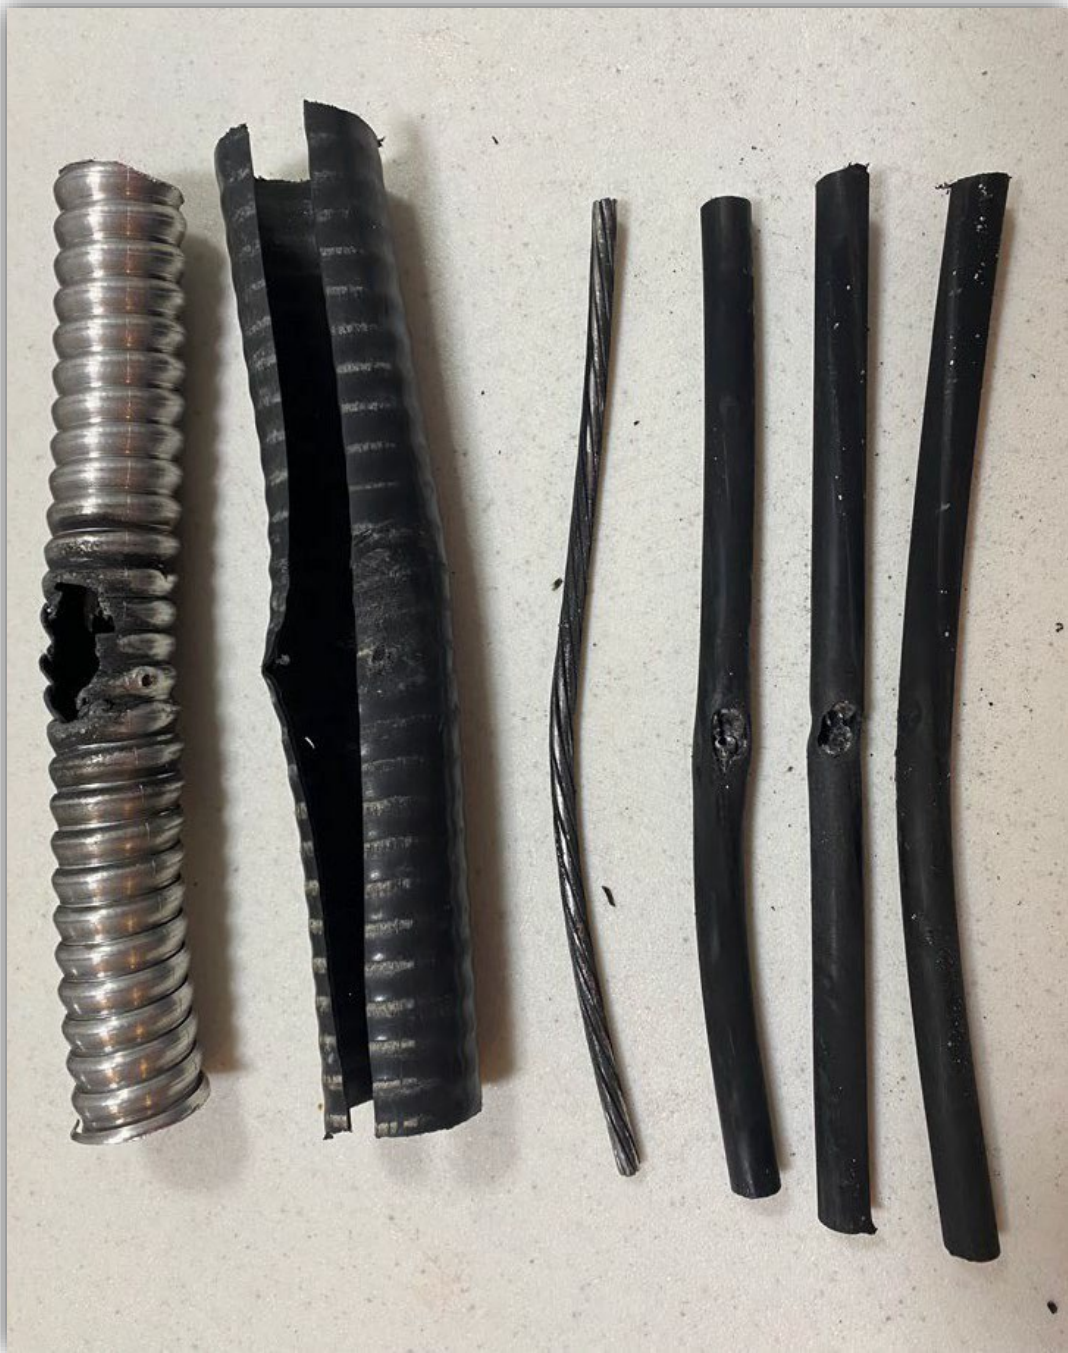
Facts and evidence	A 300mm portion of the damaged ACWU service cable where the screw pierced the armoured jacket was provided by the homeowner for examination confirming the path of the screw as it entered the cable and the subsequent damage caused. Provided images around the time of the incident verify that supplemental mechanical protection was not installed at the required location immediately behind the baseboard where the cable was installed.

Image 3 - All components of the 300mm section of damaged ACWU cable.

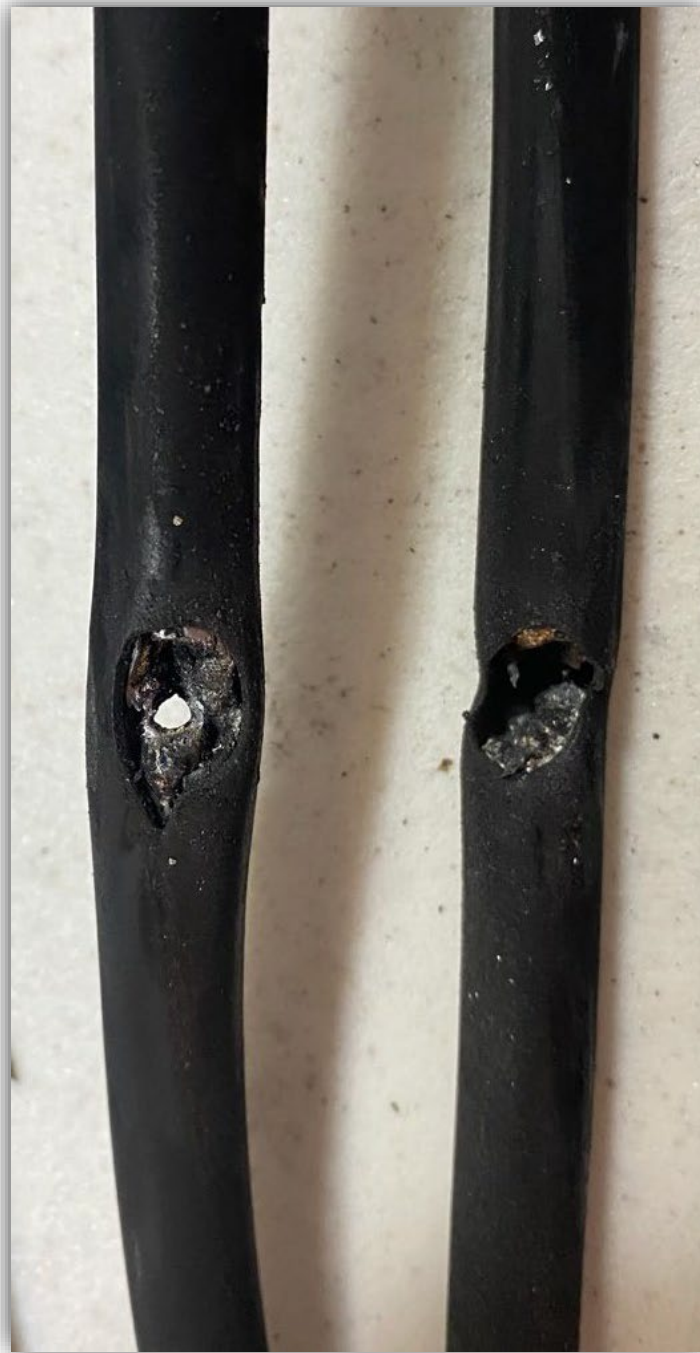
Image 4 - Close up of the ungrounded service conductor on the left showing where the wood screw penetrated through the internal aluminum conductors and the neutral conductor on the right which the tip of the wood screw penetrated and where most of the internal aluminum conductors melted due to the generated heat while not entirely severing the neutral conductor.
