Incident Summary #II-1066582-2020 (#19230) (FINAL)

SUPPORTING INFORMATION	Incident Date	September 14, 2020	
	Location	Squamish	
	Regulated industry sector	Passenger ropeways - Above surface ropeway	
	Injury	Qty injuries	0
		Injury description	NA
		Injury rating	None
	Impact Damage	Damage description	The haul rope of a gondola was damaged and separated resulting in multiple cabins, which were suspended from the rope, to fall to the ground from various heights. Many of the cabins were damaged beyond repair. As the separated ends of the haul rope retracted it caused damage to towers, guard rails, security system and surrounding trees
		Damage rating	Major
		Incident rating	Major
Incident overview	In the early morning, security personnel stationed at the Sea to Sky Gondola witnessed movement of the gondola cabins attached to the haul rope. A short time later the main haul rope separated allowing a majority of the cabins which were suspended on the rope to fall to the ground.

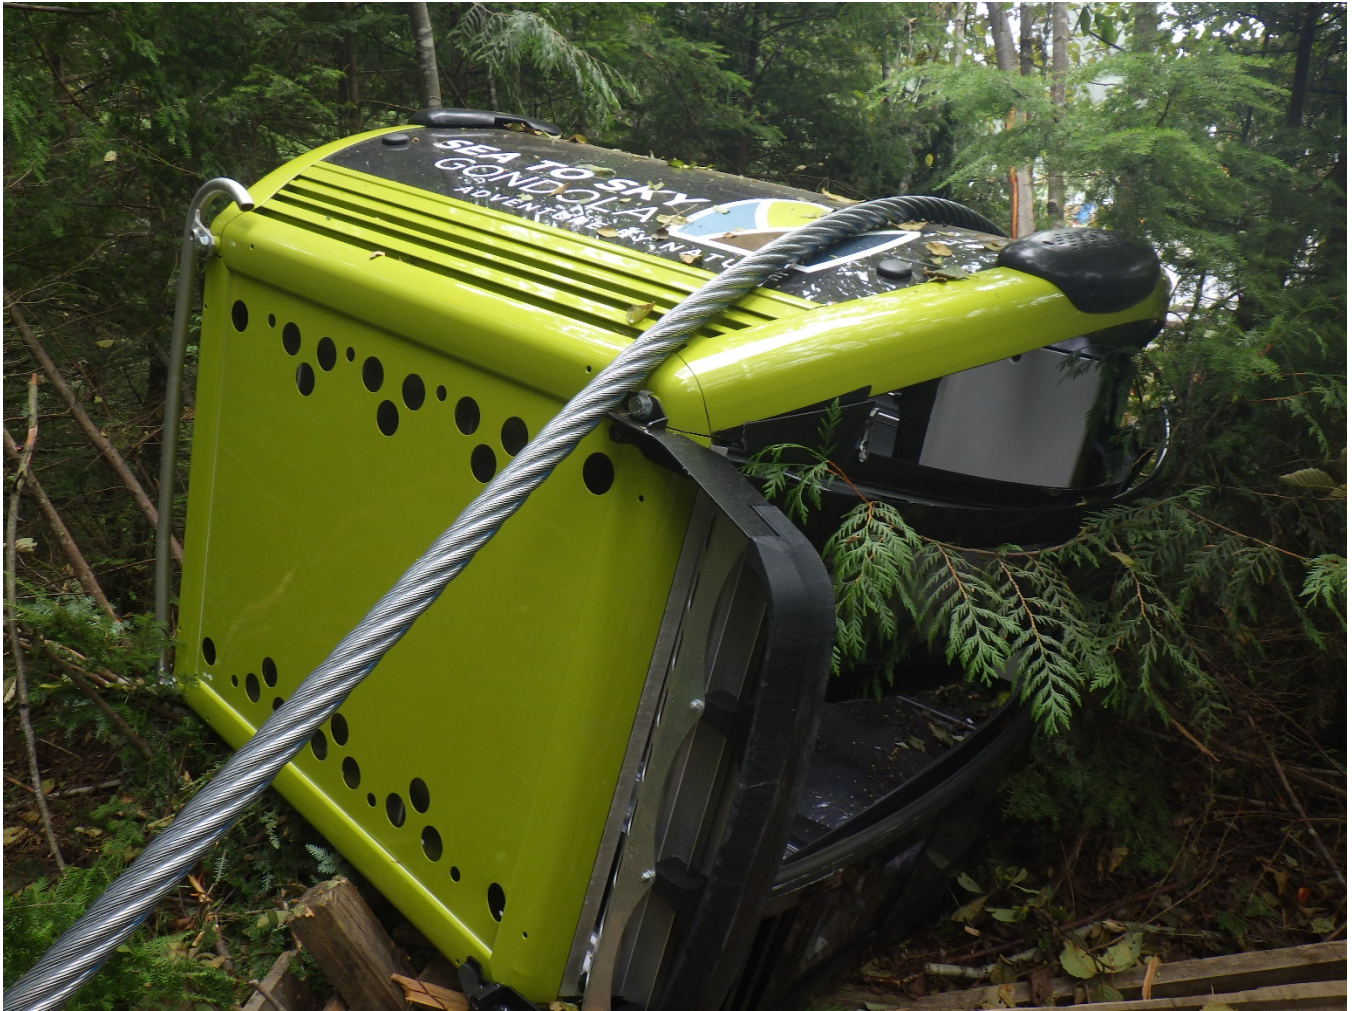
Image 4 – Damaged gondola cabin in the woods with the haul rope laying on top

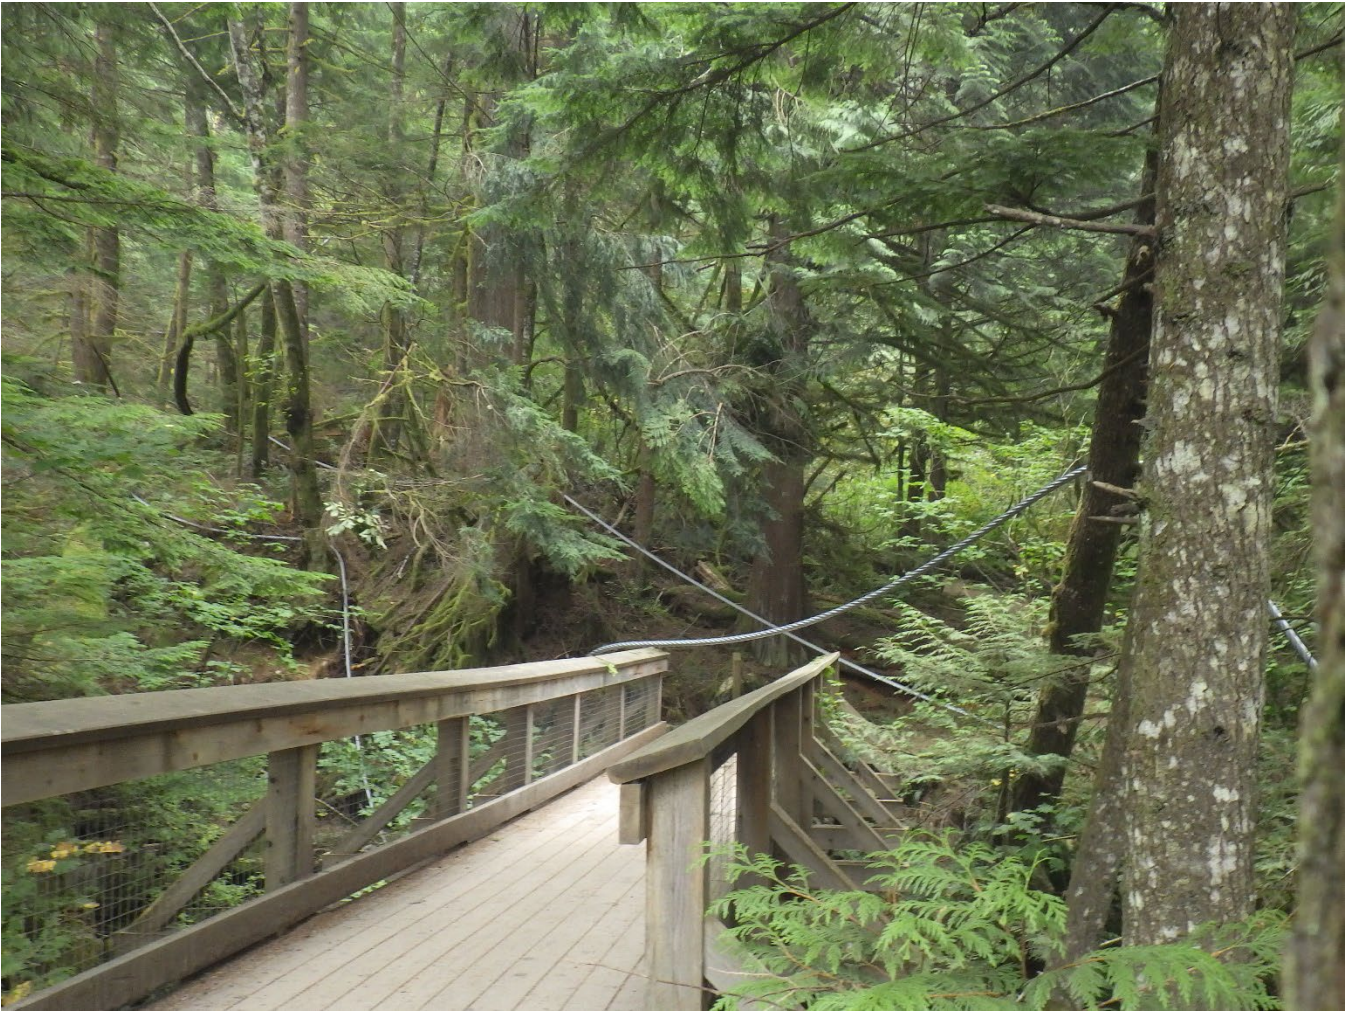
Image 5 – Fallen haul rope lying across public trail

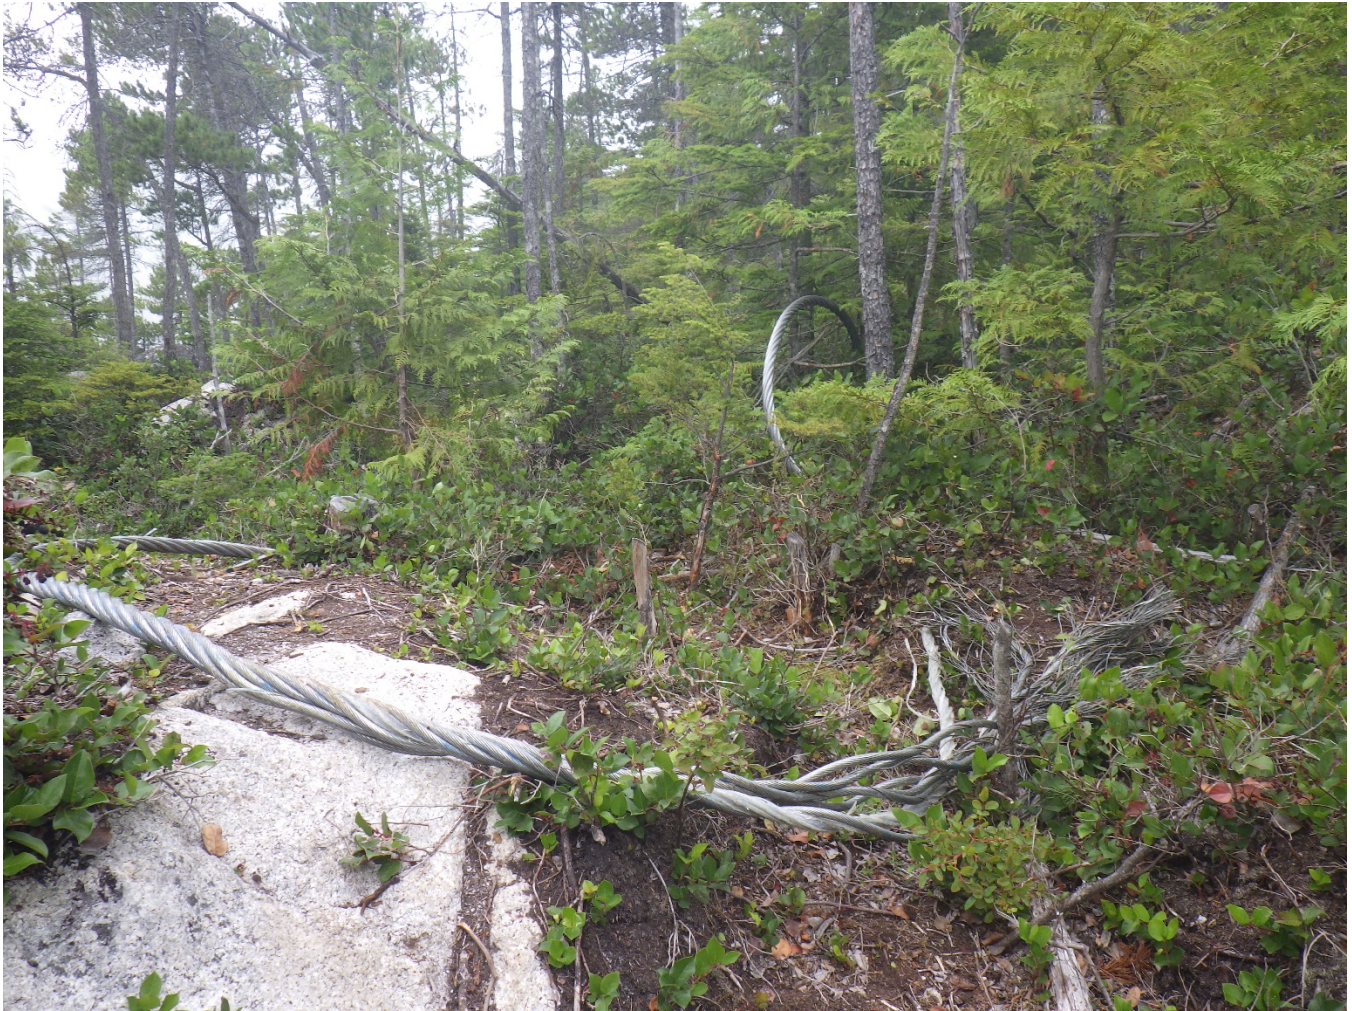
Image 7 – Upper end of cut haul rope as found

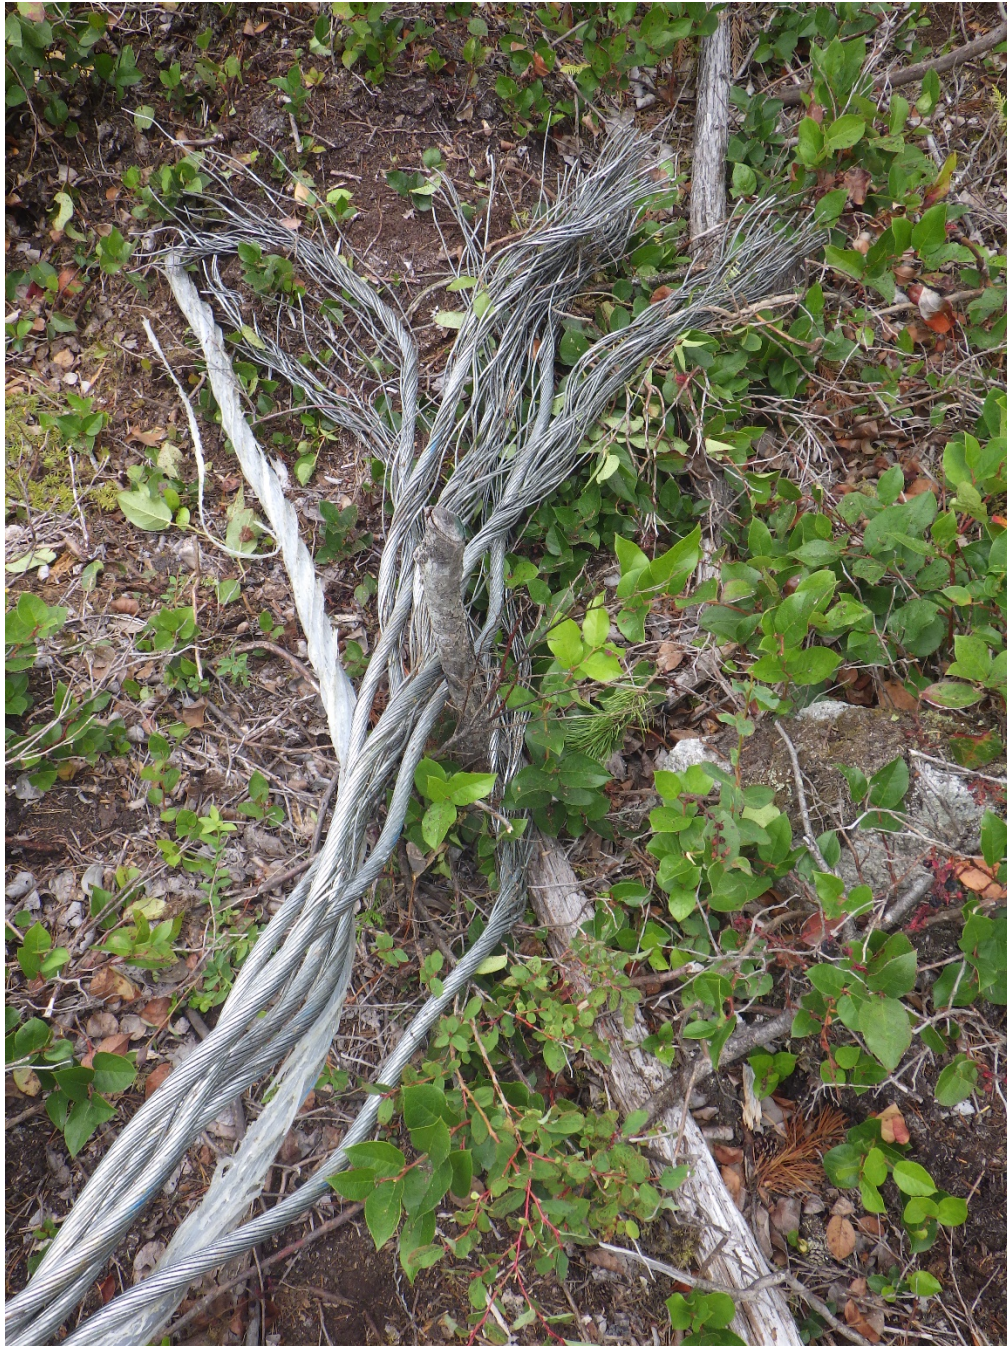
Image 8- Upper end of cut haul rope showing strands, wires and plastic core
