Incident Summary #II-1508420-2023 (#31812) (FINAL)

SUPPORTING INFORMATION	Incident Date	February 10, 2023	
	Location	Kamloops	
	Regulated industry sector	Electrical - Low voltage electrical system (30V to 750V)	
	Impact	Qty injuries	1
		Injury description	Burns to the right hand, bruising to the hips and right thigh.
	Damage	Injury rating	Minor
		Damage description	A three phase 400 Amp distribution panelboard sustained melting and fire damage to the neutral and all three-phase bussing and to all branch circuit conductors within the electrical panel.
		Damage rating	Major
	Incident rating	Major	
	Incident overview	An arc flash occurred on an energized 400-amp, 208 volts, 3 phase distribution panel in the electrical room of a hotel. A maintenance worker was replacing a circuit breaker that supplied power to the lighting in a common area. The arc flash injured the worker, damaged the bus bars, and caused fire damage to the branch circuit wiring.	
INVESTIGATION CONCLUSIONS	Site, system and components	<p>The hotel has a 600 Volt, 200 Amp, 3 phase electrical service supplied from utility power. The service terminates in a 200 Amp 3 phase rated fused main disconnect switch installed wit

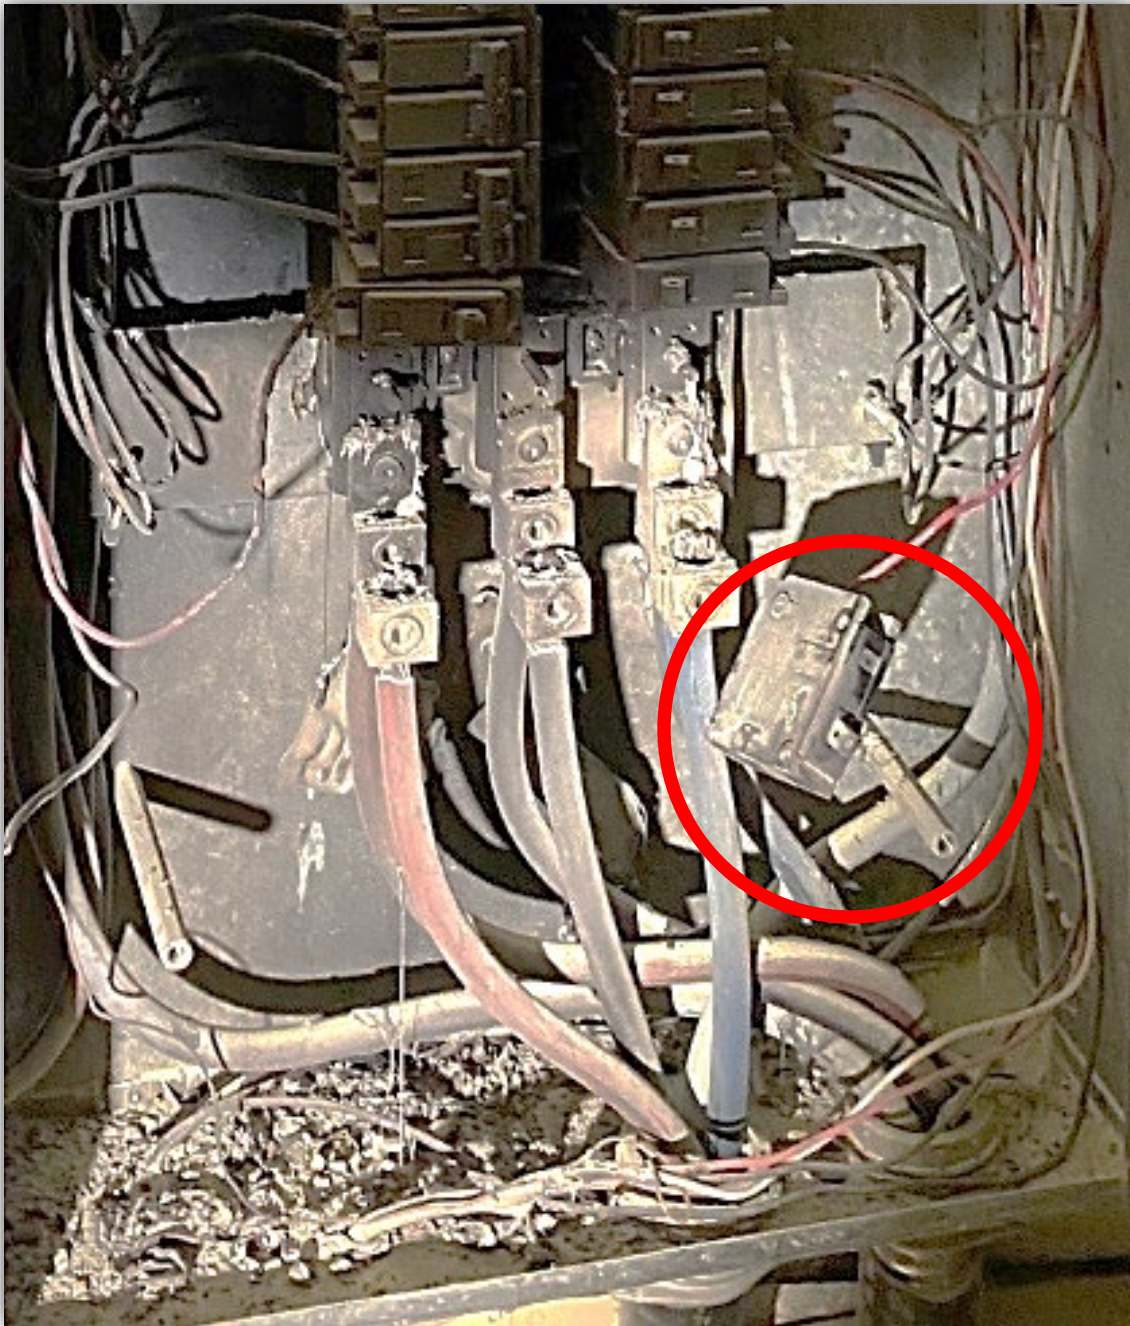
Image 1 – Condition of the 400-amp panel board after the incident. [RED] Faulty breaker.

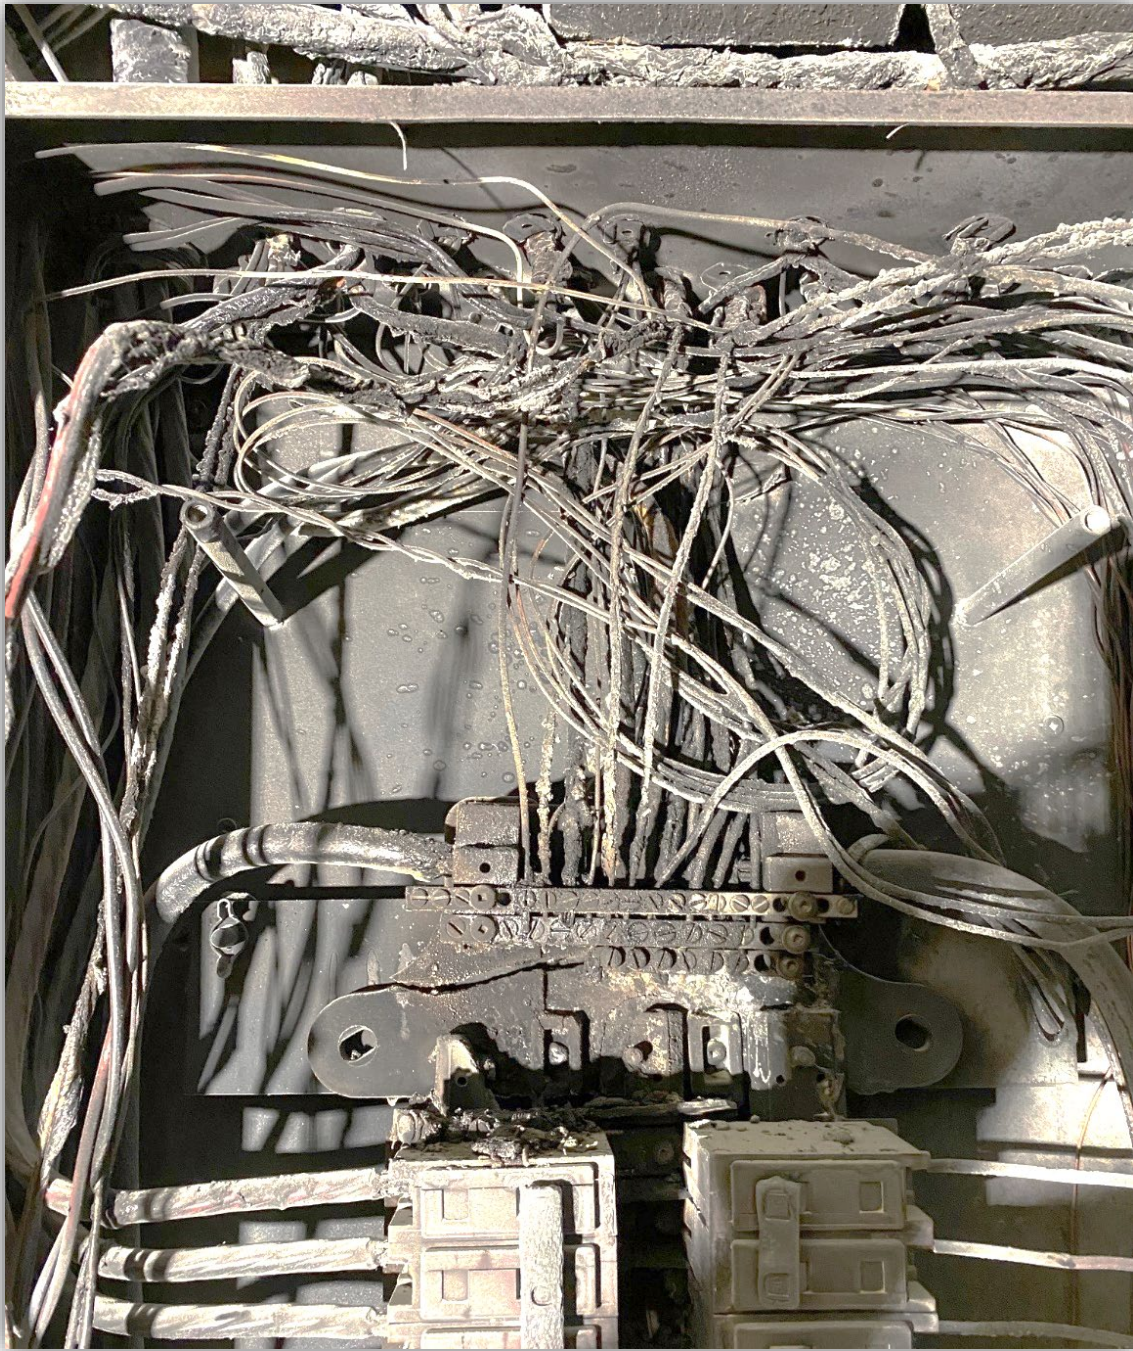
Image 2 – Heat damage to the neutral bus bar and branch circuit conductors.

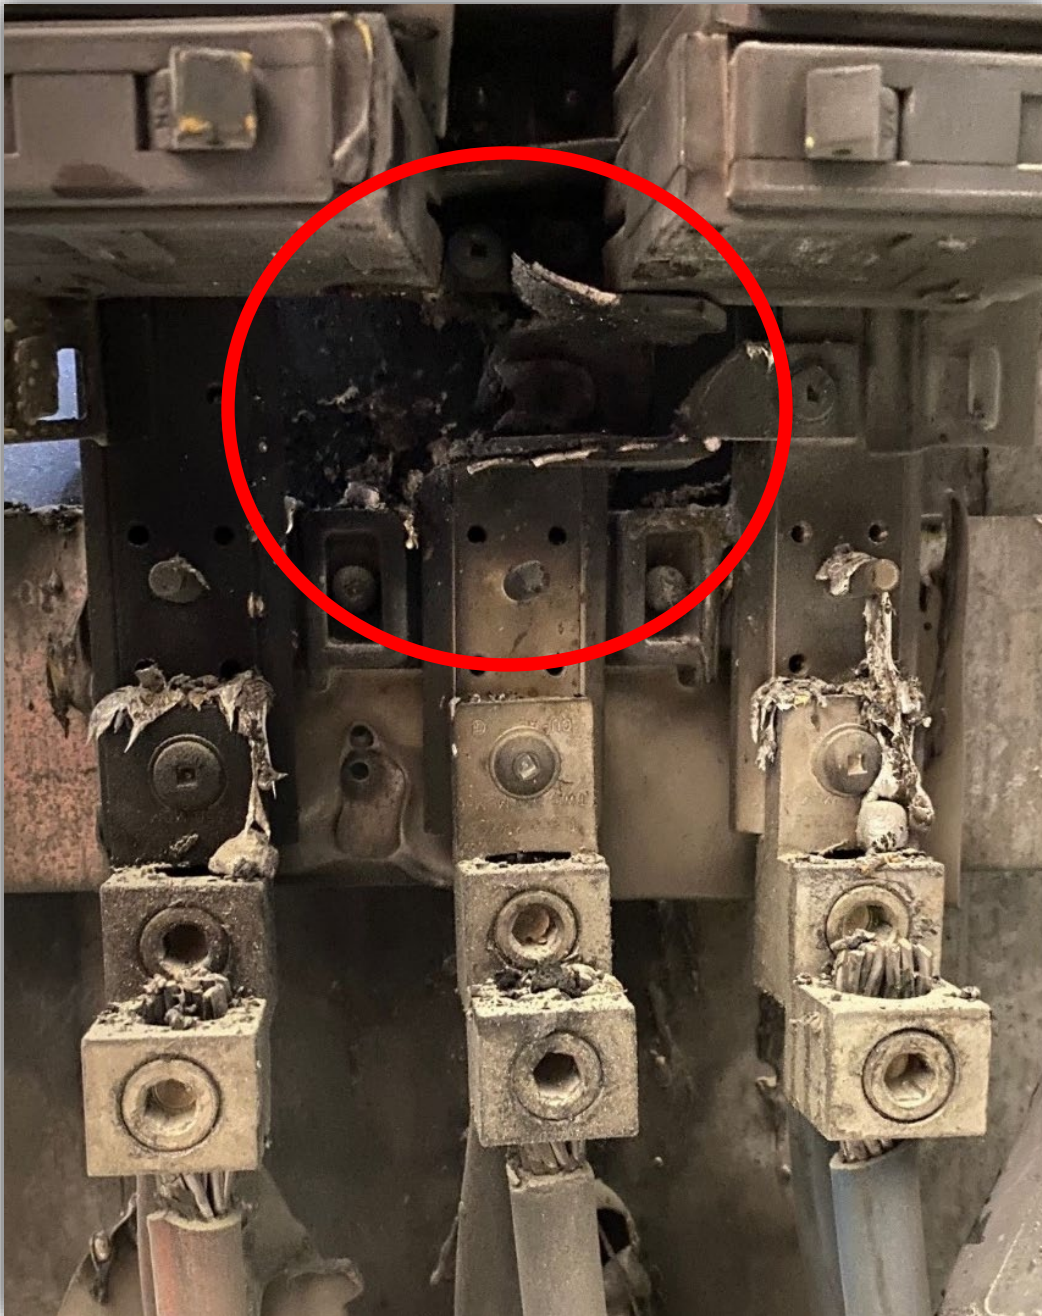
Image 3 – Melted metal on panelboard feeder termination point. [RED] Point of contact between equipment and worker.

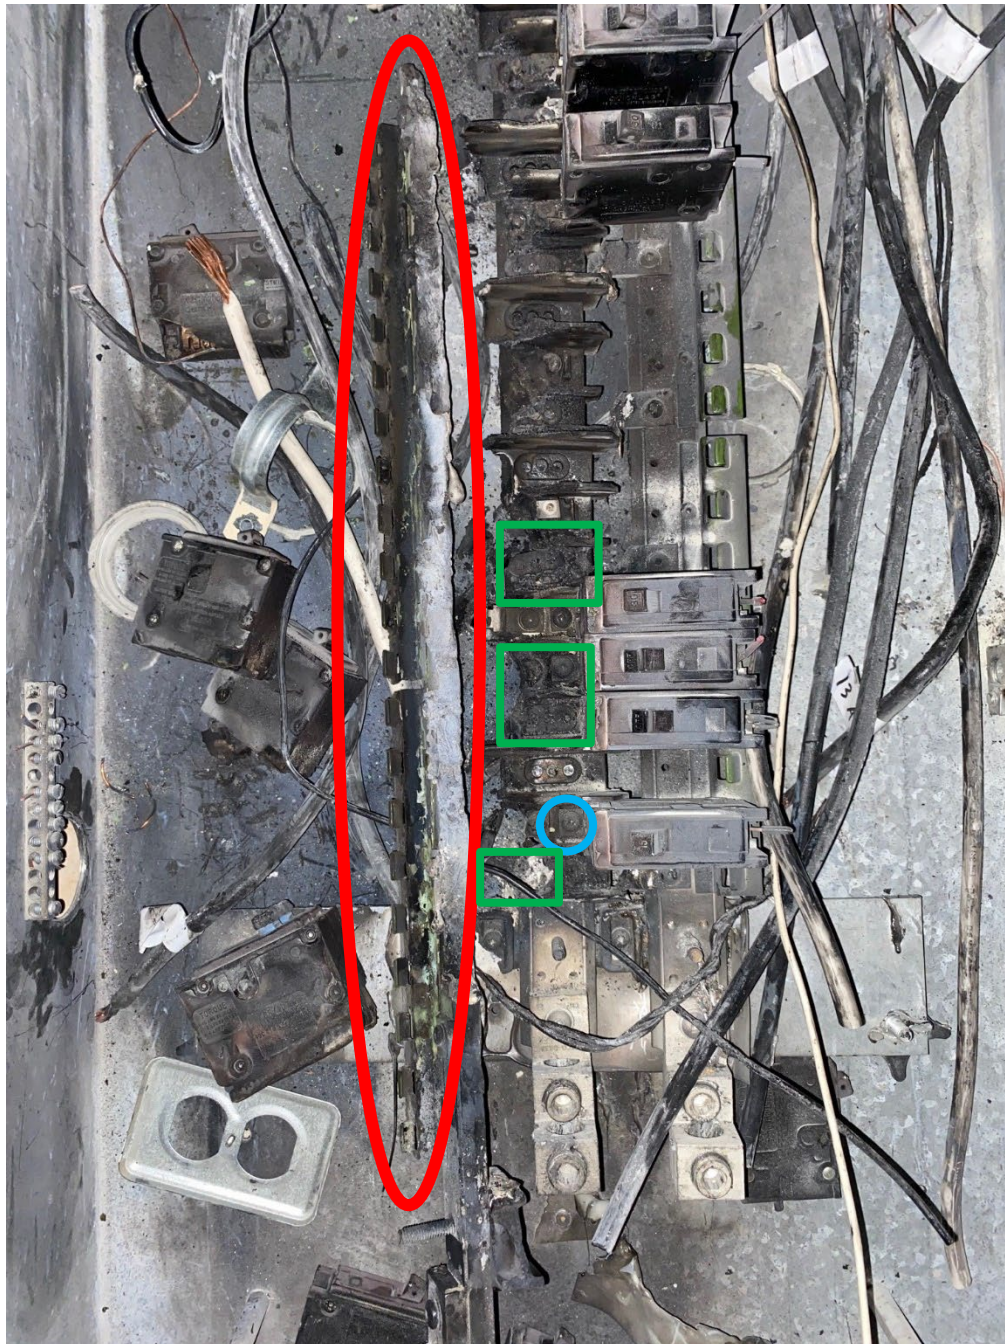
Image 4 – Burnt bus bars after panel removal. [RED] Melting of the “A” Phase bus bar. [GREEN] Melting of the “B” phase bus bar. [BLUE] Factory supplied mounting screw.

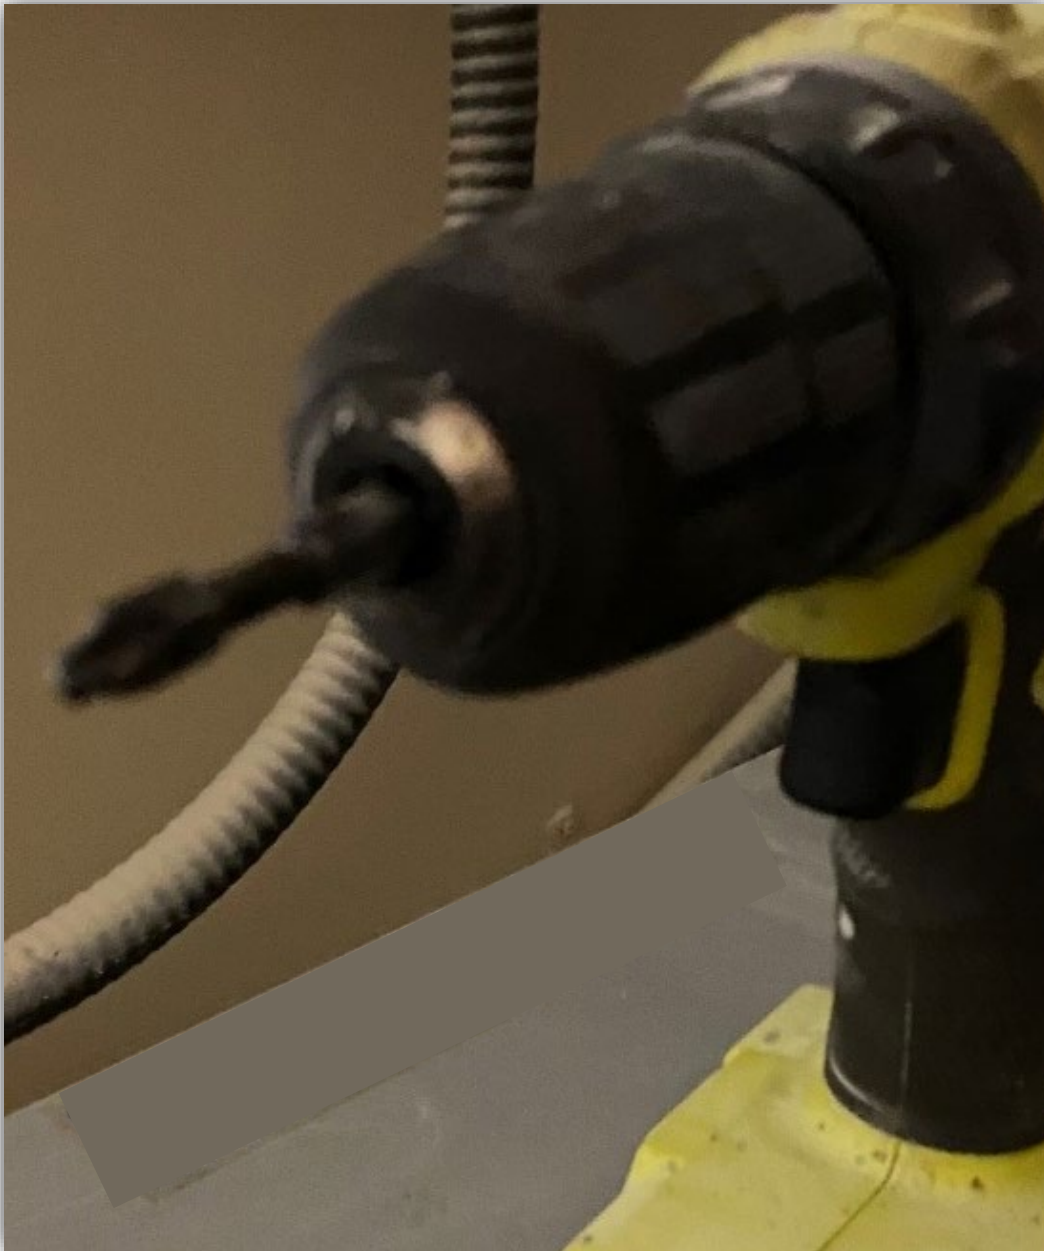
Image 5 – Drill with burnt Phillips head drill bit.

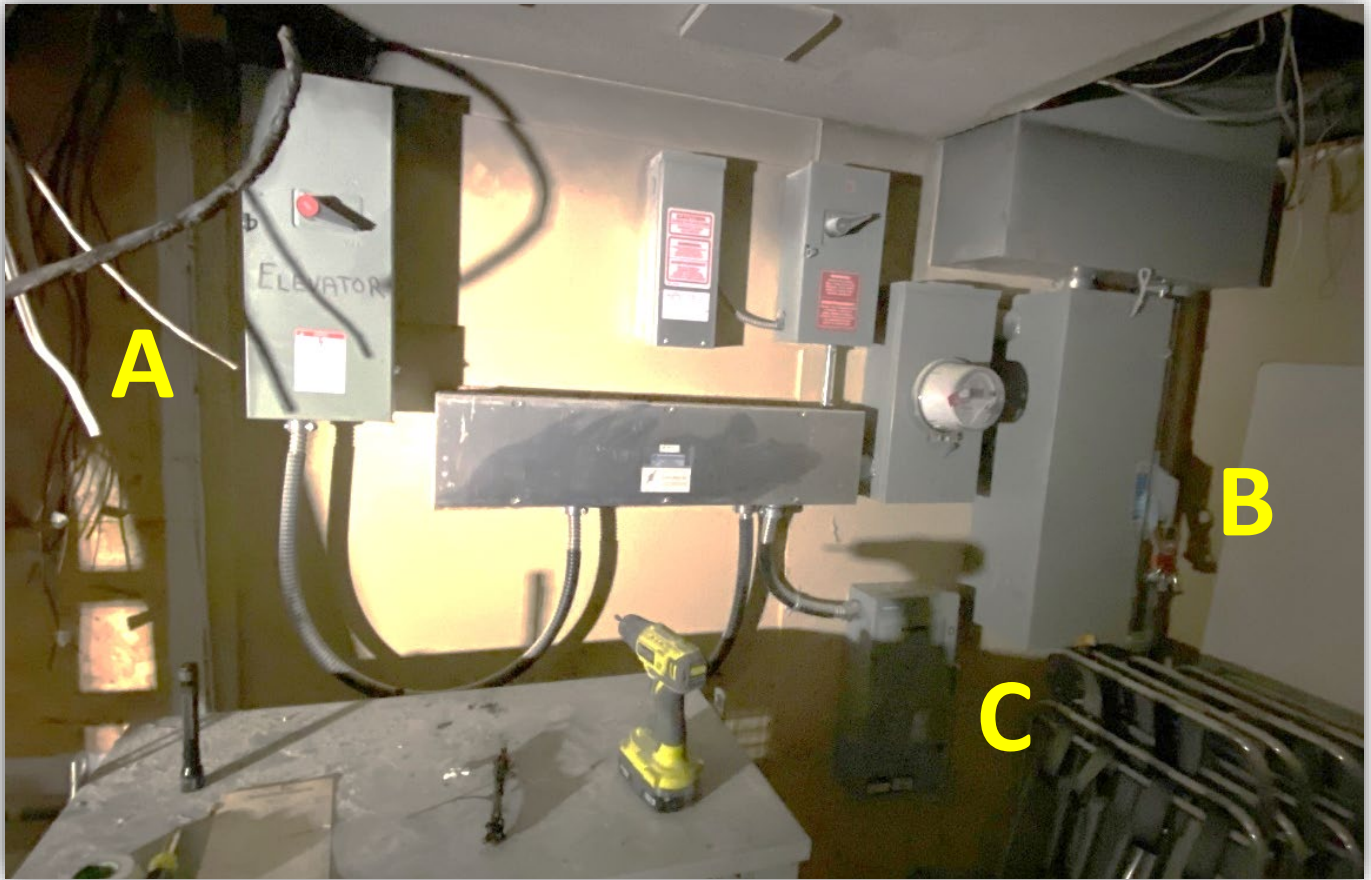
Image 6 – Service disconnect in relation to the damaged electrical panel. [A] Location of the damaged panelboard after being removed. [B] Main service disconnect. [C] Transformer / panelboard disconnect.
