Incident Summary #II-1316263-2022 (#25833) (FINAL)

Incident Date	January 16, 2022 (#25833) (FINAL)
SUPPORTING INFORMATION	Location	Interior
	Regulated industry secto	Passenger ropeways - Above surface ropeway
	Qty injuries	0
	ୁ Injury 글 description	Passenger apprehension & displeasure
	Injury rating	Minor
	⊆ _v Damage description □ Damage rating	Intermittent electrical connection/failure
	Damage rating	Minor
	Incident rating	Minor
	Incident overview	Passengers forcibly jostled within swaying gondola cabins from ropeway abruptly stopping in an excessively short distance from maximum operating speed.
INVESTIGATION CONCLUSIONS	Site, system and components	Passenger ropeway is equipped with enclosed carriers, gondola cabins. The gondolas detach/attach to the circulating haul rope as they enter stations for easier, safe, and efficient loading and unloading of passengers. A conveyance system, synchronized to the haul rope ensures carriers are precisely transported within the stations. This operation requires the use of a counter-sheave with two sensors (Image 1), as part of the safety monitoring system to verify carrier speed and spacing within the stations. The service brake systems, se

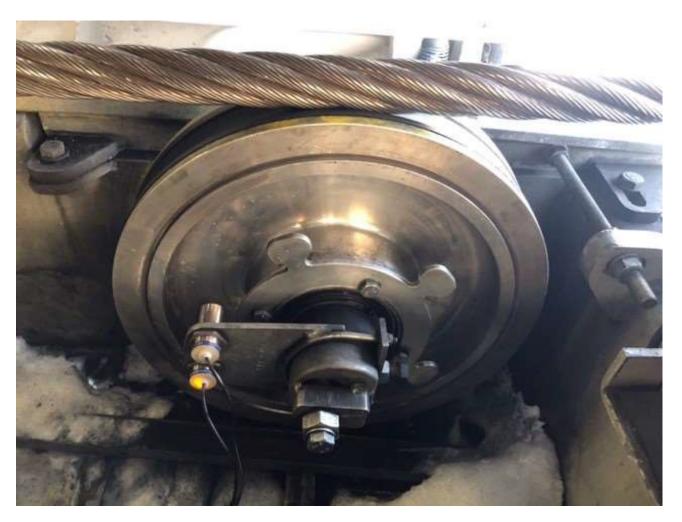
Image 1 - Station counter-sheave

Failure scenario(s)	The safety monitoring system detected a rollback fault while the ropeway was operating in a forward direction which then applied the emergency and rollback brakes resulting in the ropeway coming to an abrupt stop.
	Facts and evidence	 <u>As reported by Duty Holder</u>: Station adjustments were made the night before, after closing from the previous day's operation Ropeway was having carrier spacing issues an hour into daily operation Maintenance personnel were dispatched to the top and bottom station to determine issue During a carrier spacing fault stop the counter-sheave at the top station was determined to be out of position

Upon repositioning of counter-sheave, personnel discovered a securing bolt unable to properly tighten. Counter-sheave properly positioned, securing bolt replaced and lift restarted to full operating speed. Moments after the ropeway had a very dynamic stop at full operating speed as there was minimal deceleration and all brakes were applied. A rollback fault was annunciated, even though ropeway was operating forward direction. Ropeway re-started at a slower speed and again moments later a rollback fault stopped gondola abruptly. Ropeway passengers were unloaded at a slower operating speed. Passengers reported extreme carrier swaying online. Gondola cabins and ropeway inspected for damage Wiring was checked and counter-sheave sensors replaced – Rollback fault condition that triggered the dynamic stop has not occurred since.
	 <u>Ropeway Statistics</u>: Counter sheave has two sensors A & B, forward operation A-B-A-B-A-B Rollback fault, control system must detect counter-sheave sensors four times in reverse, B-A. Counter-sheave sensors are integral to the station carrier spacing system. Rollback fault initiates Rollback and Emergency brakes to apply immediately, and service brake applies at zero-speed. Complete Rollback sensor disconnection activates, sensor loss fault – Emergency brake applies and Service brake at zero speed. 2002 ropeway capacity increased to current limits. 2002 Acceptance test Rollback brake setting, and 2002 brake Operations Manual have contrasting values – lower value at acceptance test. 2017 Load test Rollback brakes torque values were not recorded.
