Incident Summary Report II-657117-2018 (#5386) (Final)

SUPPORTING INFORMATION	Incident Date	<i>January 28, 2018</i>	
	Location	<i>Burnaby BC</i>	
	Regulated industry sector	<i>Elevating Devices – Escalator or moving walkway</i>	
	Impact	Qty injuries	<i>1</i>
		Injury description	<i>Technical Safety BC was notified that a girl was taken to the hospital by her parents with a bruised foot due to an entrapment on the down escalator.</i>
		Injury rating	<i>Minor</i>
	Damage	Damage description	<i>No damage to regulated equipment.</i>
		Damage rating	<i>None</i>
	Incident rating	<i>Minor</i>	
Incident overview	<i>Technical Safety BC was notified that a girl got her right boot stuck on the down escalator between the step and the stationary skirt panel.</i>		
INVESTIGATION CONCLUSIONS	Site, system and components	<p>Escalators have design features to prevent users from getting their foot wear and clothing articles from being entrapped.</p> <p>This entrapment mainly occurs between the moving step and stationary skirt panel on down escalators.</p> <p>The escalator steps are designed and required to have a maximum running clearance of 5mm between the step and stationary skirt panel.</p> <p>The

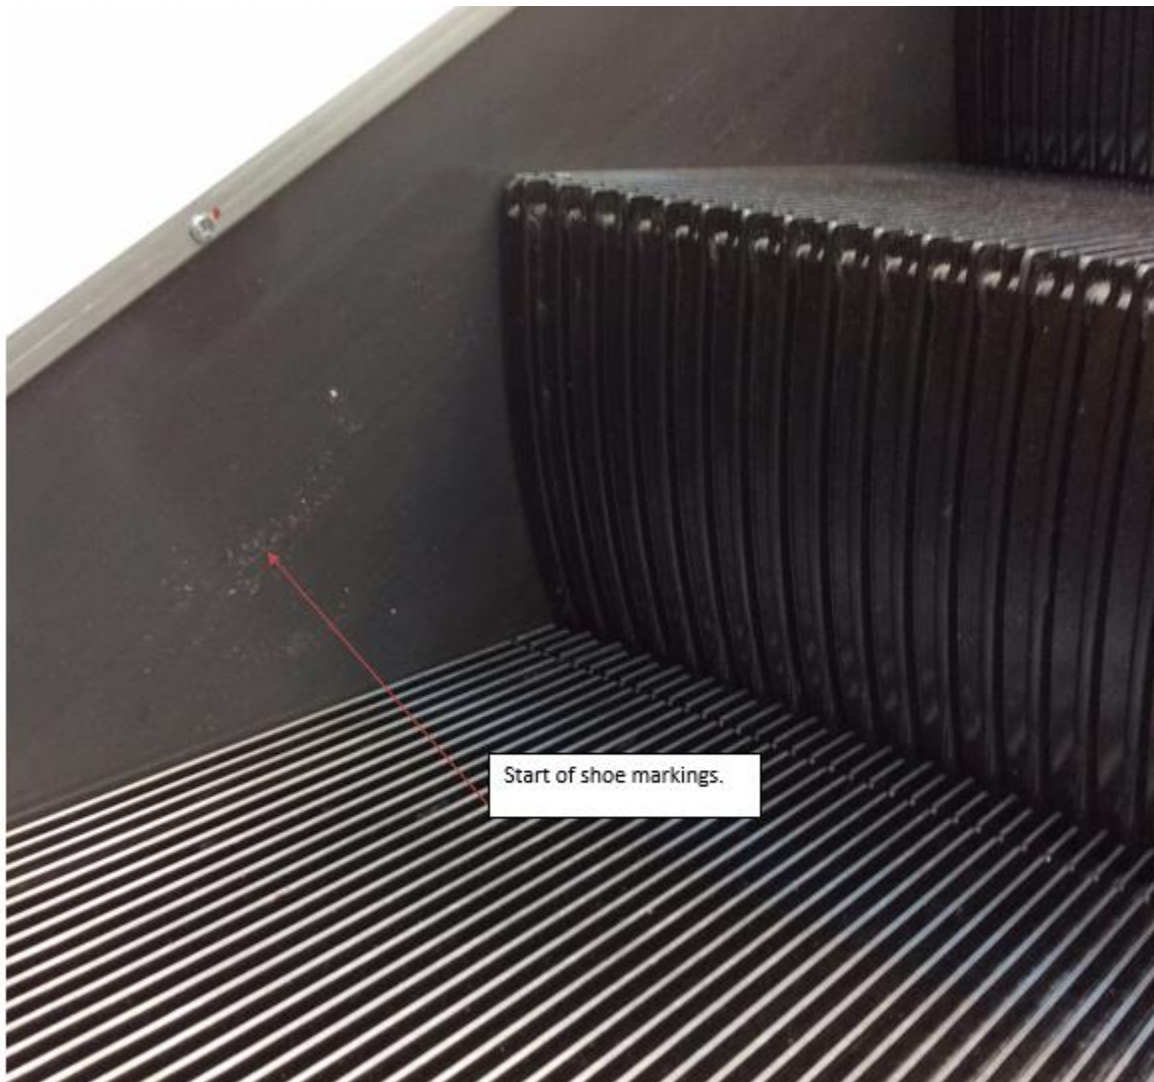
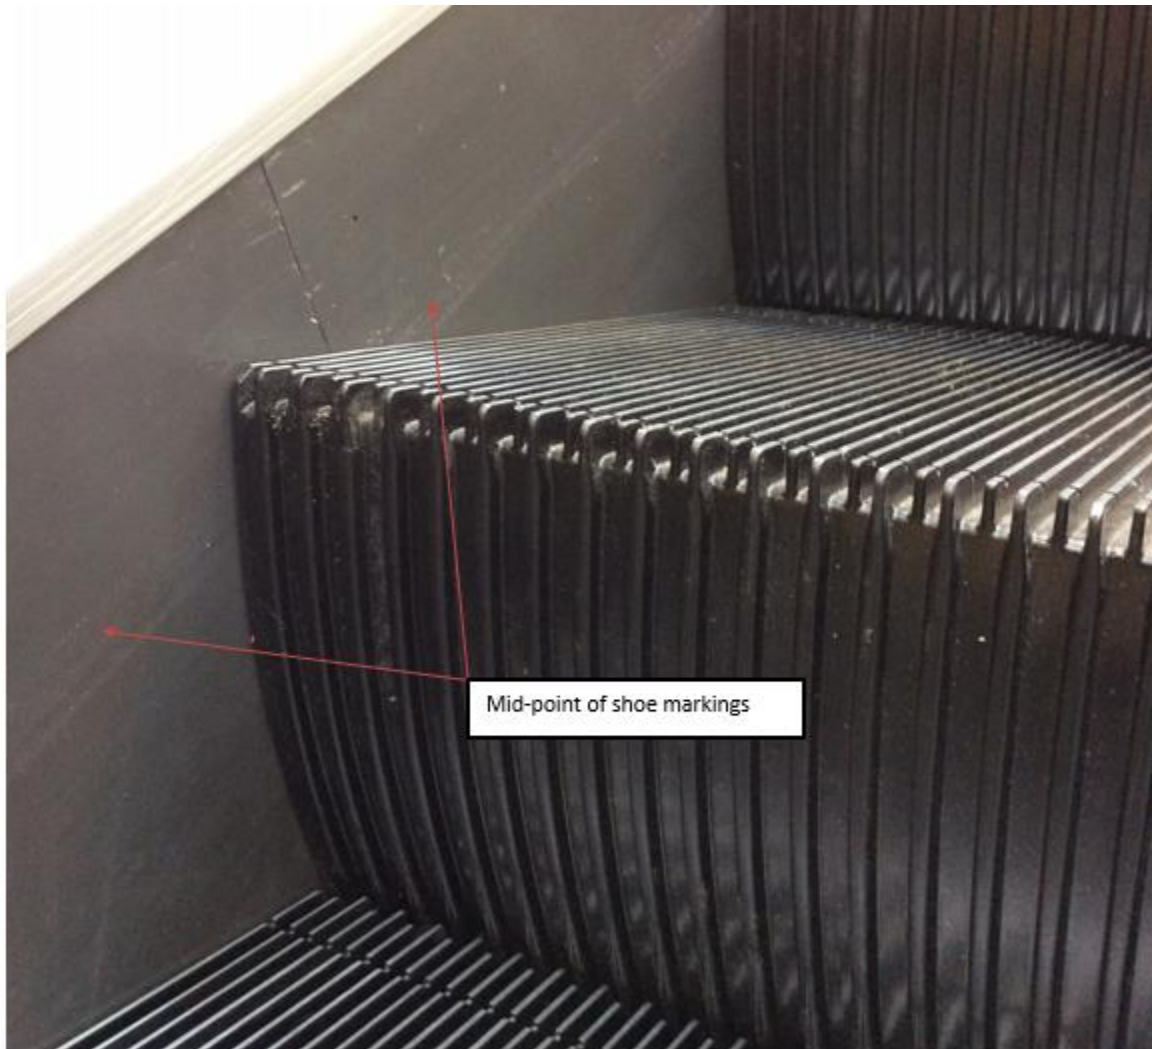
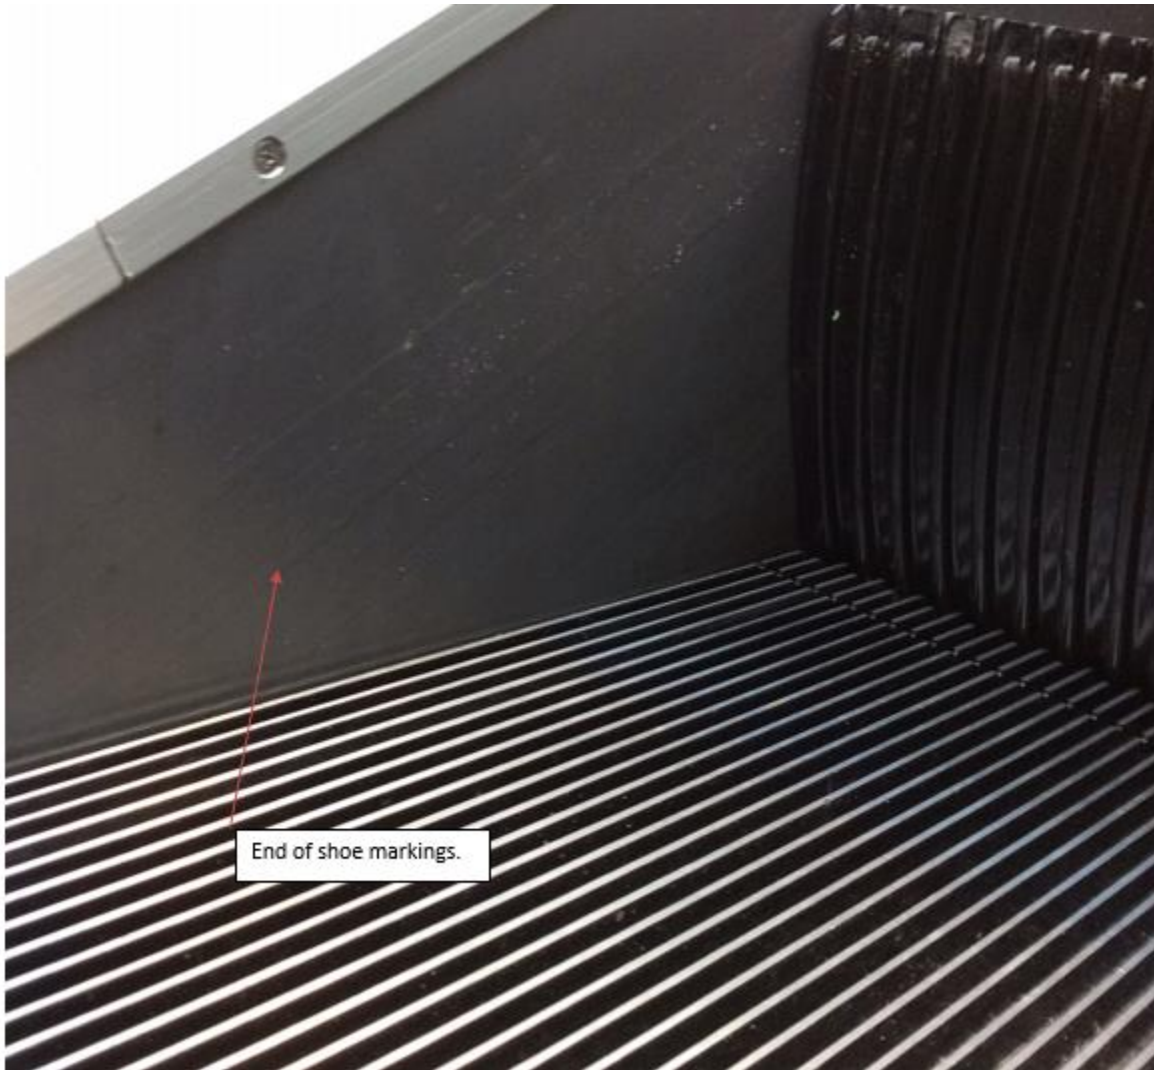
Failure scenario(s)	<p>The user while riding the down escalator had their shoe in contact with the stationary skirt panel.</p> <p>The loaded step gap may have exceeded the 5mm maximum allowable distance between escalator step and skirt panel.</p> <p>The skirt stiffening brackets may not be installed or missing.</p> <p>The skirt panel coefficient of friction Index may be higher than the maximum allowable of 0.15 for an escalator without skirt deflectors. (brushes along the entire length of the escalator)</p>	
	Facts and evidence	<p>Past the halfway point of the down escalator I found evidence of synthetic/rubber material on the skirt panel. This transfer of material continued for approximately 7 steps on the left skirt panel looking up from the bottom.</p> <p>The loaded step gap was greater than the allowable of 5mm. We recorded a discrepancy of 0.9 to 1mm.</p>

<p>The escalator skirt stiffening brackets are all in place.</p> <p>The Step/skirt performance index test showed the co-efficient of friction and Index are higher than allowed for escalators without skirt deflectors.</p>
Causes and contributing factors	<p>Likely that the interaction of the shoe with the skirt panel allowed the shoe to become entrapped.</p> <p>Contributing factor is that the step gap between the step and skirt panel exceeded maximum allowable distance.</p> <p>The step/skirt index performance test showed the co-efficient of friction was greater than allowable by code for escalators without skirt deflectors.</p>

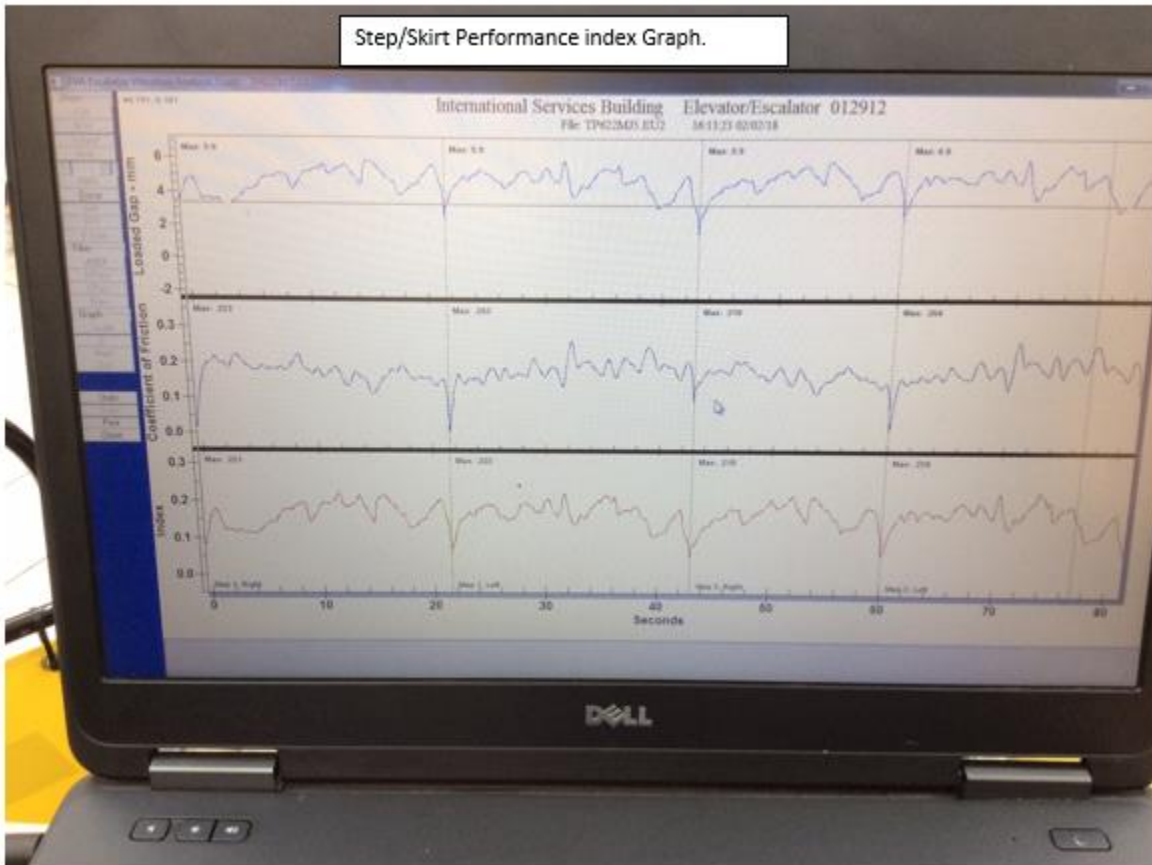
Step/Skirt Performance index Graph.
