Incident Summary #II-1249163-2021 (#23871) (FINAL)

SUPPORTING INFORMATION	Incident Date	August 25, 2021	
	Location	Richmond	
	Regulated industry sector	Electrical - Low voltage electrical system (30V to 750V)	
	Impact	Qty injuries	0
		Injury description	N/A
		Injury rating	None
	Damage	Damage description	Internal metal and plastic components of the main service switch were melted and damaged beyond repair. Two of the three fuses also had a black charred ring.
		Damage rating	Moderate
	Incident rating	Moderate	
	Incident overview	The 800 Amp 208 Volt main electrical service switch had two of its three metal switching mechanisms overheated and melted during periodic overloading.	
INVESTIGATION CONCLUSIONS	Site, system and components	<ul style="list-style-type: none"> The incident occurred in the electrical room of a commercial building that has multiple warehouse and office tenant spaces. Main electrical service gear for the building consists of a three phase 800 Amp 208 volt service switch with fuses, metal conductor termination components, friction fit metal connection points, and insulating barriers made of thermoset polymer, which is a hardened type of plastic. These connection

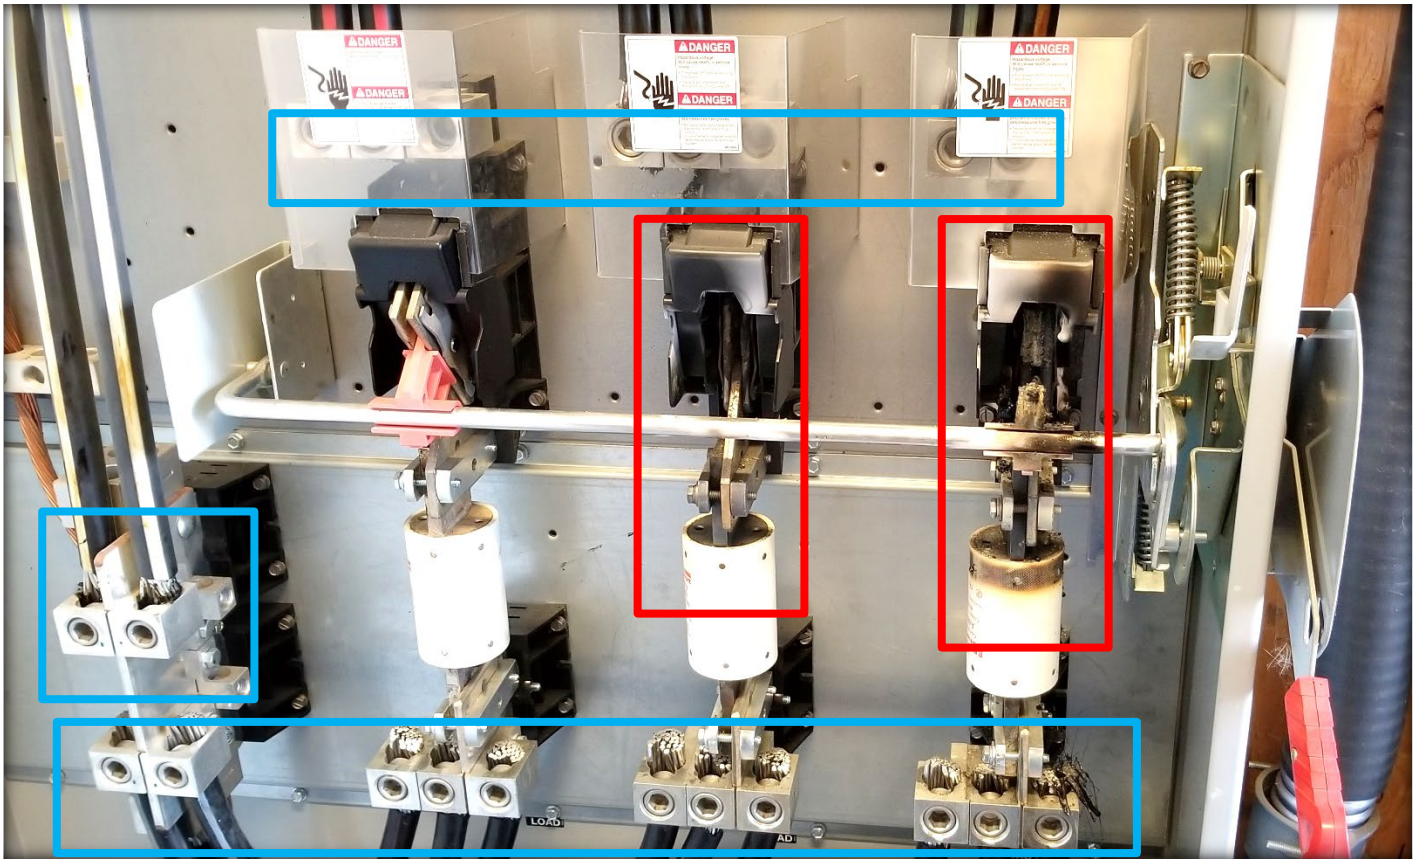
- Two of the three knife blade connection points for the service switch had degradation of the metal switching mechanisms and melting of the surrounding plastic insulating barrier components ([Image 3](#)).

- There were no visual indications of loose terminations (such as a backed off Allen lug) or of heat damage at the line or load conductor termination points in the service switch ([Image 1](#)).

Image 1 - Service switch damage (red rectangles). No visual indications of loose terminations or heat damage at the conductor terminations (blue rectangles).

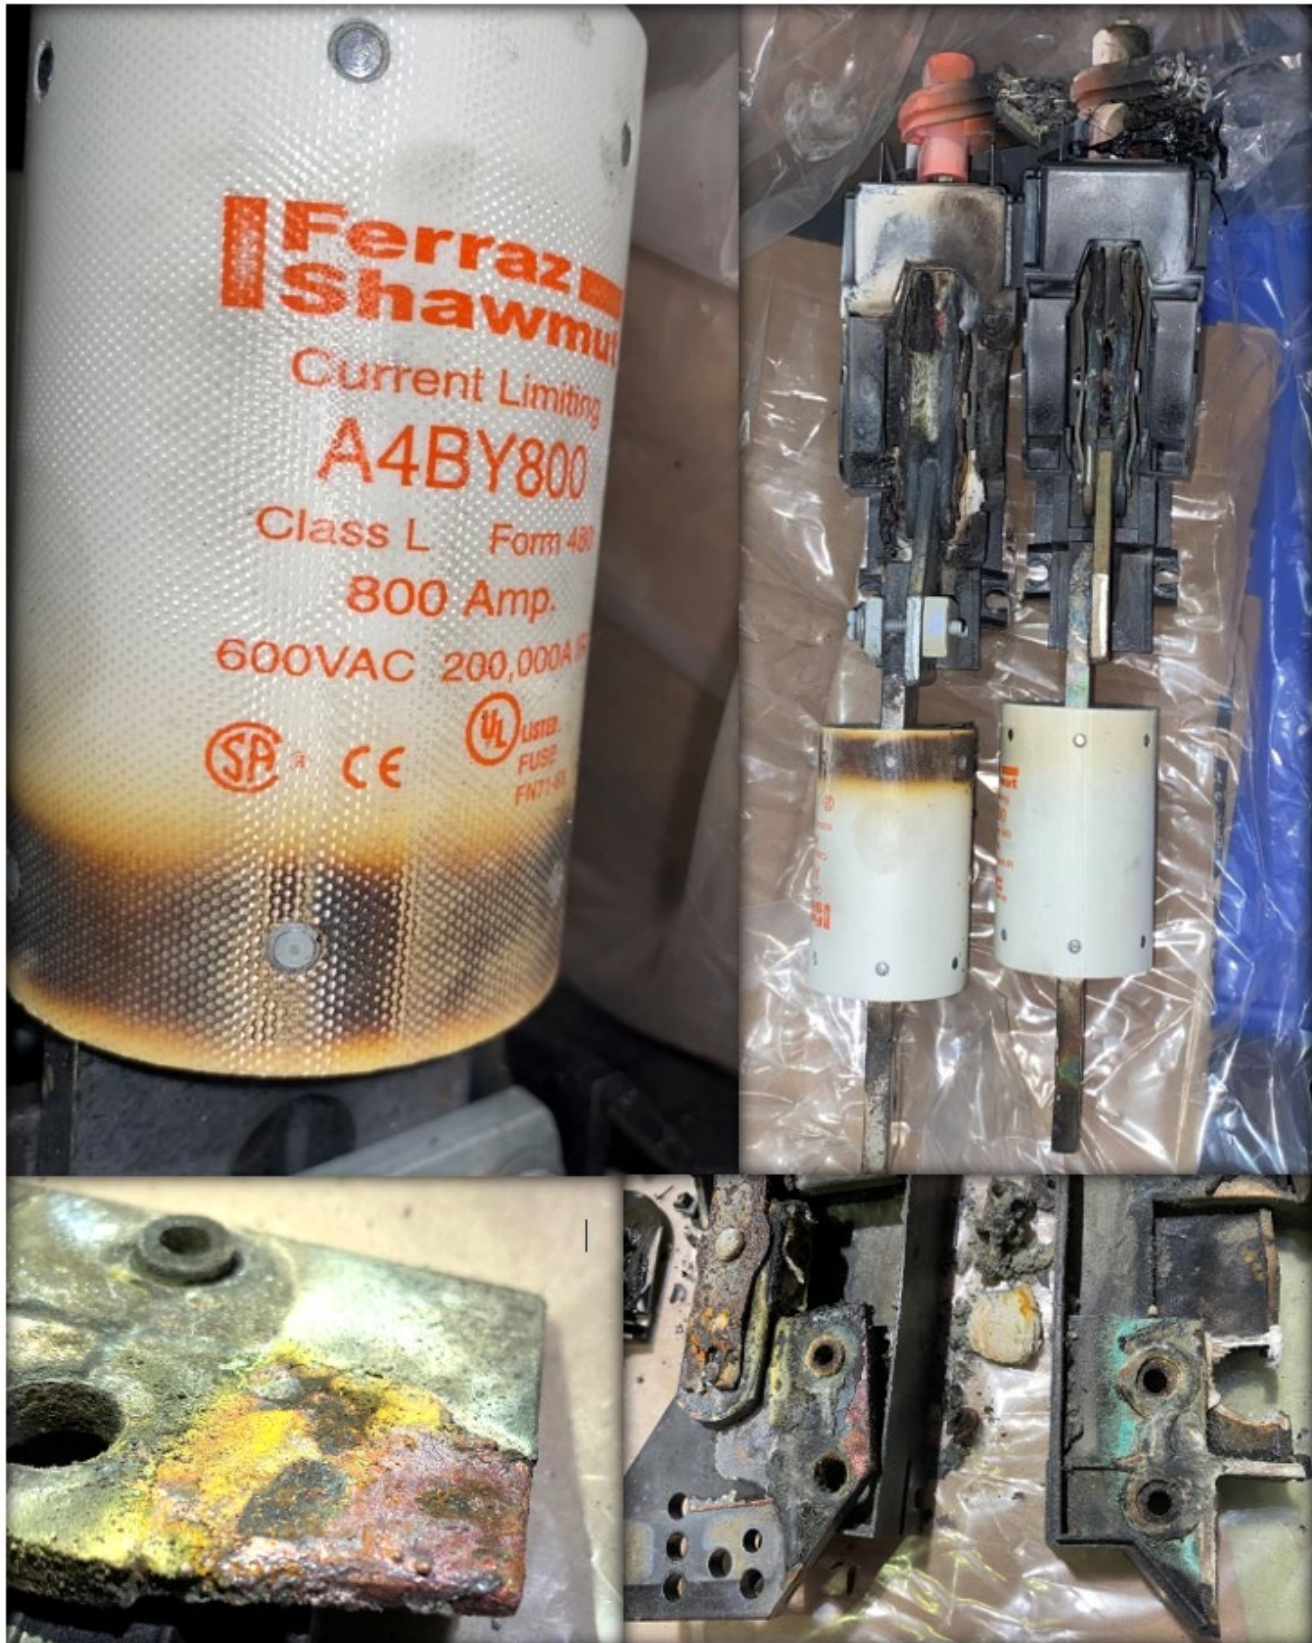
- The service switch fuses were rated at 800 Amps. Two of the fuses had heat damage with circumferential ring charring with one ring quite darker than the other ([Image 3](#)). While the fuses were damaged, they had not blown.

Image 3 - 800 Amp service switch fuses and mechanisms with heat/ melting damage

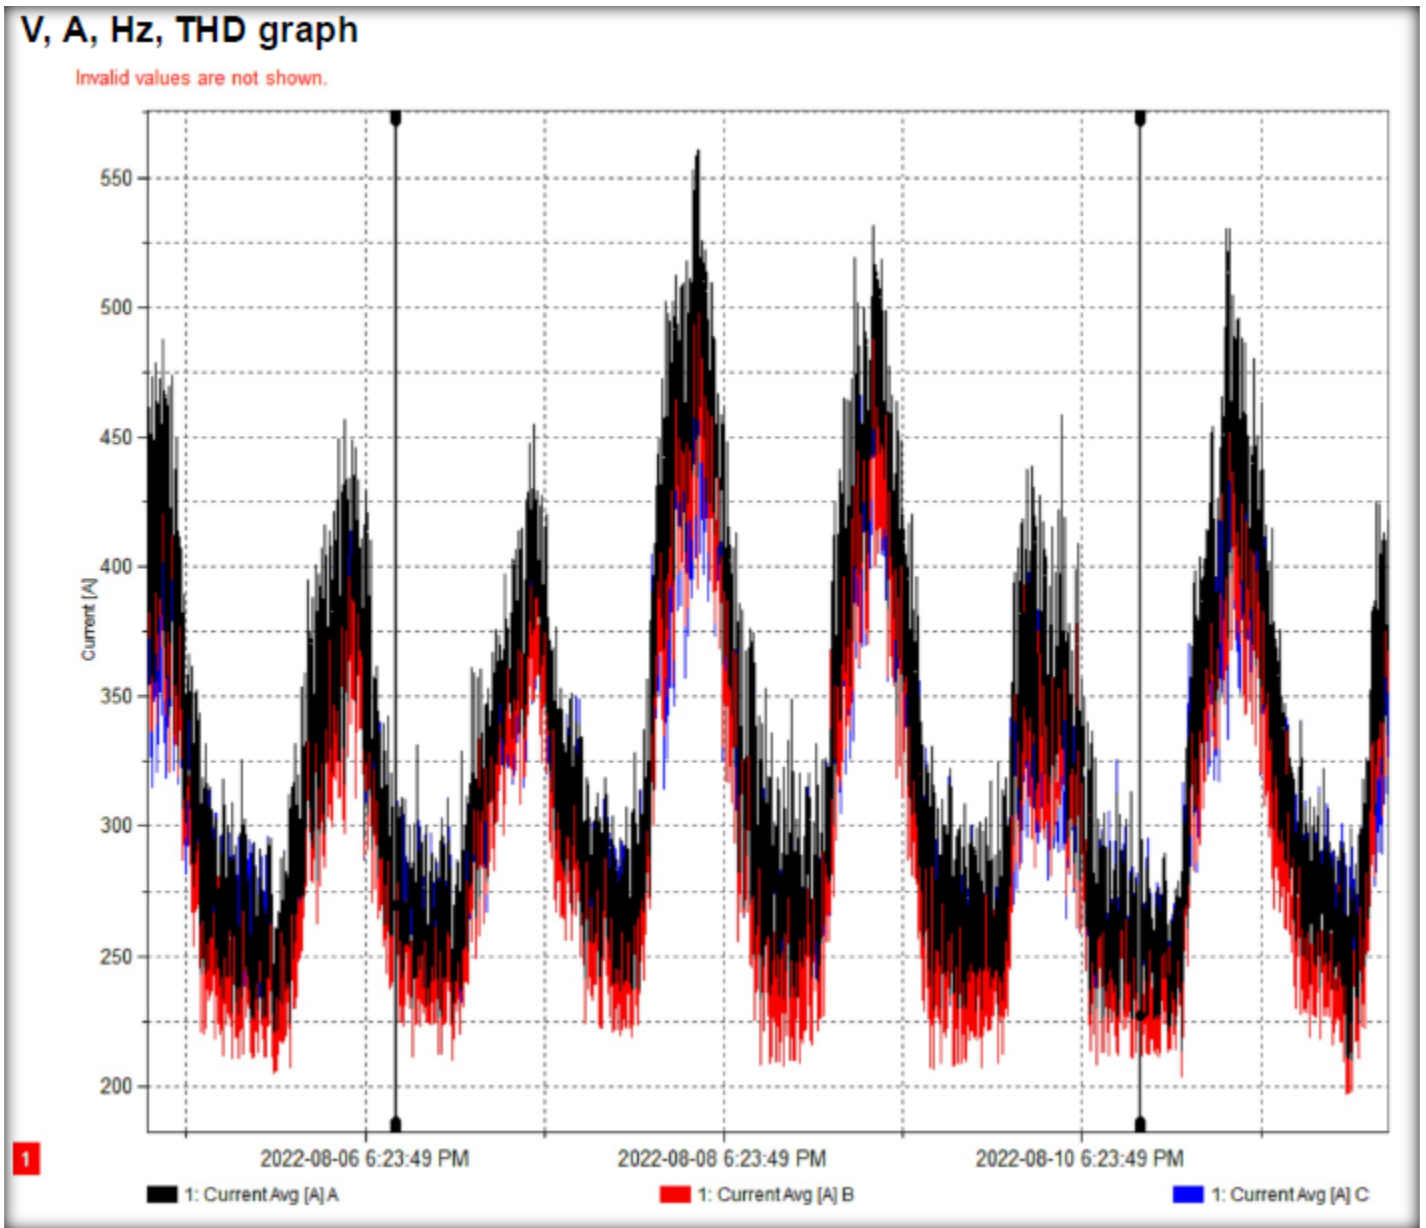
Image 5 - Post incident (Aug 2022) contractor testing indicating average current readings over 7-day testing.

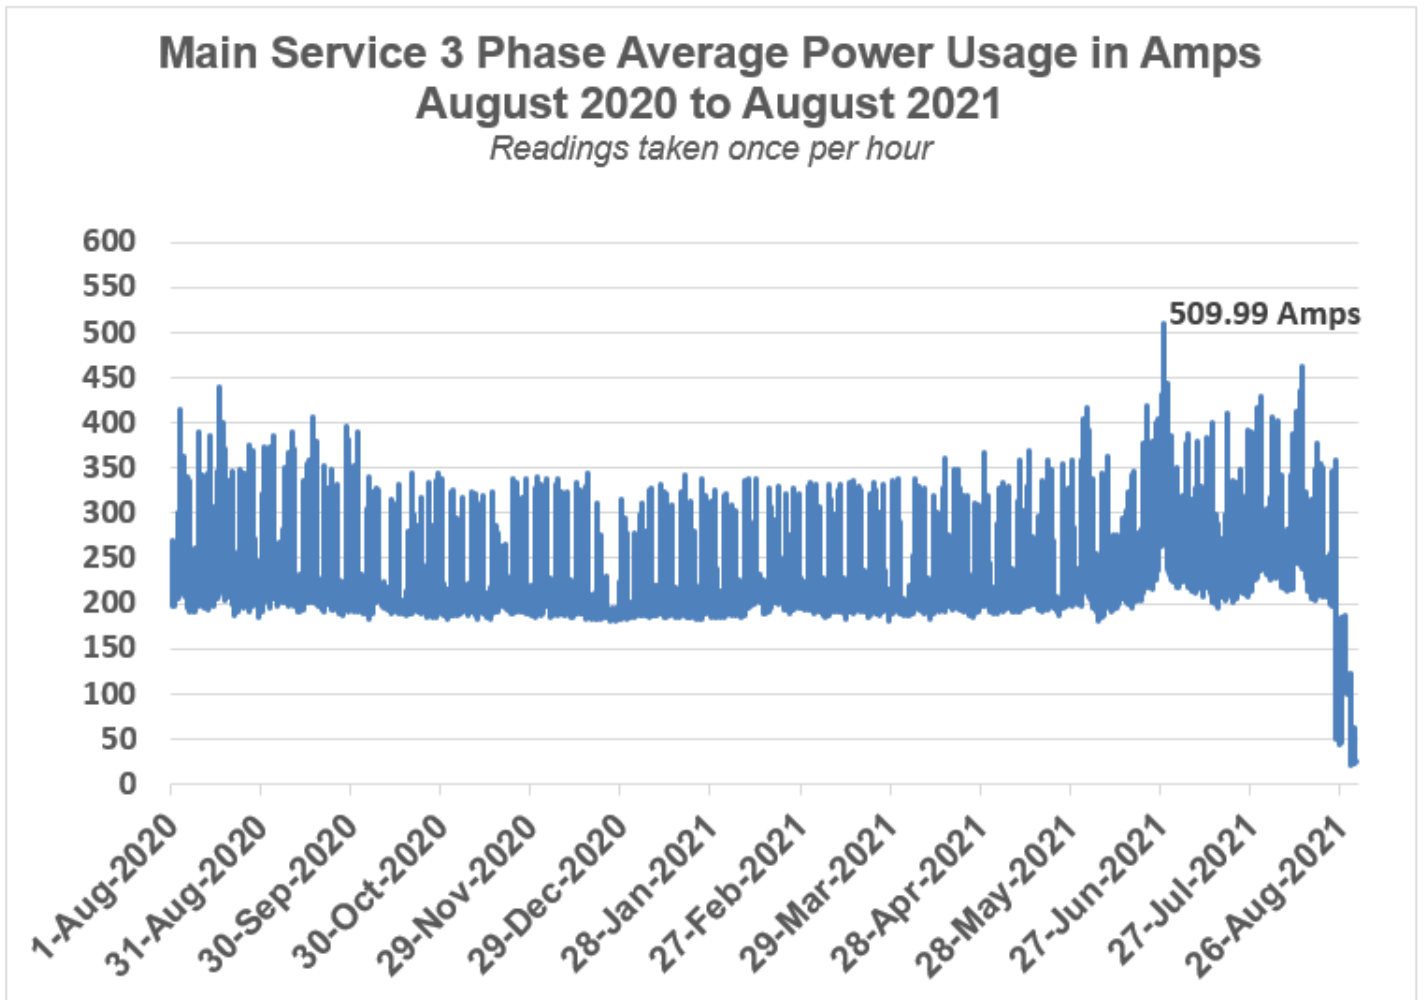
- Utility metering data ([Image 6](#)) taken for a one year period (August 2020 to August 2021) including the date of the incident indicates an average peak load of 509.99 Amps. This is based on a load average of all three phases in 1 hour measurement periods and does not indicate the maximum loading per phase. Using the average of three phases does not provide accurate loading for each phase, for example if phase 'A' had 400A, phase 'B' had 600A, and phase 'C' had 800A, the loading data would show 600 Amps, with no awareness of an 800 A overloading on phase 'C'.

Image 6 – 3 phase power usage for 1 year prior to the incident with average peak at 509.99 Amps. Note that this indicates the average of the three phases and not the maximum power per phase.

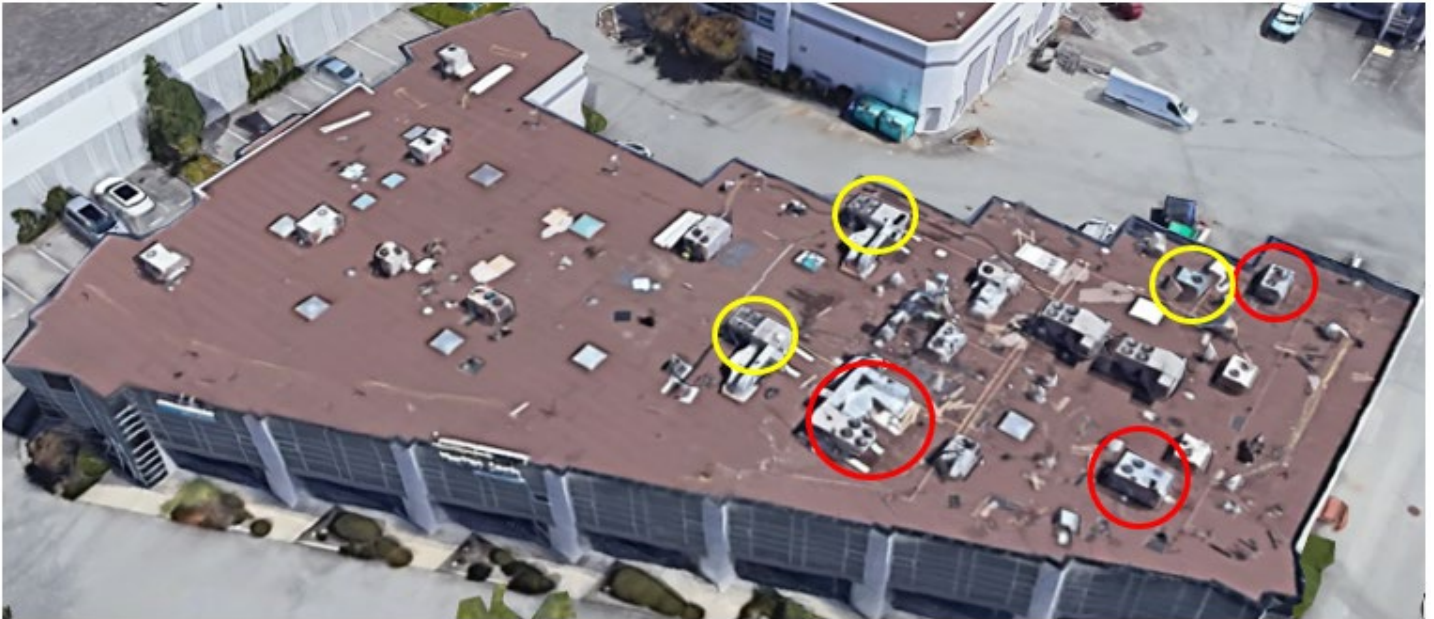
- The electrical room had a thermostat controlled exhaust fan.
- Records indicate the main service switch was replaced in 2013.
- Overhead images show rooftop/ air conditioner units added to the building since it was built including some after the service was upgraded to 800 Amp ([Image 7](#)).

Image 7 (2022) - Rooftop/air conditioner units added 2002 to 2014 (yellow) and 2014 to 2017 (red)

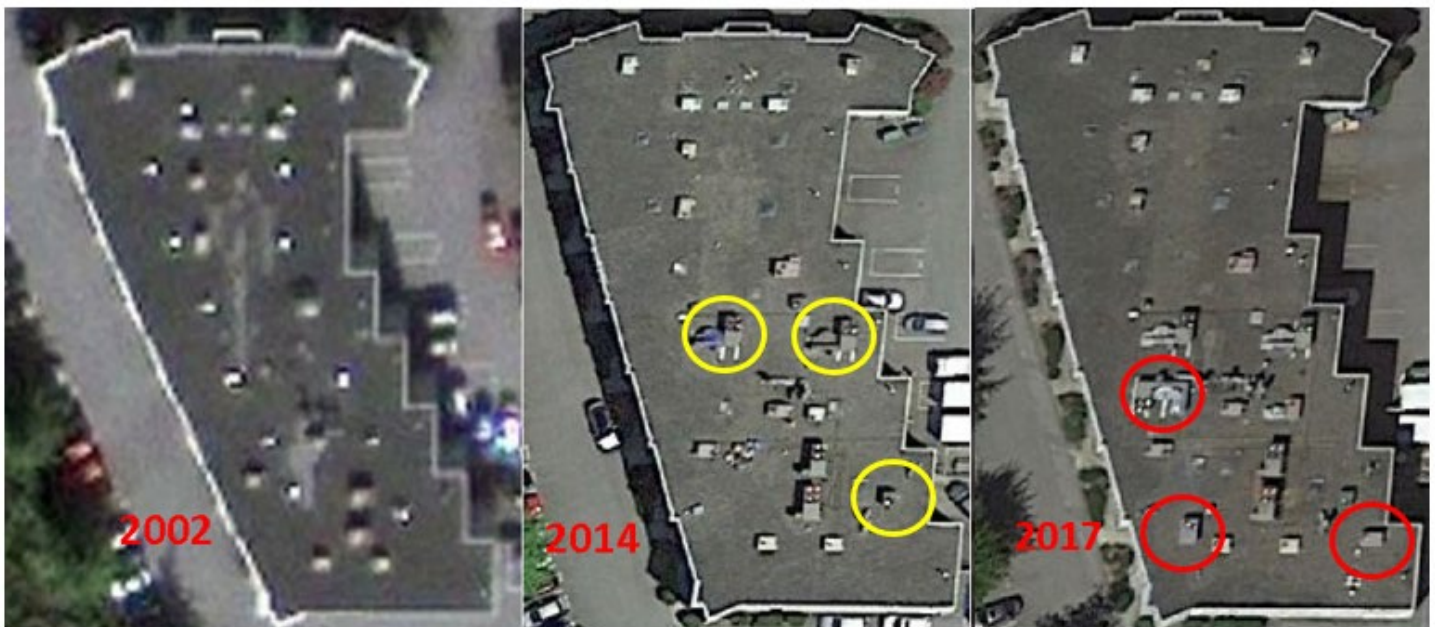
Image 8 – Reference image used to produce [image 7](#) showing timeline.
