INVESTIGATION REPORT

AMMONIA RELEASE — FERNIE MEMORIAL ARENA

DATE OF INCIDENT: OCTOBER 17, 2017

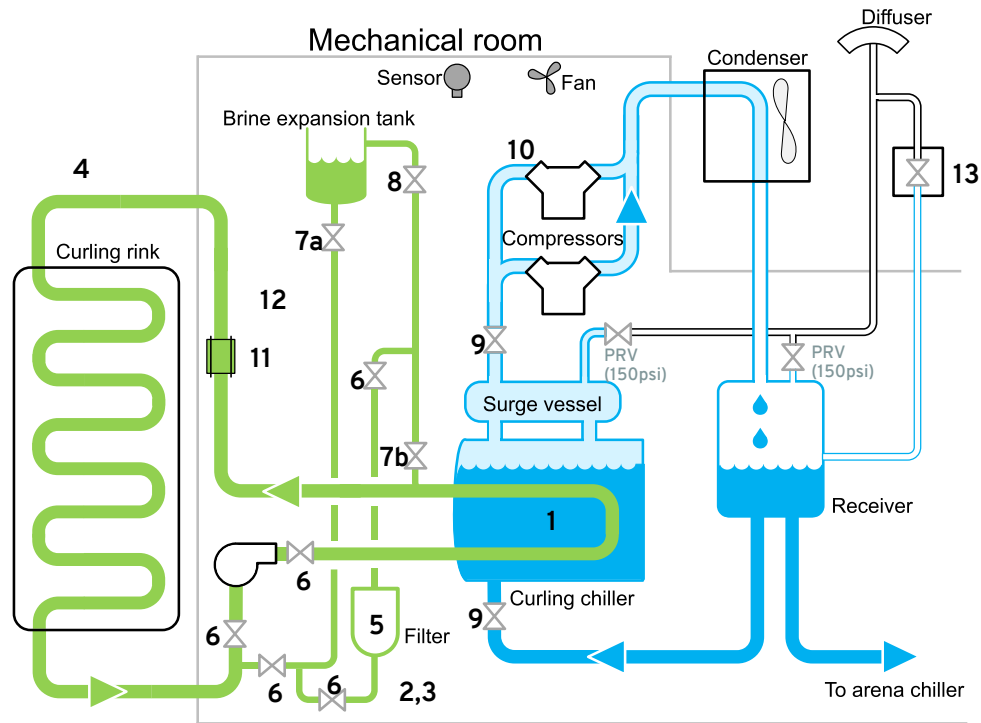
Figure 3: Schematic of the Fernie Memorial Arena curling refrigeration system. Numbers identified correspond to the items and descriptions in the Table 1 below.

#	ITEM DESCRIPTION & FINDING	#	ITEM DESCRIPTION & FINDING
1	Curling Brine Chiller – One 2.2 mm x 0.2 mm hole found in an upper tube along a weld seam.	7a	Valve found in OPEN position
2	Brine analysis results – prior to incident: (sample locations indicated as item 2) 0 ppm ammonia – Jan 2016 3,320 ppm ammonia – May 2017 1,830 ppm ammonia – Aug 2017	7b	Valve found failed in OPEN position
		8	Valve concluded to be effectively CLOSED . A very small opening may have facilitated some leakage, while pressure relief was impeded.
3	Brine analysis results – post-incident: (sample locations indicated as item 3) 113,400 ppm ammonia measured on Oct 20 2017	9	Ammonia system valves found CLOSED , isolating an estimated 90 lb. ammonia in chiller
		10	Compressors contaminated – salt deposits found indicate brine leaking from chiller
4	Brine analysis results – post-incident: (sample locations indicated as item 4) 5,395 ppm ammonia measured on Oct 23 2017	11	Separated brine system coupling. Pipe segment not supported for pressure loading

5	Brine filter changed April 13, 2017 – log book notes strong smell of ammonia. Filter valve found plugged and filter element clean	12	Brine spray in mechanical room
		13	Emergency discharge valve (firebox) - OPEN
6	Brine system valves found CLOSED

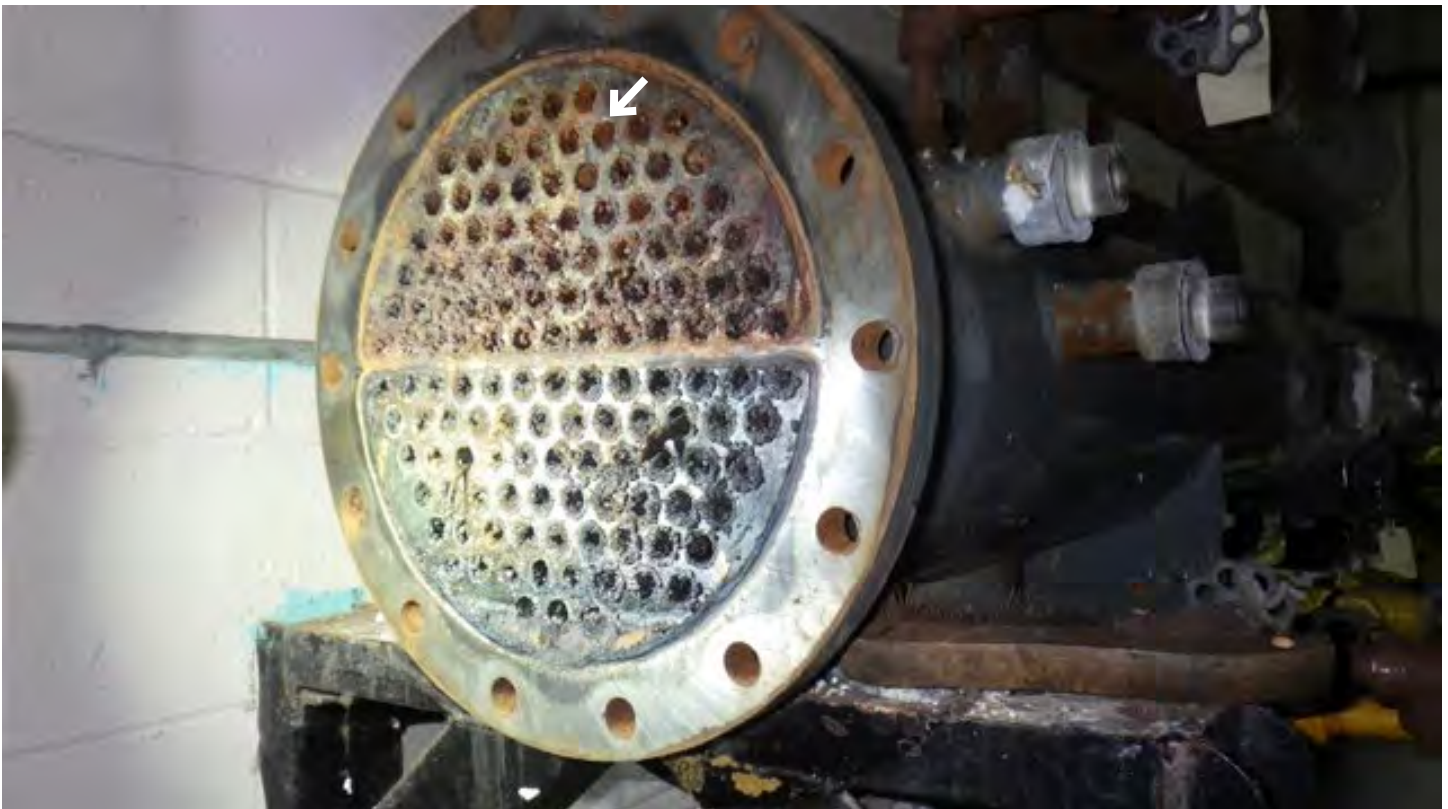
- Tubes and tube sheets appeared corroded and contaminated.
- Lower tube contamination was dark and oily in appearance.
- Contamination was soluble in water.
- Ultrasonic measurement detected one leaking tube (row 2, tube 3).
- The identified leaking tube was noticeably less contaminated than other tubes.

Photo 1: Curling chiller opened showing contamination. The leaking upper tube is identified by the white arrow – second row, third tube from the right side of the photo.

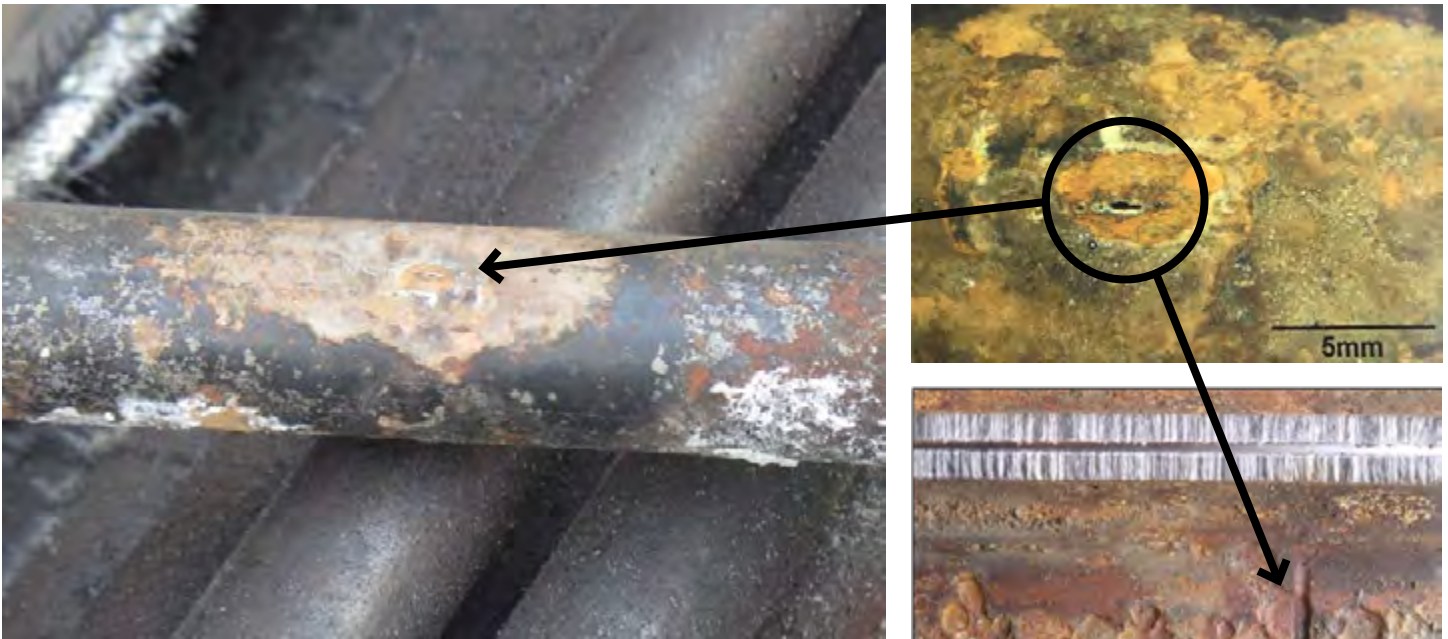
Ammonia was detected to have leaked into the curling brine system during the 2016/2017 operating season at the Fernie Memorial Arena. Examination of the curling brine chiller after the incident identified the source of the leak as a carbon-steel tube failure within the curling system brine chiller. The failed tube showed evidence of corrosion pitting along the inner tube walls with accelerated pitting on an electric resistance weld line due to weld line fusion defects. A corrosion penetration occurred at a weld location resulting in a hole measuring approximately 2.2 mm x 0.2 mm with potential adjacent smaller holes along the same weld line.

Photo 2 (above): outside of failed tube showing hole and corrosion due to brine spray.

Photo 3 (right-upper): close-up of hole from outside surface of tube.

Photo 4 (right-lower): close-up of hole from inside surface of tube showing pitting corrosion and line of smaller pits along weld line (Appendix E).

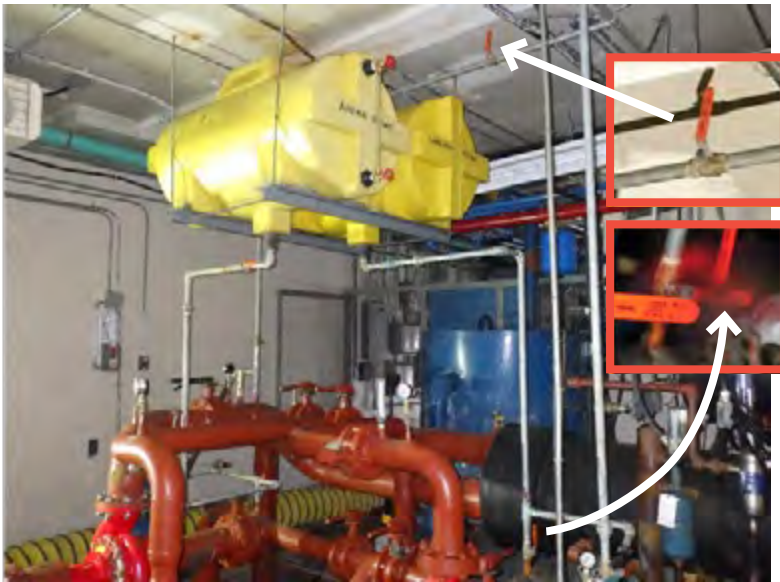
This configuration isolated an estimated 90 lb. of ammonia within the chiller (Appendix A) and inhibited brine system venting and pressure relief through the expansion tank.

Photo 5: Brine expansion tanks – closed valve positions as found after incident shown in photo insets. Main photo taken after hazardous material removal.

An inlet valve to the curling system brine expansion tank was found slightly cocked, as shown in the upper inset of Photo 5. The valve handle had been re-installed in a flipped condition allowing for a different orientation and range of motion. Lab analysis (Appendix E) estimated the handle angle at 10 degrees from perpendicular. Radiography and leak testing to determine if the valve was fully closed or permitting free flow (unplugged) was inconclusive. An exemplar valve was configured per the as-found valve and suggests this valve may not have been completely closed. In such an ‘almost closed’ and unplugged configuration, this valve may have facilitated some leakage while impeding pressure relief from brine expansion or displacement. This valve is concluded to be effectively closed but

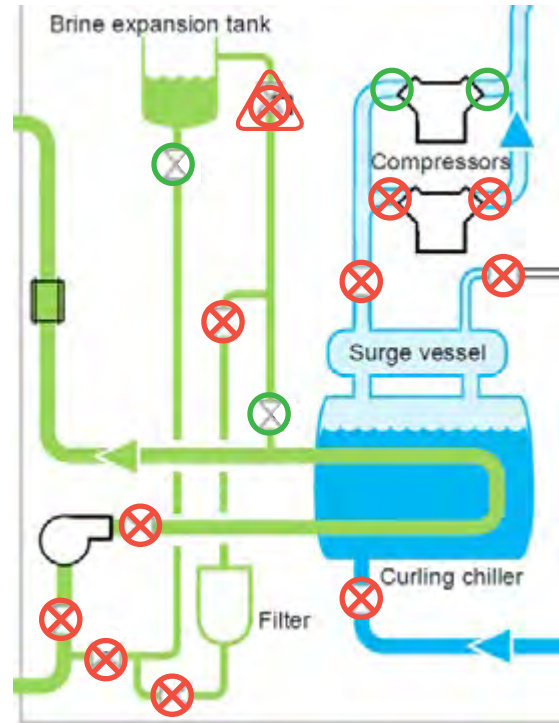
Figure 4: Valve positions found resulted with liquid ammonia contained in the leaking chiller and no pressure relief in the brine system.

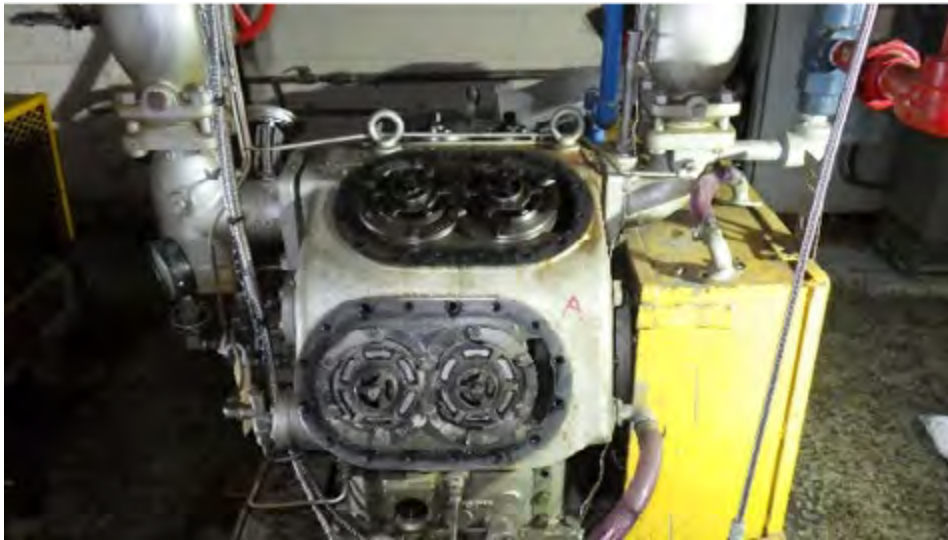
Oil with a cloudy or milky appearance is identified as an indication of a water/brine contamination. The compressor and cylinder heads were removed post incident and inspected which revealed the presence of salt deposits most likely from brine contamination of the ammonia.

Photo 6: Compressor #2 (#1 similar) showing salt crystal build-up on lower compressor cylinder heads, upper heads were clean.

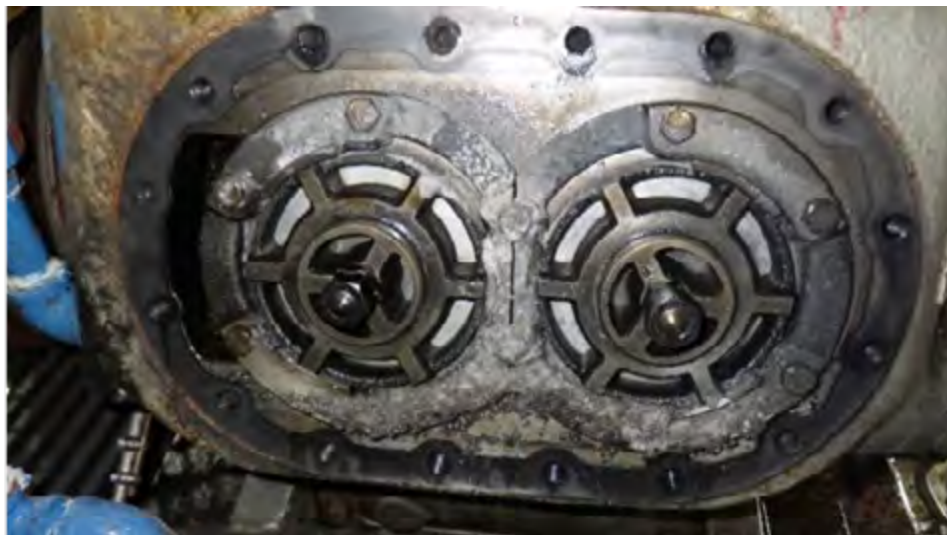
Photo 7: Build-up of salt crystals from brine around lower compressor cylinder heads of compressors #1 and #2.

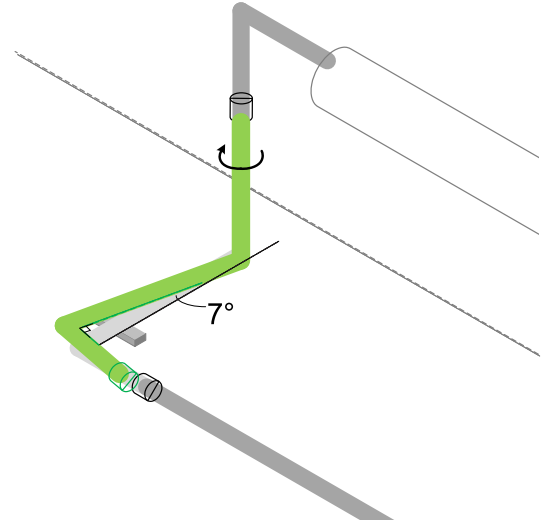
A brine system pipe segment was joined at two locations near the chiller by pipe couplings that were not supported to resist pipe movement from pressure or mechanically applied forces. The rising pressure within the brine system eventually exceeded the strength of the joint and one of the couplings separated. This separation suddenly depressurized the brine system and caused the ammonia in the system to rapidly expand, propelling the pipe contents into the room. As ammonia was released, it quickly expanded within the room, reaching estimated concentrations over 20,000 ppm.

Figure 5: Piping segment installed with in-line water system couplings.

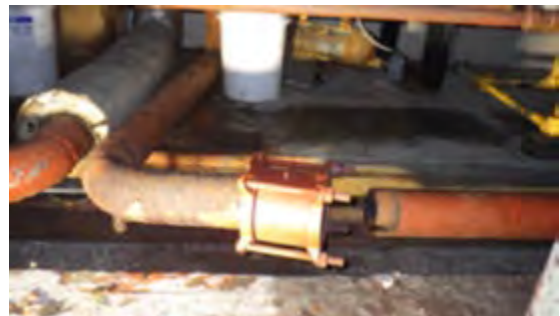
It is therefore estimated that the pressure within the brine system reached between 30 psi and 150 psi. The friction from the weight of the pipe and the torsional friction of the vertical coupling would have added to the force needed to separate the coupling beyond that associated with the 30 psi coupling separation pressure.

Photo 8: Separated brine system coupling.

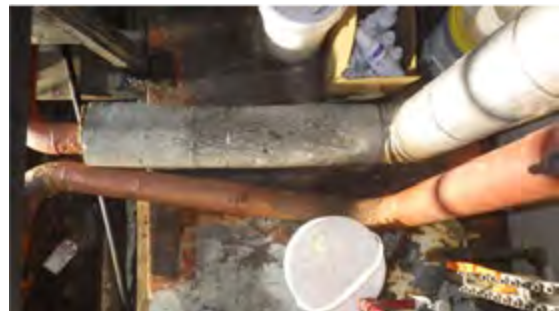
Photo 9: View looking down on pipe segment between vertical coupling and horizontal coupling. Angle of rotation estimated at approximately 7 degrees.

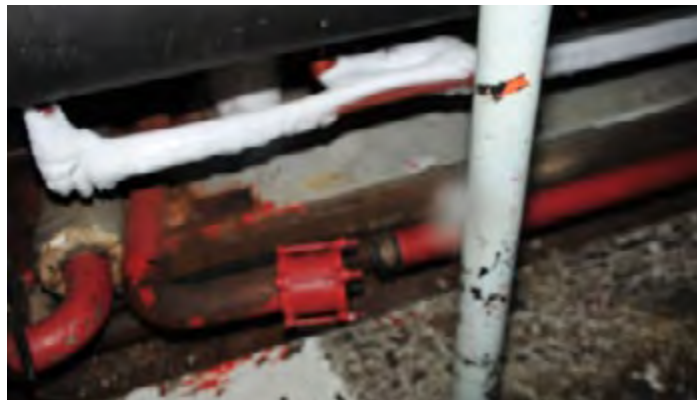
Evidence of brine chiller and pipe contents projecting from the separated brine system coupling was observed immediately following the incident as shown in Photo 10 and Photo 11 below.

Photo 10: Separated coupling and projected brine system contents. Photo taken on October 18, 2017.

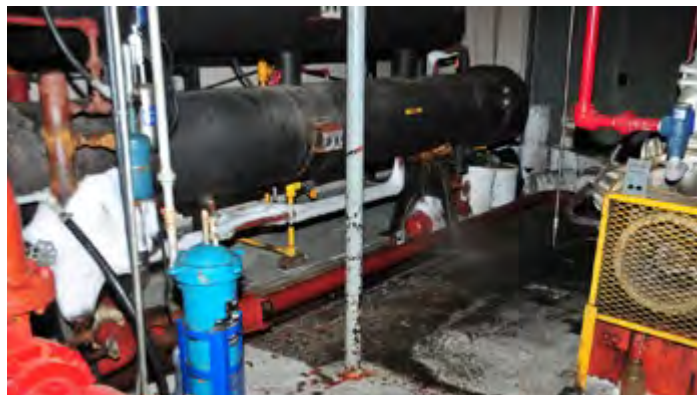
Photo 11: Projected contents of the brine piping from the separated coupling.

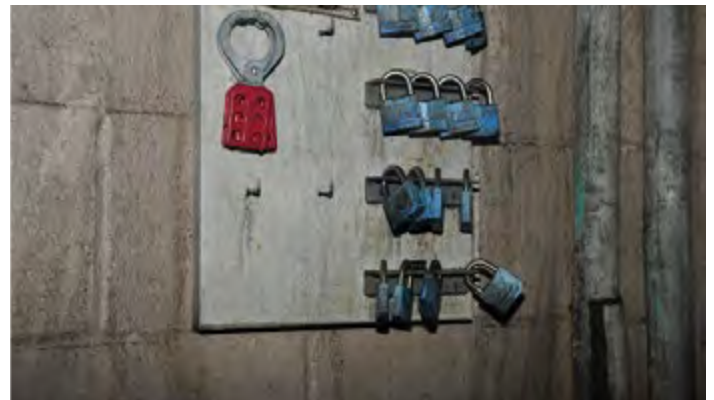
Exposed copper pipe and locks within the mechanical room were observed to be corroded (blue) indicating exposure to ammonia.

Photo 12: Lock-out board showing corroded (blue) copper consistent with ammonia exposure.

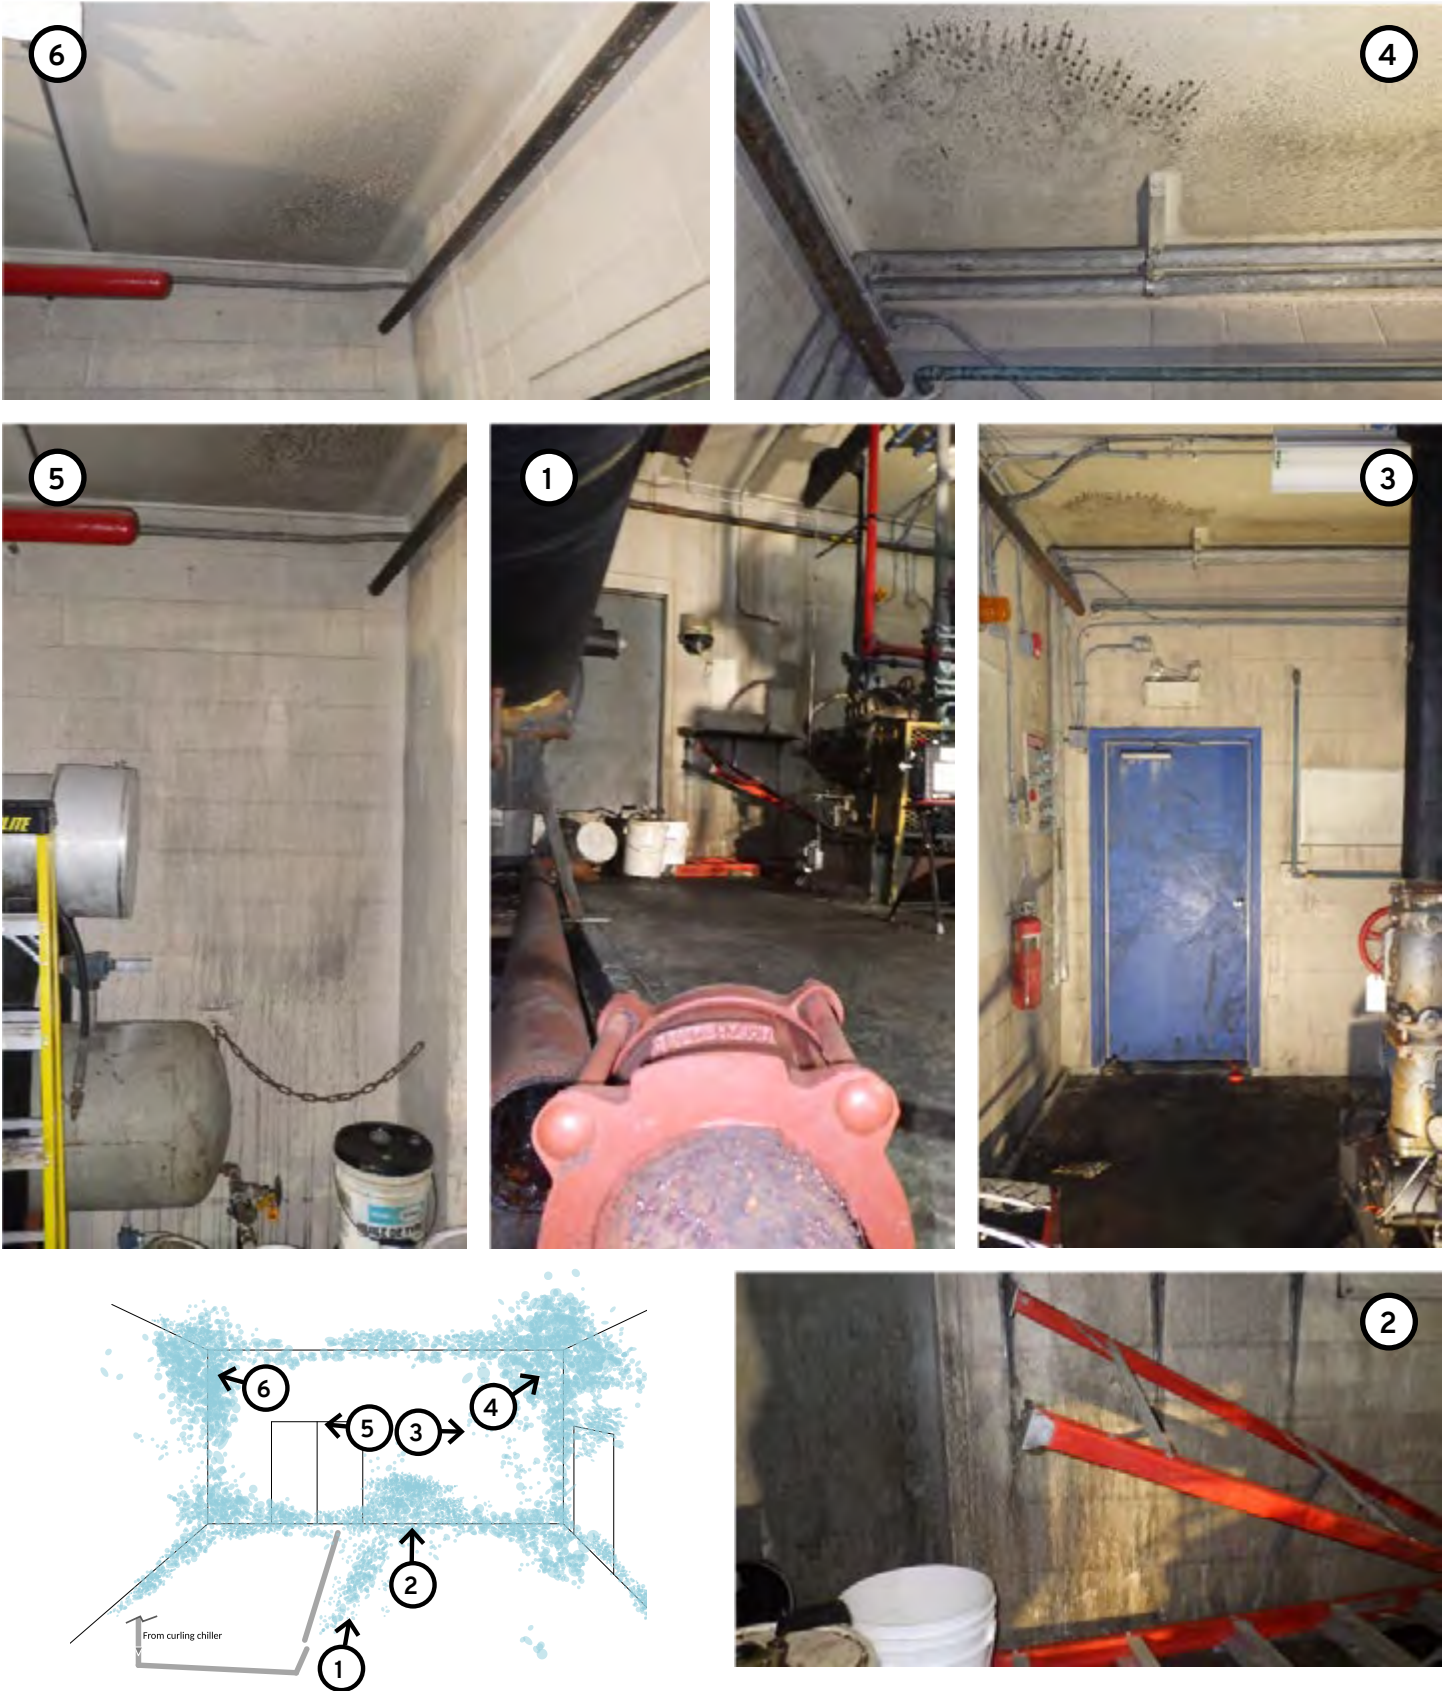
Samples from the residue on the walls were taken and analyzed. The results are contained in Appendix I and identified the likely presence of calcium chloride, consistent with brine having originated from the chiller/brine system piping.

Figure 6: Photos of residue locations on the mechanical room wall. Pattern location is consistent with originating from the separated brine coupling. Samples of the residue tested identified a likely presence of calcium chloride consistent with brine.

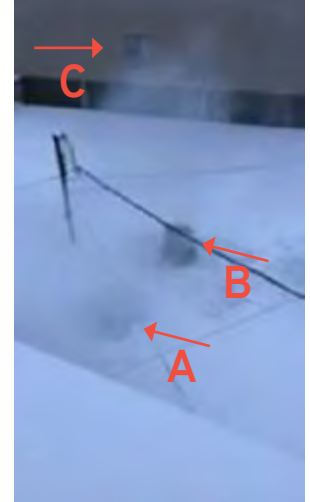
Photo 15 (above): Smoke test showing small fan (A) and large fan (B). Vented smoke shown moving toward air inlet on arena wall (C).

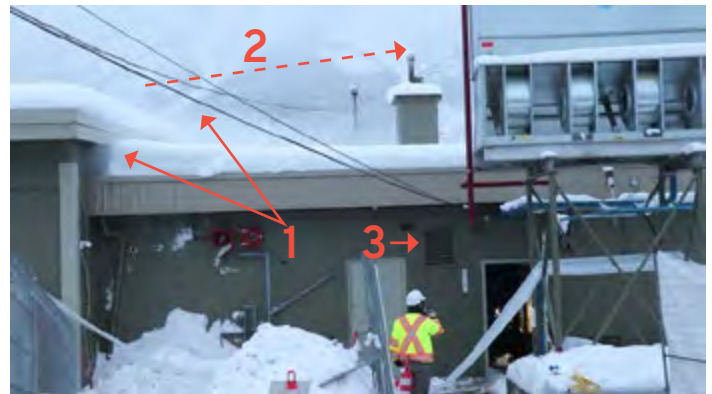
Photo 14 (above): Smoke test showing roof above mechanical room. Smoke became trapped (1) in depression between curling and arena roofs and was observed moving toward the roof edge rather than up into outside airstream (2). The air inlet for the furnace room for the building is identified (3).

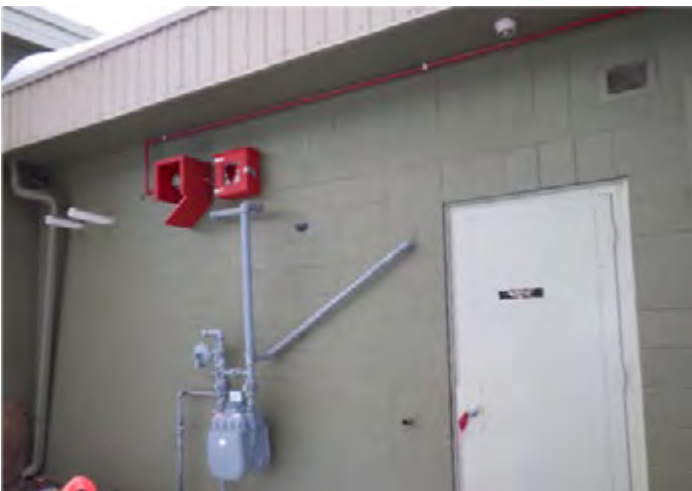
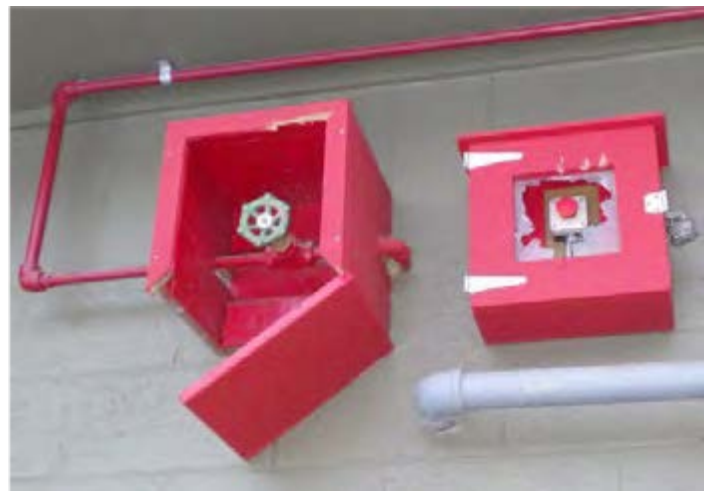
During the initial response to the incident, fire department first responders were instructed by a previous arena refrigeration operator to open the emergency discharge valve and activate the emergency stop button. The valve was opened at approximately 1:50 p.m. on October 17 and was evaluated to have initially released approximately 55 lb. of ammonia into the atmosphere.

Photos 16 (left) and 17 (right): Opened Emergency Discharge Valve and Actuated Emergency Stop Button.

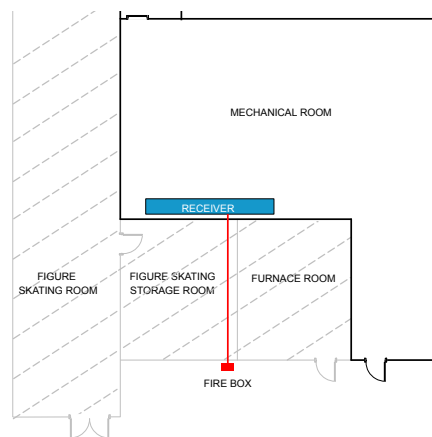
This pipe could have been mistaken for red fire suppression water piping. If this pipe had broken or been cut at any point, the contents of the liquid ammonia receiver and system would have leaked into the storage room. The emergency discharge system piping presented a risk of ammonia exposure due to pipe routing within the figure skating storage room.

Figure 17 (left): emergency discharge piping routed through figure skating club storage closet.

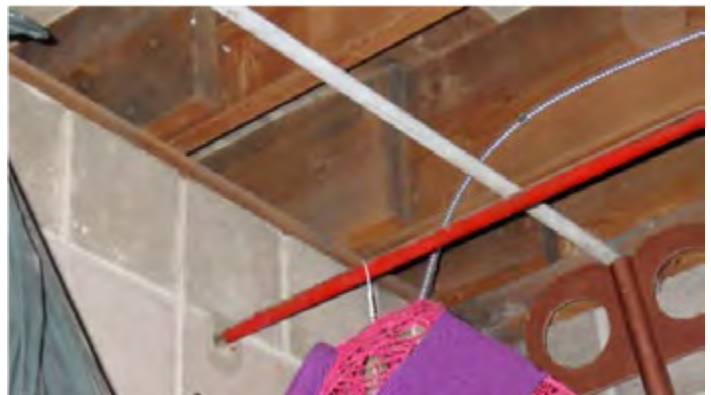
Photo 18 (above): Emergency discharge piping routed through concrete wall of closet used to hang storage item.
