## Incident Summary #II-877906-2019 (#14224) (FINAL)

SUPPORTING INFORMATION	Incident Date	July 8, 2019	
	Location	Prince George	
	Regulated industry sector	Electrical - Low voltage electrical system (30V to 750V)	
	Impact	Qty injuries	1
		Injury description	Minor burn on left wrist
	Damage	Injury rating	Insignificant
		Damage description	Minor arc damage to cover and panel case with minor damage to bus on the load side of the main breaker.
		Damage rating	Insignificant
	Incident rating	Insignificant	
Incident overview	A contractor was removing the panel cover when the cover contacted the main bus on the load side of the main breaker.		
INVESTIGATION CONCLUSIONS	Site, system and components	The main service is located in a small utility room in the basement. The building is older and has been renovated a number of times. The economy of space has made changes and additions difficult to execute in this room. The result is a very full utility room with very little working room.

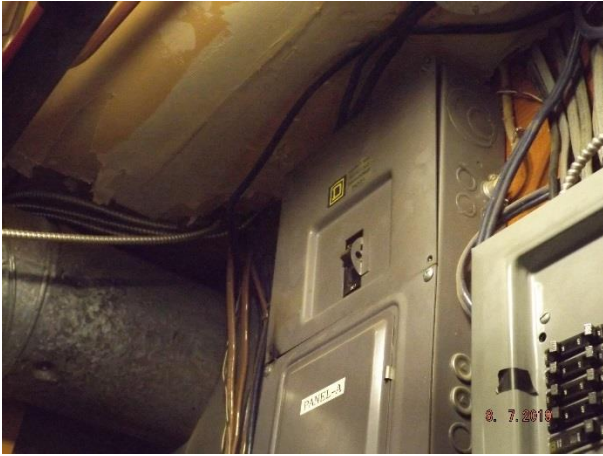
Photo 1: Panel location in basement. Utility room

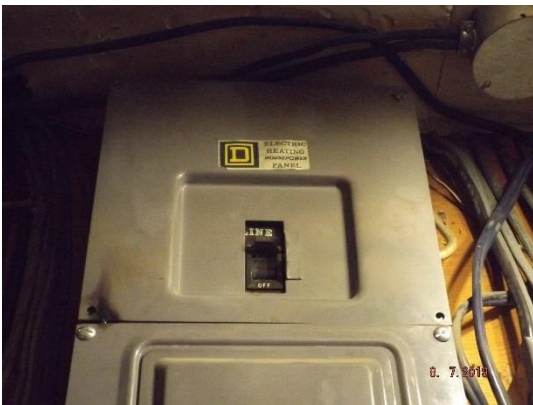
Failure scenario(s)	The building is older and has a large footprint. The building service is 200 amps single phase fed underground to the backside of the building. There has been a number of renovations to the building over the years. The main service panel is located too high. To remove the top panel cover a ladder is required to access the screws. The compact space in the utility room makes the positioning of the ladder in such a way that an individual is standing in an awkward position to remove the cover. This top panel cover has very little clearance from the bus due to the cover design. Tilting the cover more than ¼ inch would cause the cover to contact the bus.	
	Facts and evidence	When the power was disconnected at the meter base the cover was removed and the damaged checked. There was just minor arc damage. The cover was then placed in position and tilted forward. The contact point could be felt as the cover touched the bus. Contact was just under ¼ inch measured at the top of the panel case to the edge of the cover as it tilted forward.

Photo 2: Panel mounted too high

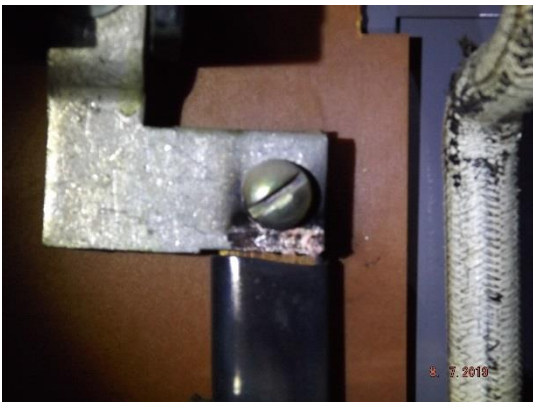
Causes and contributing factors	This Square D panel is a legacy product that is no longer supported. The covers are not easy to remove and care must be taken to remove the top cover, even under ideal conditions. Two people should be involved if the panel is energized. The clearance between the cover and bus does not allow for much movement of the cover, it would have to be firmly held in place as the screws are removed. In this case, it is highly probable that main contributing factor for this incident was the working environment created by the original electrical installation and the subsequent renovations that filled the utility room.

Photo 3: Panel cover contacted on this bus when the cover was tilted forward.

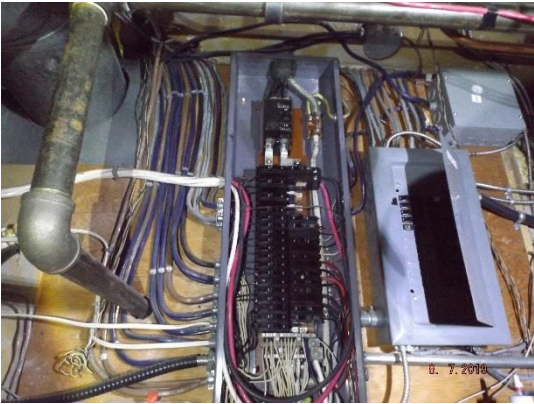
Photo 4: The main breaker did not trip during the fault. The location is difficult to work around.

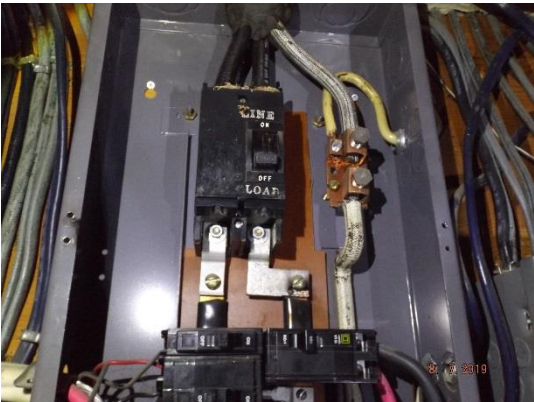
Photo 5: The panel height could have been fixed with a longer nipple from the meterbase. There is no evidence of a bond bushing on the service conduit.
