## Incident Summary (5608515)

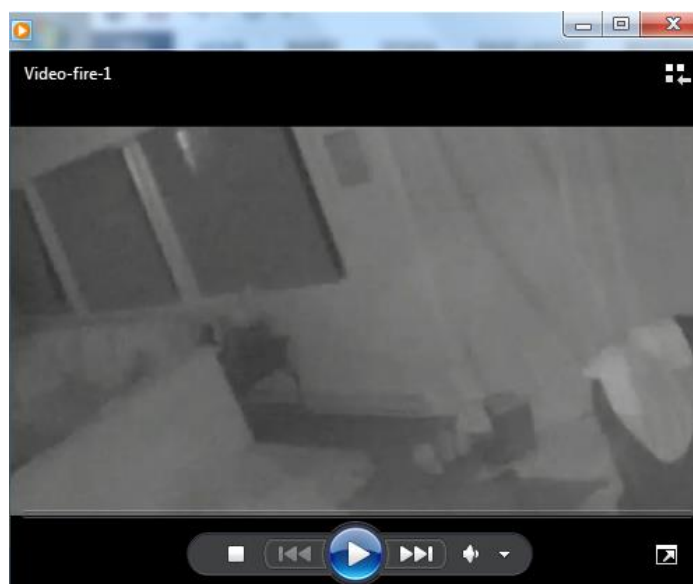
Figure #1 - Video home security footage of the incident confirming the baseboard heater as the point of origin for the fire.

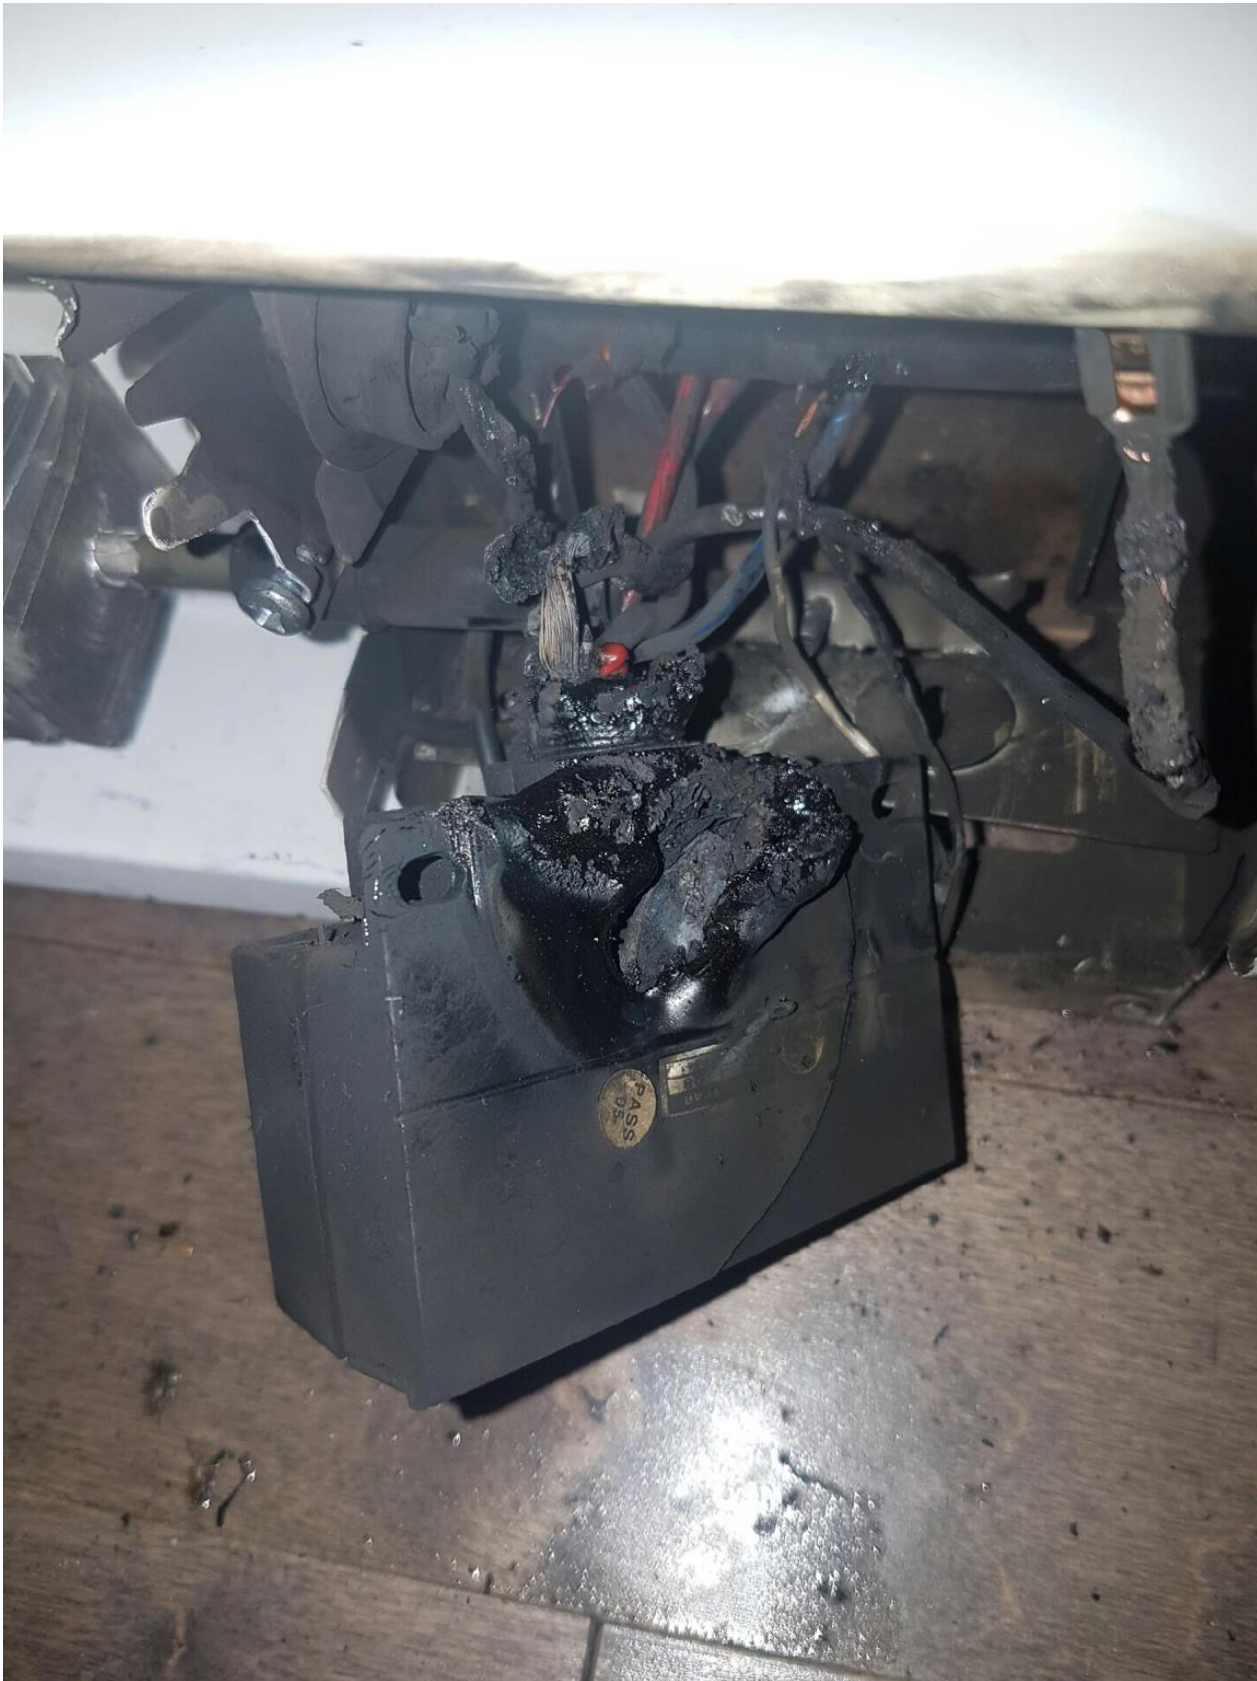
Figure #2 - Photo of relay with the side of the enclosure melted. Also showing the 240 volt and 24 volt wiring were not in separate compartments as per the manufacturer's instructions.

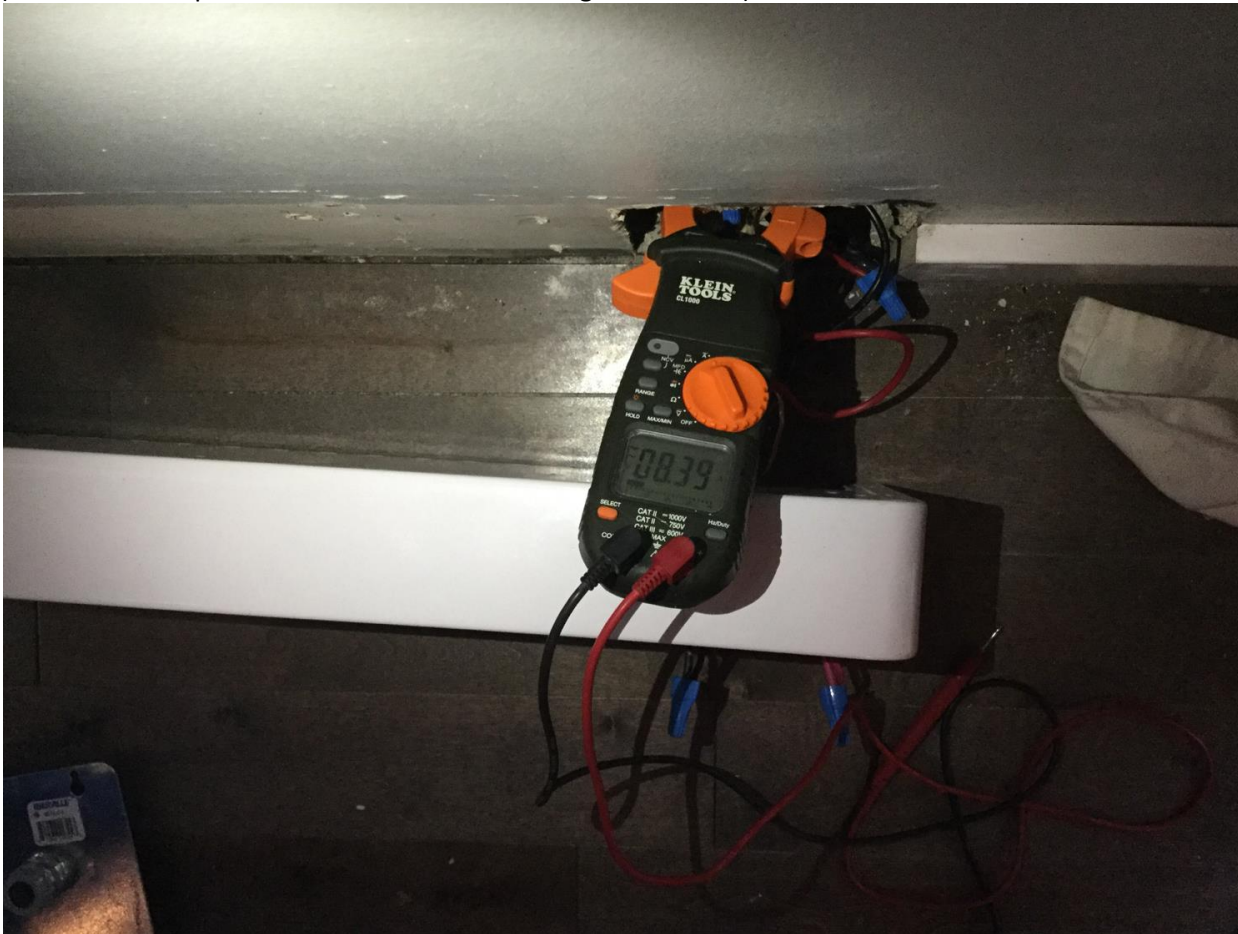
Figure #3 - Photo showing the circuit loaded at 8 amps on a 22 amp relay within tolerable levels.  
(Circuit and components rewired similar to during the incident)

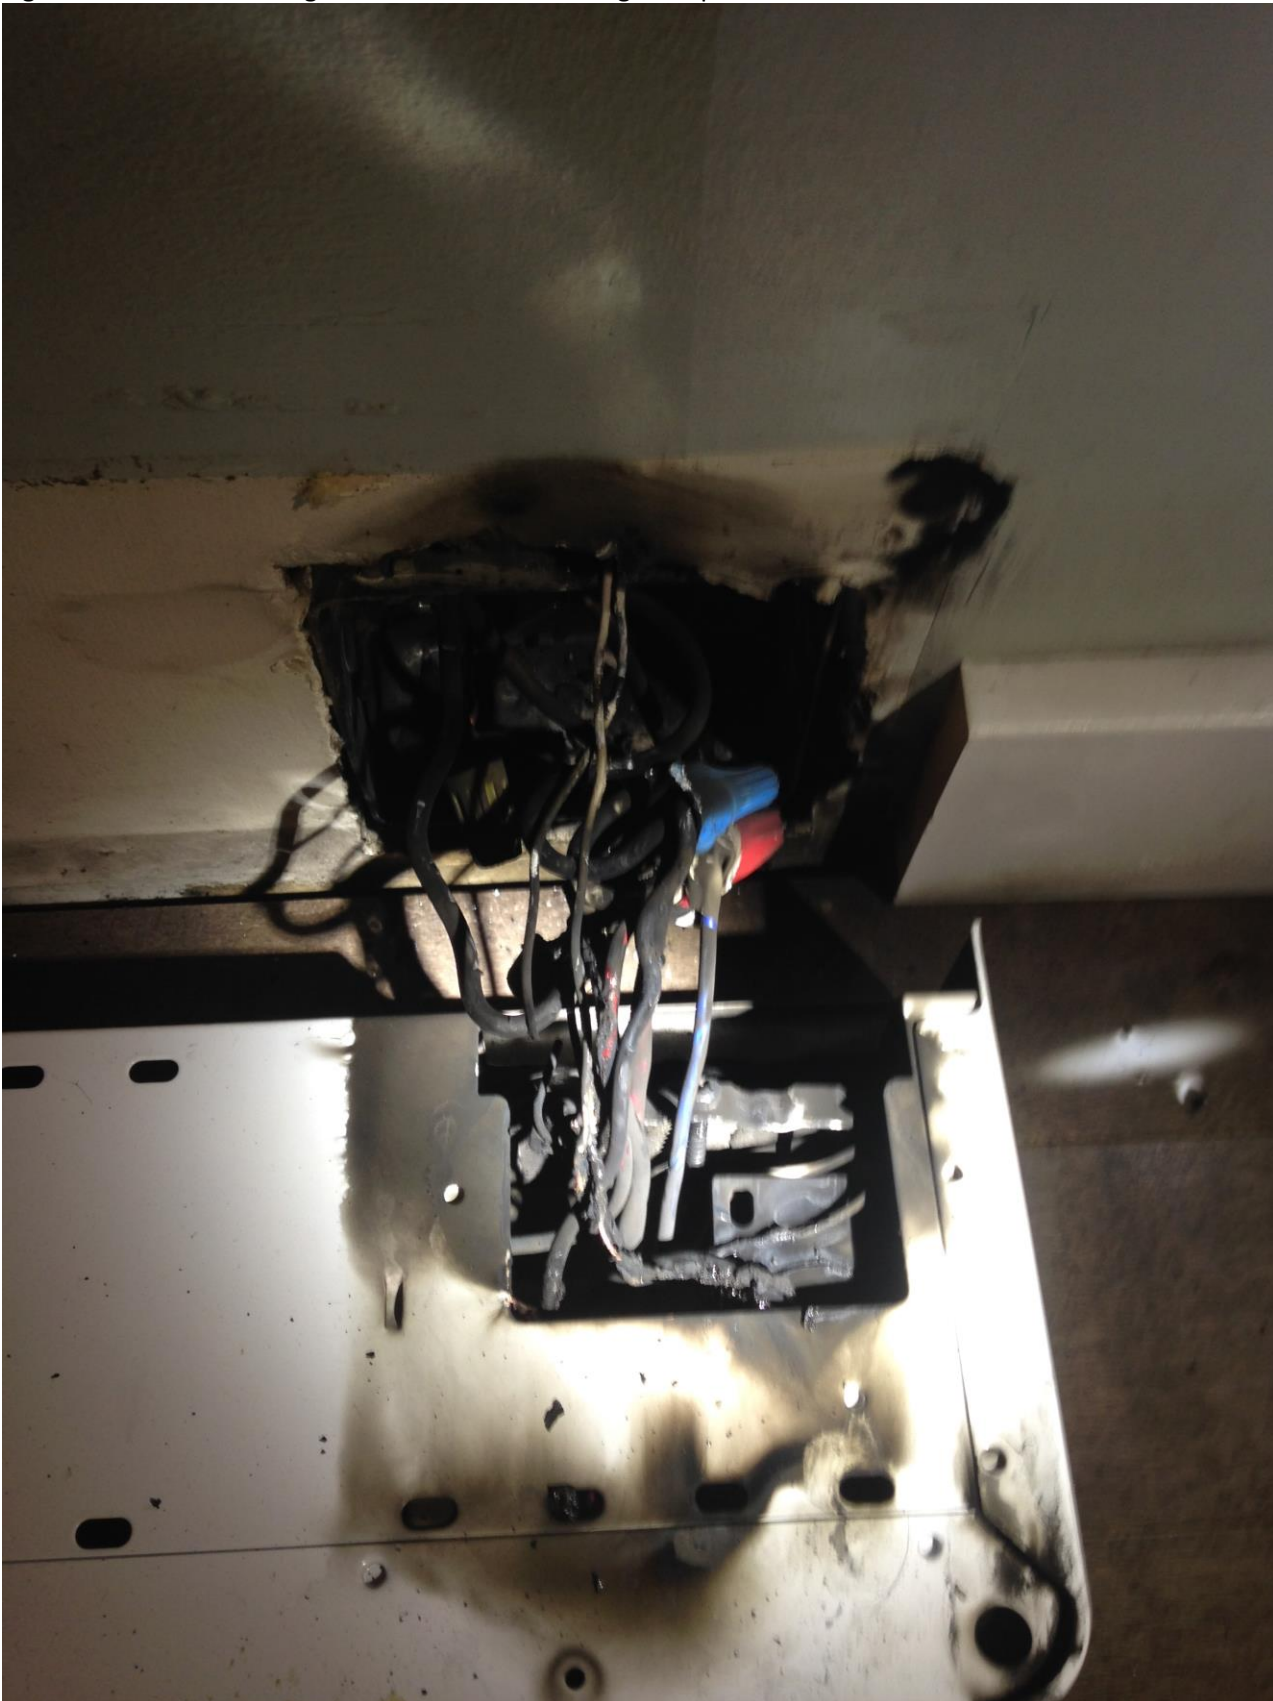
Figure #4 – Photo showing baseboard heater missing back plate.

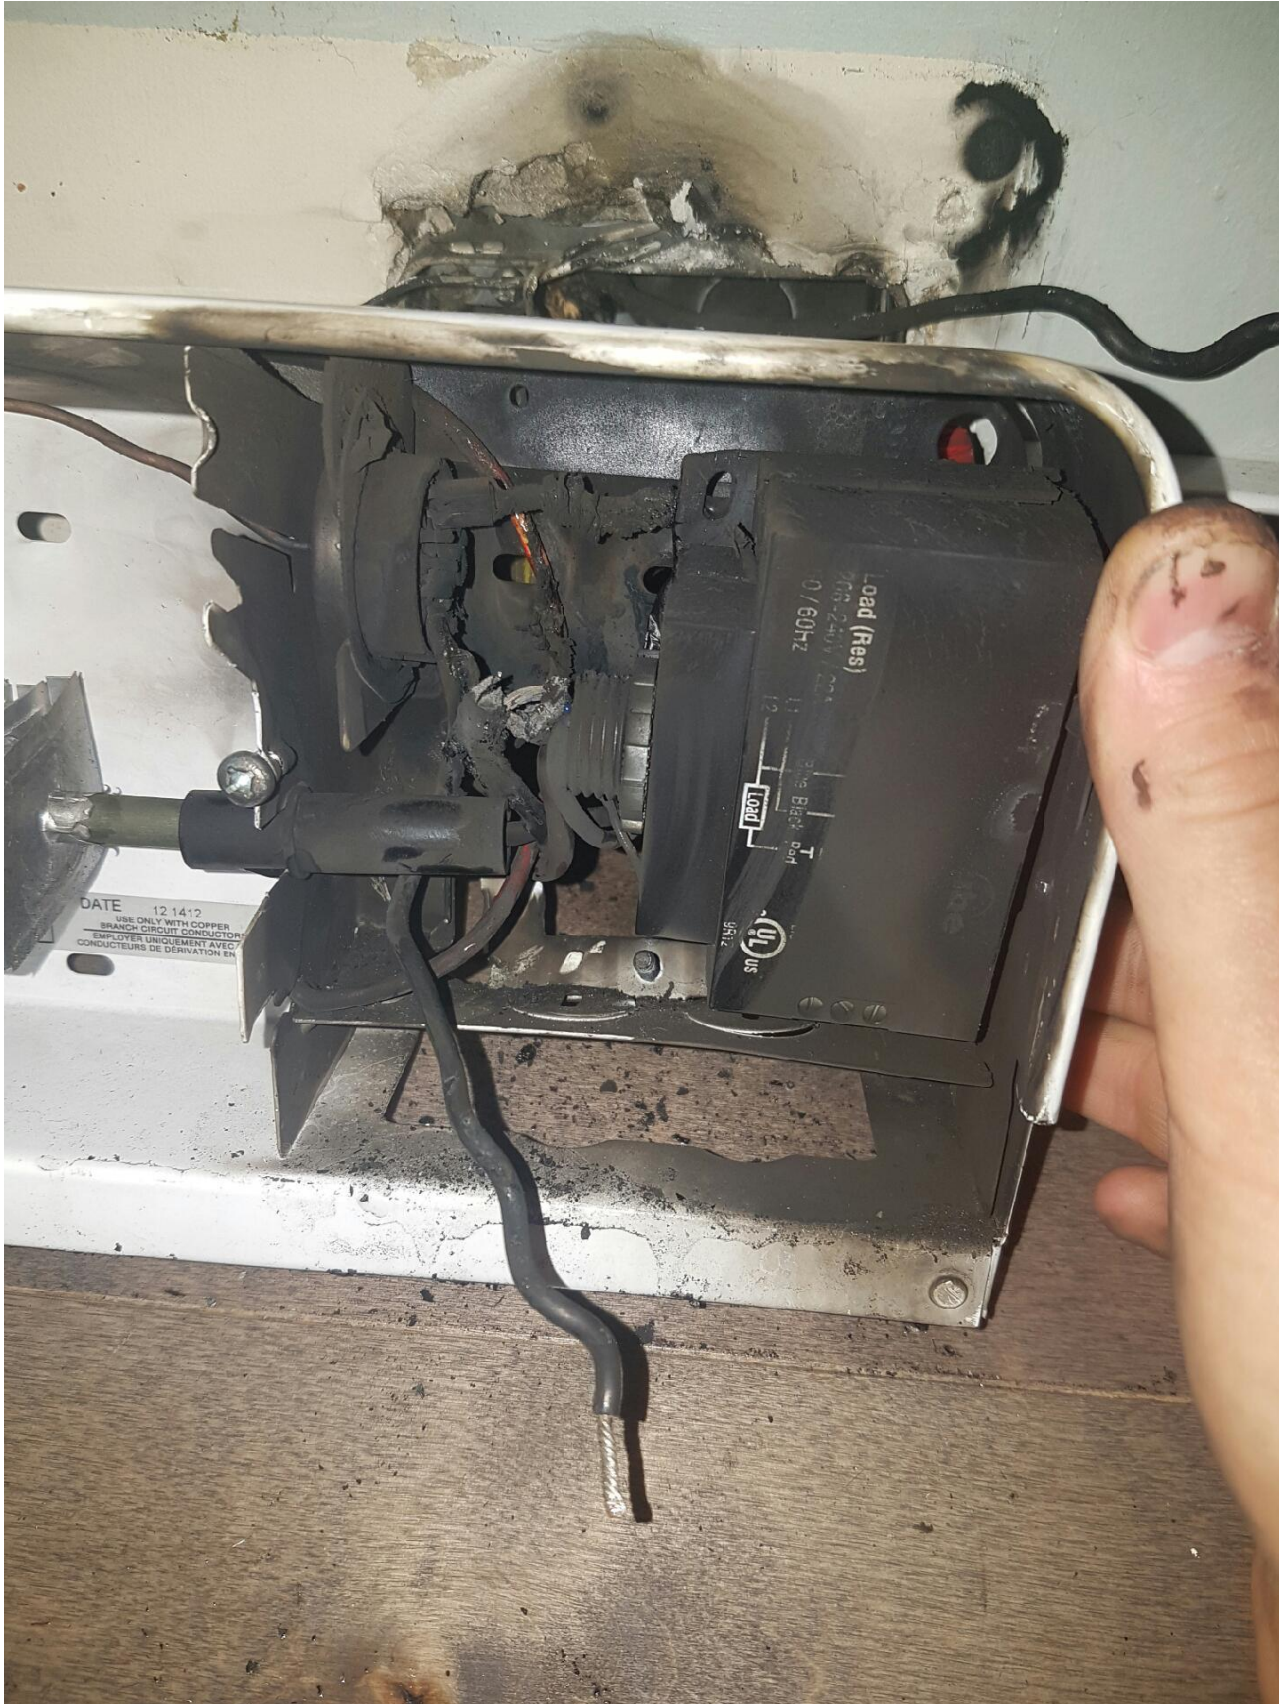
Figure #5 - Photo showing that the relay was not securely mounted as per the manufacturer's instructions.
