Incident Summary #II-965095-2020 (#16314) (FINAL)

SUPPORTING INFORMATION	Incident Date	Jan 9, 2020	
	Location	Victoria	
	Regulated industry sector	Elevating Devices – Freight Elevator	
	Impact	Qty injuries	1
		Injury description	Bruised Hand
		Injury rating	Minor
	Damage	Damage description	None
		Damage rating	None
Incident rating	Minor		
Incident overview	A user was entering the freight elevator with a rolling platform and the freight doors unexpectedly closed, striking their left hand. After striking their hand, the freight door reversed direction and re-opened.		
INVESTIGATION CONCLUSIONS	Site, system and components	At the car station panel (inside the car, door-open and door-close buttons are used to open and close the powered freight elevator doors (See Photos Below). These buttons activate relays that subsequently power the opening and closing of the doors. The freight elevator doors should not close unless the user presses and holds the door-close button and continues to hold it until the doors are fully closed. If the door-close button is released before the doors are fully closed, the freight doors will stop, reverse direction and re-open. The bi-parting freight doors con

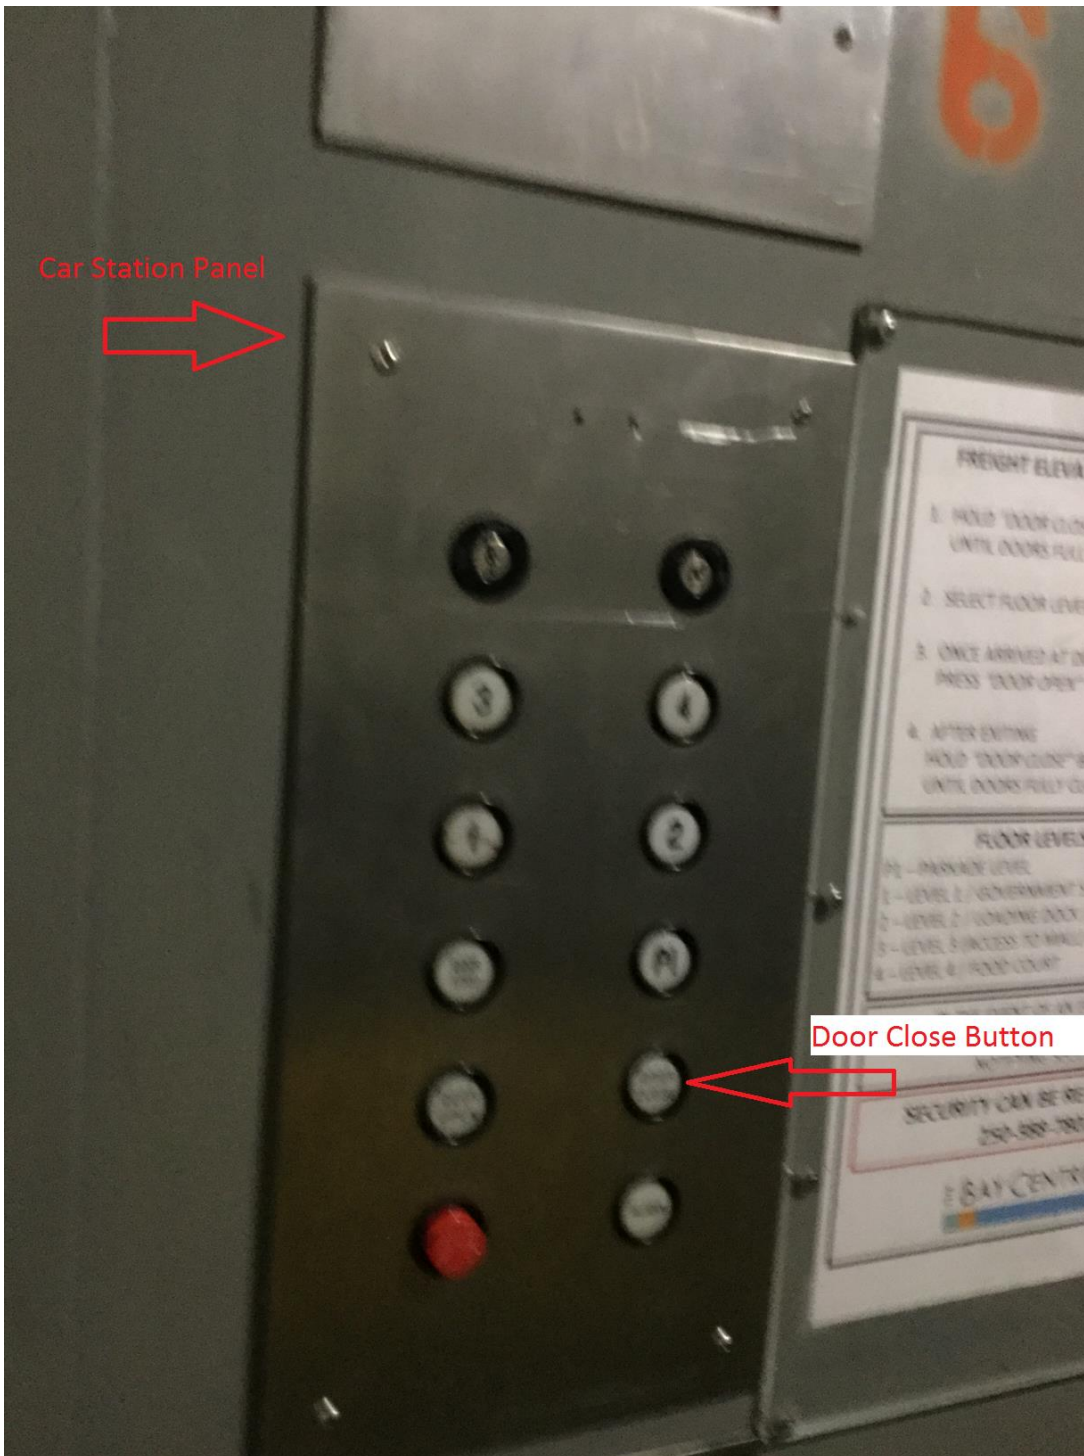
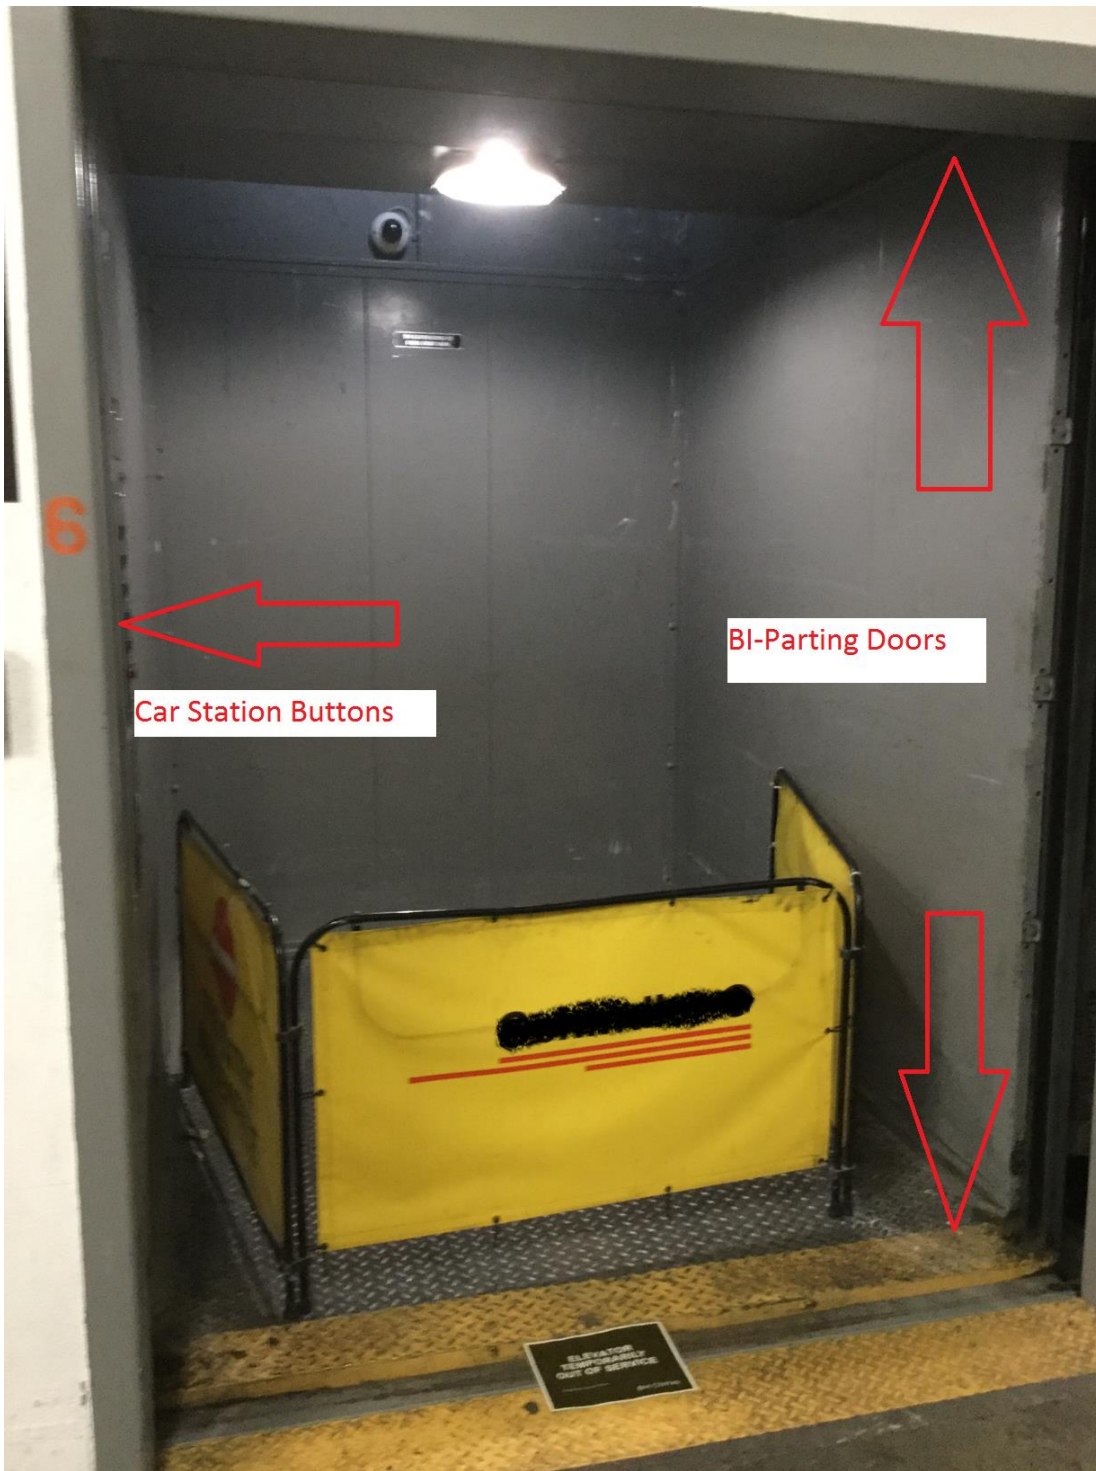
<ul style="list-style-type: none"> • Contractor confirmed that the relays located in controller, some of which operate the powered door, were going to be replaced as a precaution to eliminate them as a possible cause of the intermittent fault. • The contractor was informed they must contact the safety officer when the work was complete and prior to returning the elevator back to service. The elevator remained locked off since the incident occurred and was to remain out of service until repair work was confirmed with the safety officer. • The controller relays were replaced. • A secondary fault was then noted by the contractor when the car station panel was taken apart. The push button for the door-close operation was faulty, the door-close button was replaced. • Safety Officer confirmed the unit could be returned to service based on a conversation with the contractor (mechanic), where it was clear the car station push button was the likely cause of intermittent short(s). Testing was completed by the contractor with no faults found.

<p>Causes and contributing factors</p>	<p>A faulty door-close push button at the car operating panel, was likely the main contributing factor to the incident. A faulty door-close relay was possibly a secondary contributing factor to the incident.</p>
