Incident Summary #II-1011125-2020 (#17192) (FINAL)

SUPPORTING INFORMATION	Incident Date	May 6, 2020	
	Location	Interior	
	Regulated industry sector	Passenger ropeways - Above surface ropeway	
	Impact	Qty injuries	0
		Injury description	N/A
		Injury rating	None
	Damage	Damage description	Haul rope abrasion, bent grip jaw and the work carrier platform and hanger bent and twisted. Deformation of the top terminal door closing mechanism.
		Damage rating	Moderate
	Incident rating	Moderate	
	Incident overview	During maintenance work, while ropeway was closed to public for the season an unoccupied work carrier came into terminal too fast and became entangled with terminal door closing device.	
INVESTIGATION CONCLUSIONS	Site, system and components	The pulsed ropeway carries passengers in an arrangement of 3 gondolas grouped together, a pod. The pod is fixed to the haul rope and another pod is fixed symmetrically to the first pod, balancing the ropeway. As pod 1 is at the bottom terminal, pod 2 will be at the top terminal. The ropeway operates continuously in one direction, slows as the pods approach the terminals and accelerates as the pods depart terminals. The ropeway speed changes (puls

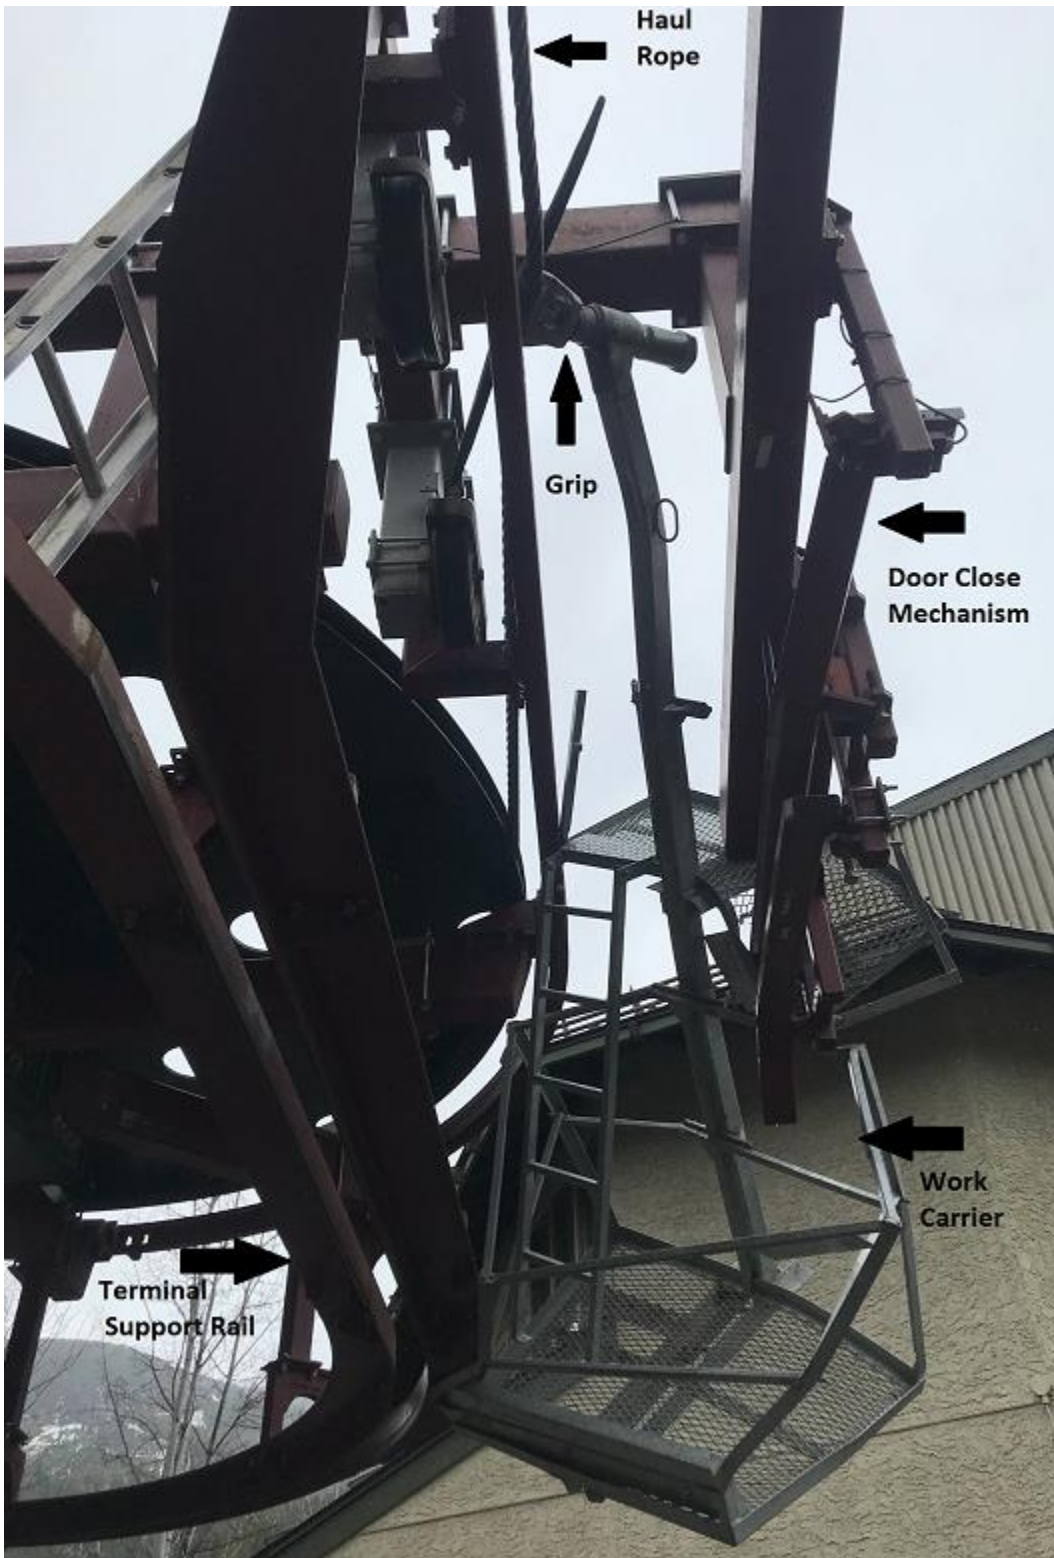
Running the work carrier through the top terminal at operating speed caused the work carrier to impact the terminal. Damaging the work carrier, the terminal door close mechanism and haul rope abrasion. Positioning the work carrier to be alone and in a place where the ropeway would not automatically slow upon approach of top terminal is certainly a contributing factor.

Entangled Work Carrier with Terminal
