## Incident Summary #II-1346918-2022 (#26711) (FINAL)

SUPPORTING INFORMATION	Incident Date	March 18, 2022	
	Location	Port Coquitlam	
	Regulated industry sector	Electrical - Low voltage electrical system (30V to 750V)	
	Impact	Qty injuries	0
		Injury description	No Injuries
		Injury rating	None
	Damage	Damage description	Arcing and corrosion damage to an electrical floor receptacle located in a grocery stores customer walking area.
		Damage rating	Minor
Incident rating	Minor		
Incident overview	Water and corrosive contaminants (wax floor stripper and floor cleaners) used to clean the floors in a grocery store seeped into the floor receptacle. Over time this caused damage to the floor receptacle gaskets and caused the metal components of the receptacle to corrode and oxidize.		
INVESTIGATION CONCLUSIONS	Site, system and components	<p>When receptacles are installed in floors, they are required to be installed in floor boxes. These floor boxes are either installed flush with the finished floor or raised slightly above and are equipped with special covers designed to restrict water, dust and other particulates from contacting the receptacle when not in use.</p> <p>Receptacles are insta

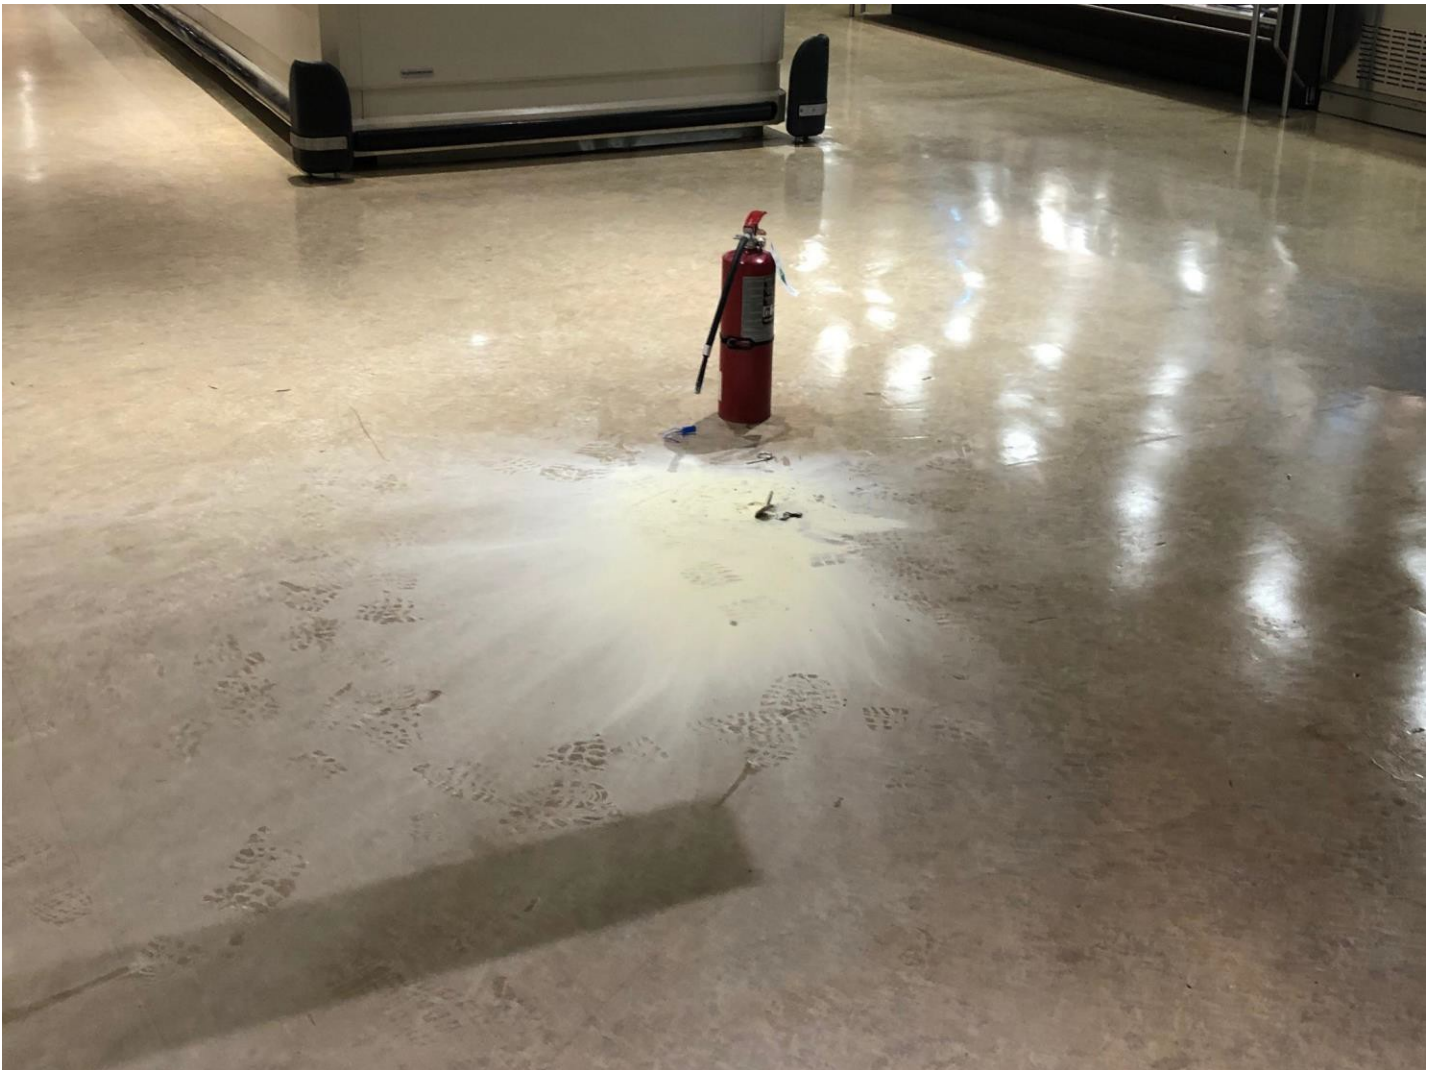
Image 1 – Location of floor receptacle involved in the incident.

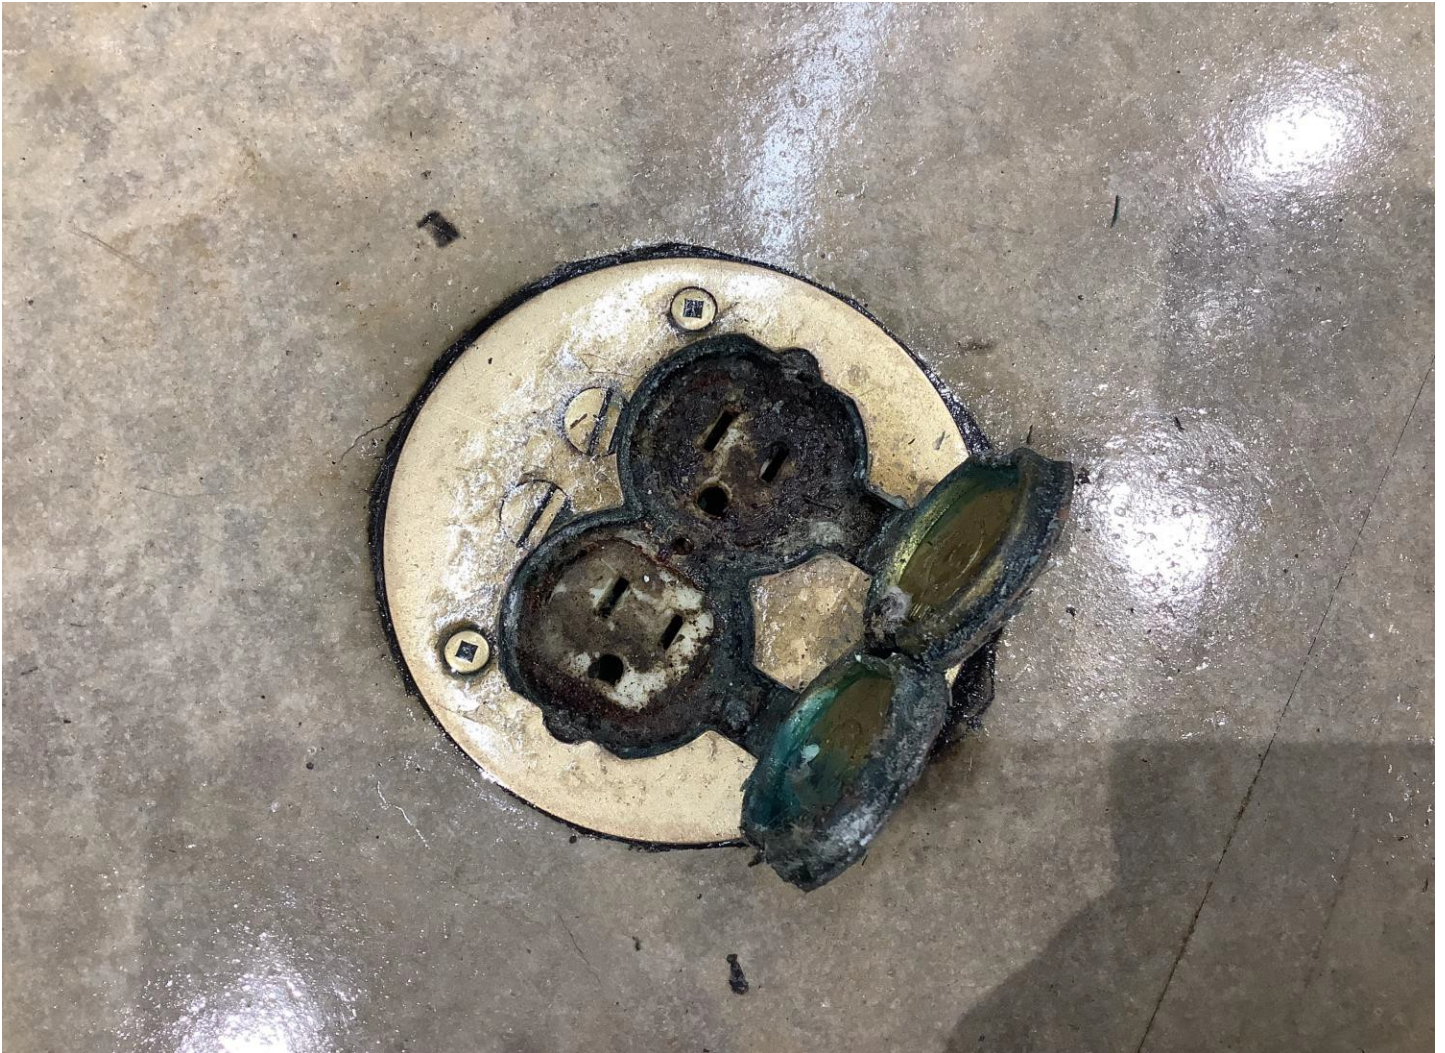
Image 2 – Images (2-5) are from a sampled floor receptacle located in the same building showing corrosion (not the one involved in the incident) sampled receptacle was energized before removal.

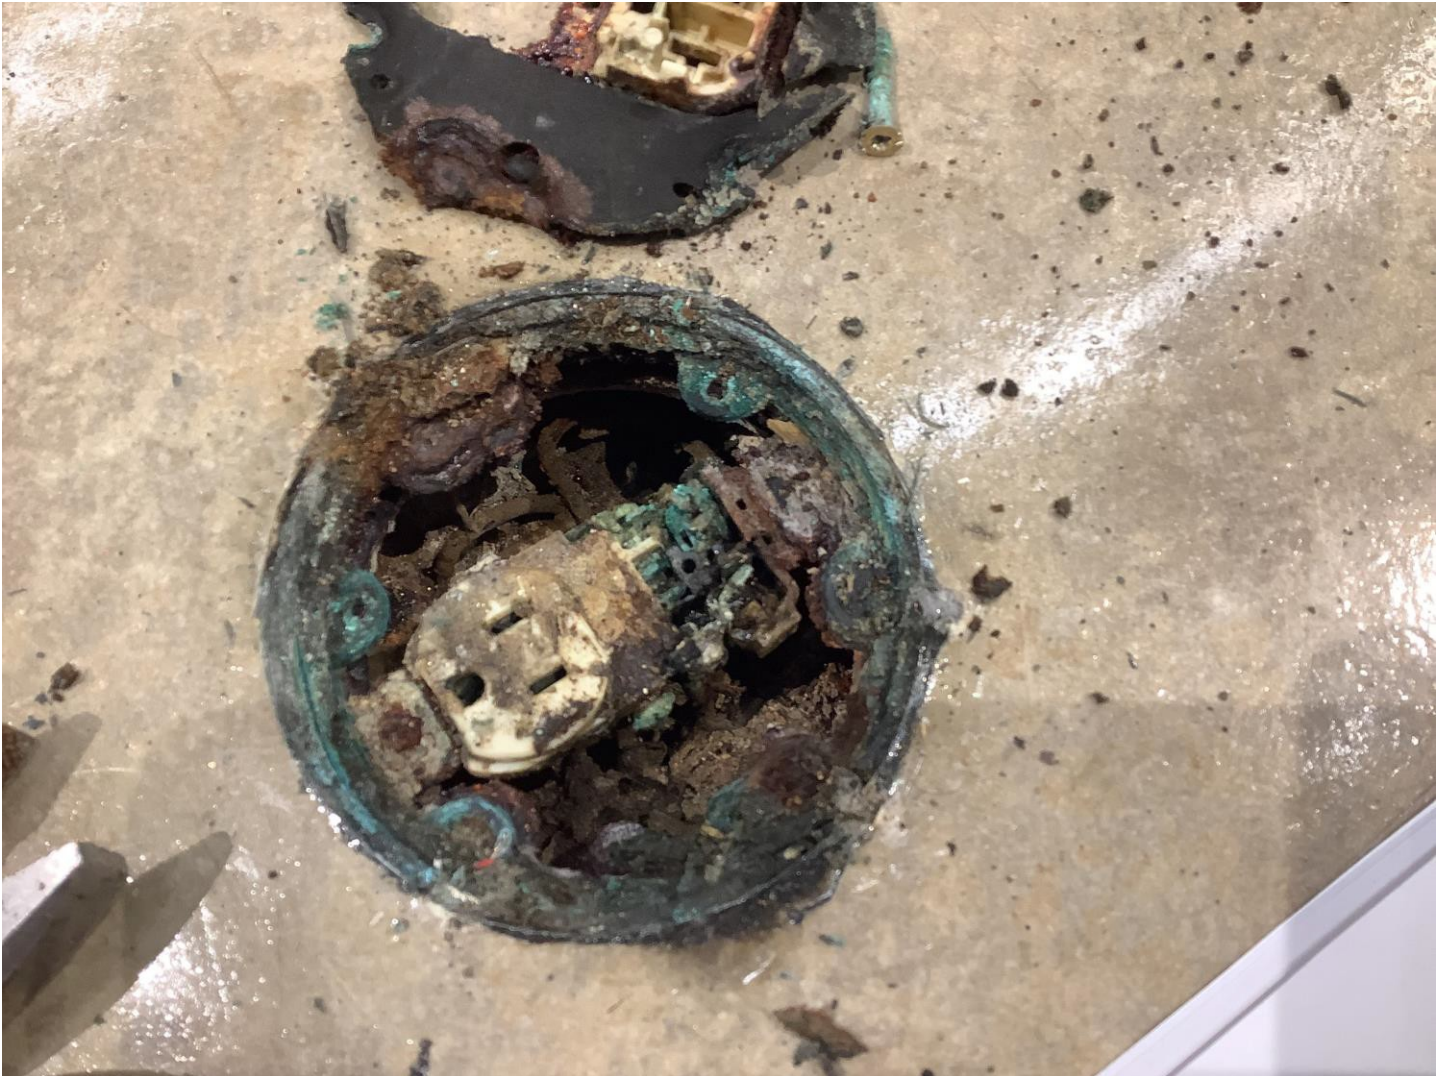
Causes and contributing factors	<p>It is highly probable that over time the floor cleaning, finishing and treatment liquids damaged the floor receptacle gaskets allowing moisture and particulates to enter the receptacle causing the receptacle to corrode, rust and oxidize. Those liquids created shorting between the energized components and grounded components of the receptacle leading to overheating and/or arcing causing the smoke to be emitted from the floor receptacle.</p>

Image 3 – Floor receptacle with cover and gasket removed, when the cover was removed the receptacle corrosion was so severe the receptacle broke away exposing the corroded unprotected terminals.

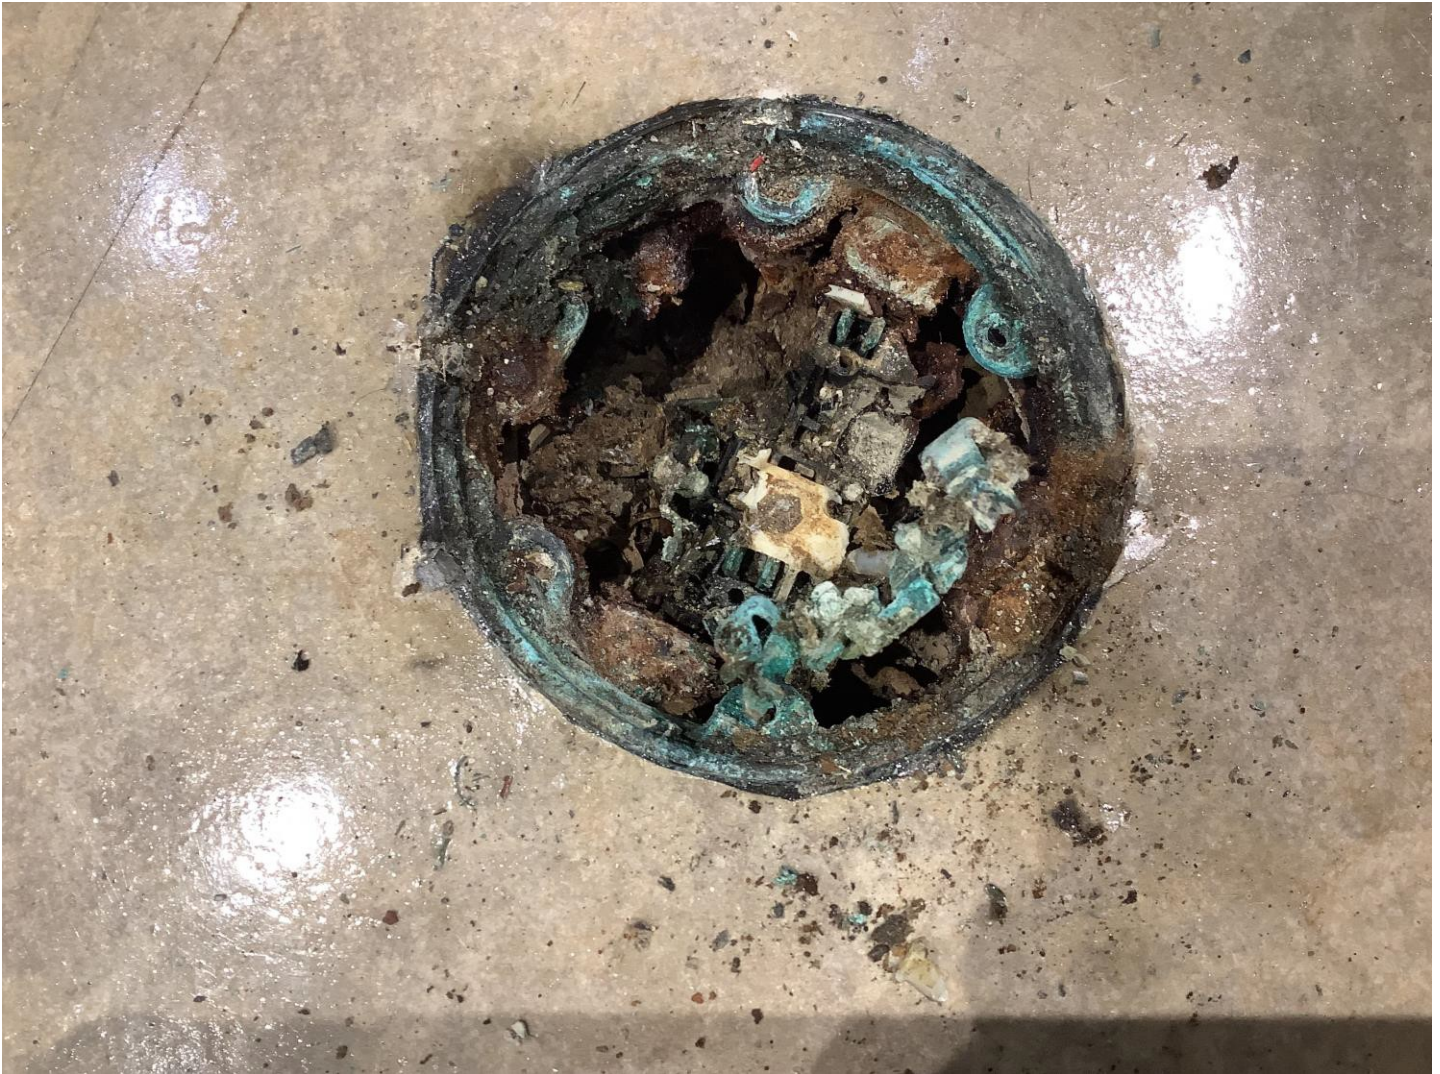
Image 4 – Removing the receptacle from the floor box, the corrosion was so severe the receptacle was fragmenting into pieces.

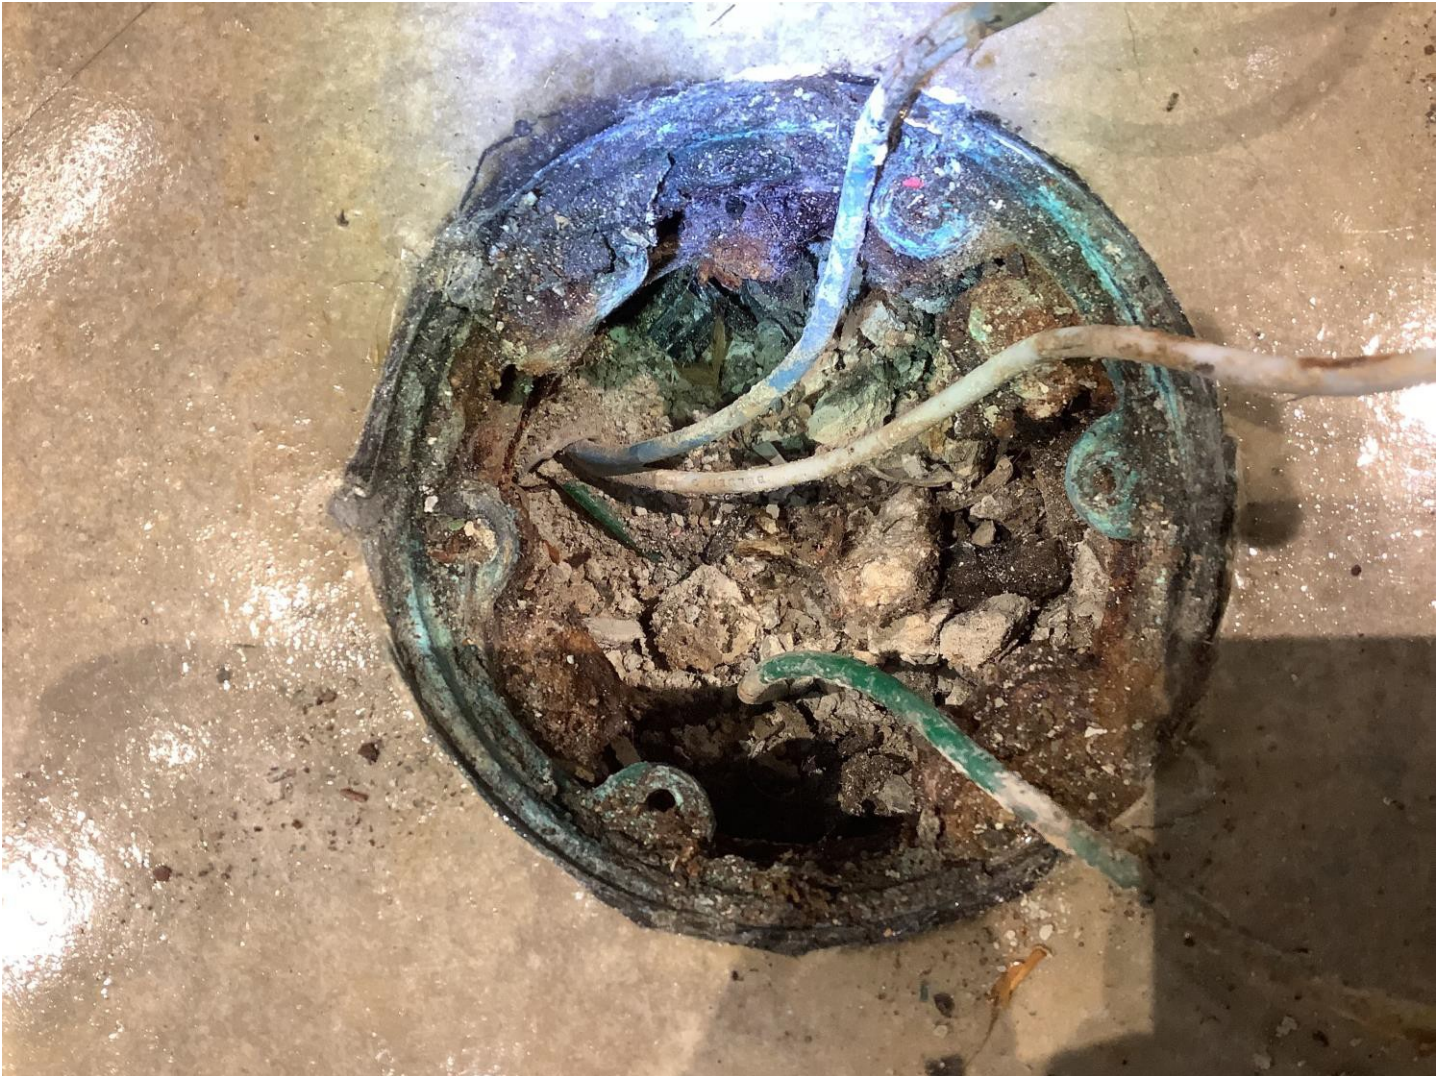
Image 5 – The amount of debris inside the floor box.
