Incident Summary #II-1114872-2020 (#20141) (FINAL)

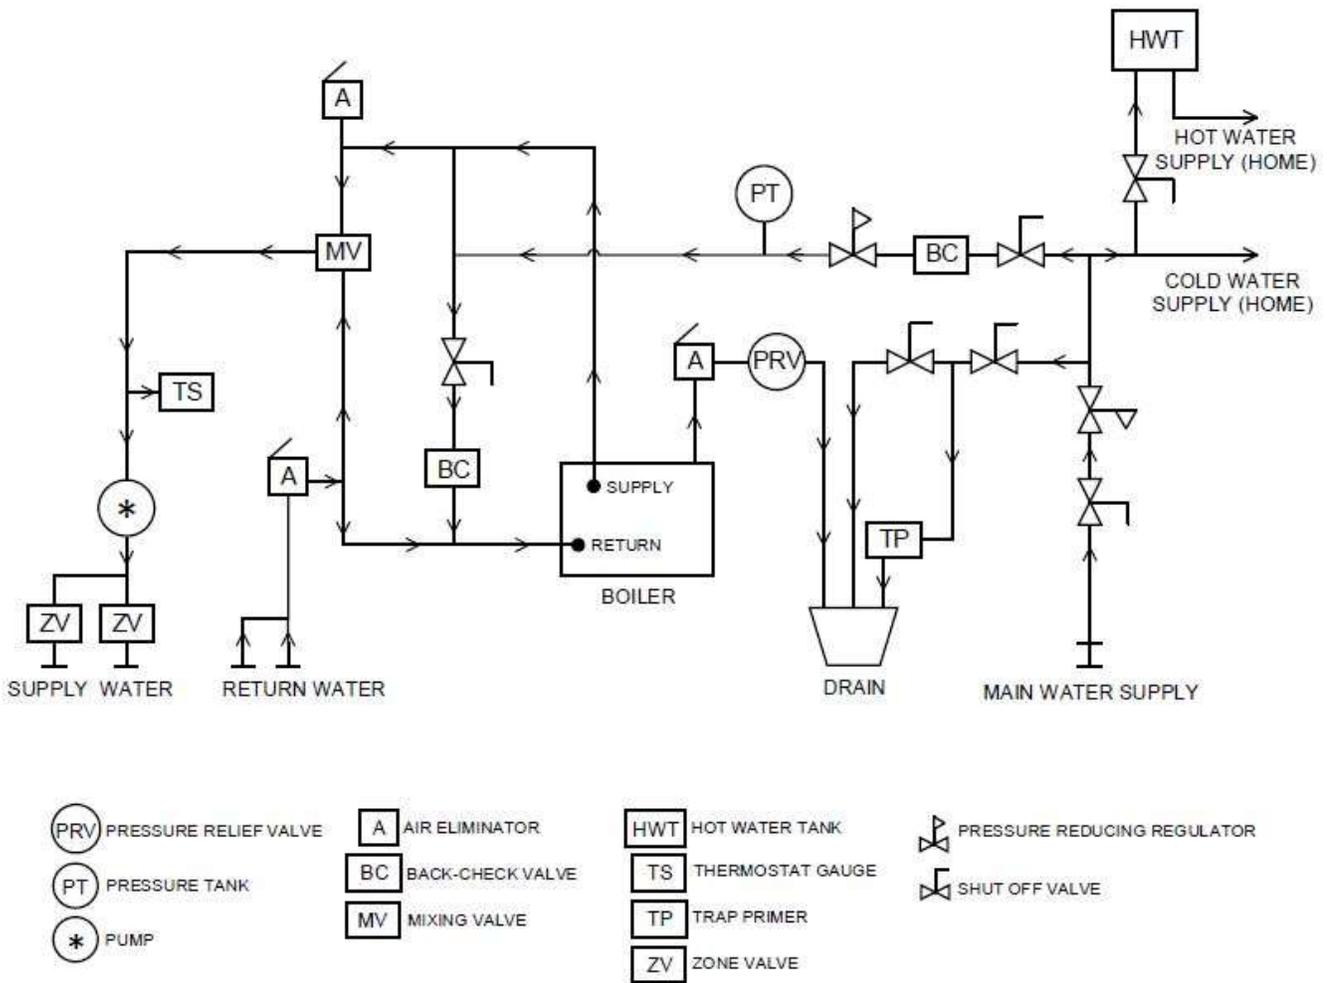
Image 1 – Diagram of hydronic heating system identifying components and water flow

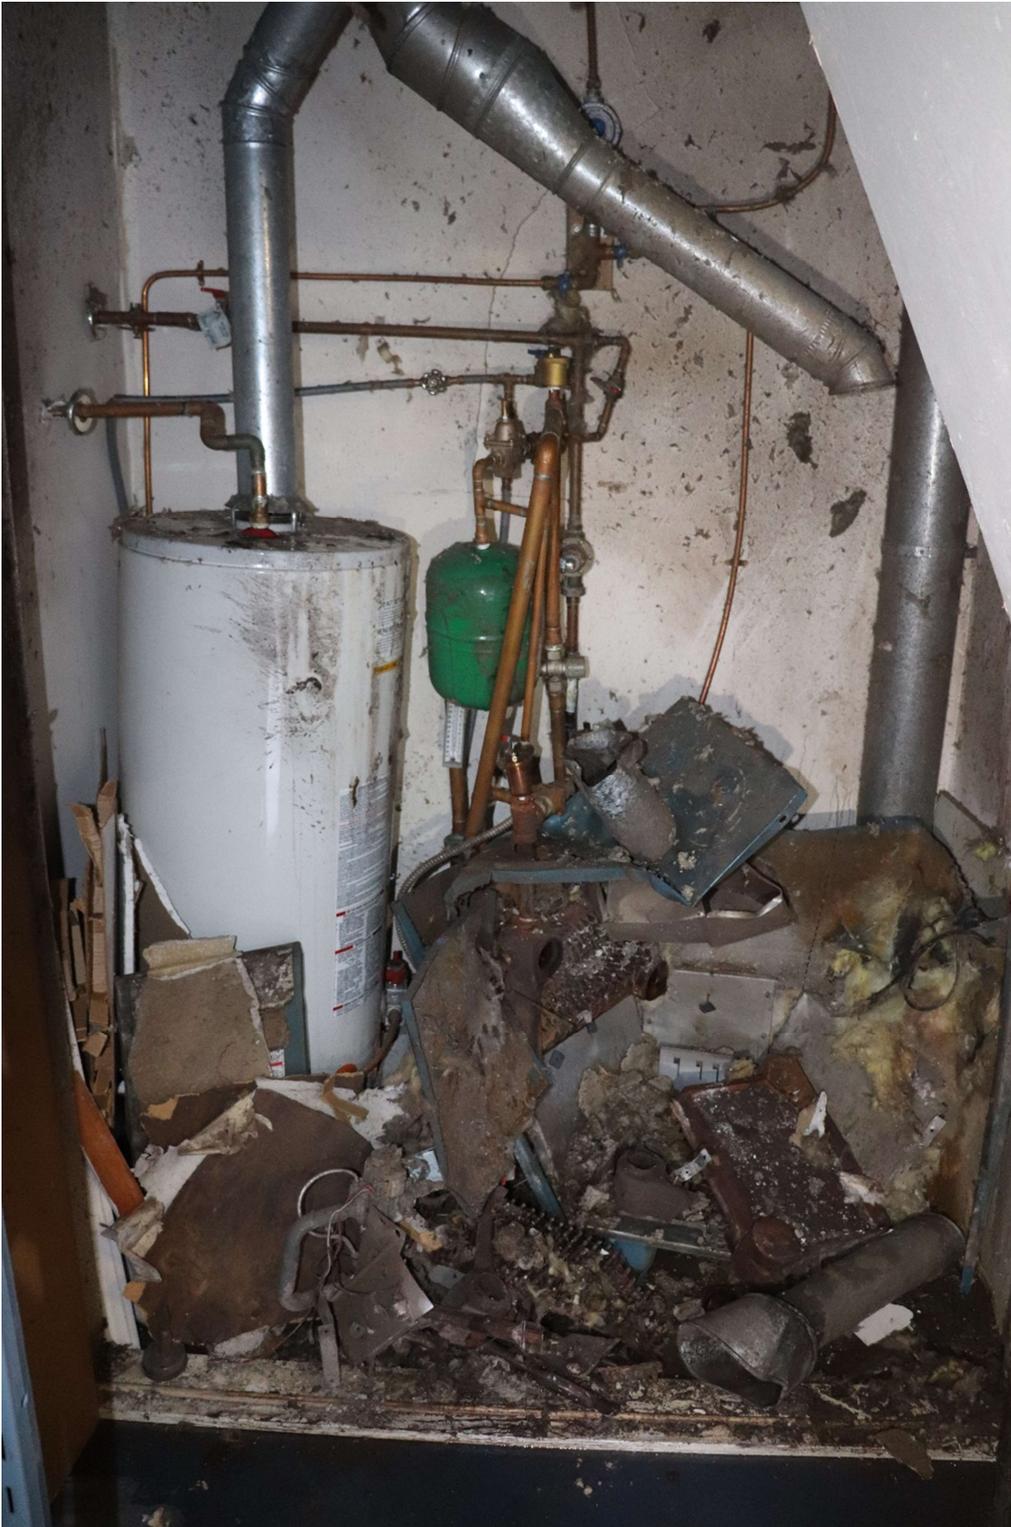
Image 2 – Mechanical room from inside garage showing damaged boiler

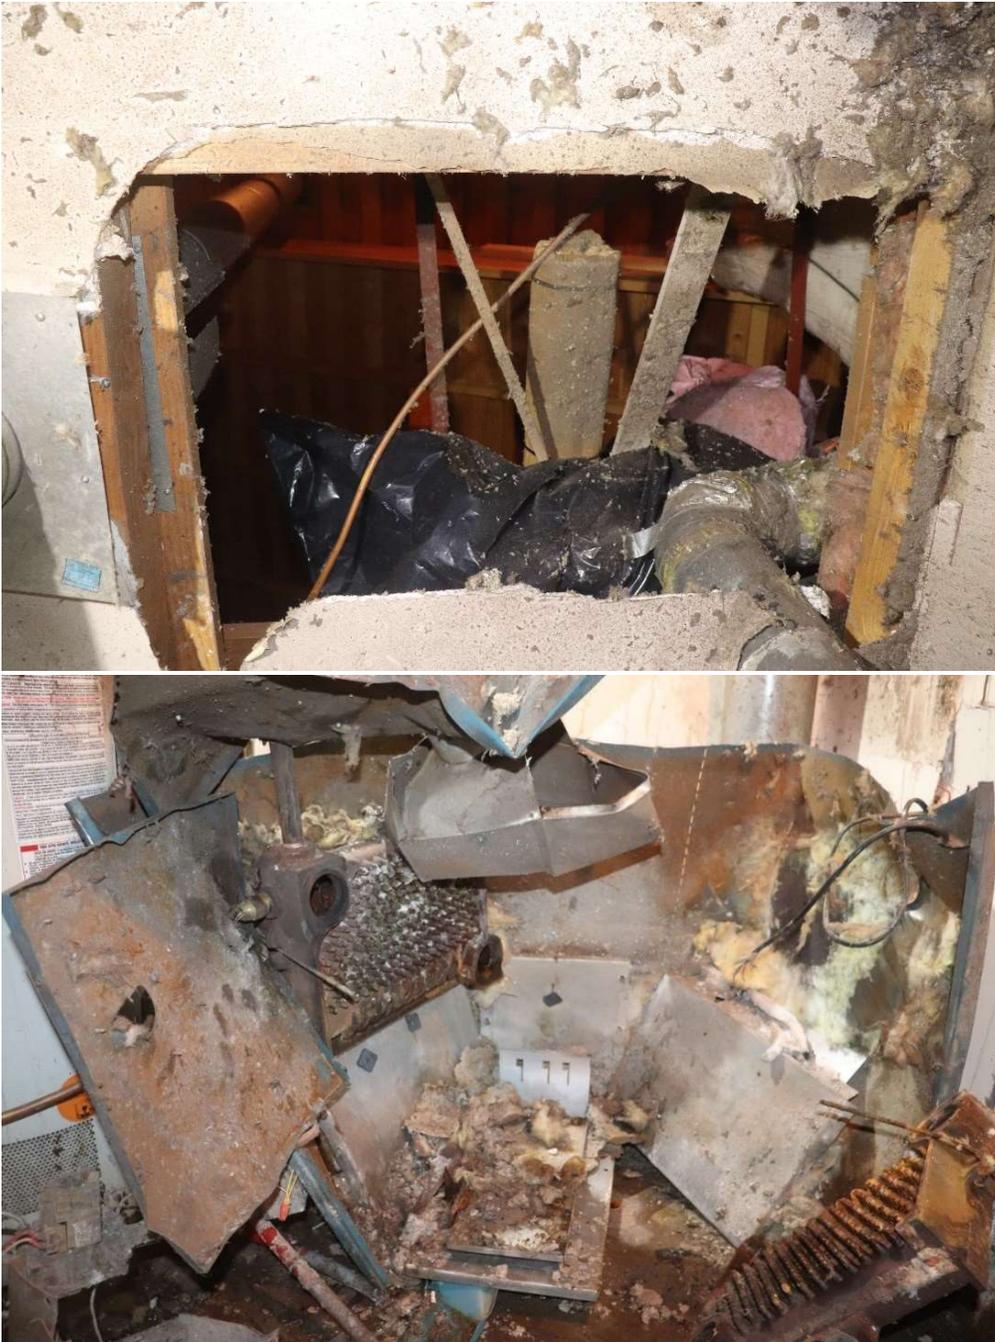
Image 3 – Damaged boiler and drywall into attic space above boiler in mechanical room

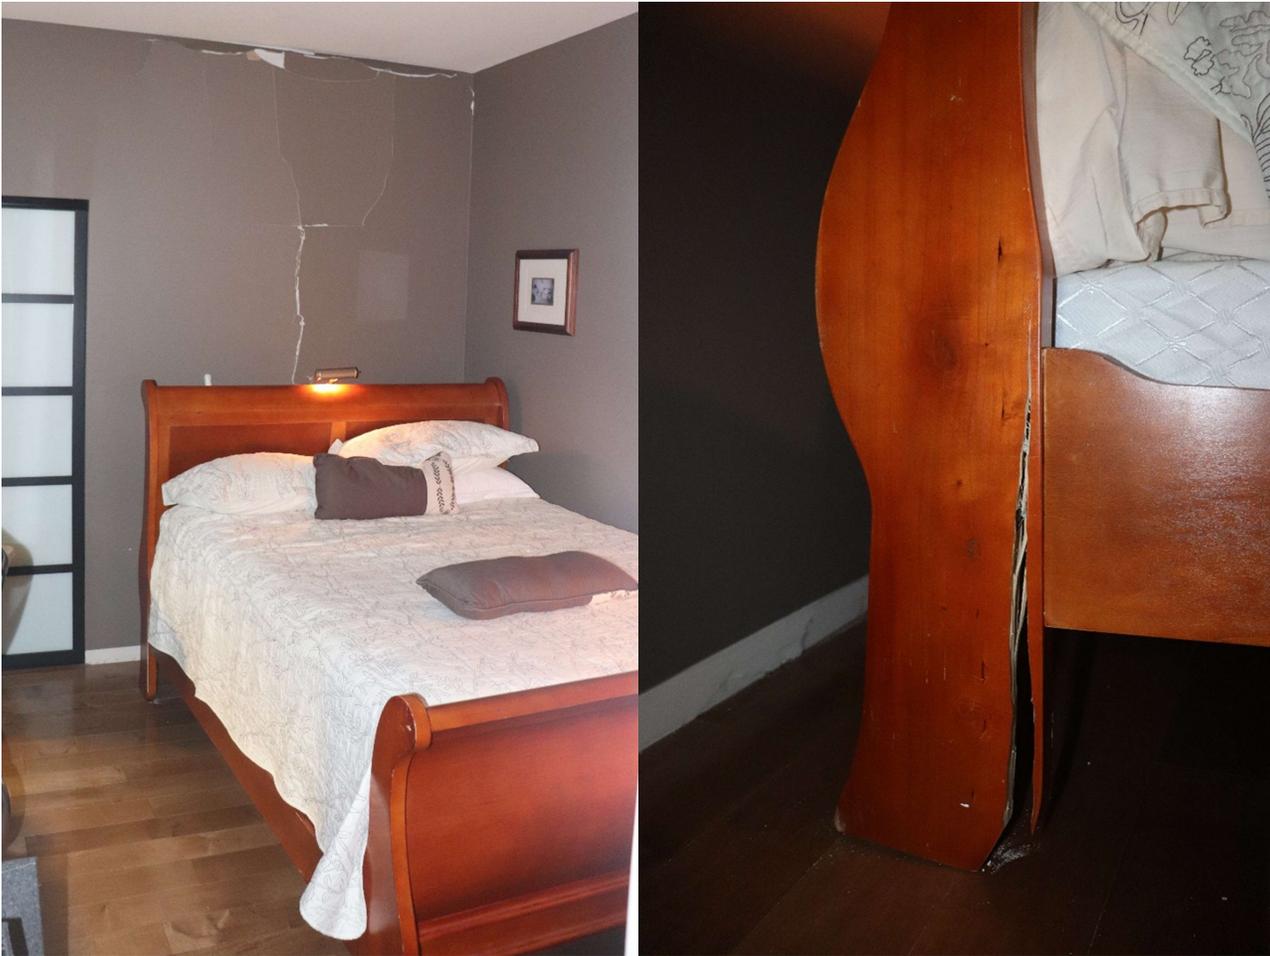
Image 4 - Damage to interior bedroom wall opposite mechanical room and wooden bed frame

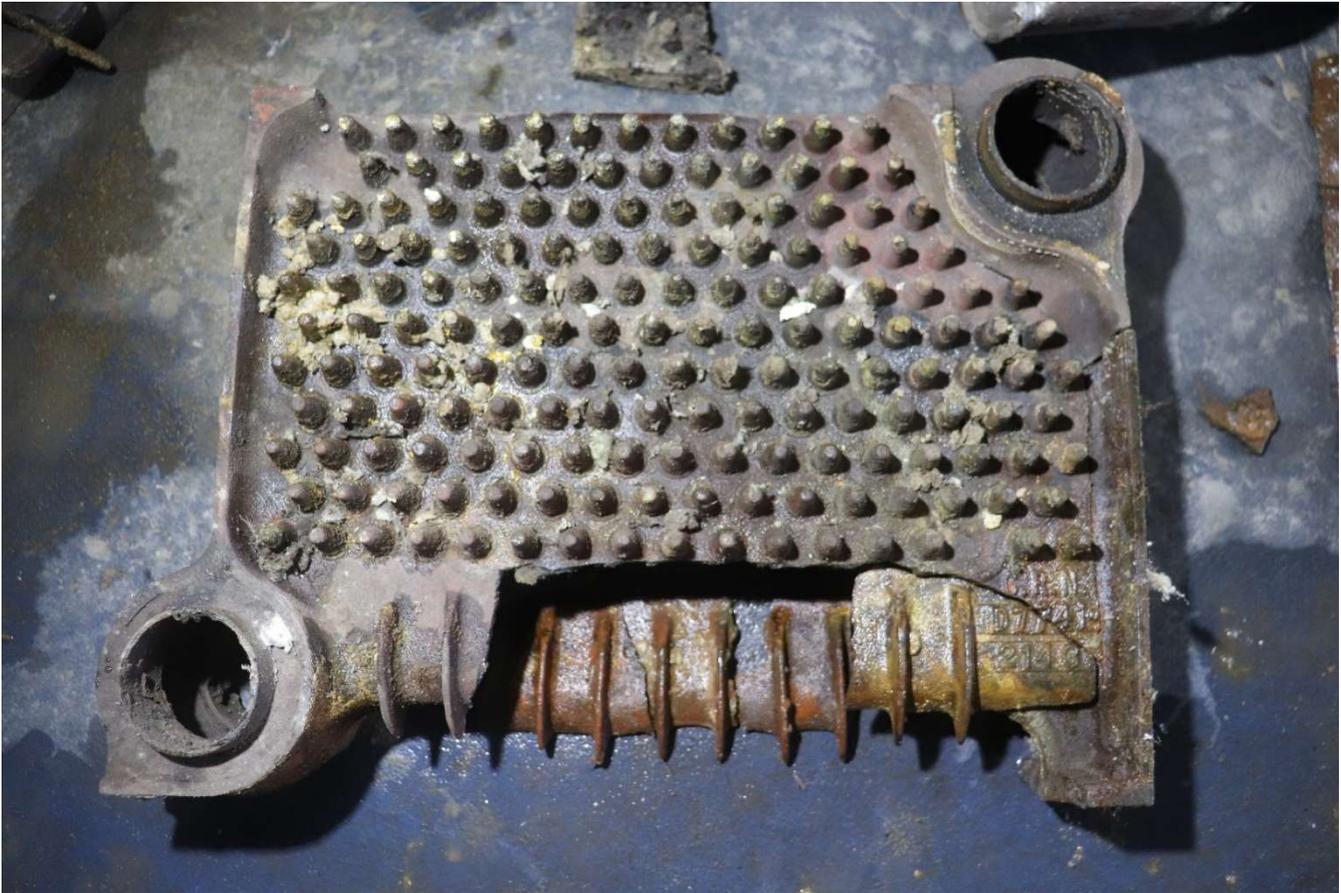
Image 5 – Reassembled portions of fractured heat exchanger

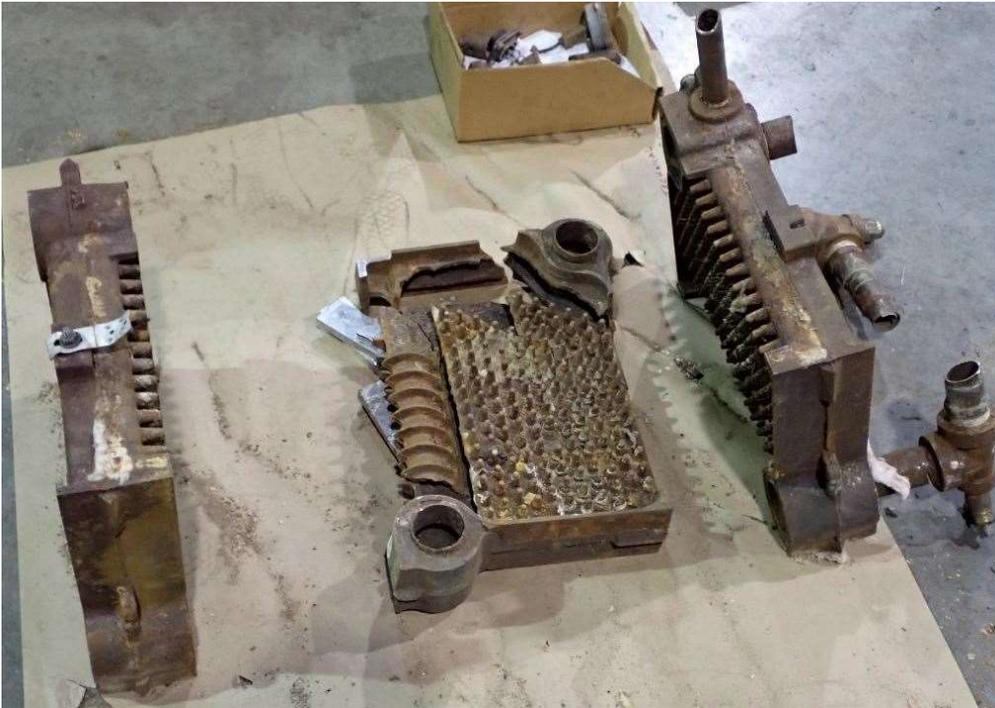
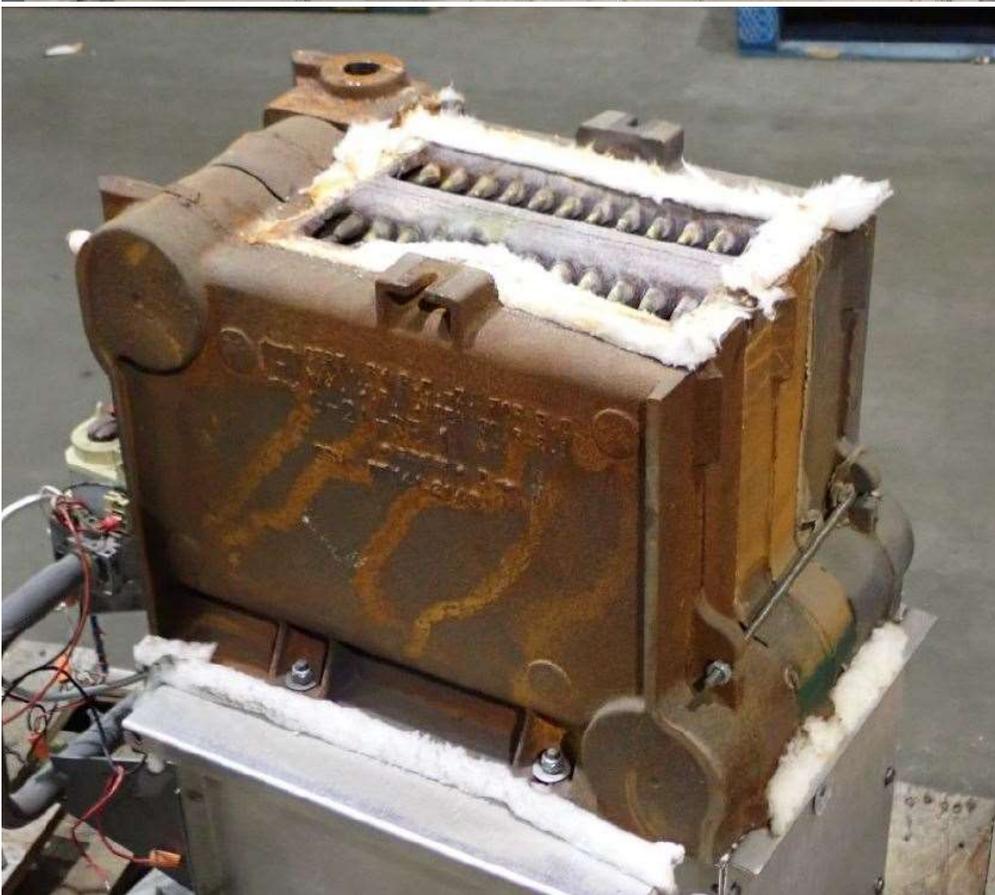
Image 6 - (Top) fractured center heat exchanger section in relation to end sections (Bottom) Exemplar heat exchanger showing sections fully assembled

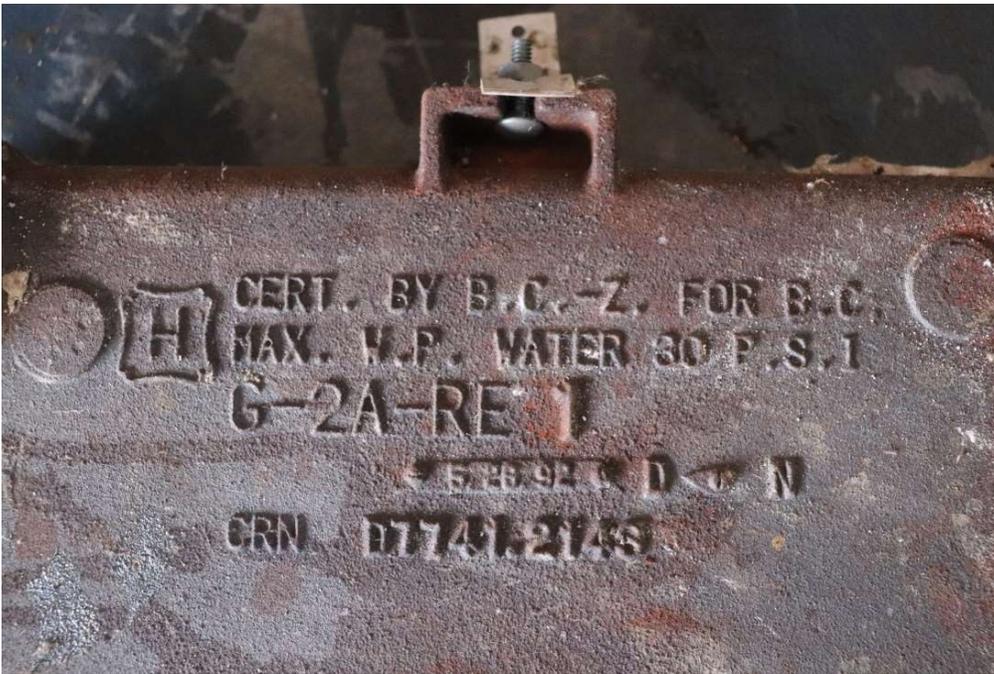
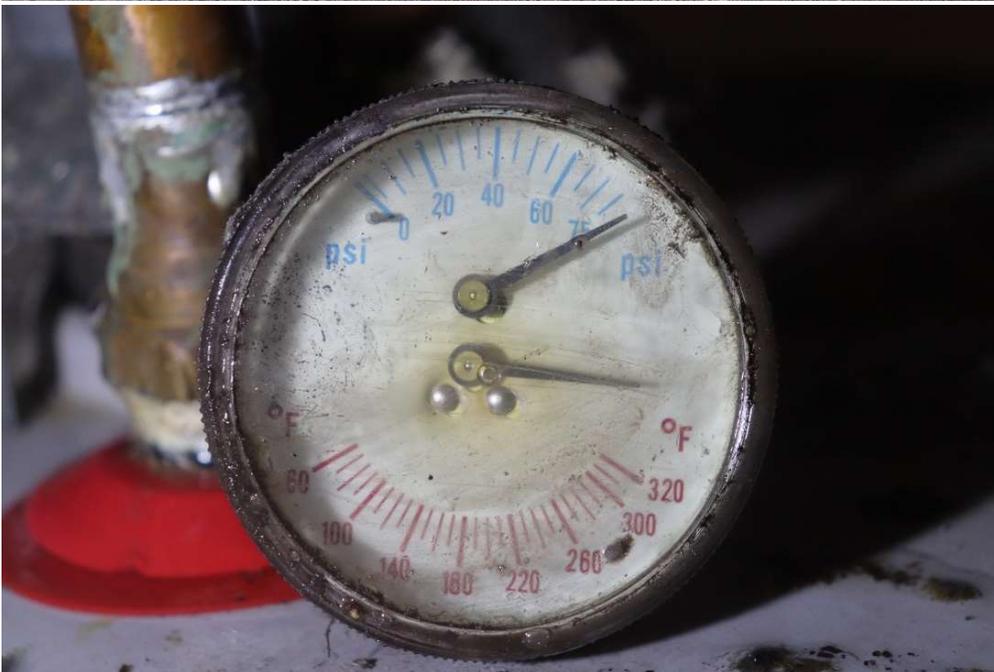
Image 7 – (Top) Heat exchanger casting showing 30 psi maximum working pressure (Bottom) Temperature/pressure gauge showing needles pinned above 75 psi and 320°F maximum readings
