**TECHNICAL
SAFETY BC**

Safe technical systems. Everywhere.

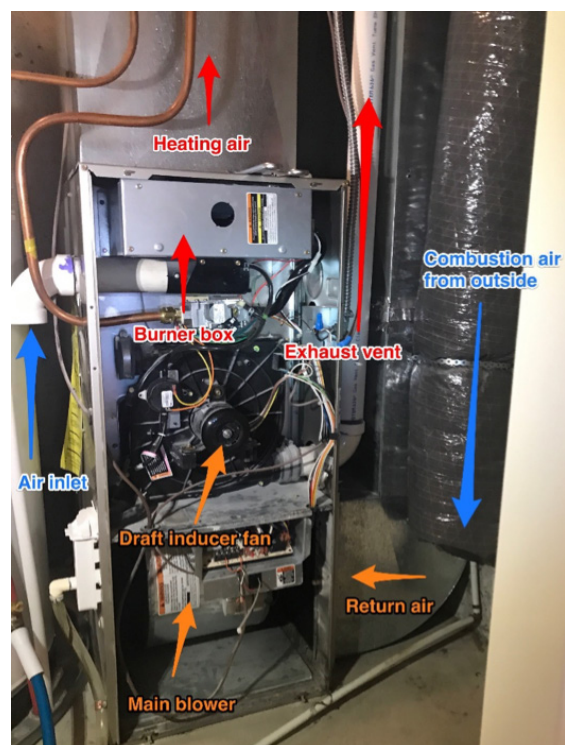
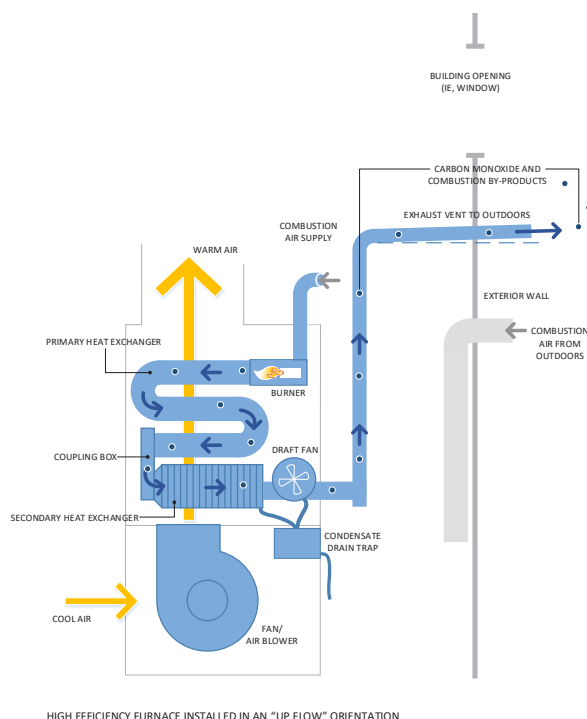
Figure 1: (Left) Gas furnace front cover removed to show main compents that are visible, secondary heat exchanger not visible as the furnace must be disassembled to access; (Right) Diagram of flue gas flow inside the furnace components.

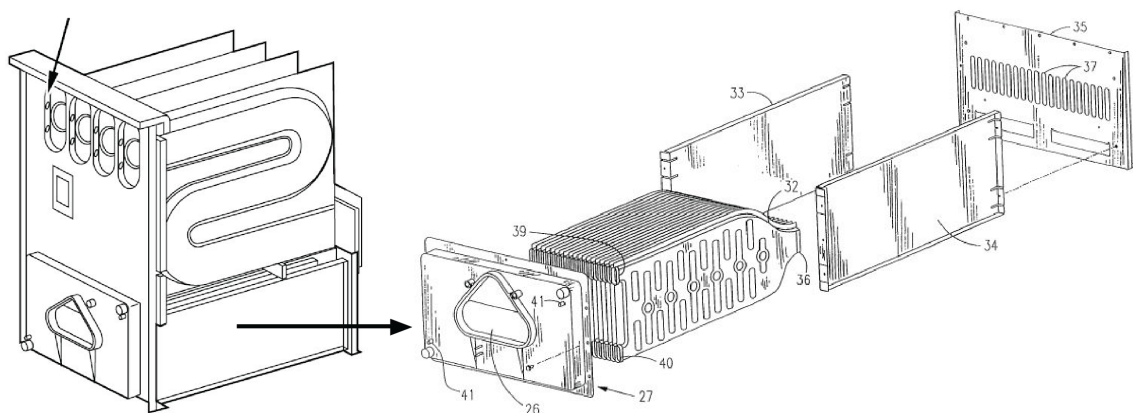
Figure 2: Expanded diagram showing secondary heat exchanger, located below the primary heat exchanger (Carrier Service and Maintenance manual, and Carrier patent document).

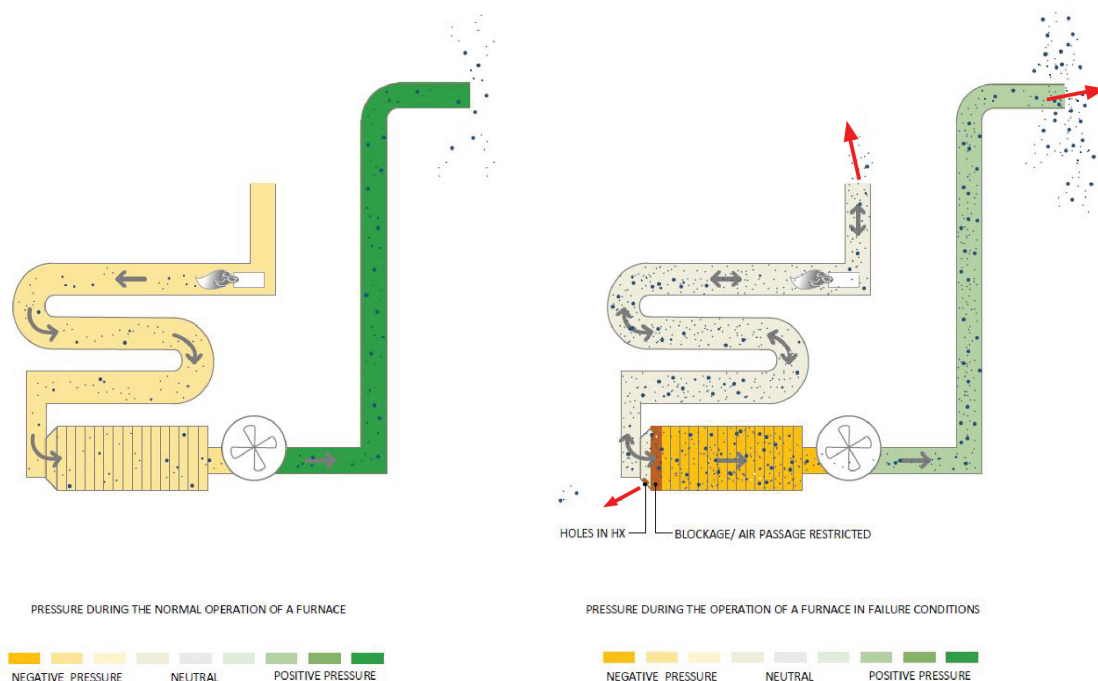
Figure 3: Internal pressures, gas flow and CO produced in normal (left) and failed (right) condition (red arrows show paths for CO escaping furnace).

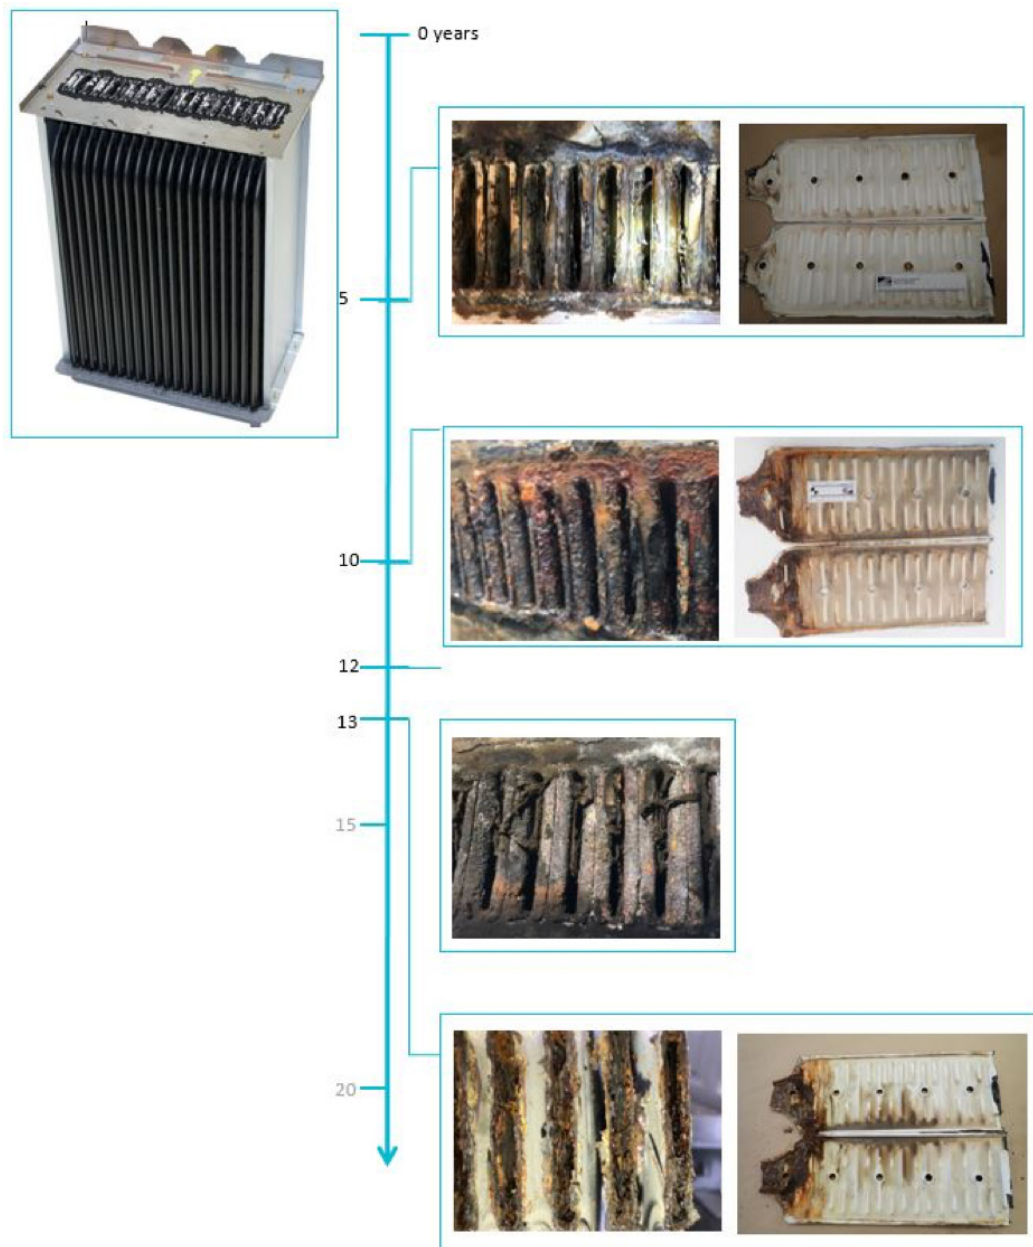
Appendix D: Manufacturer's Literature

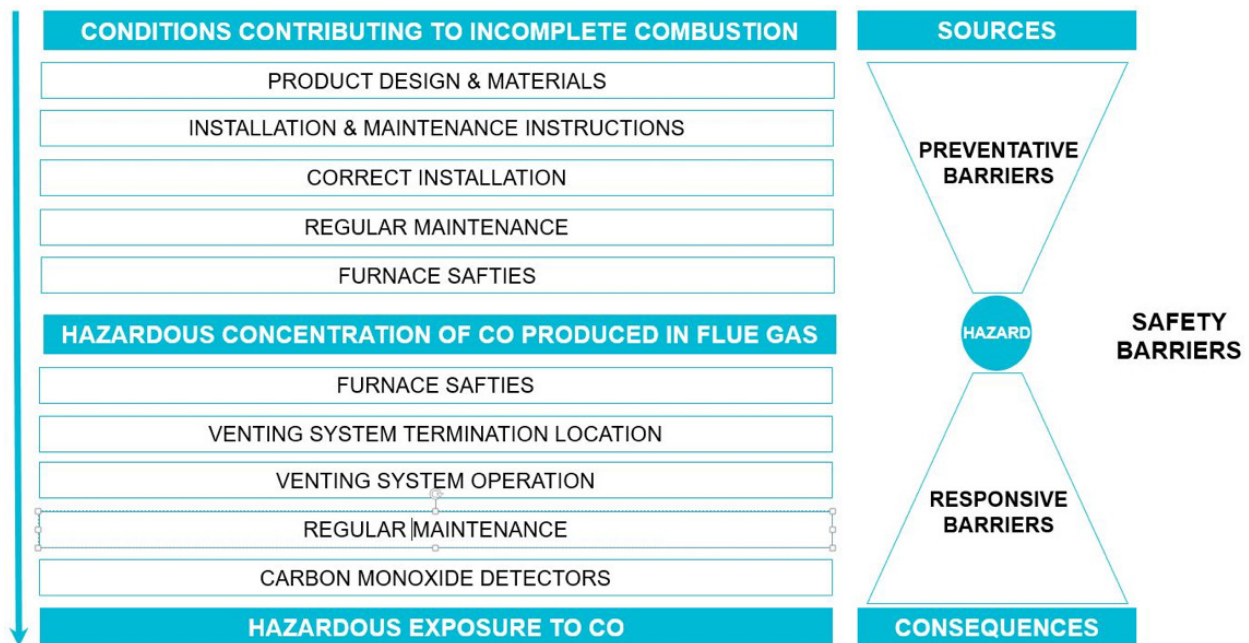
Figure 5: Actions to prevent failures and those to mitigate CO hazards following the failure.
