SUPPORTING INFORMATION	Incident Date		April 24, 2024
	Location		Lake Country
	Regulated industry sector		Gas - Propane system
		Qty injuries	1
	Injury	Injury description	One person was inside the building when the explosion took place and received burns and contusions.
	pact	Injury rating	Moderate
	Im amage	Damage description	The force of the explosion pulled one door off its hinges and forced another closed door open damaging the door and locking mechanism. The building wall was pushed out and three of the appliances had their outer enclosure deformed and dented.
	ä	Damage rating	Moderate
	Incident rating		Moderate
	Incident overview		An explosion occurred inside a mobile trailer containing 5 gas fueled clothing dryers when they were being started for the first time a day after being connected to a fuel source by a contractor.
INVESTIGATION CONCLUSIONS	Site, system and components		The facility is a fruit orchard and processing facility that utilizes and houses seasonal migrant workers. Guidelines for seasonal housing for temporary workers in BC from the provinces Seasonal Agricultural Worker Program (SAWP) previously outlined that laundry facilities must include one machine for ev

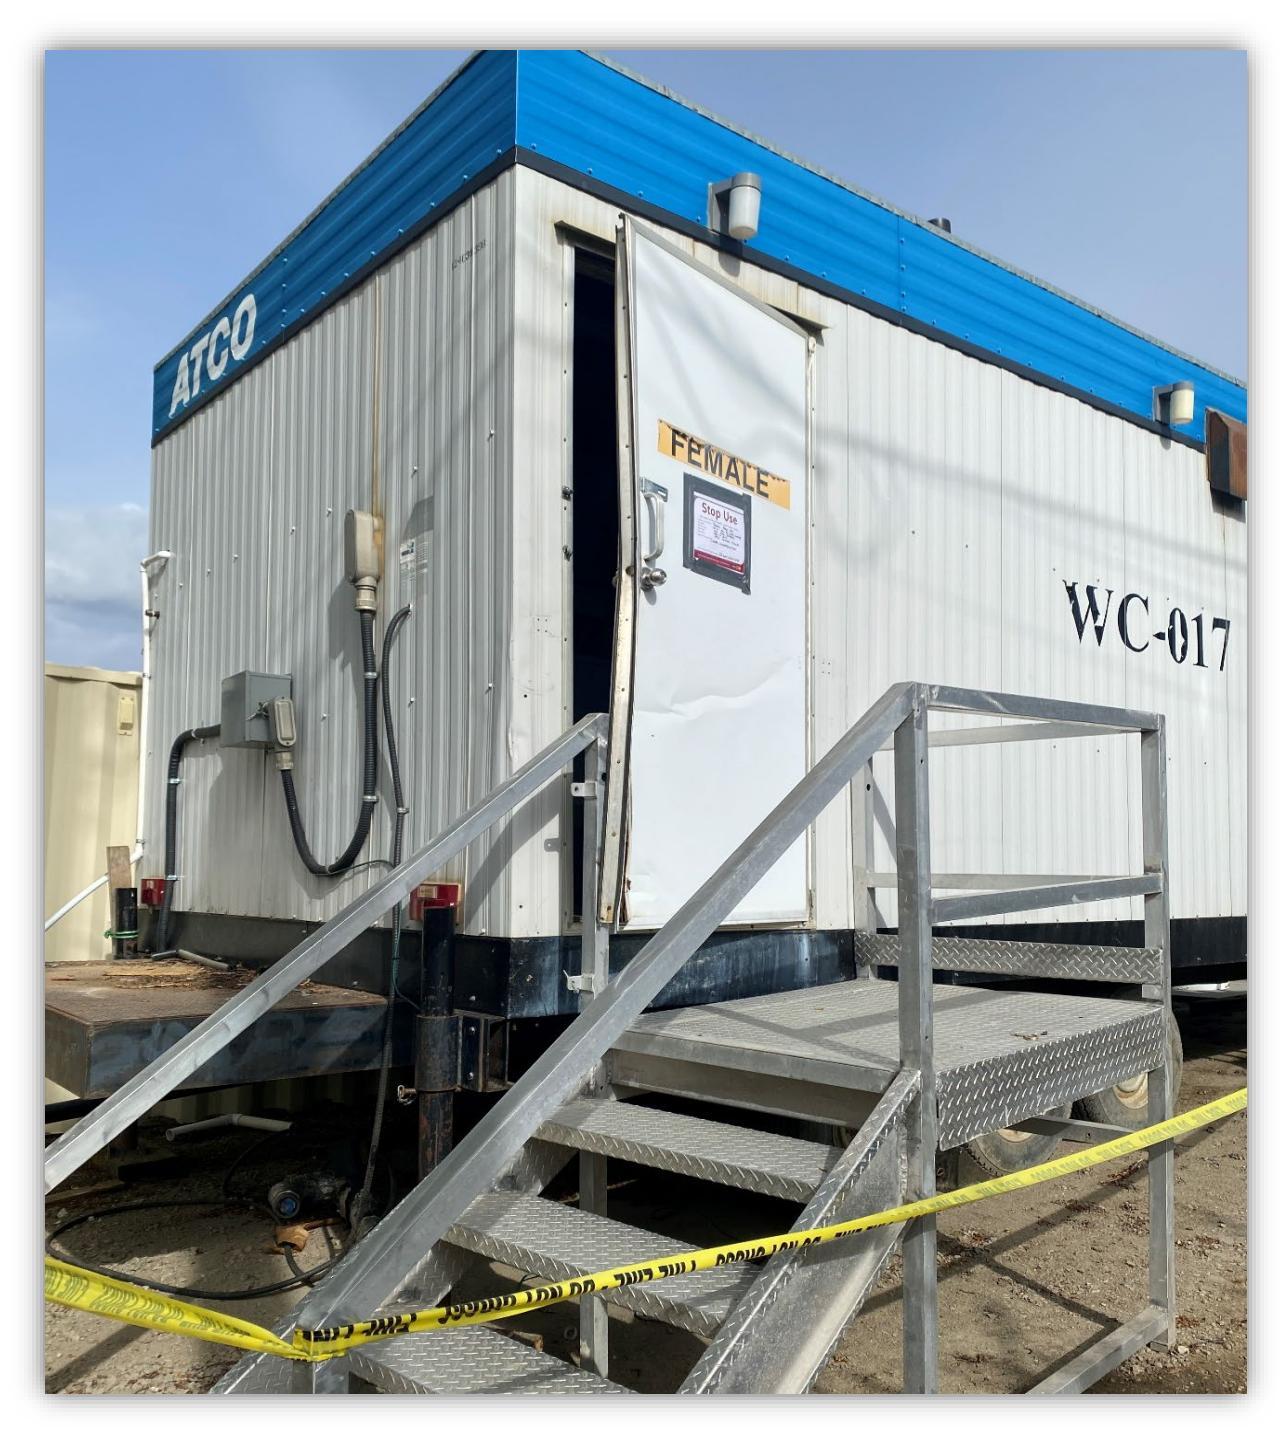
They purchased the trailer at an auction in 2015 and it was stored at the facility unused until 2018. He along with another employee of the facility installed the five new laundry appliances in the trailer and did the fuel conversions in 2019. The appliances were never connected to a fuel source or turned on and the trailer was stored until 2024.
<u>S</u>	 ite observations A new copper gas line was connected between the propane cylinders and a black iron gas piping manifold. The data tags on all five of the appliances identified they were factory set for use with natural gas. The factory natural gas orifices were found in a conversion kit bag inside the building. Four of the appliances had gas conversion decals installed on the gas valve brackets that were only visible by removing the gas valves and one appliance had the conversion decal installed on the rear of the appliance that
	 was visible from the rear of the appliance. None of the appliances had gas record labels supplied with the conversion kits applied that identify the date of conversion and the name and address of the organization making the conversion, who accepts the responsibility for the correctness of the conversion. Three of the five gas connection unions on the dryers that were behind closed access panels were loose. The mobile trailer had two damaged doors and the back wall behind the appliances had been pushed out from the force of the explosion.

Image 1 – Laundry trailer showing door damaged from explosion.

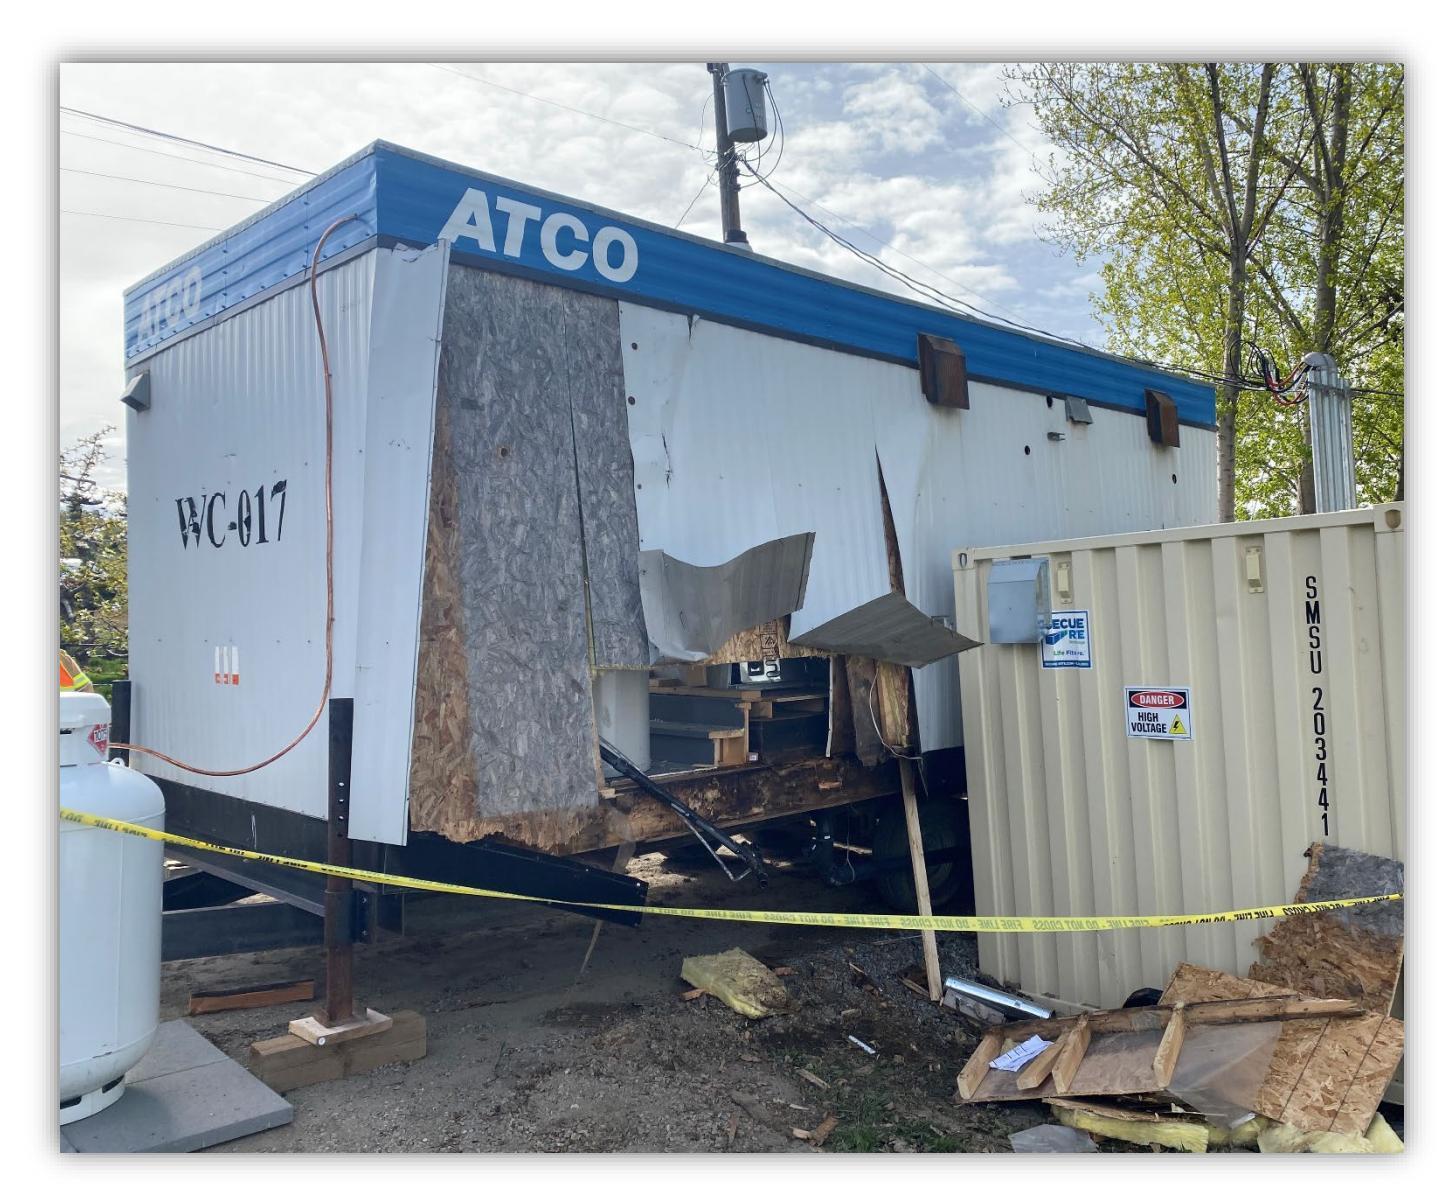
Image 2 – Rear of trailer showing damage from explosion and fire department overhaul.

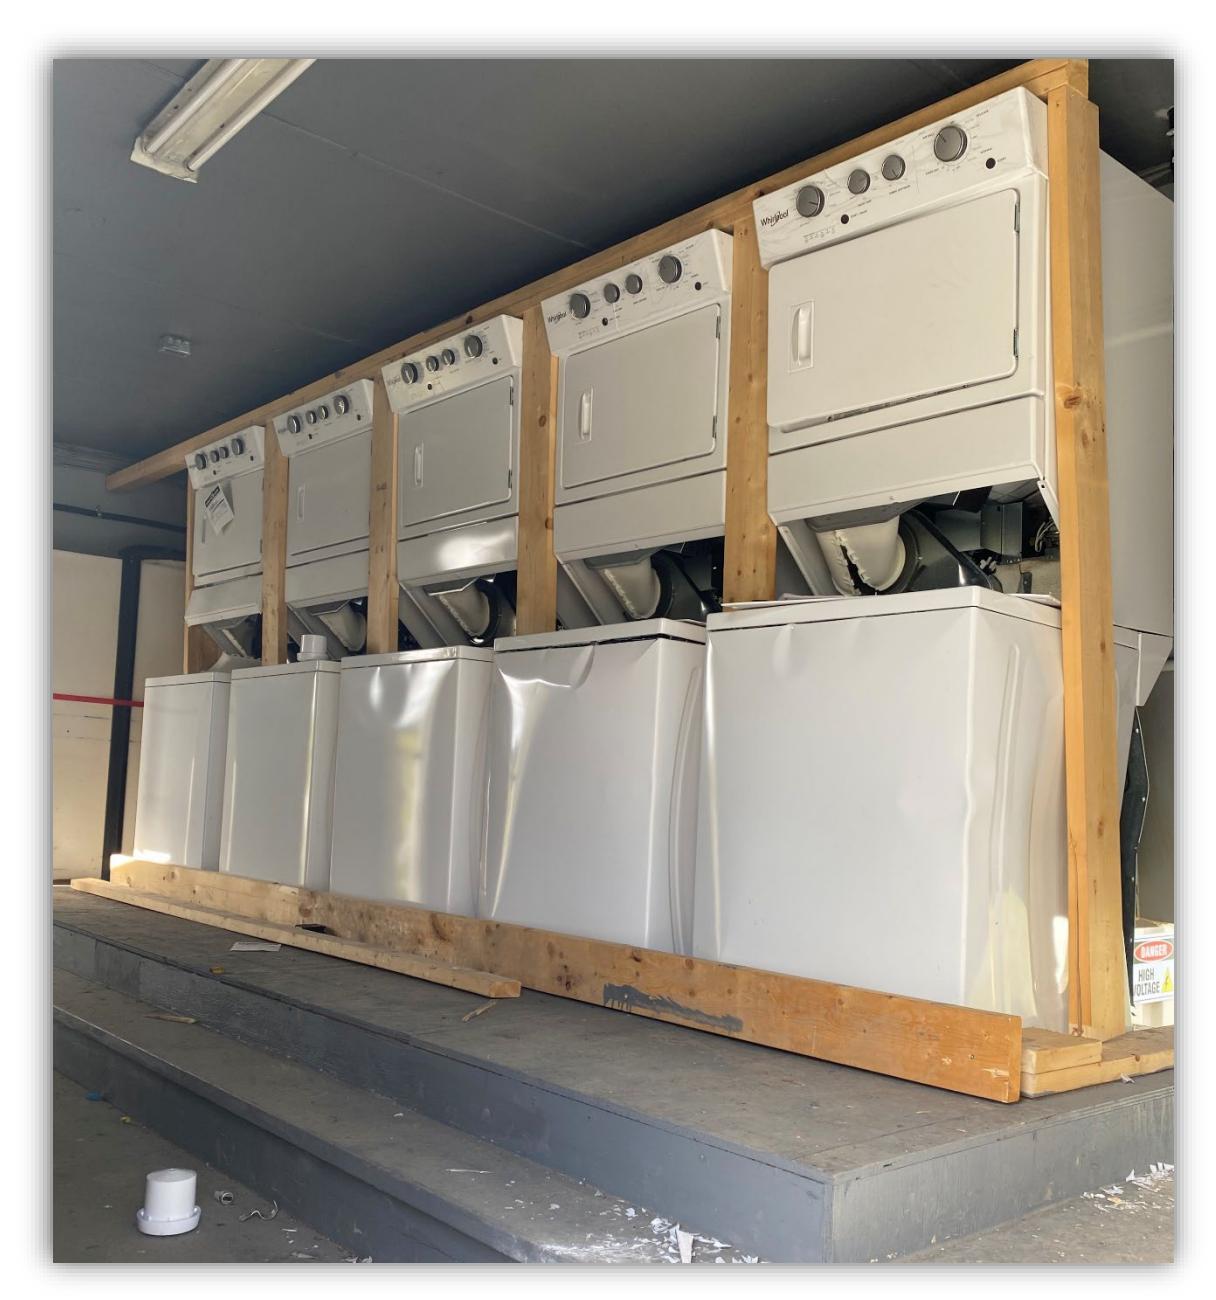
•	The 5 gas dryers had already been installed in the trailer and connected to a
	black iron gas pipe manifold before he started connecting the system to the
	propane cylinder.

Image 3 – Five Stacker washer and gas dryers installed in trailer.

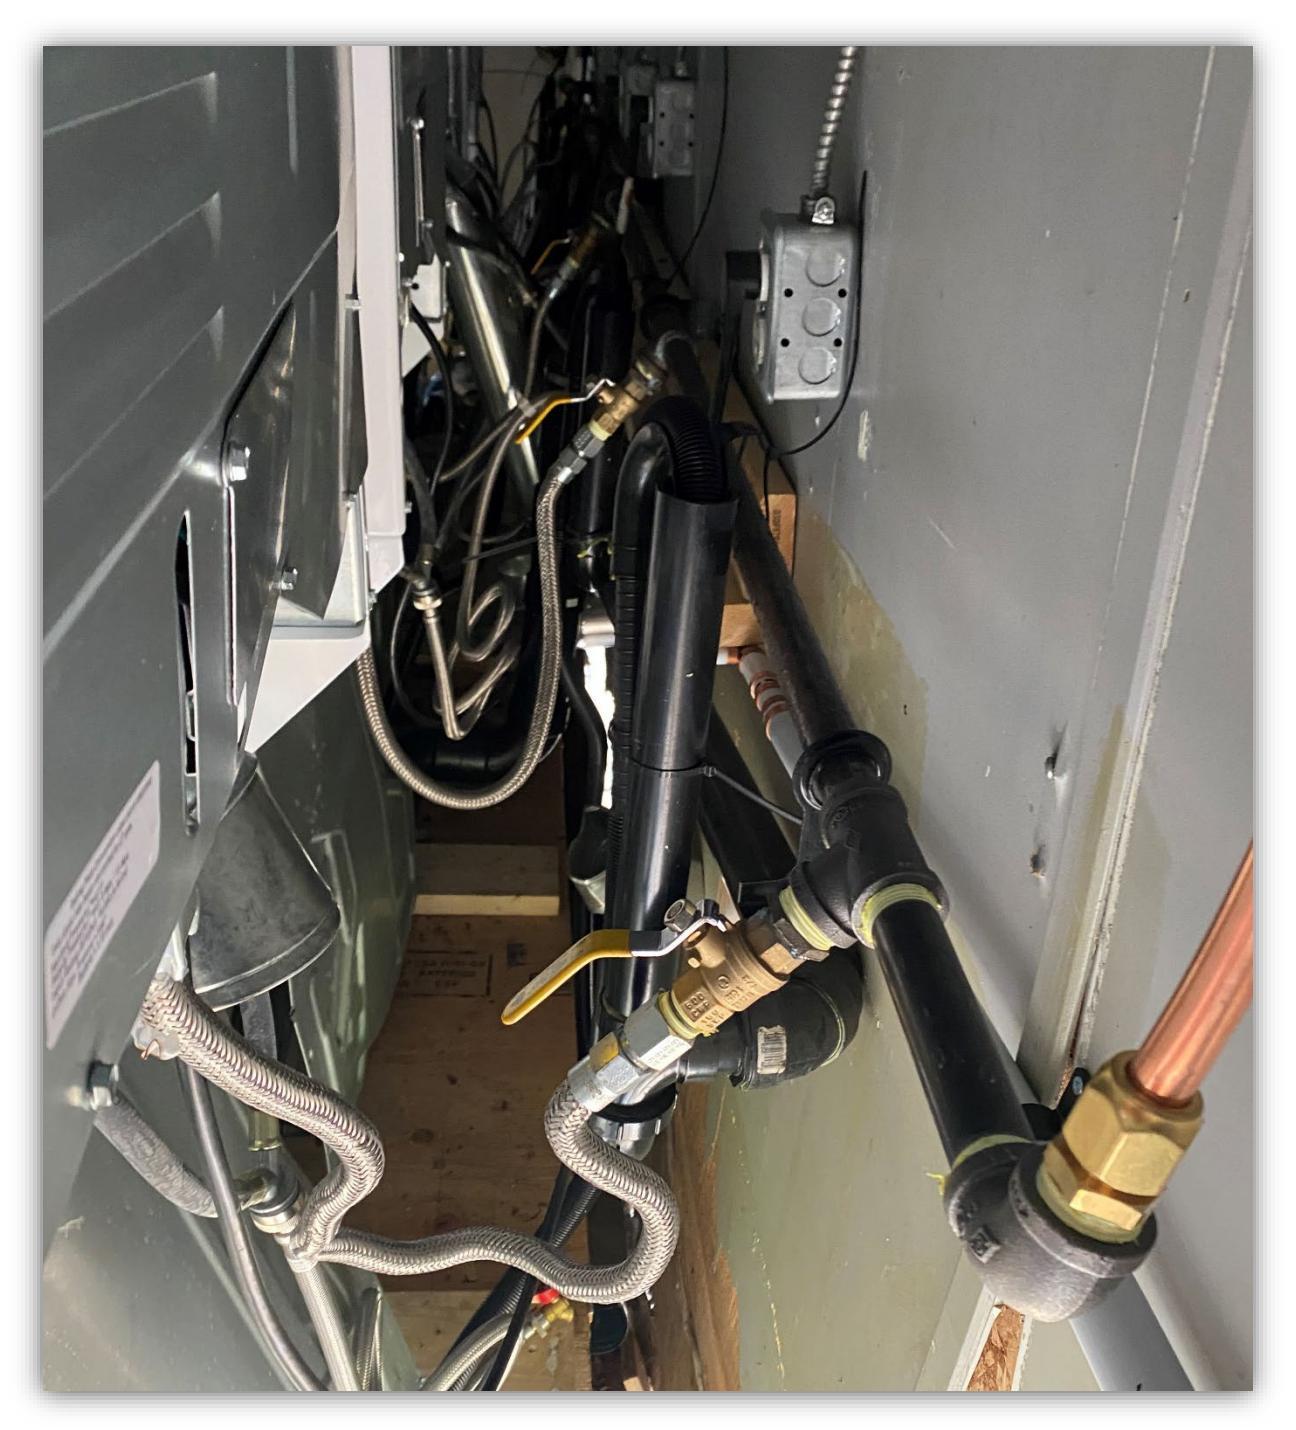
- He had pressure tested the gas line between the propane cylinder and the appliance shut off valves but did not test for leaks downstream of the valves or within the appliances.

Image 4 – Rear of appliances showing factory appliance connectors, pre-existing gas manifold and shut off valves, and new copper gas tubing and brass fitting.

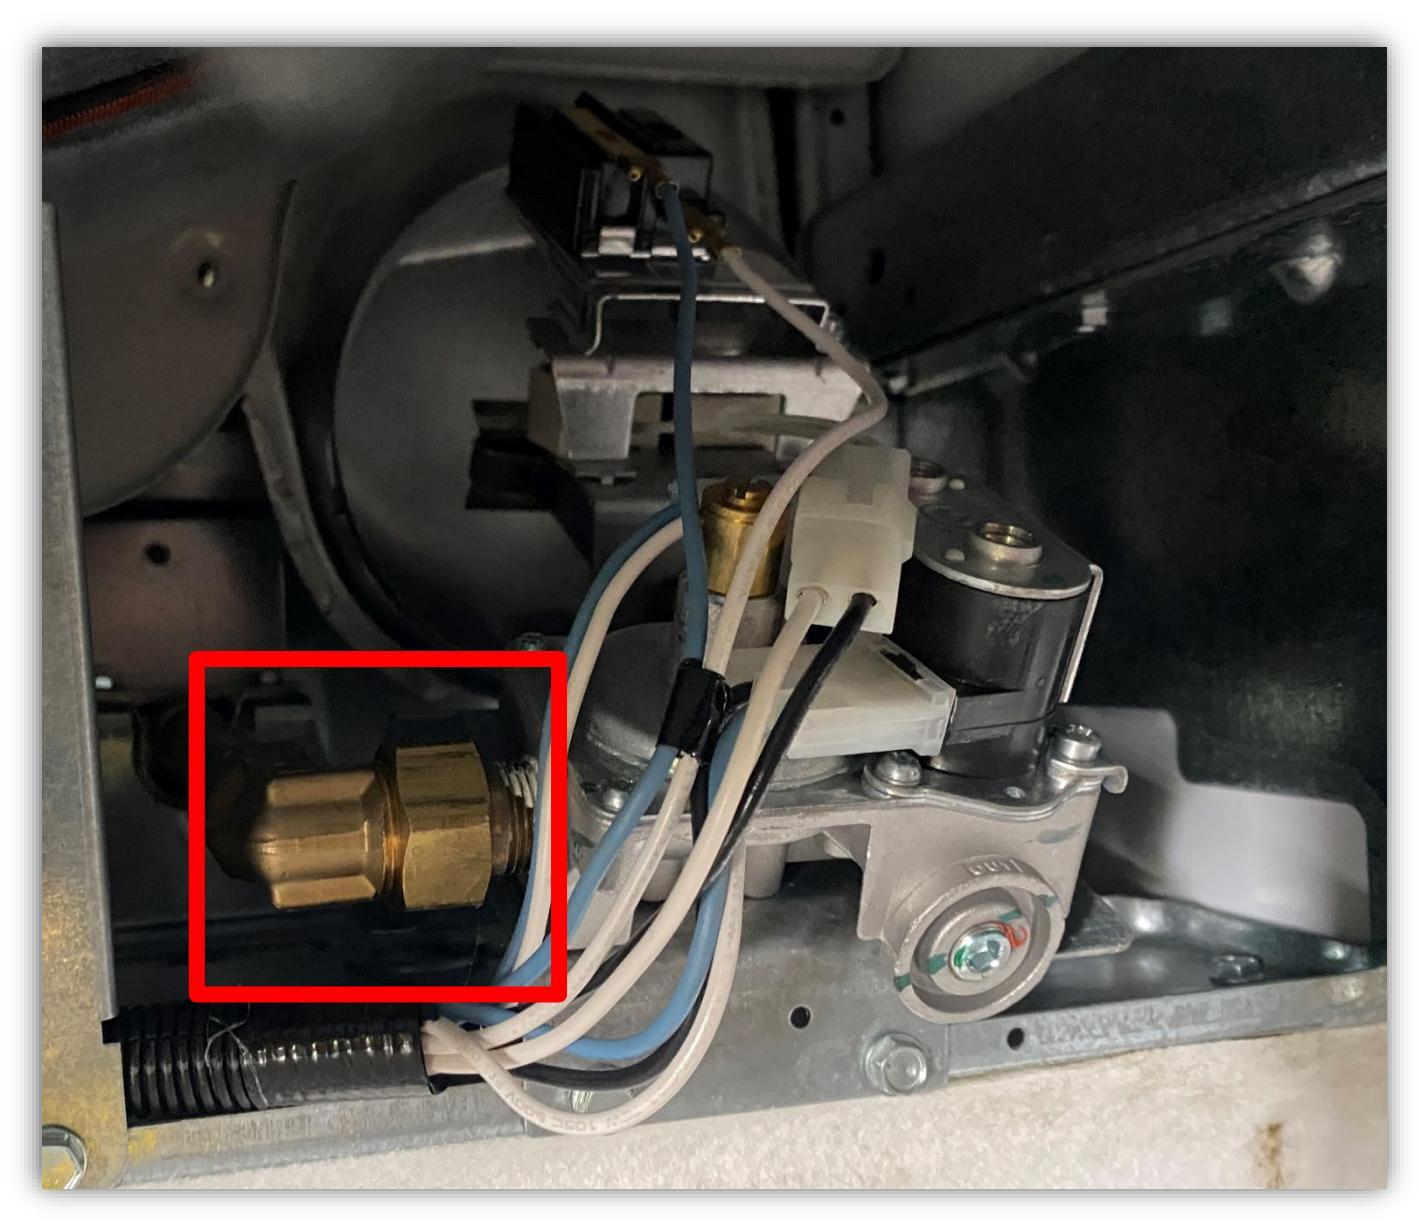
Image 5 – Dryer gas valve. Tight gas union connector.

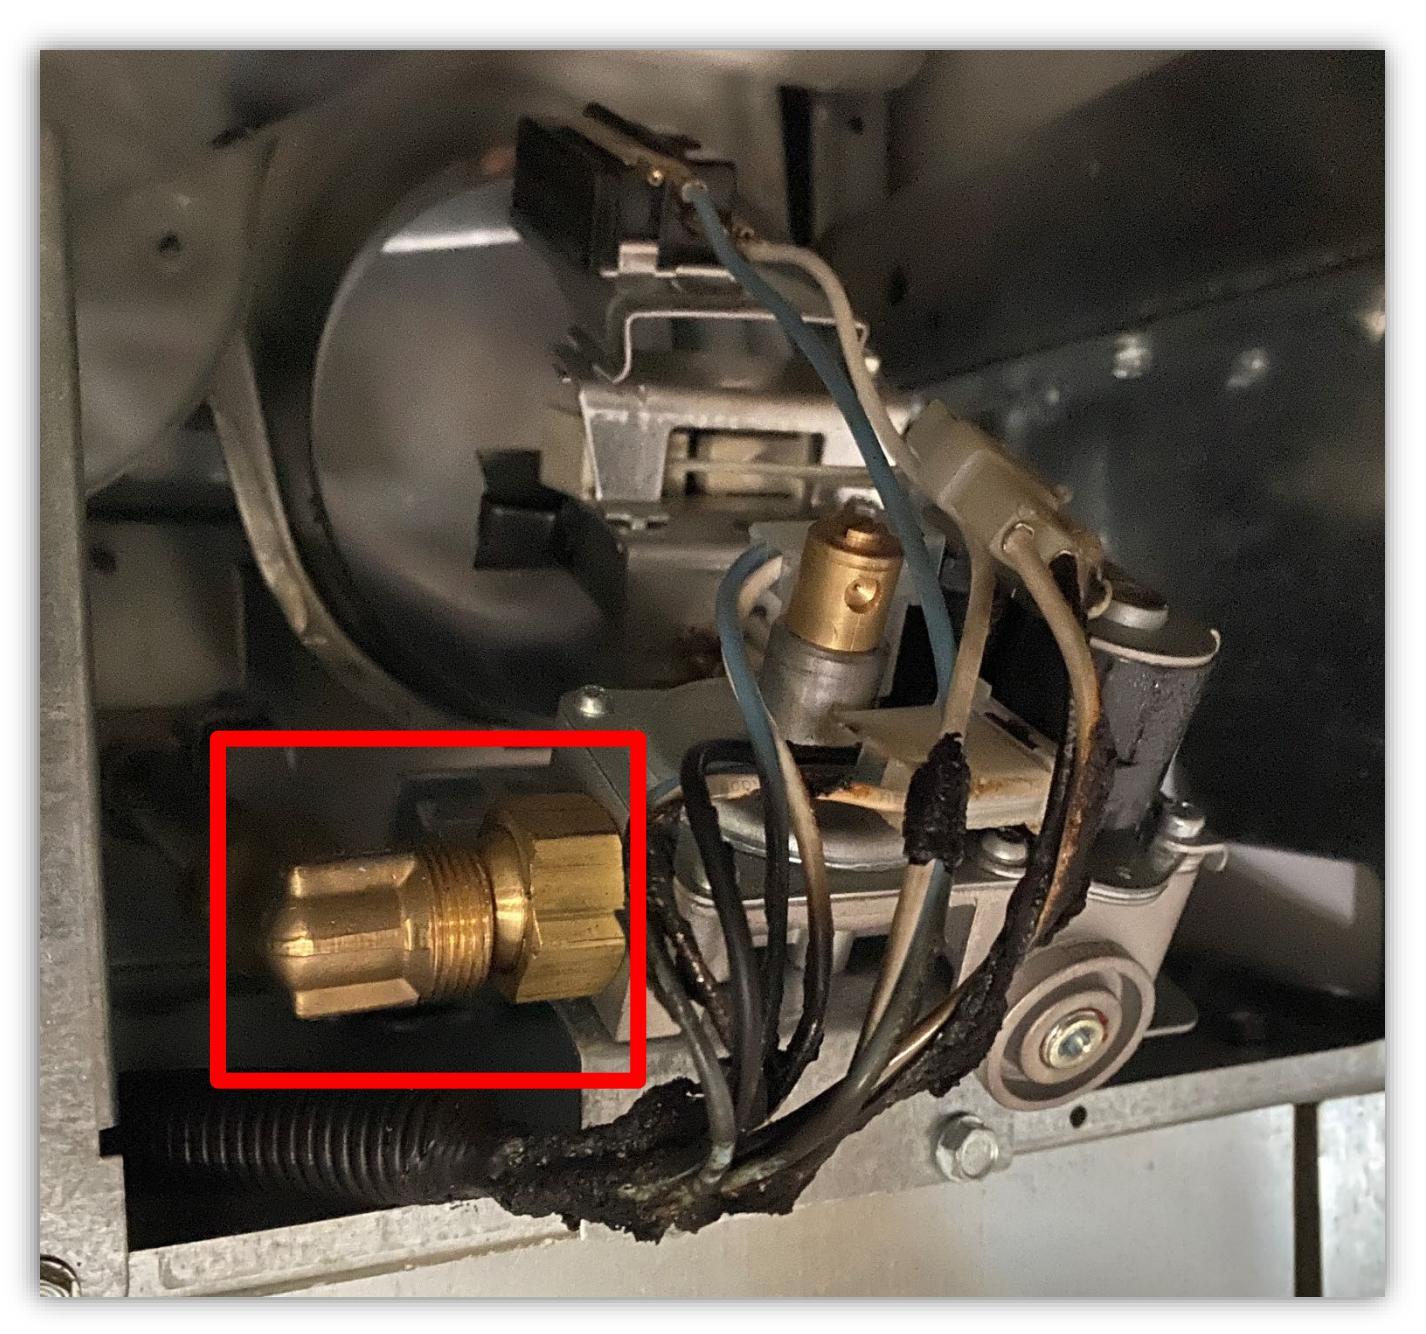
Causes and contributing factors	The leaking gas connections on the dryers allowed propane gas to leak indoors. The activation of the dryers created a source of ignition that likely ignited the air/fuel mixture creating the explosion. The contributing factors to the incident include:
		 Incomplete regulated work The conversion of the appliances not being completed at the time of first installation left them in a state that leaked gas when they were connected to a fuel source. The uncertified plumber not checking for leaks downstream of the pressure test allowed the gas leak to occur when the fuel was turned on by the facilities manager. The gas piping not being purged of air by the plumber allowed the leak to begin without it immediately being identified by the odour by the facilities manager.
		 Ineffective communication Ineffective communication between the previous facilities manager and the new facilities manager allowed for a misunderstanding of the status of what work needed to be done to safety complete the installation. The plumber informing the facilities manager that the job was complete and "ready to go" when he had not completed all of the required steps to ensure the appliances were safe for operation and the contractor failing to inform the farm manager the appliances had not been fully checked after he was informed by the plumber both led the facilities manager to believe the system was safe for operation when he opened the gas supply and started the appliances.

Image 6 – Dryer gas valve. Disconnected gas union connector (Union was loose but not fully disconnected at the time of the incident) and burnt wiring insulation.

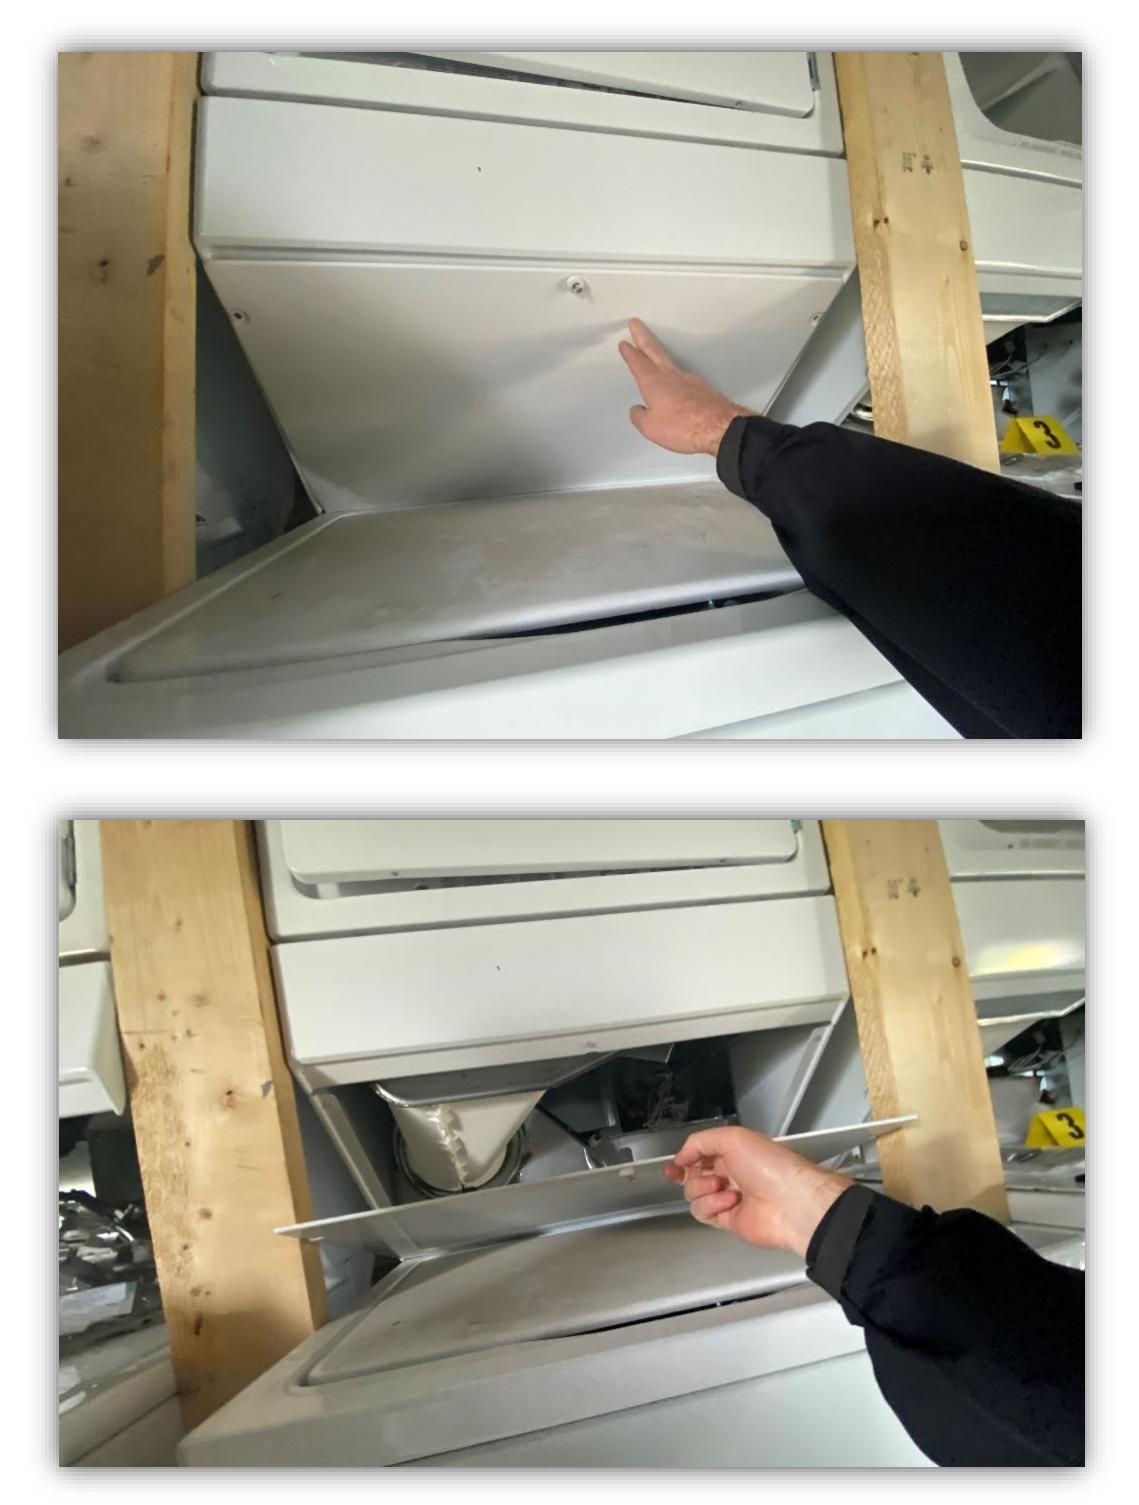
when the job began that day. Access panels were installed on all the appliances and the loose connections on the gas valve unions were not visible or assessable unless the access panels were removed. He then connected the gas from the propane tank to the existing gas system and informed the facilities manager that the work was complete and asked the facilities manager if he wanted the gas turned on. The facilities manager told him he didn't need to turn the gas on, and he would be by the next morning to start the dryers and check their operation. The plumber did not turn the gas on after making the final piping connection to the propane tank regulator and did not purge air from the piping system. After leaving the site, the plumber contacted his employer via text message and informed him that he did not check if the appliances were set up for operating on propane. The contractor did not immediately notify the facilities manager that the appliances had not been checked. The next morning the facilities manager arrived on site, and he was informed by the plumber that the job was complete and was "ready to go". He entered the trailer and checked that the electrical was on then he went to the propane cylinder and slowly opened the service valve and heard the regulator operate until the pressure in the piping had equalized. He then went into the trailer through the one of the doors and heard a high-pitched sound. At that time, he did not smell any gas and texted the plumber a video asking him what the sound was from the back of the appliances. The gas piping was still full of air and had not been purged so the odor of the propane was delayed in reaching the indoor space. The sound was air and gas escaping from the three loose gas valve connections on the dryers from when the fuel gas conversions were previously done. He then turned on the first gas dryer, which started the dryer drum, air fan, and began the burner ignition sequence. He then turned on the second dryer. Once the air had been purged out of the gas piping propane vapor began leaking from the loose connections on the appliances and began filling the enclosed space. eventually the first dryers hot surface ignitor got hot enough and ignited the gas-air mixture in the space causing an explosion that forced the one door open outward and the ripped the inward facing door off the hinges. After the explosion, the facilities manager exited the trailer, removed his shirt, doused himself with water, shut off the tank and called 911. He was taken to hospital, treated for burns to his face and arms and was released early the next morning.

Image 7 – Inspection panel for access to dryer gas valve.

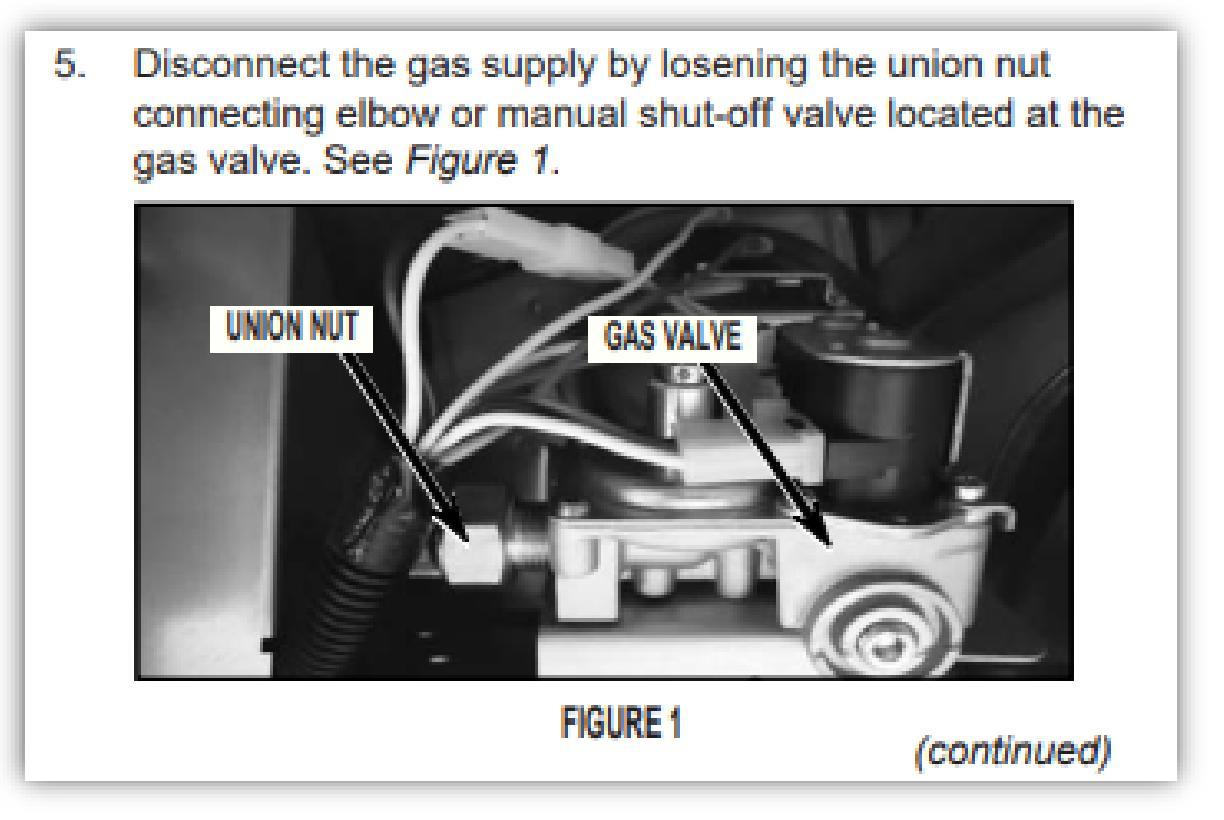
Image 8 – Gas conversion kit instructions showing the disconnection of the union nut for removal of the gas valve.

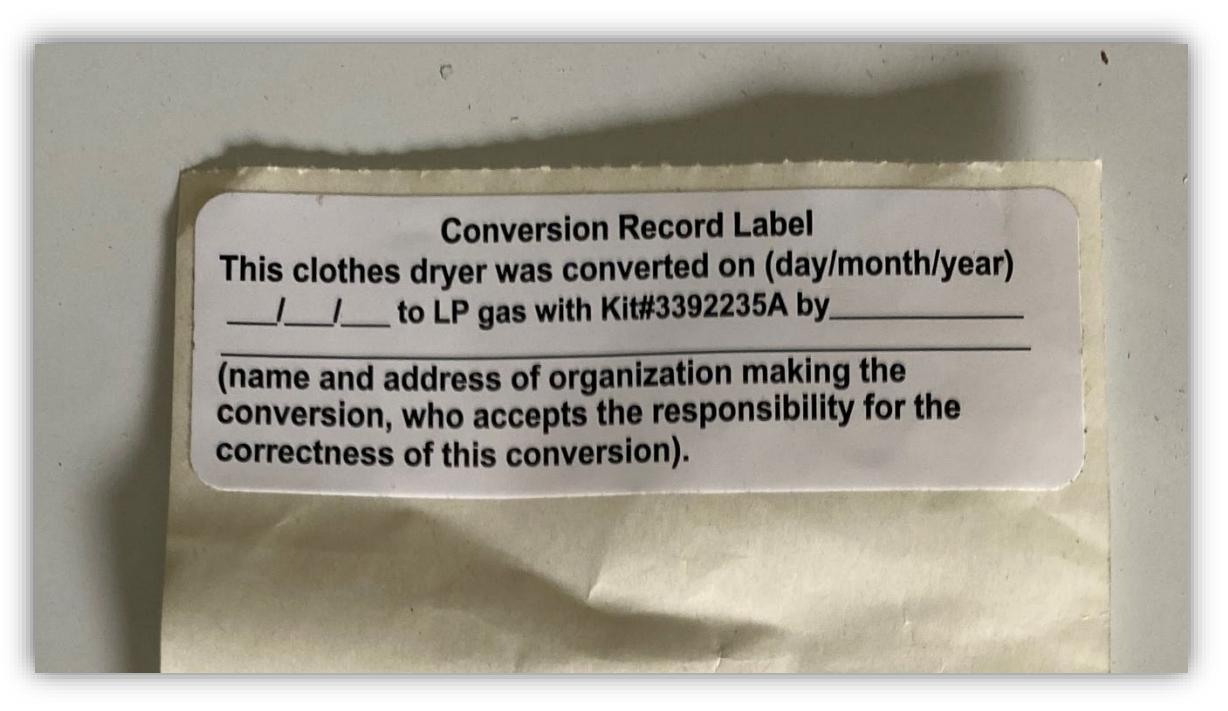
Image 10 – The conversion record label that was not filled out or installed on any of the appliances.
