Incident Summary #II-1514425-2023 (#32612) (FINAL)

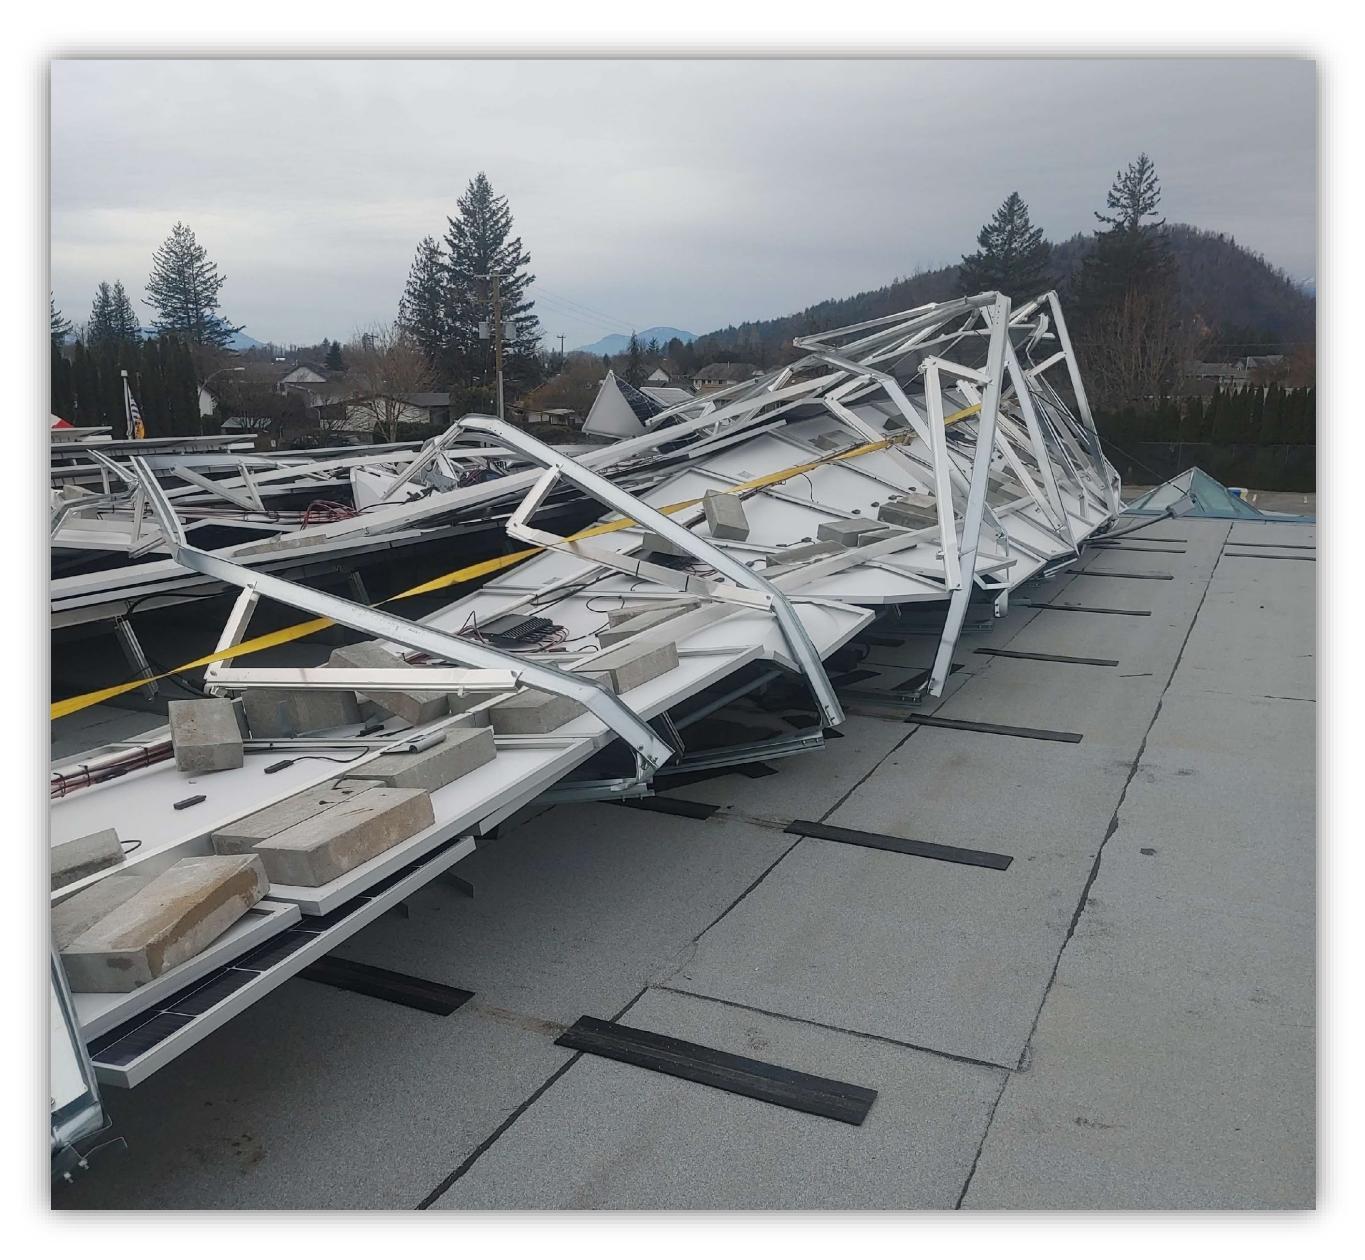
Failure scenario(s)			An insufficient number of weighted ballasts were installed securing the modular racking system to the flat roof top which failed to prevent the wind from uplifting a large area of solar panel arrays.
	Facts and evidence			 No evidence of mechanical fastening or anchoring the modular racking system to the building roof. Weighted concrete ballasts displaced from their installation position(s) on the modular racking during the uplift event (<u>Image 1</u>).
	Causes and contributing factors		s and outing factors	It is certain that the combined weight, amount, and layout of the installed weighted ballasts securing the solar panel array to the flat roof was insufficient in preventing the windstorm event from damaging the installation.

Image 1 - Effects of windstorm overcoming the weight of the concrete weighted ballasts and uplifting the solar array (concrete ballasts visible).

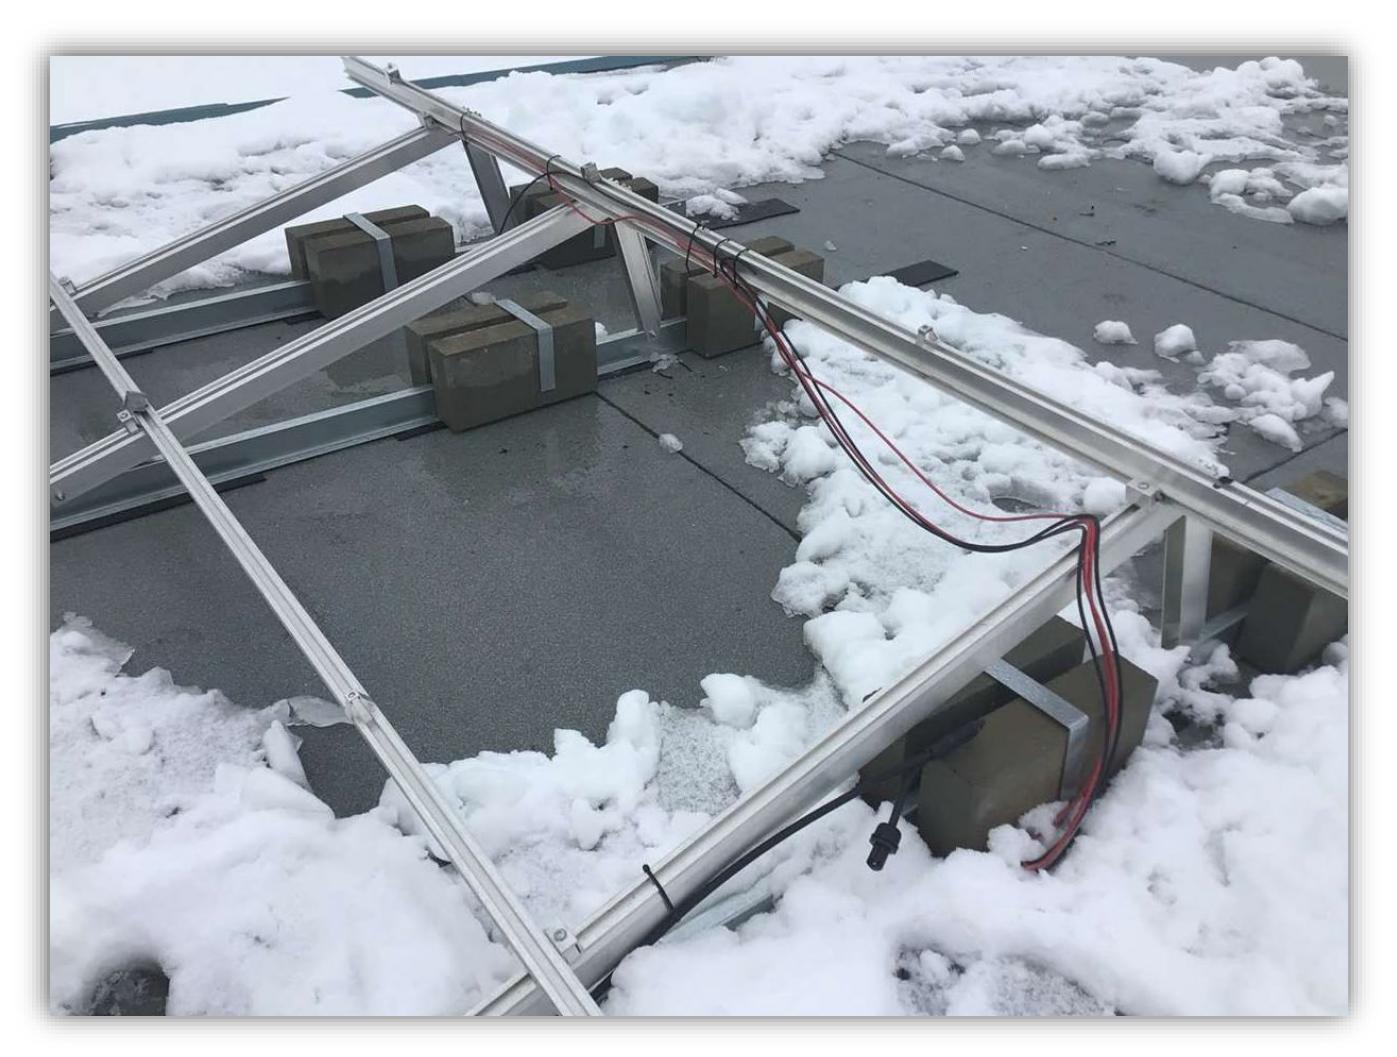
Image 2 - Weighted ballast installation methods for this array. Two ballasts float over a metal channel plate and are secured together by a metal strap.

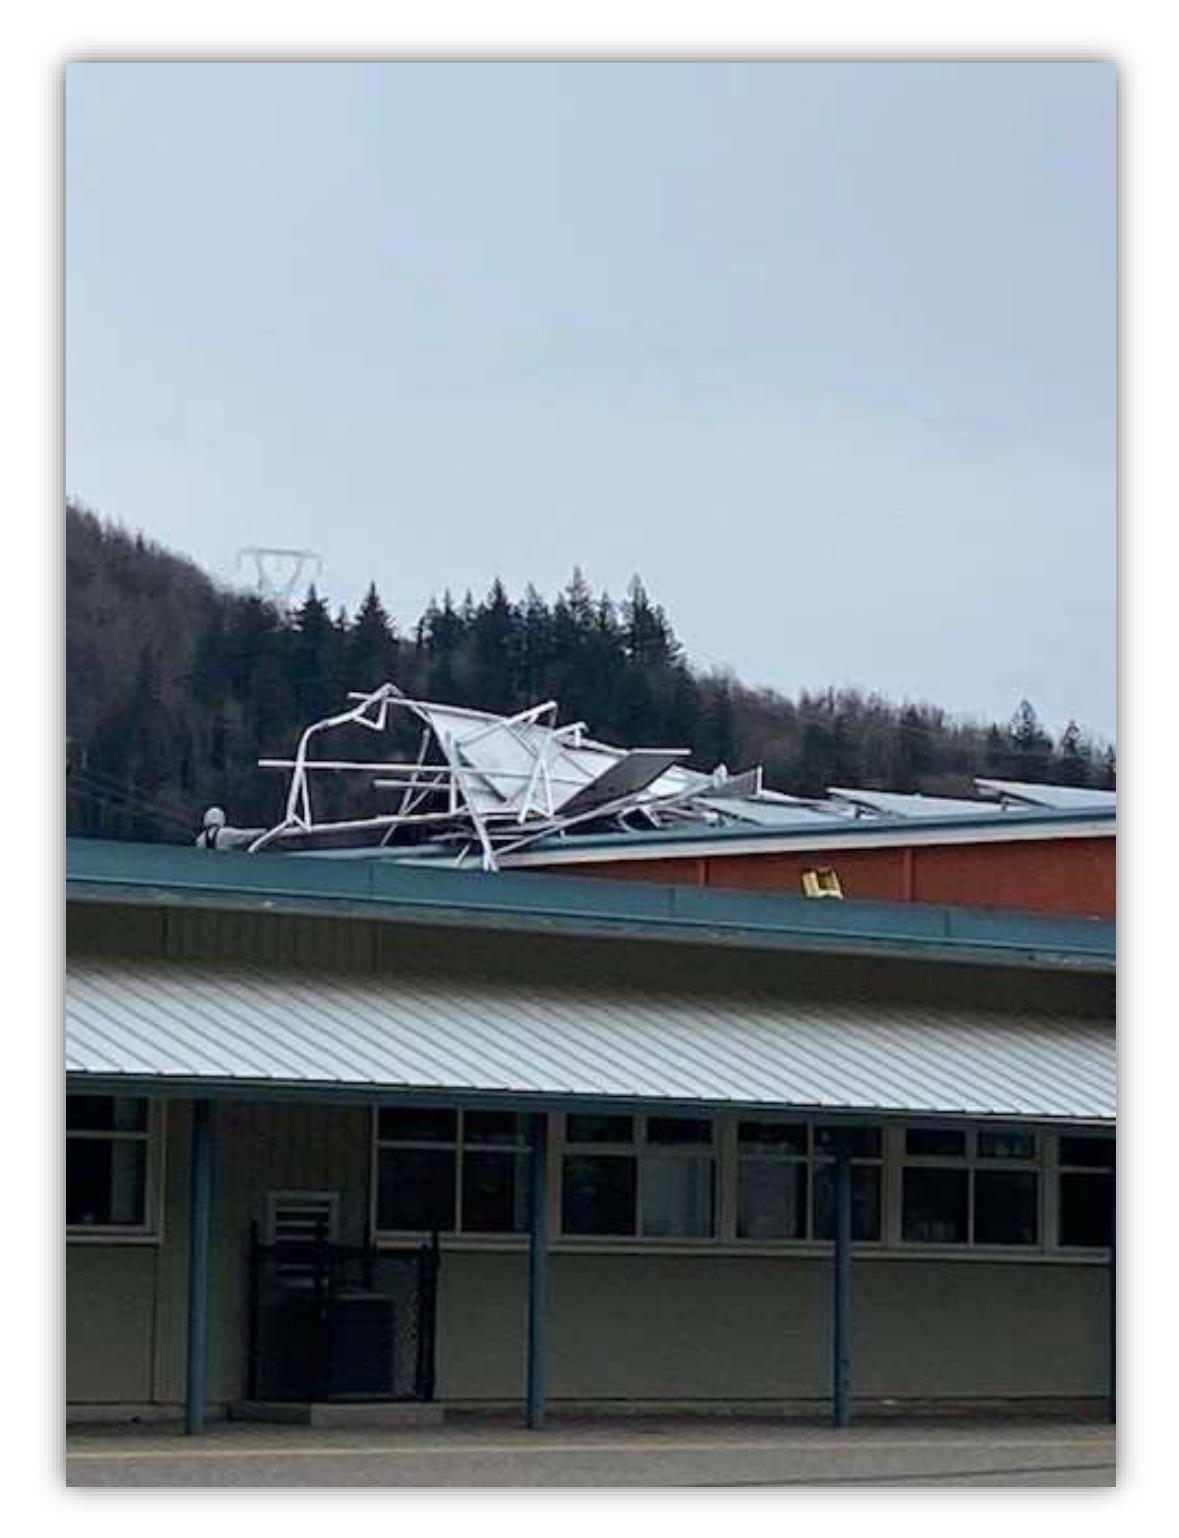
Image 3 - View of damage from ground level.

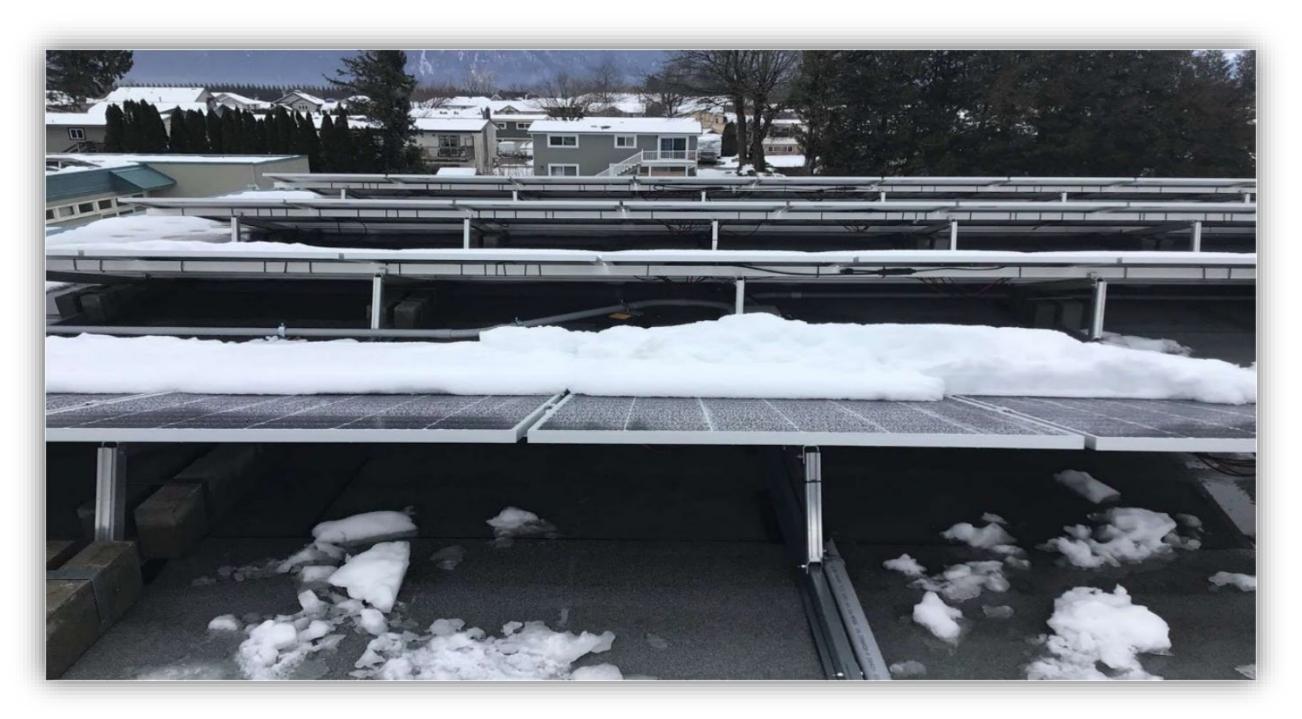
Image 4 - Typical installation of this flat roof top array.

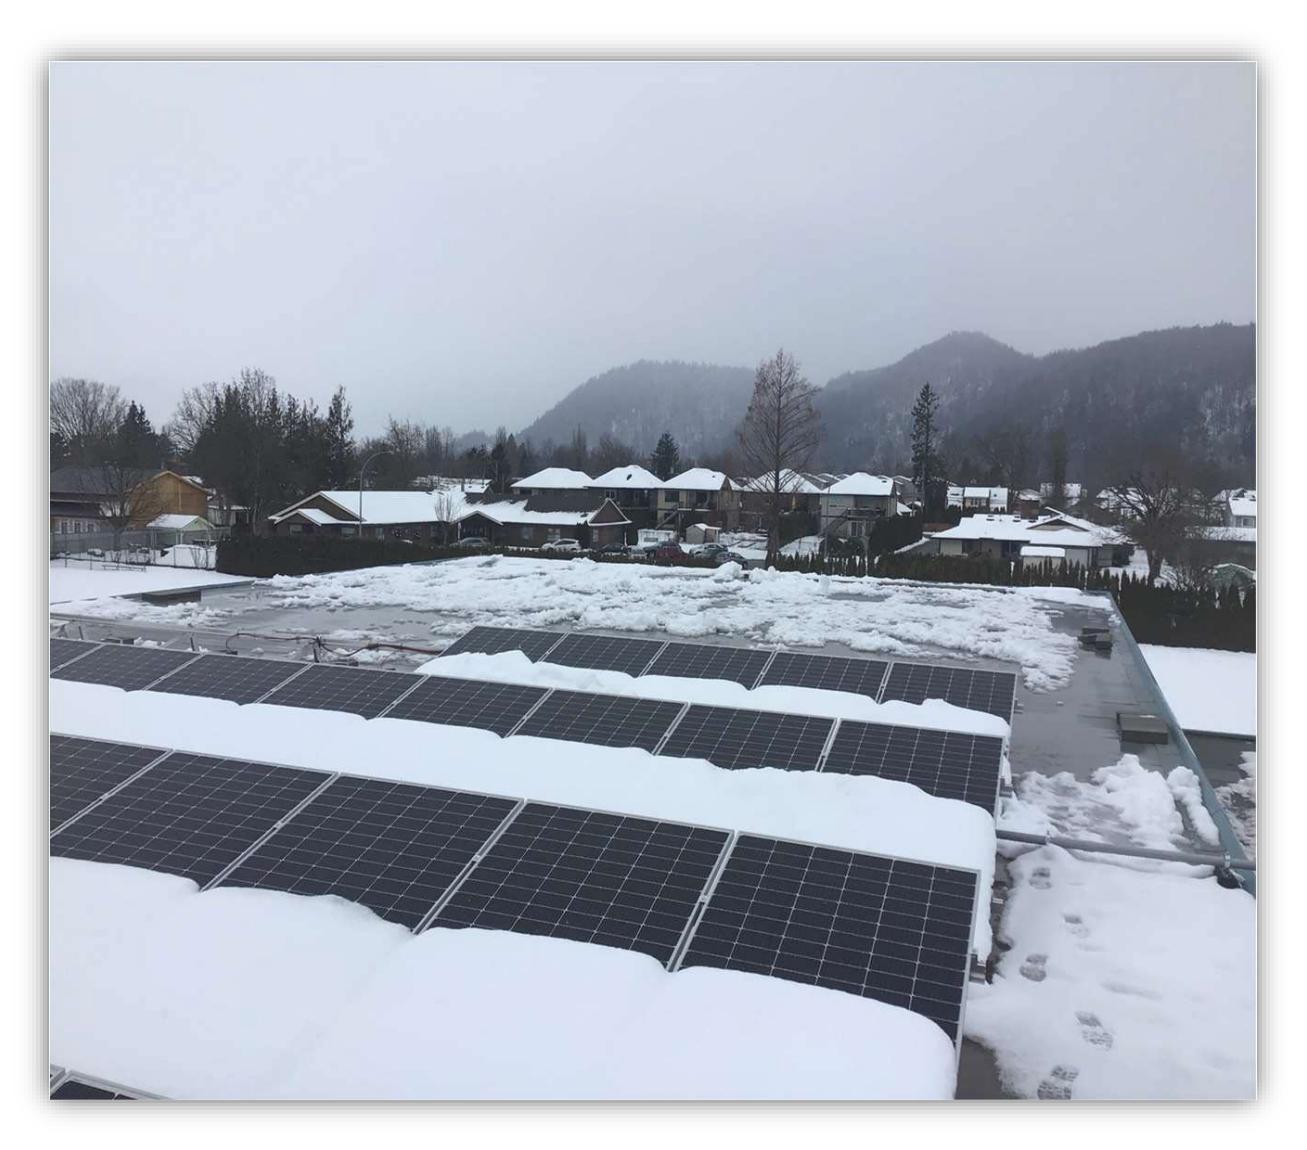
Image 5 - Size of affected area post removal of damaged solar arrays.
