Incident Summary (#5624551)

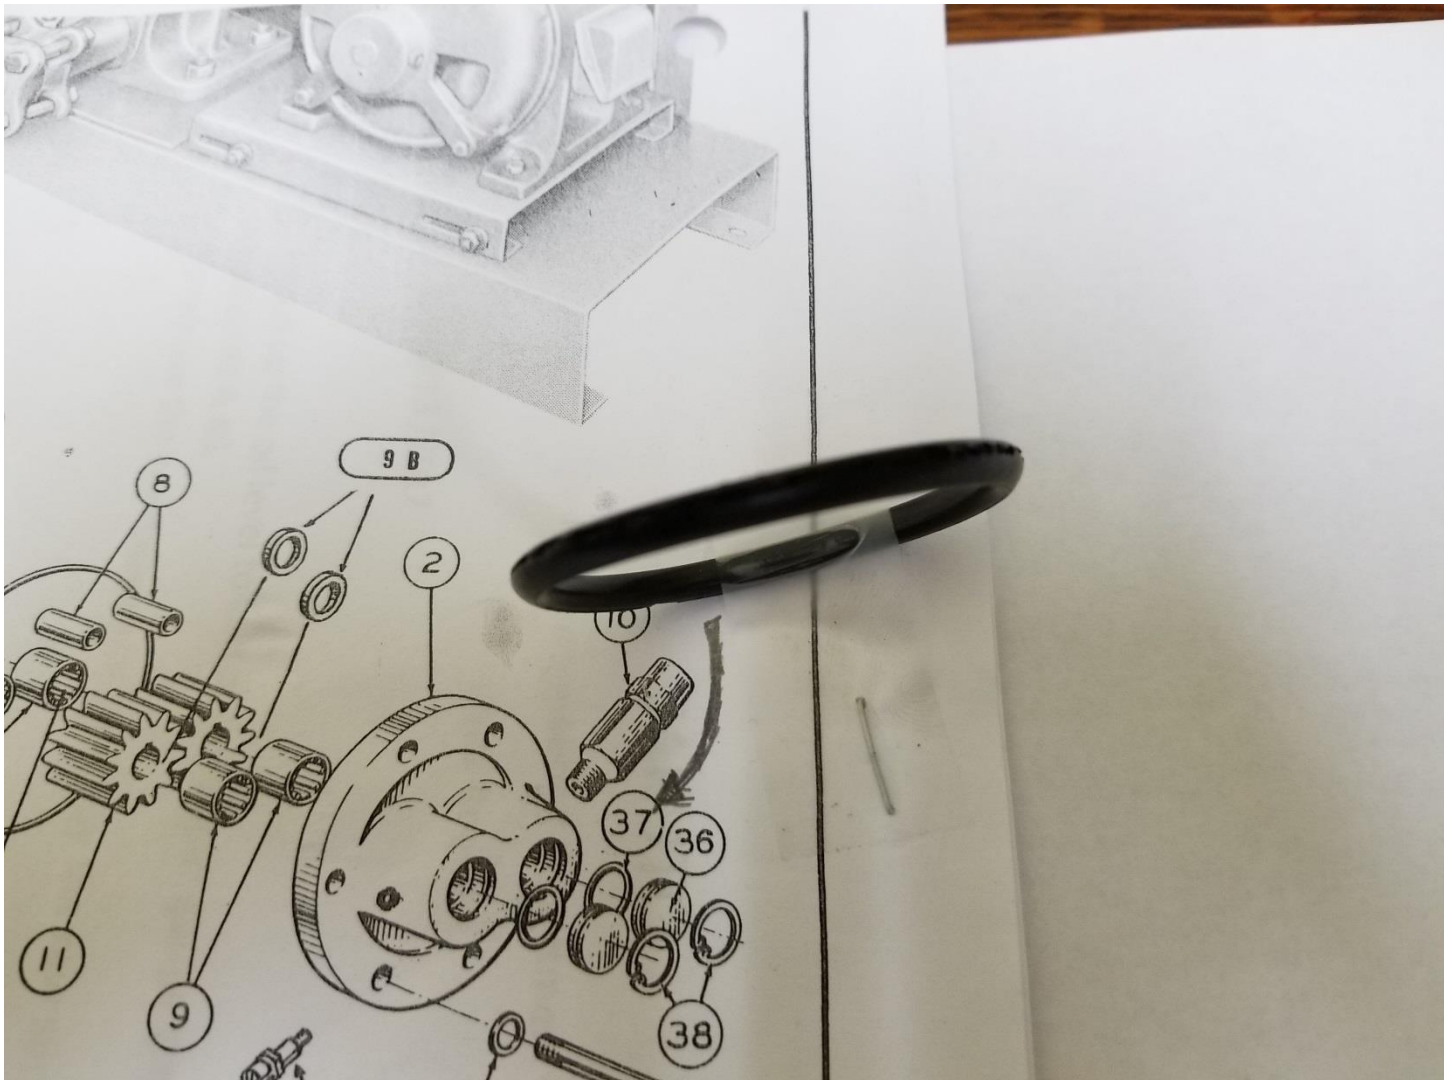
Photos or diagrams (if necessary)
