Incident Summary #II-140058-2022 (#28573) (FINAL)

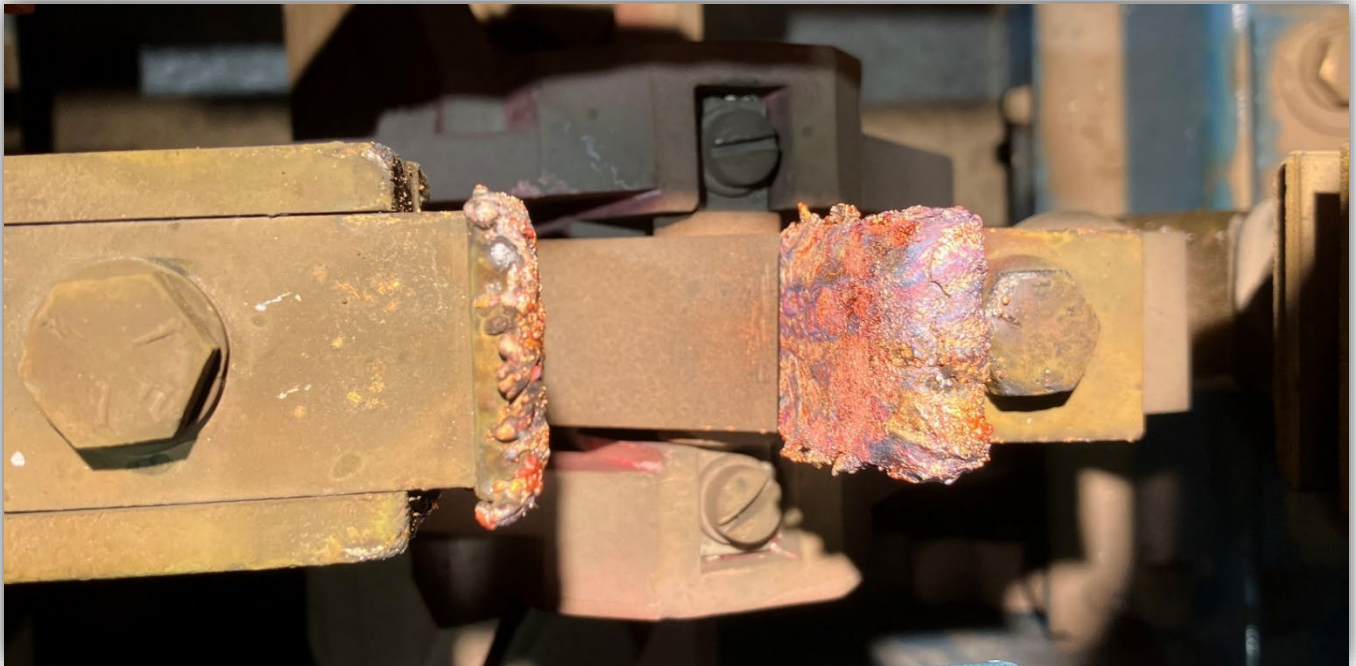
Photo 1 - Burnt switch contacts.

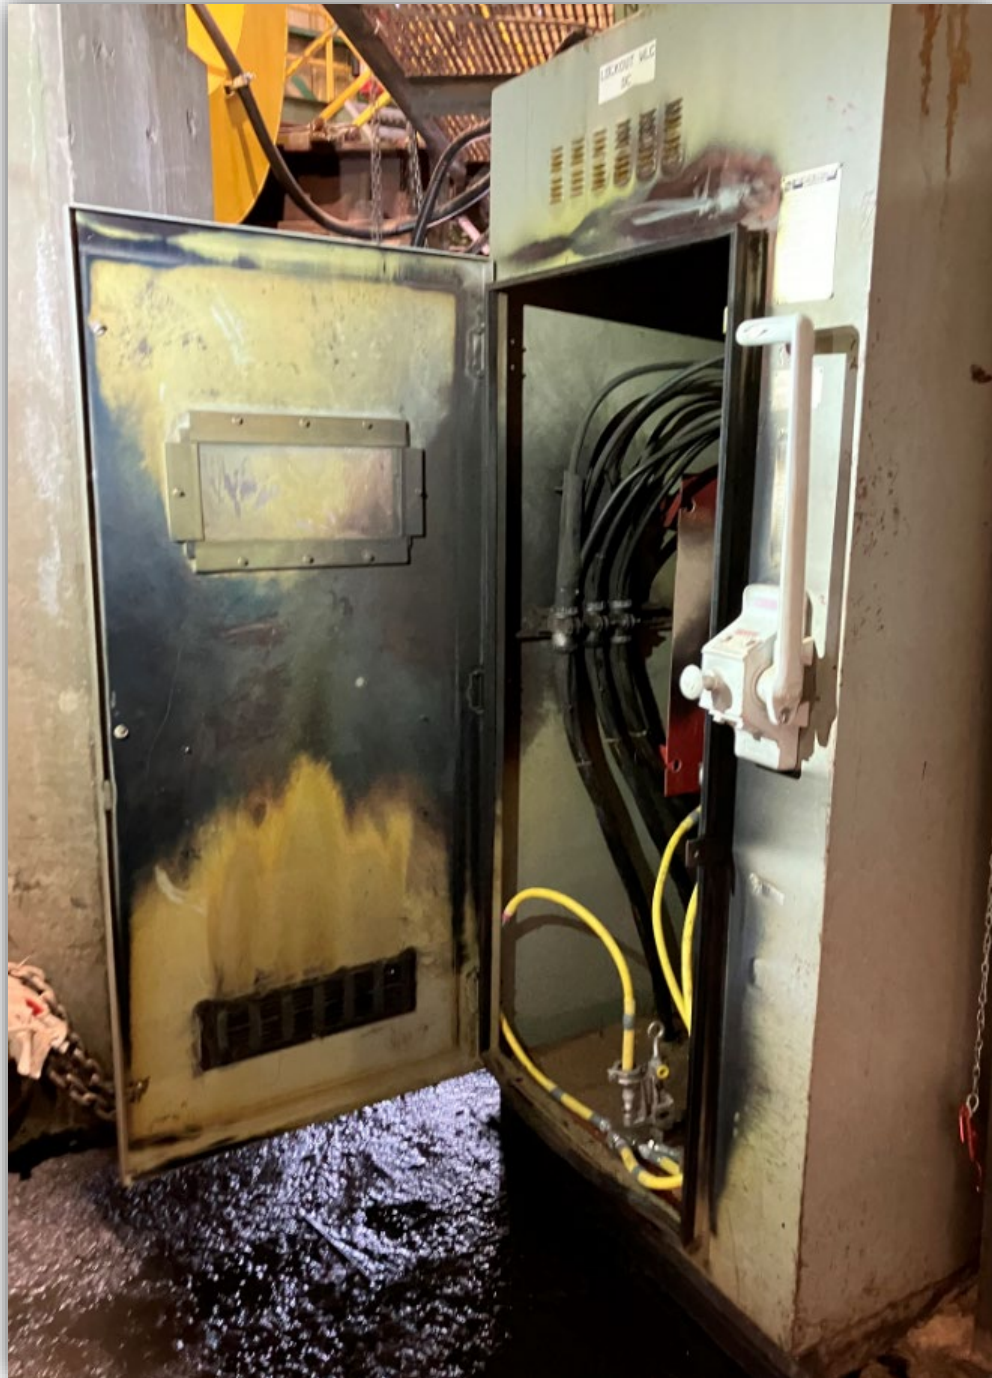
Photo 2 – Arc flash damage

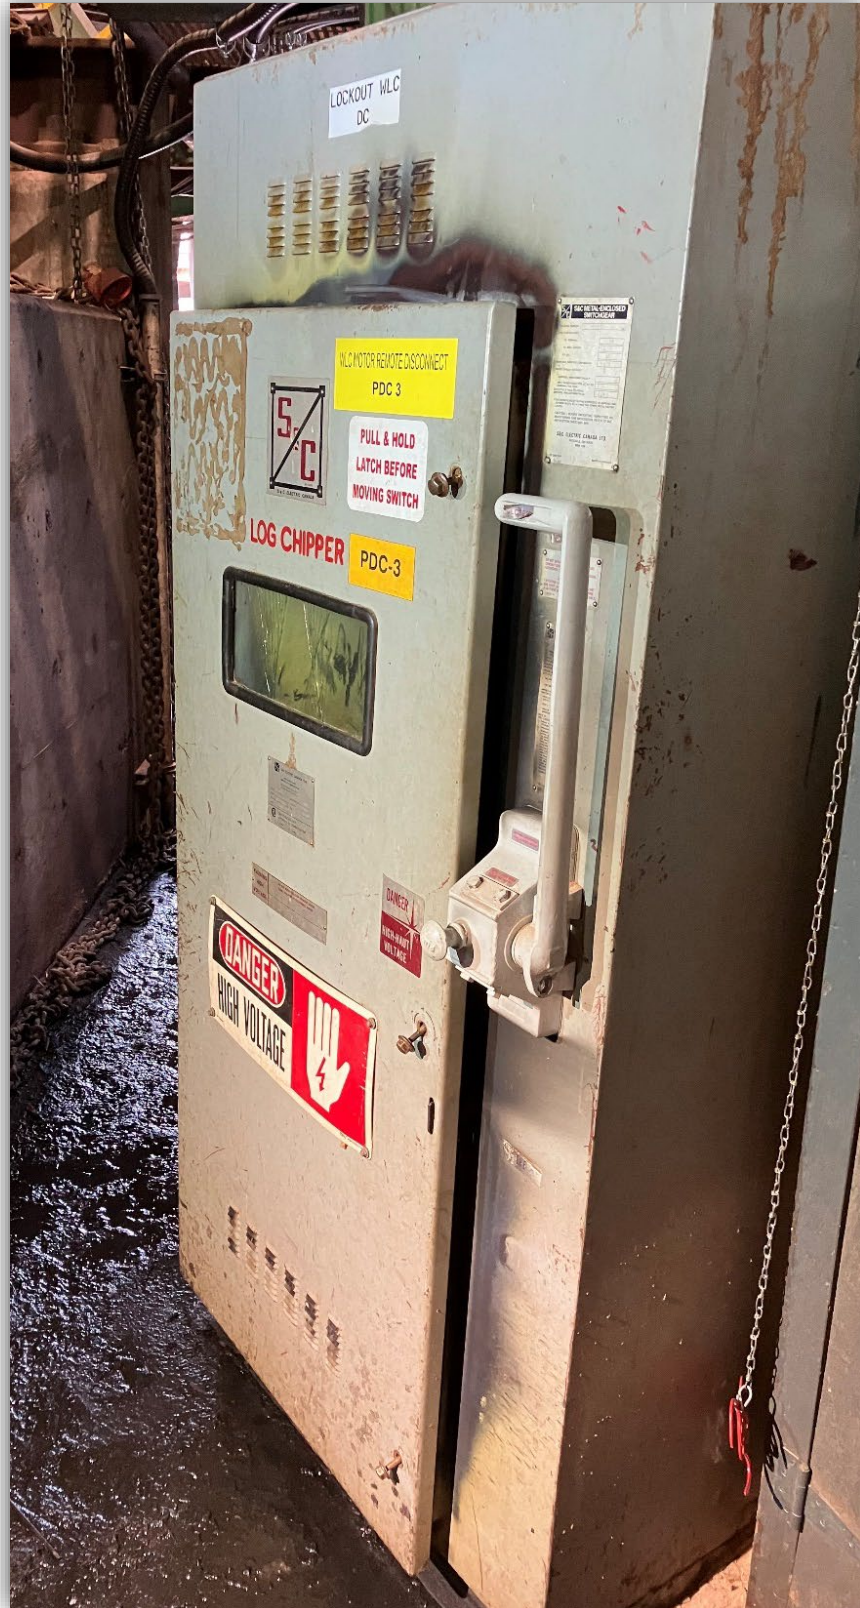
Photo 3 – Whole log chipper local disconnect.
