Incident Summary #II-1556393-2023 (#35692) (FINAL)

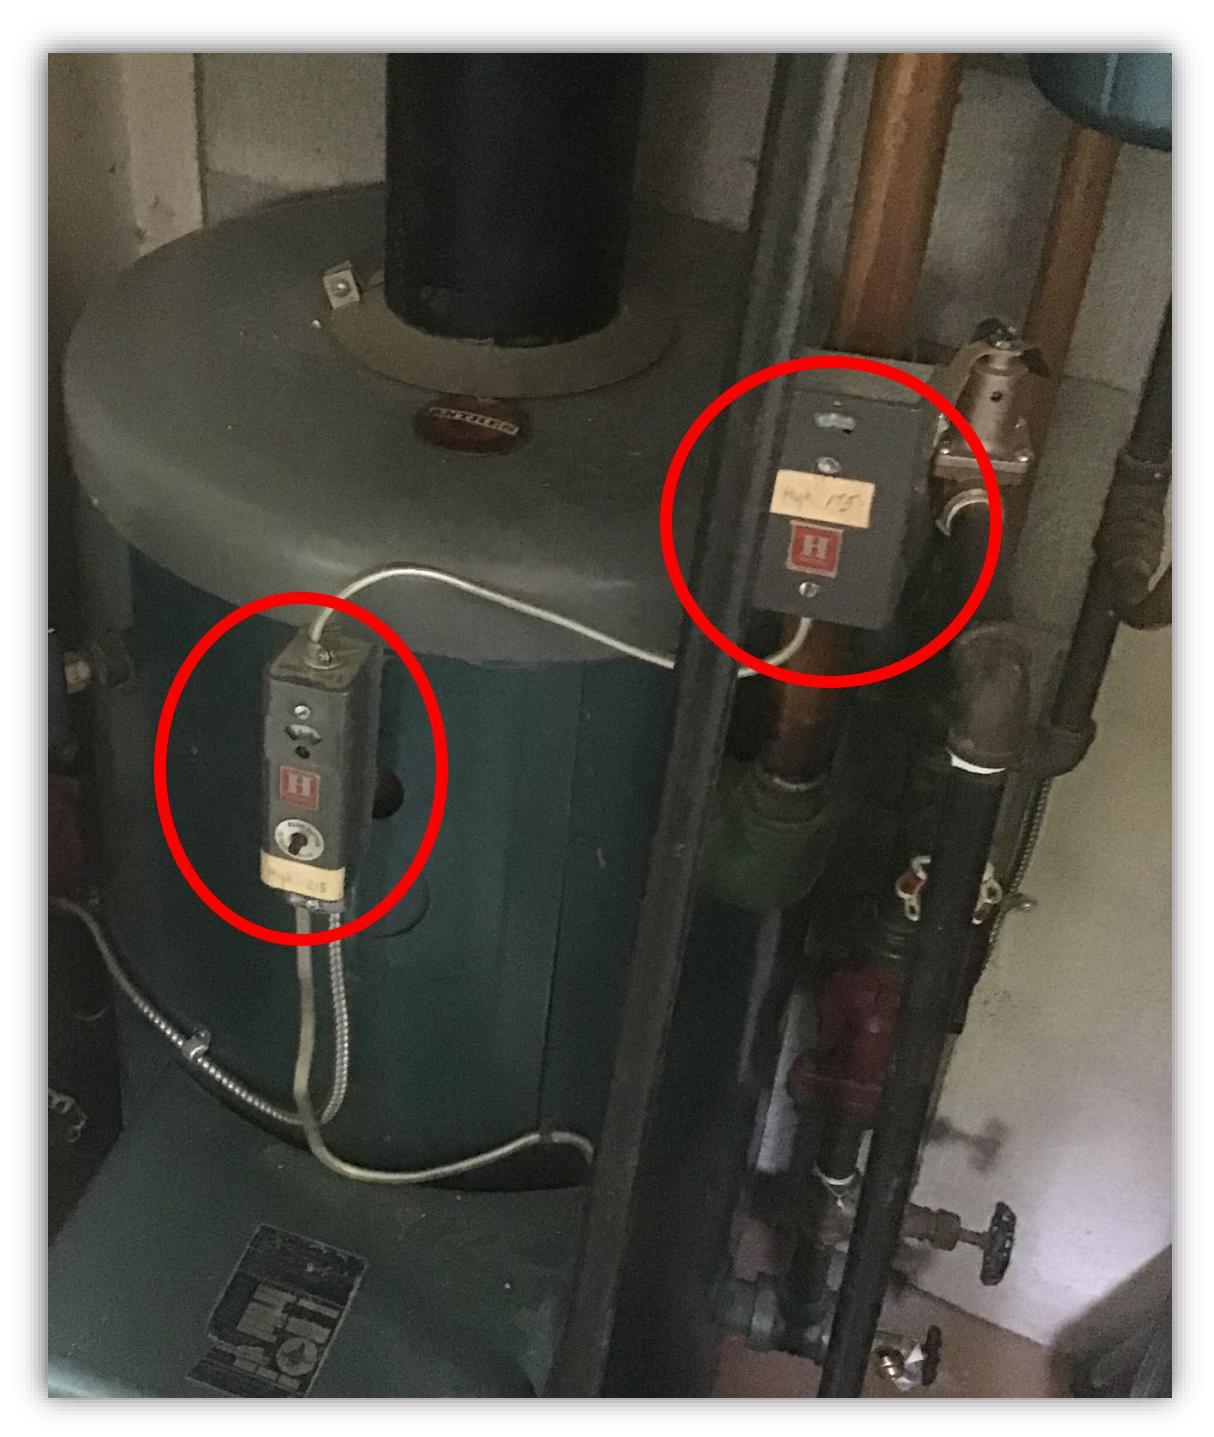
Image 1 - Dwelling boiler, 120-volt control circuit, hydrostats and circulation pump.

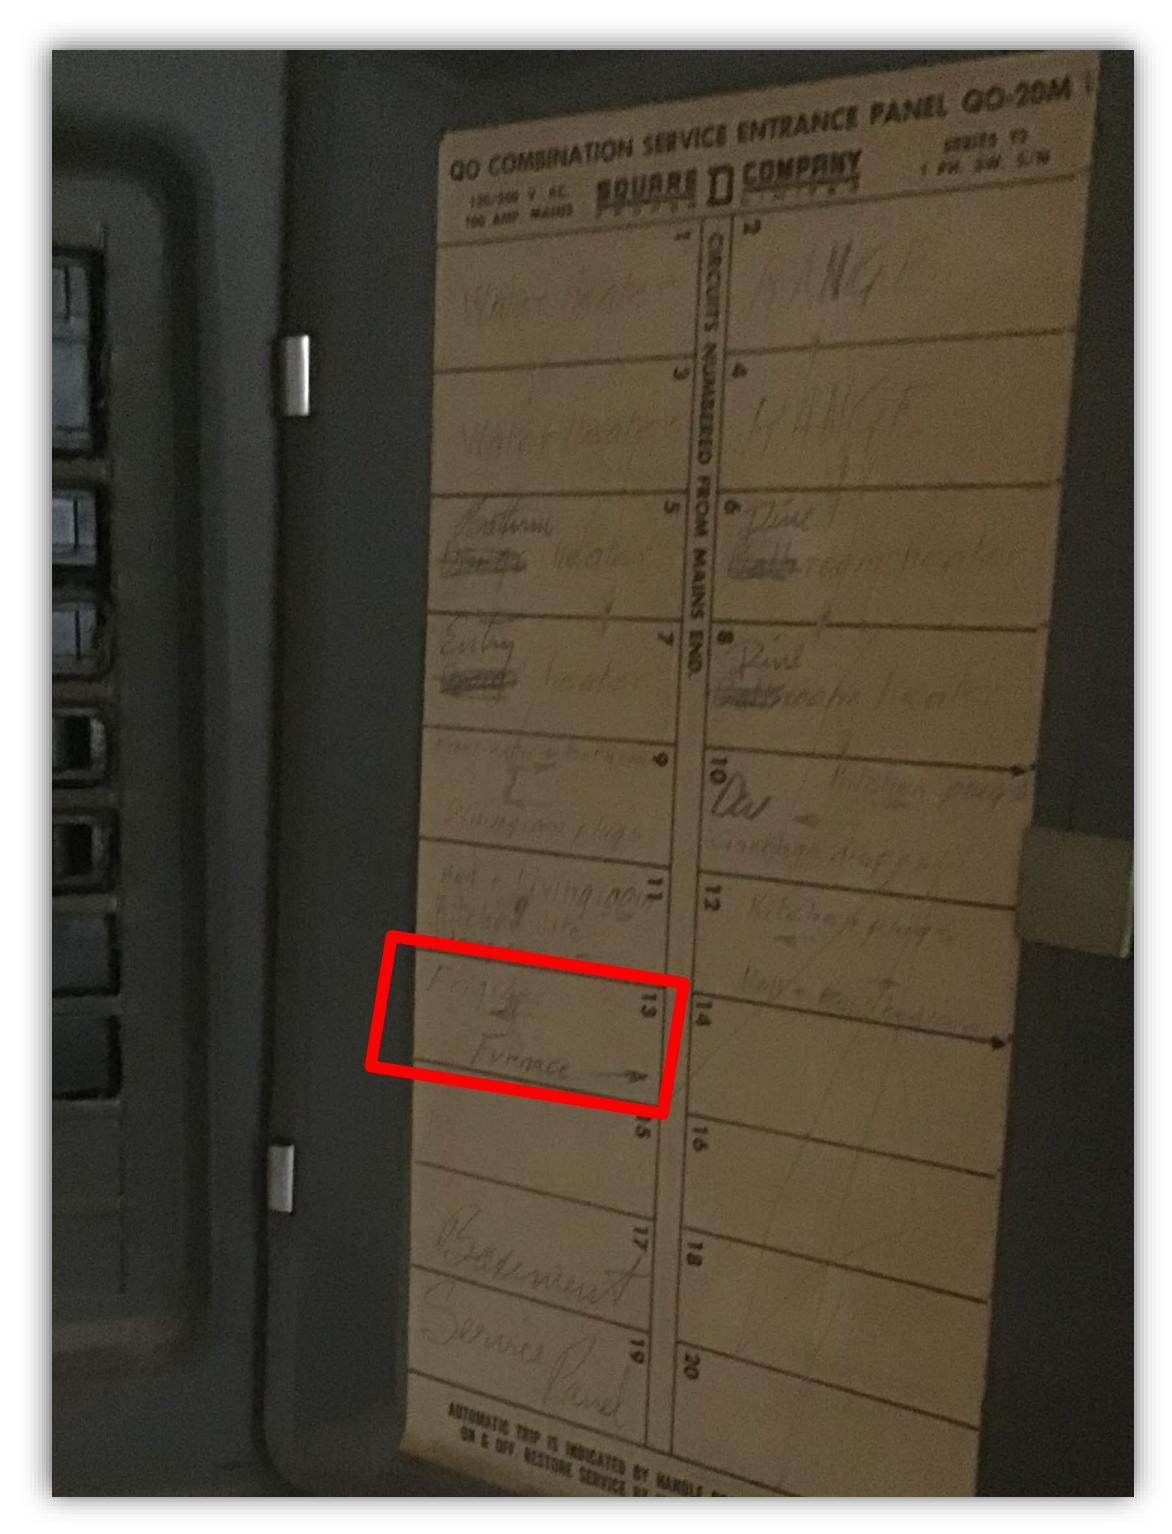
Image 2 - Dwelling panel board – circuit #13 supplying boiler controls.

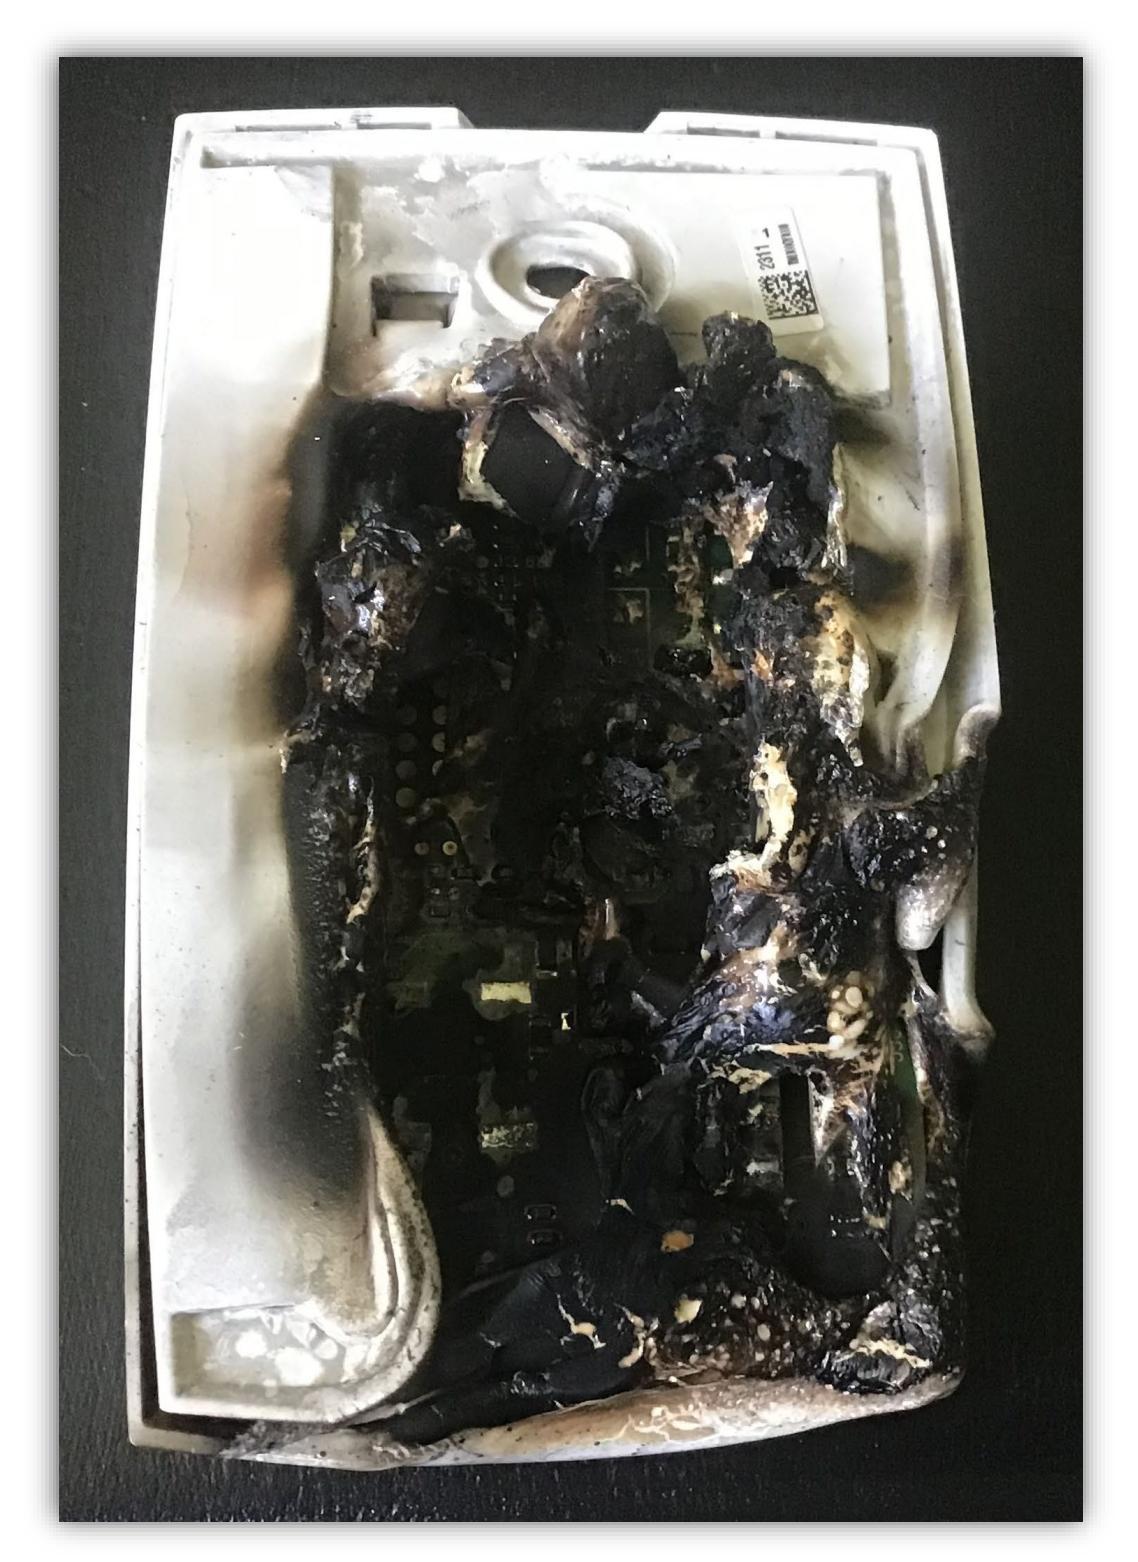
Causes and contributing factors	Thermostats that were replaced were the incorrect style with respect to the electrical rating for the application. It is likely that installation confusion around the replacement thermostat ratings was contributed to by labelling on wholesale packaging not being obvious resulting in a misapplication and subsequent failure of regulated equipment.

Image 3 - Damage to thermostat.
