# Incident Summary #II-901832-2019 (#15107) (FINAL)

| STIGATION CONCLUSIONS SUPPORTING INFORMATION | Incident Date | | April 3, 2019 | |
|--|---|---|---|--|
| | Regulat | ed industry sector | Electrical - Low voltage electrical system (30V to 750V) | |
| | Incident overview | | Two separate fires within approximately one week of each other occurred on two linear fluorescent tube style luminaires with electronic ballasts that were retrofitted with 6 Universal brand light emitting diode (LED) tubes each and clear covers in the high ceiling of a storage warehouse. | |

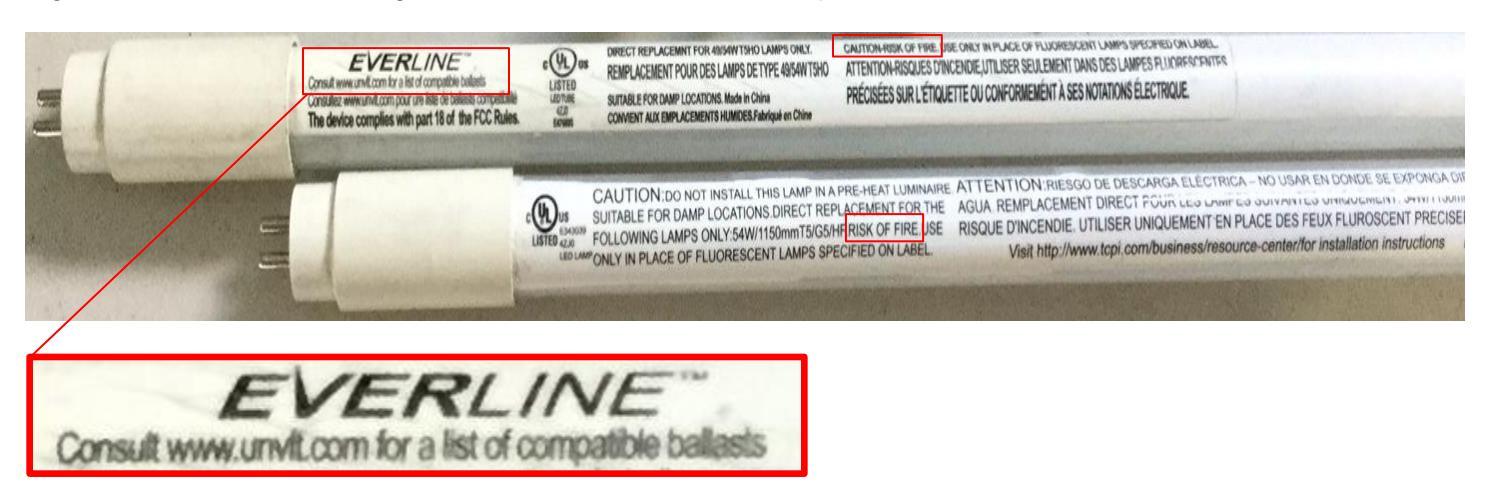
| STIGATION CONCLUSIONS SUPPORTING INFORMATION | Incident Date | | April 3, 2019 | |
|--|---|---|---|--|
| | Facts a | nd evidence | Figure 1 – Video of light fixture on fire<br>Figure 2 – LED tube warning labels<br>-The LED tube specified to consult the manufacturers website for ballast compatibility<br>Figure 3, 4 – Fluorescent ballasts (4 & 2 tube) | |

### Figure 2 – LED Tube warning labels – "Consult for list of compatible ballasts/ caution risk of fire"

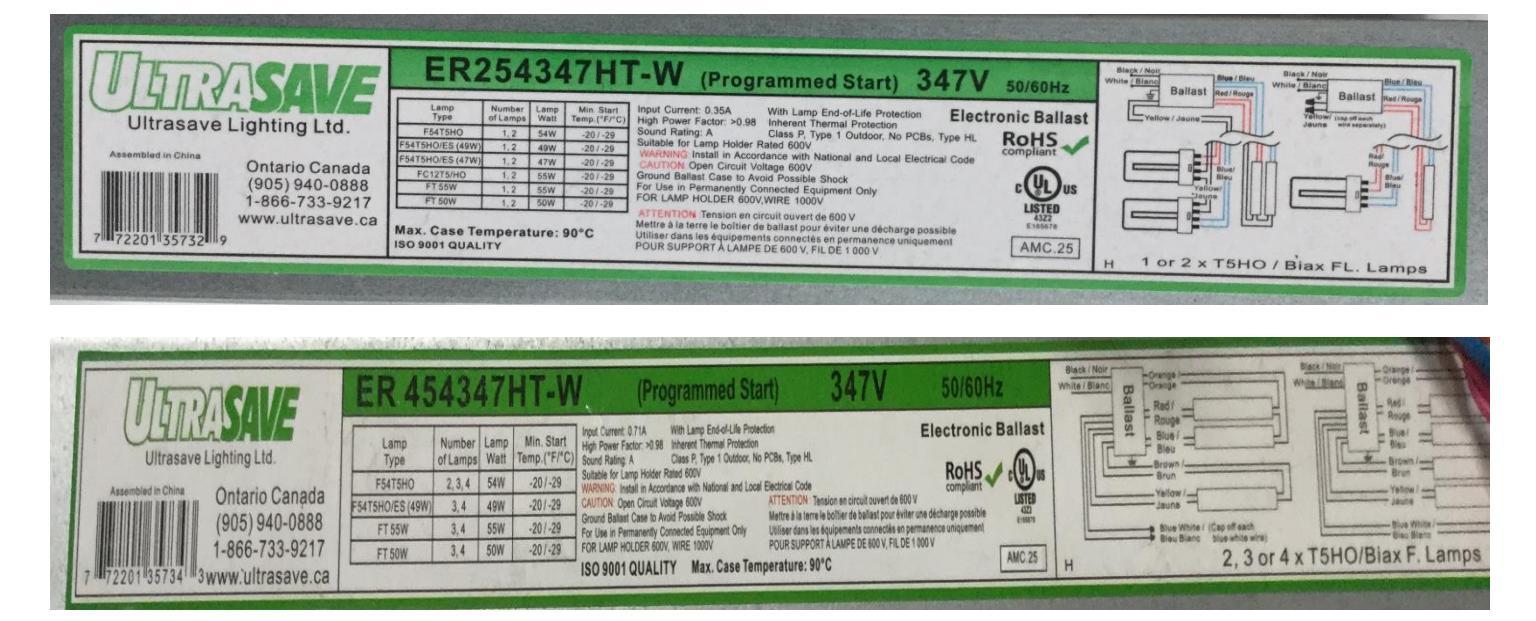
#### Figure 3, 4 – Ultrasave fluorescent ballasts one 2 tube & one 4 tube per each light fixture

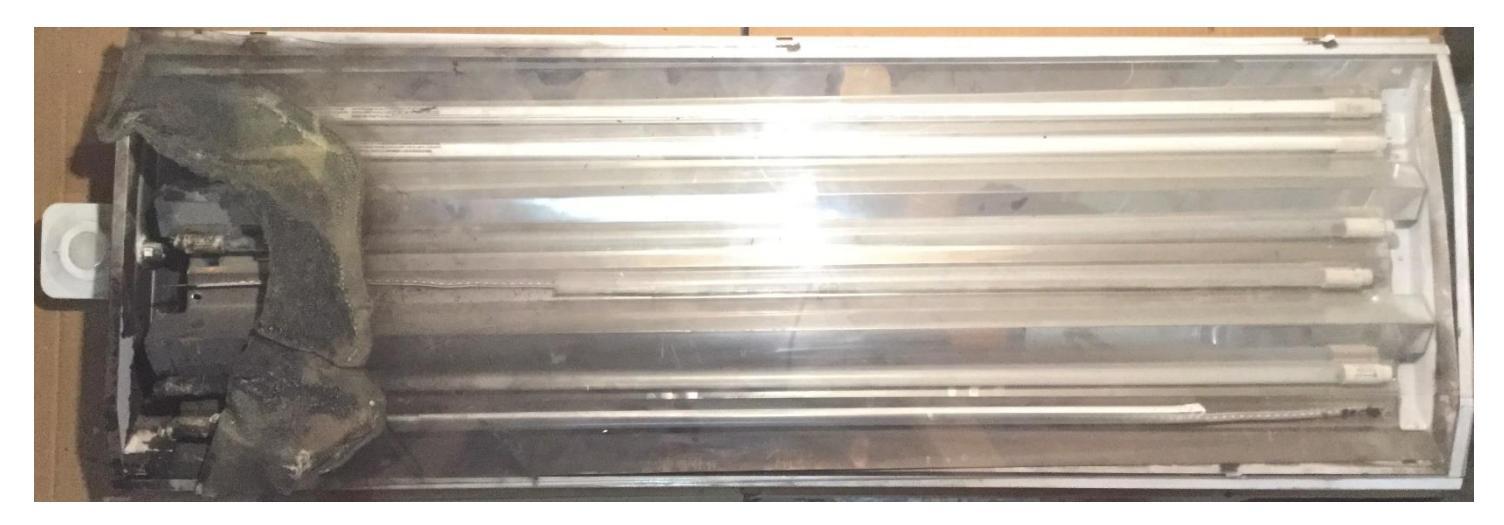
### Figure 8 – Luminaire Damage

| STIGATION CONCLUSIONS SUPPORTING INFORMATION | Incident Date | | April 3, 2019 | |
|--|---|---|---|--|
| ING IN | In | Damage<br>description | Major damage to two light fixtures and damage to a pallet of stored materials. | |
| INVE | Failure scenario(s) | | Overheating due to incompatibility between the existing ballasts and the LED tubes breaking down the electronic components of the LED tube, creating high resistance, heat and fire igniting the LED tubes and clear covers. | |

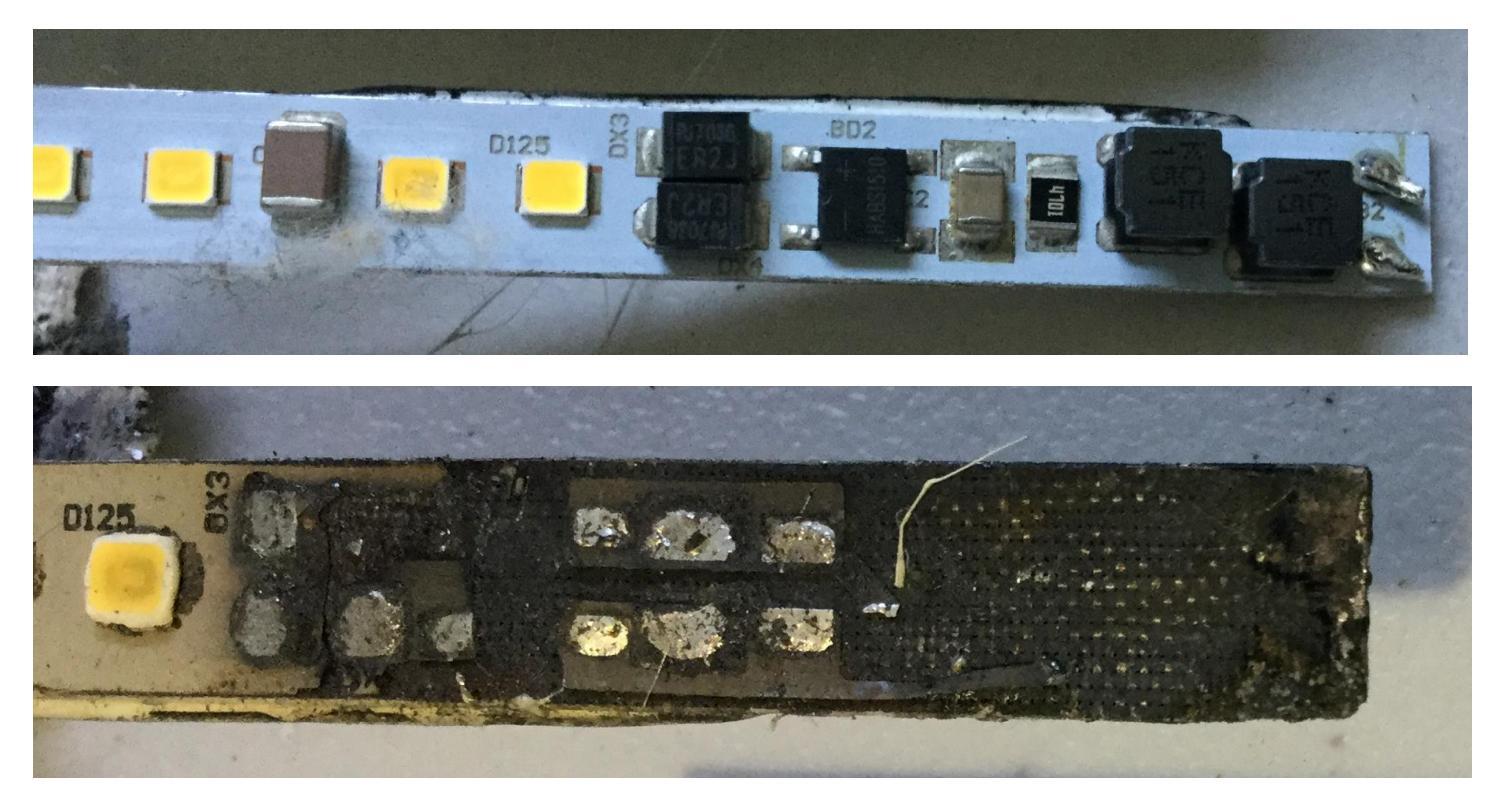
| Causes and contributing factors | It is very likely that the LED tubes incompatibility with the existing ballasts was the cause of the fires<br>Contributing factors:<br>-The manufacturers installation instructions and warnings were not followed during installation<br>-The clear solid covers provided additional fuel to the fire |

Figures 9, 10 - LED Tube internal damage before and after
