Incident Summary #II-777900-2018 (#9828) (FINAL)

SUPPORTING INFORMATION	Incident Date		November 21, 2018
	Location		Port Coquitiam
	Regulated industry sector		Electrical - Low voltage electrical system (30V to 750V)
		Qty injuries	0
	t Injury	Injury description	N/A
	Ipac	Injury rating	None
	In nage	Damage description	Burning and heat damage occurred to interior and exterior components of an electrical power bar. Heat and smoke damage to surrounding area.
	Dam	Damage rating	Insignificant
	Inciden	t rating	Insignificant
	Incident overview		Electrical power bar began to smoke and burn in an interior office environment, behind an open shelving unit. Heat and smoke damage has occurred to the power bar and the power bar is no longer operable.
INVESTIGATION CONCLUSIONS	Site, system and components		Electrical power bar was plugged in to a wall receptacle outlet. Power bars are plugged into wall receptacles to provide an increased number of receptacles at one location. Power bars have information printed on the back of them for the user: •Manufacturer's electrical ratings: maximum voltage and amperage the power bar operates at safely. •Location for use, indoor or indoor/outdoor •Certificat

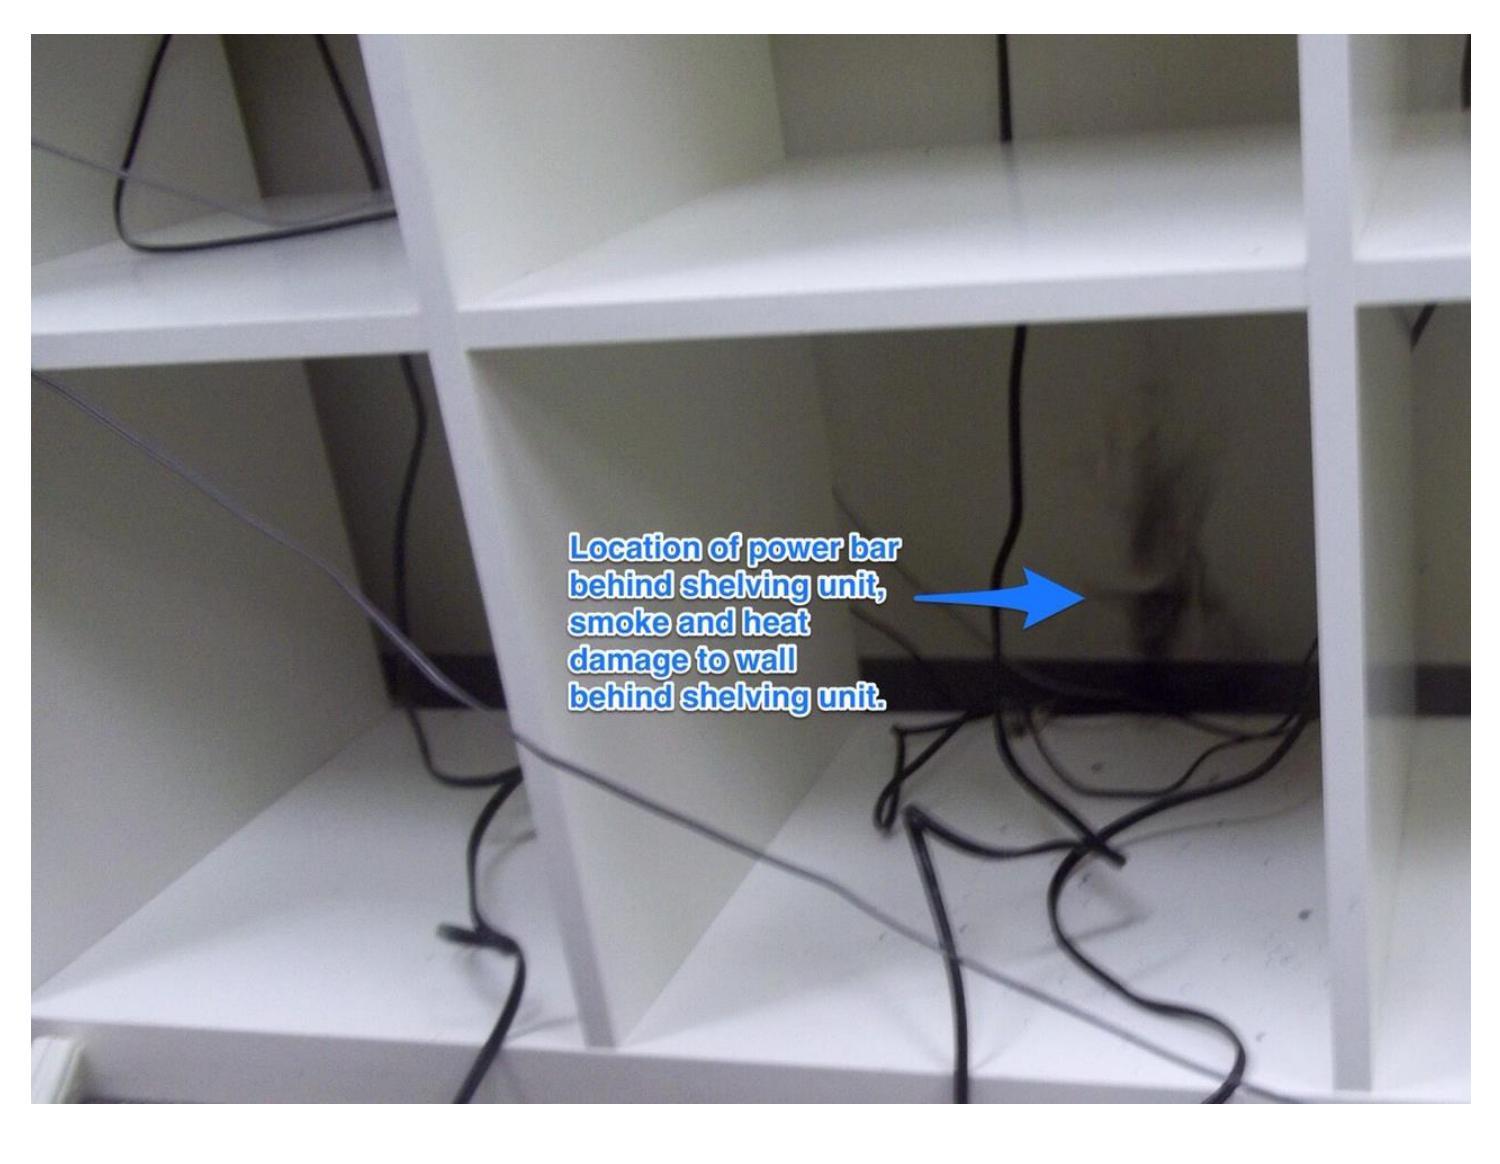
Burn left into the carpet where the power bar was located and smoke damage to wall.

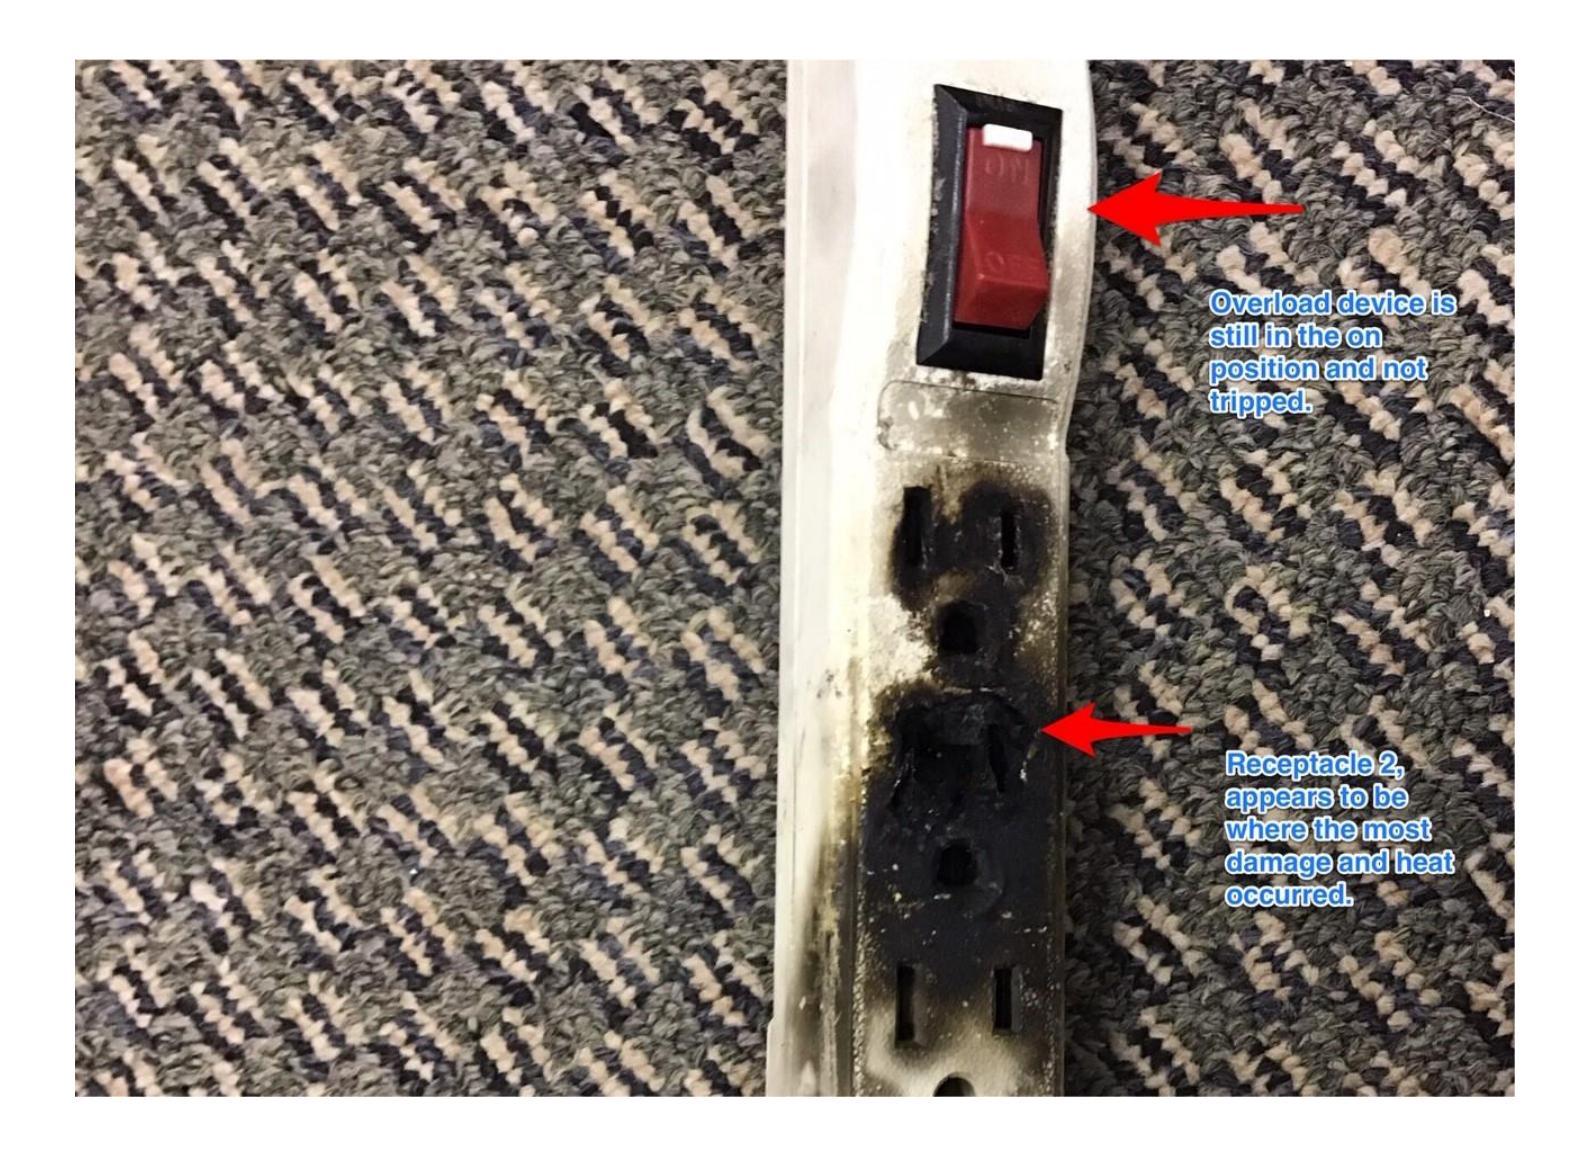
A large amount of burning on the fish tank pump cord. This cord was located in receptacle 2 on the power bar.
