## Incident Summary #II-922268-2019 (#15652) (FINAL)

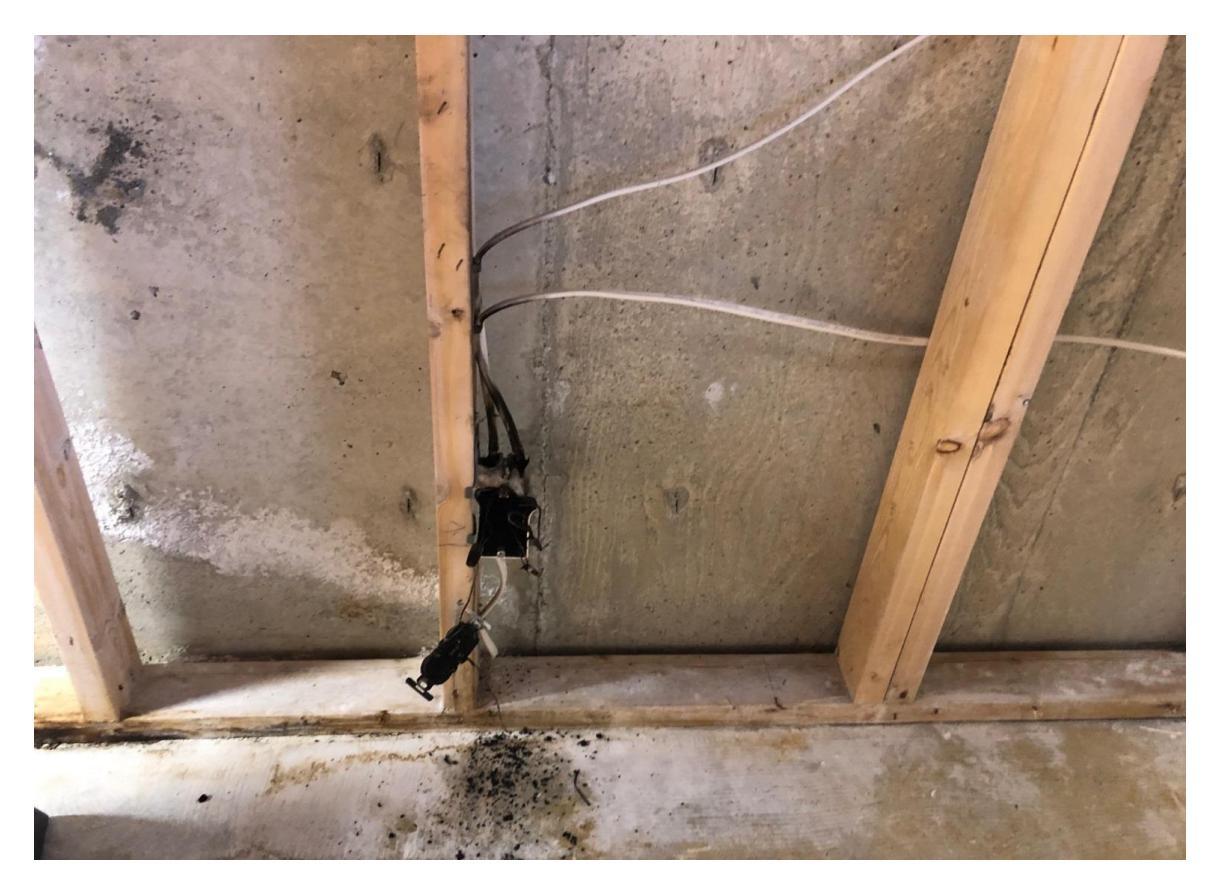
Photo 1: Burnt receptacle and outlet box.

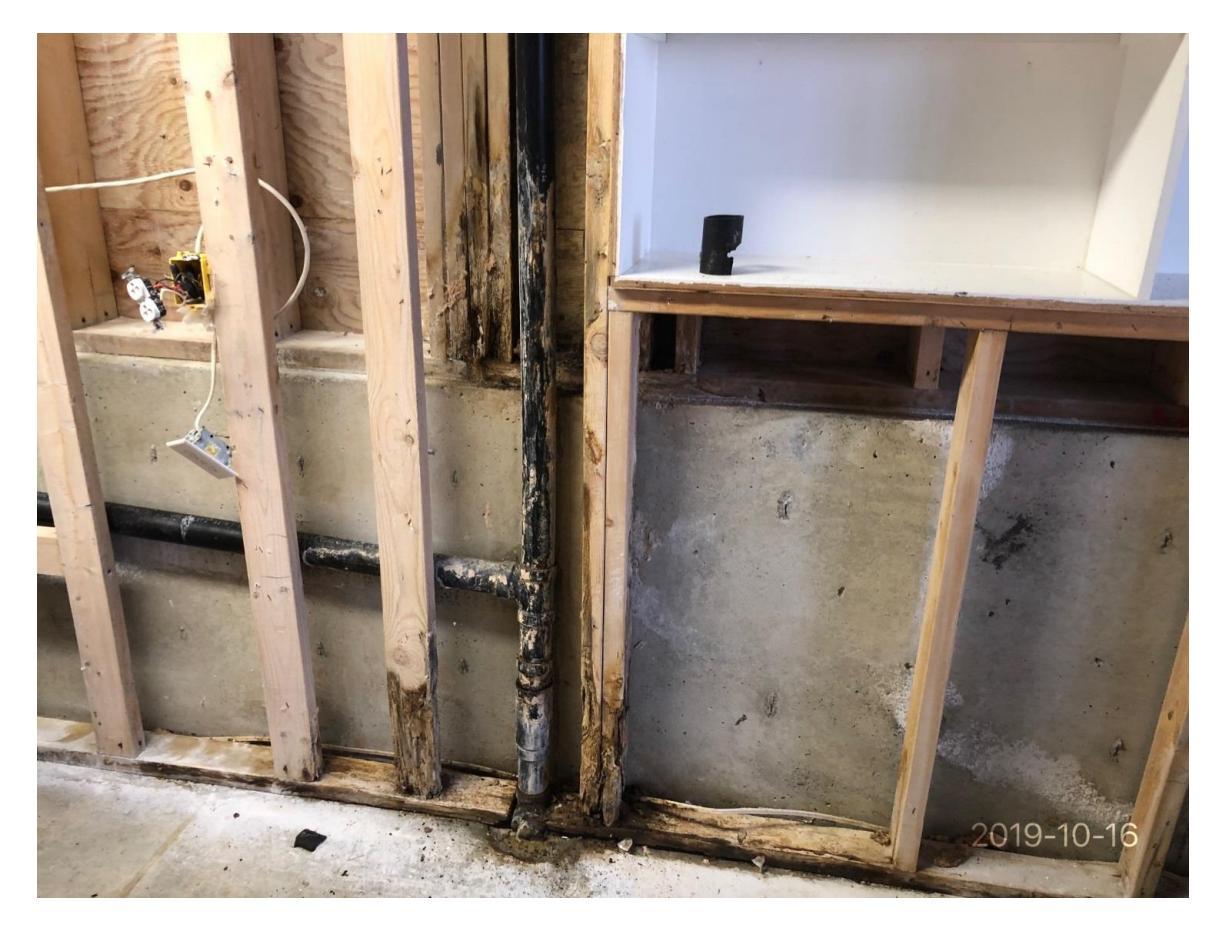
Photo 2: Outside wall with damaged drain. The electrical boxes do not have gaskets, and no sealant was used on the wall. The electrical boxes were wrapped in polyethylene and the cables poked through the polyethylene into the boxes, the holes in the polyethylene were not sealed.

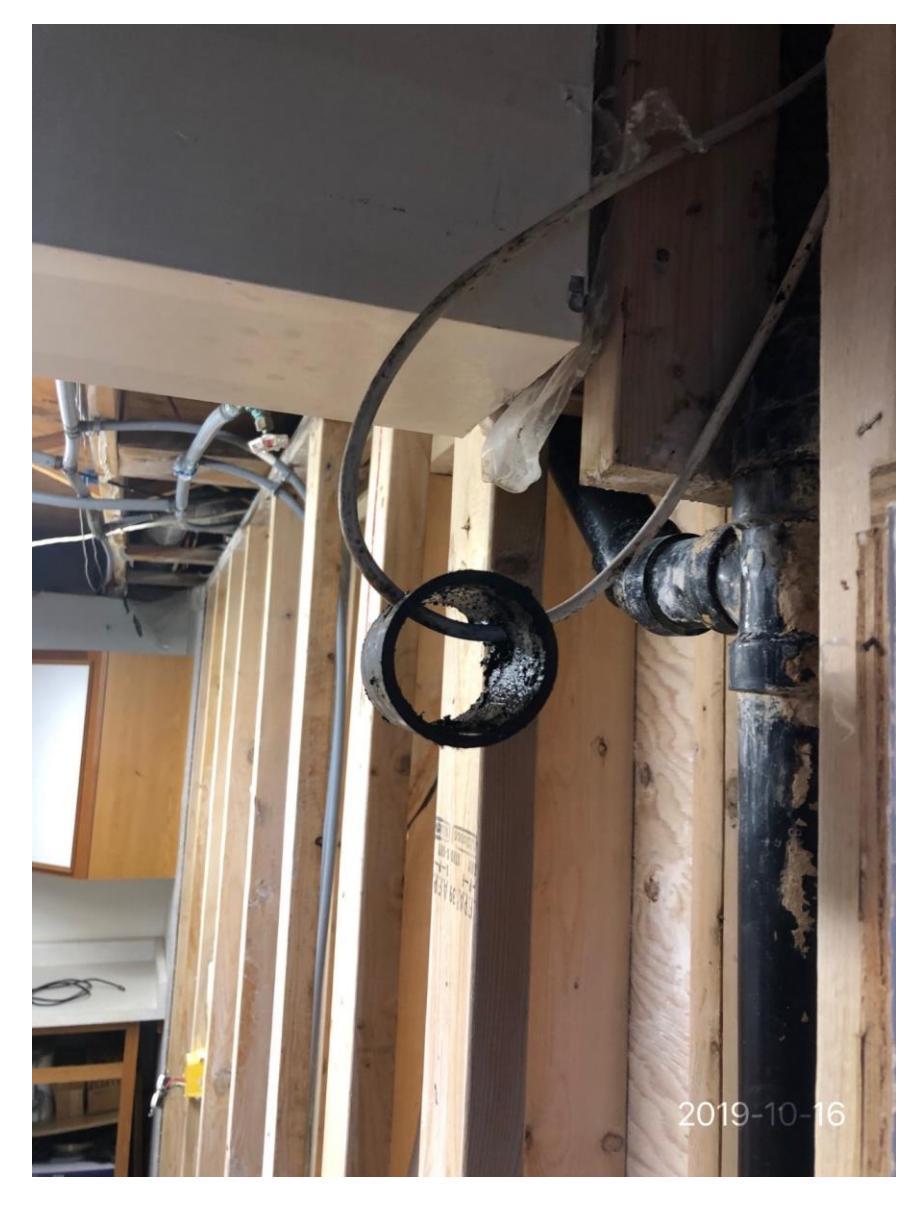
Photo 3: Section of drain pipe with a coaxial cable installed through it.

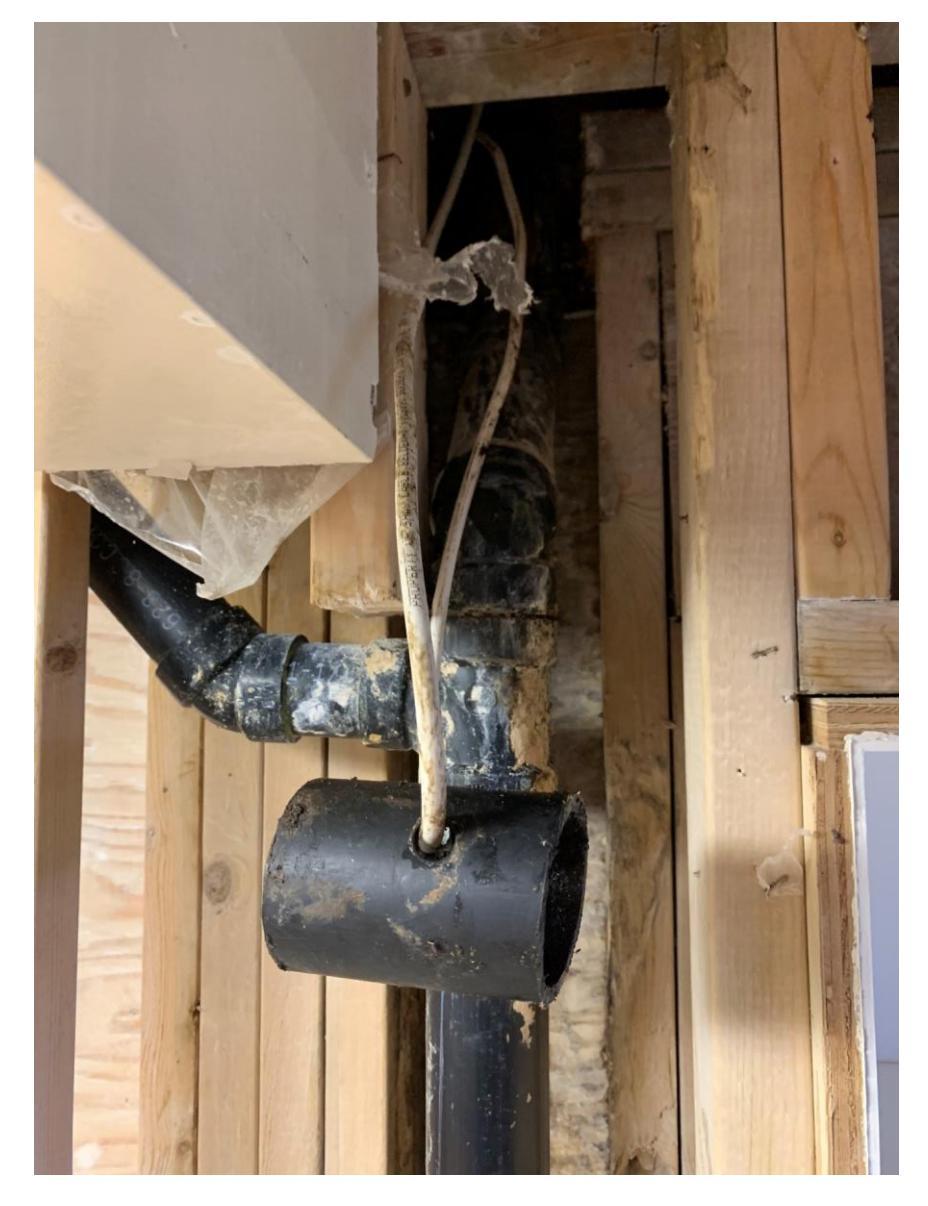
Photo 4: Damaged drain pipe. Hole drilled through pipe when electrical cable installed

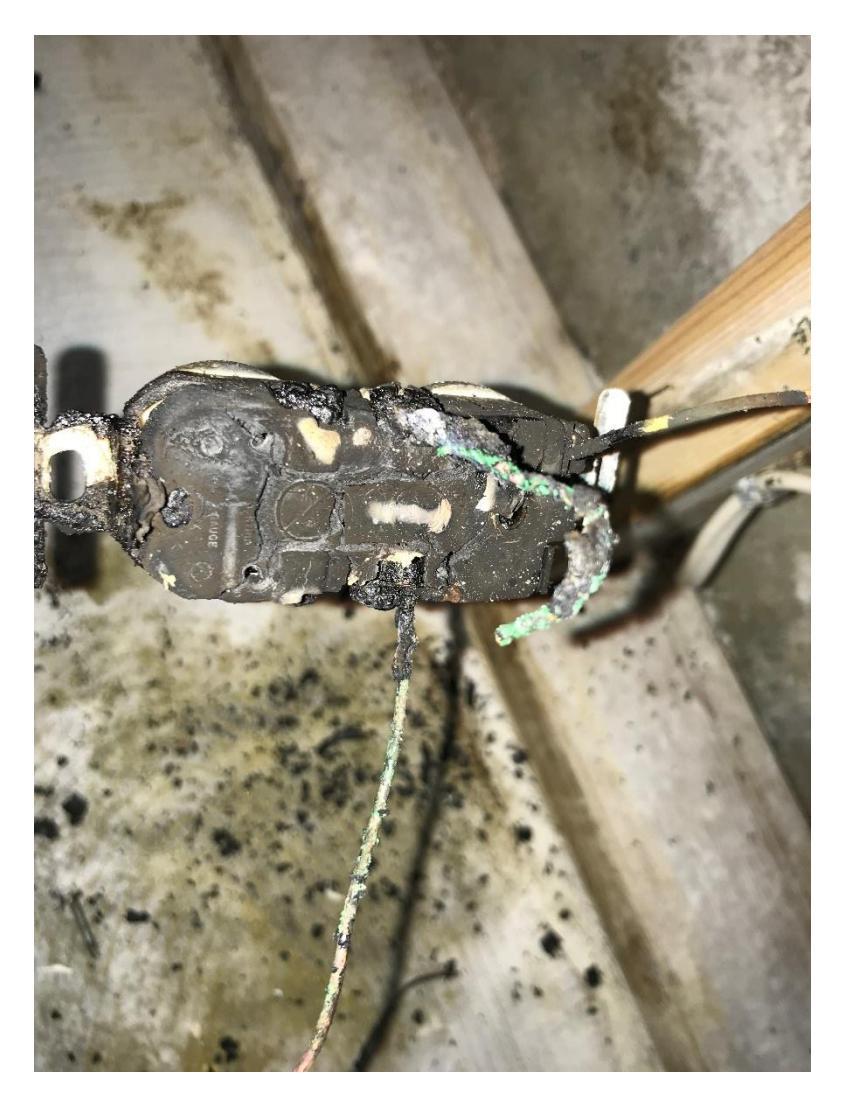
Photo 5: Damaged receptacle

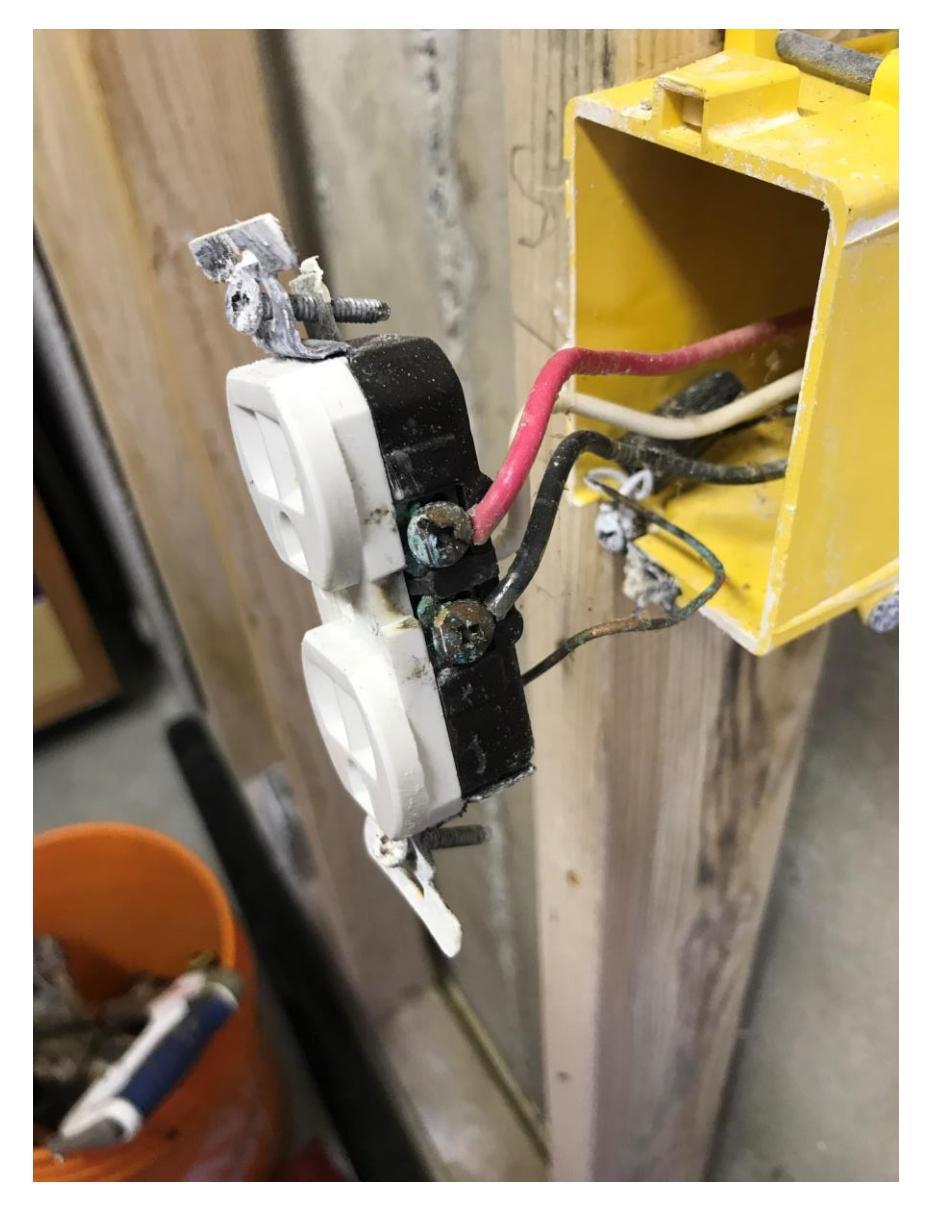
Photo 6: Oxidation of a nearby receptacles terminals.

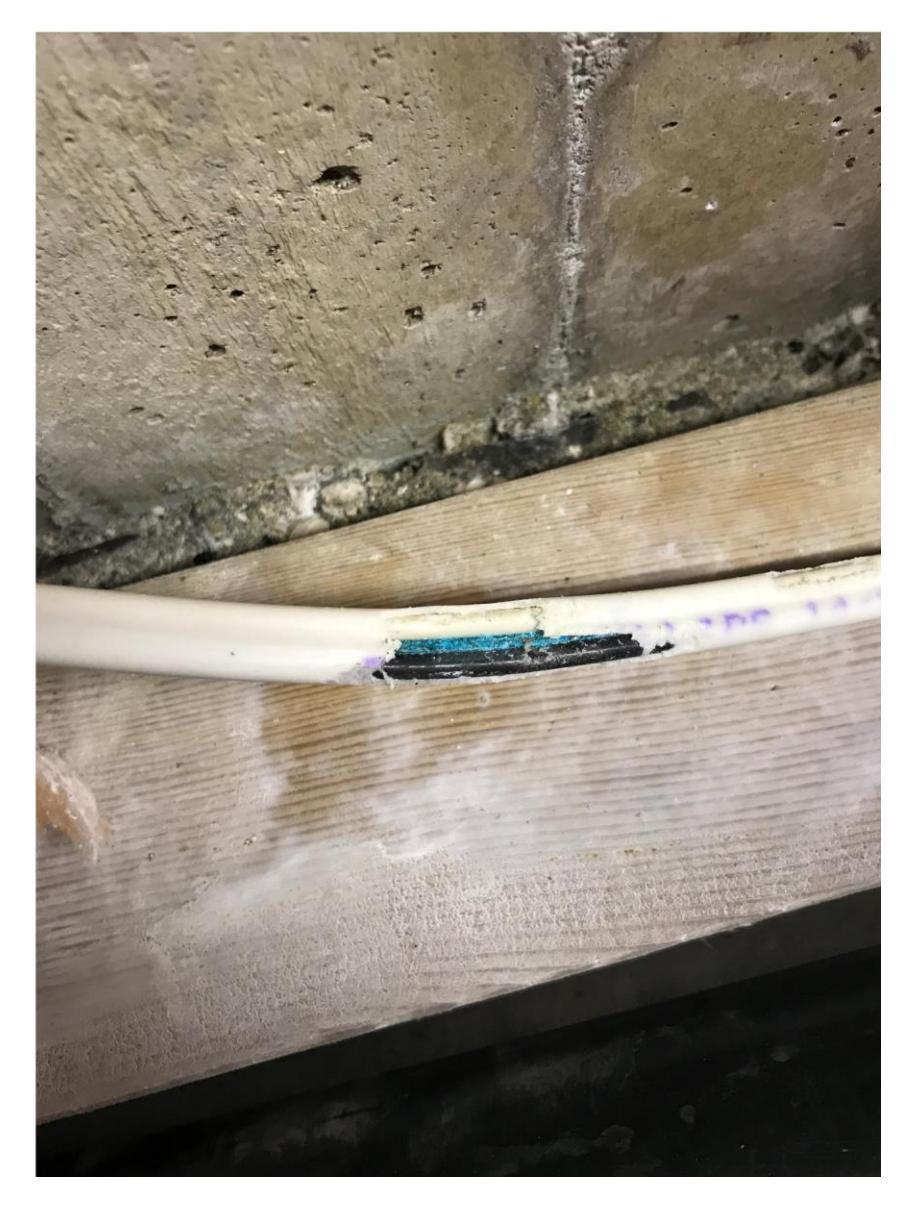
Photo 7: Rodent damaged wire in the same wall as the burnt receptacle, notice the heavy corrosion of the bare bonding conductor.

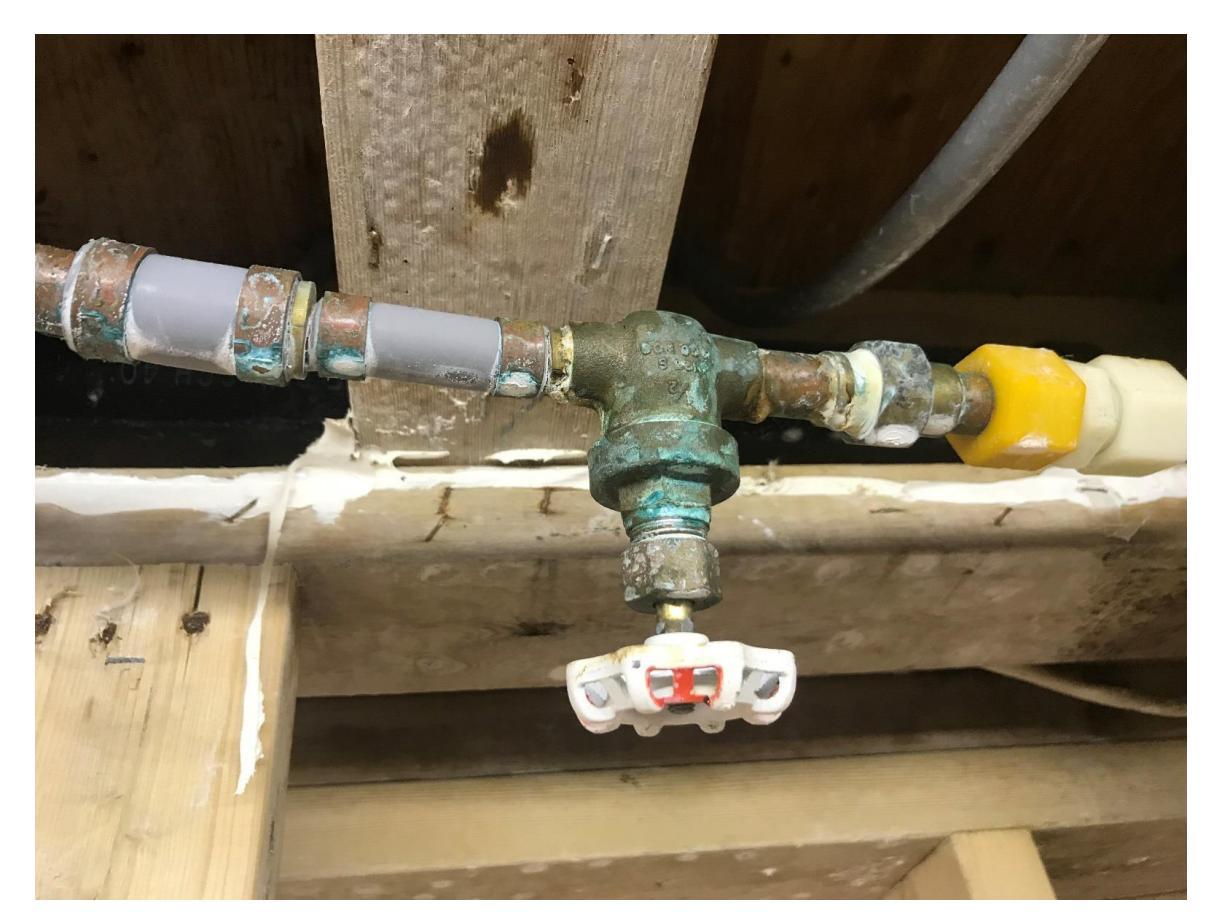
Photo 8: Brass and copper plumbing fittings show corrosion.

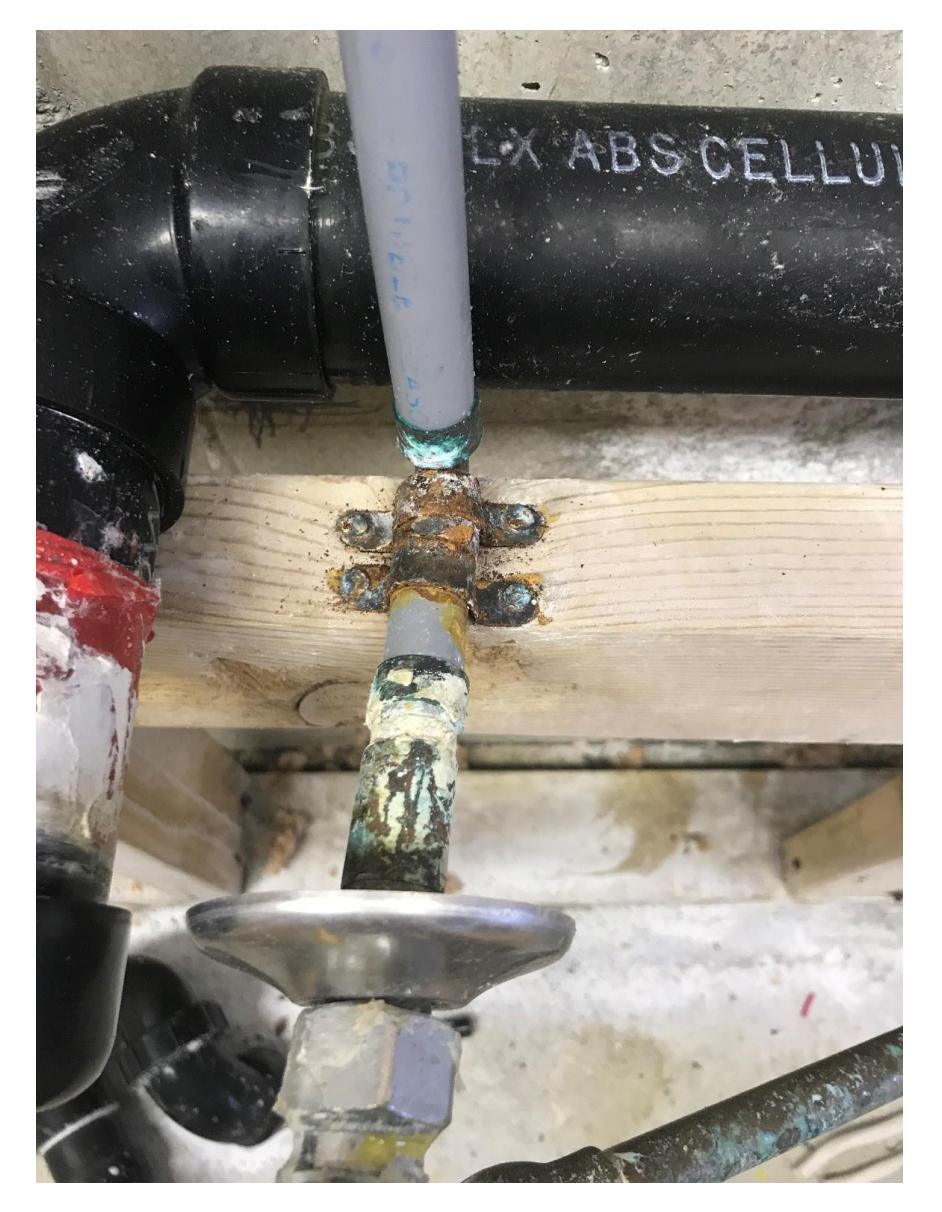
Photo 9: Copper and steel plumbing fittings corroded.
